## Profile/Photo Observation Report

Street:	<b>Summerlin</b>	Flow Control:	<b>Not Controlled</b>
City:	<b>Hobart, IN</b>	Year Renewed:	
Location:	<b>Light Highway</b>	Tape/Media #:	
Purpose:	<b>Not Known</b>	Dia/Height:	<b>8"</b>
Use:	<b>Sanitary</b>	Material:	<b>VCP</b>
Drain Area:	<b>NA</b>	Lining:	
Category:	<b>NA</b>		
Comment:

Location Details:		Direction of Survey:	<b>Downstream</b>
US MH:	<b>M-404-010</b>	DS MH:	<b>M-404-009</b>
		Total Length Surveyed (ft):	<b>6.7</b>

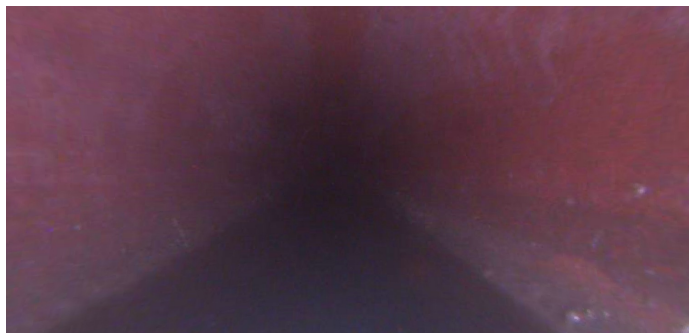
Code: **AMH**  
Description: **Manhole**

Distance (ft): **.0**  
Structural Grade: **0**  
O&M Grade: **0**  
Clock Start/From:  
Clock To:  
1st Value:  
2nd Value:  
Value Percent:  
Continuous Index:  
Within 8" of Joint: **NO**  
Remarks: **M-404-010**

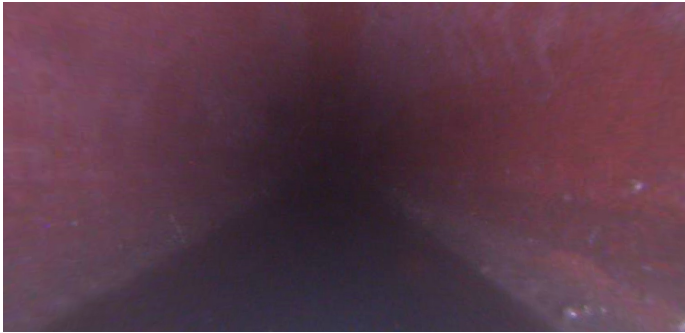
Code:	<b>MWL</b>
Description:	<b>Water Level</b>

Distance (ft):	<b>.0</b>
Structural Grade:	<b>0</b>
O&M Grade:	<b>0</b>
Clock Start/From:	
Clock To:	
1st Value:	
2nd Value:	
Value Percent:	<b>20.000</b>
Continuous Index:	
Within 8" of Joint:	<b>NO</b>
Remarks:

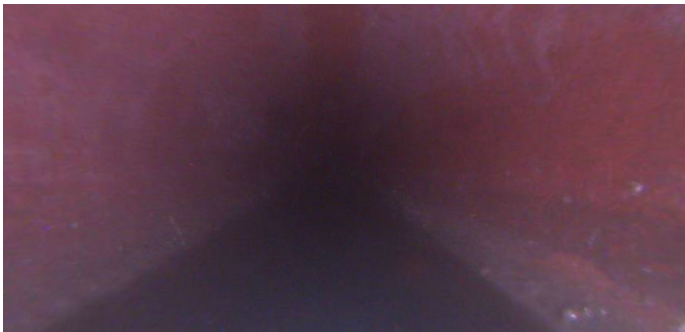
Code:	<b>MSA</b>
Description:	<b>Abandoned Survey</b>

Distance (ft):	<b>.0</b>
Structural Grade:	<b>0</b>
O&M Grade:	<b>0</b>
Clock Start/From:	
Clock To:	
1st Value:	
2nd Value:	
Value Percent:	
Continuous Index:	
Within 8" of Joint:	<b>NO</b>
Remarks:	<b>no mobility</b>
