Profile/Photo Observation Report

Date:	04/19/2018	Weather:		Coding:	PACP 6.0
Pipe Length (ft):	164.3	Owner:	NA	Pre Clean:	Not Known
P.O.#:		Surveyor:	Byrd Fitzgerald	PSR:	P-404-010-009
Customer:		Clean Date:	01/01/1900	Shape:	C

Location Details:		Direction of Survey:	Upstream
US MH:	M-404-010	DS MH:	M-404-009
		Total Length Surveyed (ft):	30.0

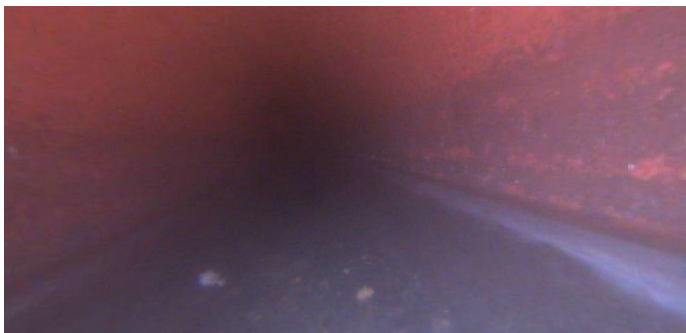
Code: **AMH**
Description: **Manhole**

Distance (ft): **.0**
Structural Grade: **0**
O&M Grade: **0**
Clock Start/From:
Clock To:
1st Value:
2nd Value:
Value Percent:
Continuous Index:
Within 8" of Joint: **NO**
Remarks: **M-404-010**

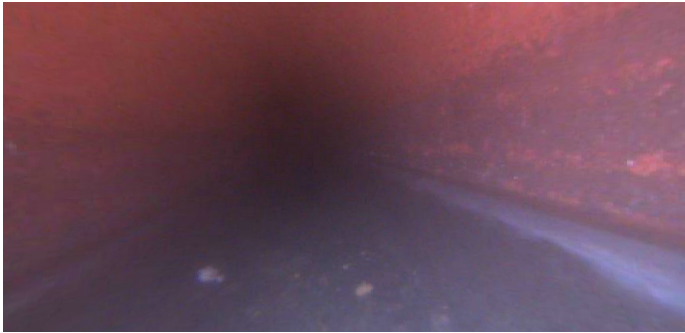
Code:	MWL
Description:	Water Level

Distance (ft):	.0
Structural Grade:	0
O&M Grade:	0
Clock Start/From:	
Clock To:	
1st Value:	
2nd Value:	
Value Percent:	10.000
Continuous Index:	
Within 8" of Joint:	NO
Remarks:

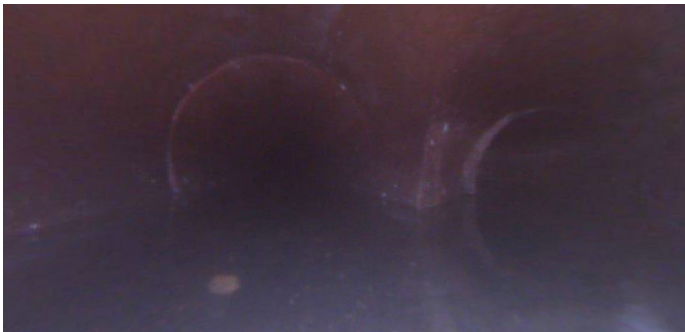
Code:	TF
Description:	Tap Factory

Distance (ft):	9.9
Structural Grade:	0
O&M Grade:	0
Clock Start/From:	3
Clock To:	
1st Value:	4.000
2nd Value:	
Value Percent:	
Continuous Index:	
Within 8" of Joint:	YES
Remarks:

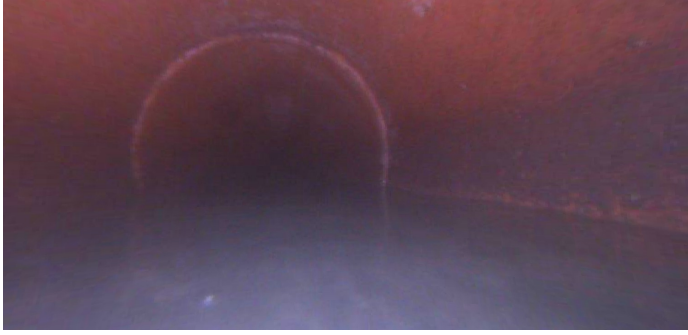
Code:	MSA
Description:	Abandoned Survey
Distance (ft):	30.0
Structural Grade:	0
O&M Grade:	0
Clock Start/From:	
Clock To:	
1st Value:	
2nd Value:	
Value Percent:	
Continuous Index:	
Within 8" of Joint:	NO
Remarks:	no blockage
