## **Profile/Photo Observation Report**

Date:	10/23/2021	Weather:		Coding:	PACP 7.0
Pipe Length (ft)	: <b>88.8</b>	Owner:	City of Hobart	Pre Clean:	<b>Heavy Cleaning</b>
P.O.#:	YES502259	Surveyor:	S. Bucklin	PSR:	P-404-011-010
Customer:	City of Hobart	Clean Date:	10/22/2021	Shape:	С
Street:	North Wabash Stre	et	Flow Control:	Not Controlled	ı
City:	Hobart, IN		Year Renewed:		
Location:	Local rural streets v	with light traffic	, t Tape/Media #:		
Purpose:	Routine Assessmen	nt	Dia/Height:	8"	
Use:	Sanitary Sewage Pi	pe	Material:	VCP	
Drain Area:			Lining:	None	
Category:	NA				
Comment:					
Location Details	5:		Direction of Survey:	Upstream	
US MH:	M-404-011	DS MH:	M-404-010	Total Length Surveyed (ft	): <b>88.8</b>

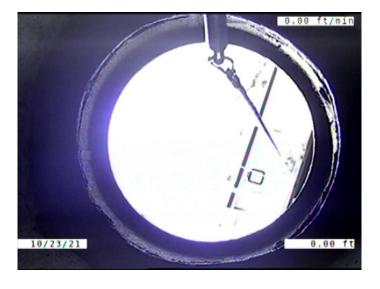
Code: Description:	AMH Manhole		
Distance (ft):	.0		
Structural Grade:	0		
O&M Grade:	0		
Clock Start/From:			
Clock To:			
1st Value:			
2nd Value:			
Value Percent:			
Continuous Index:			
Within 8" of Joint:	NO		
Remarks:	M-404-010

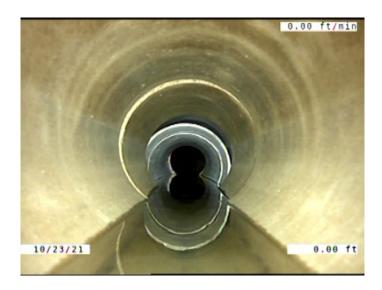
Code: MWL

Description: Miscellaneous Water Level

Distance (ft): .0
Structural Grade: 0
O&M Grade: 0

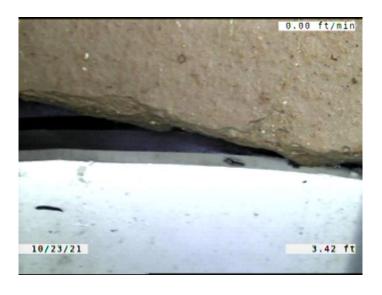
Code: MMC

Description: Miscellaneous Material Change

Distance (ft): 3.4
Structural Grade: 0

Remarks: VCP TO PVC

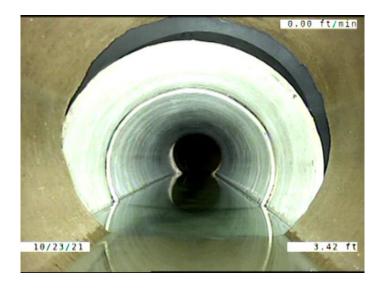
Code: JOL

Description: Joint Offset Large

Distance (ft): 3.4
Structural Grade: 4

1st Value: **1.000**

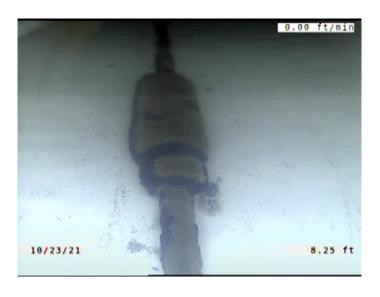
Code: OBZ

Description: Obstruction Other

Distance (ft): 8.2
Structural Grade: 0
O&M Grade: 2
Clock Start/From: 5
Clock To: 7
1st Value:

Remarks: LOOKS TO BE A SEWER RODDER.

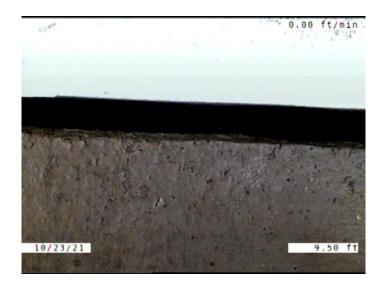
Code: MMC

Description: Miscellaneous Material Change

Distance (ft): 9.5
Structural Grade: 0

Remarks: PVC TO VCP

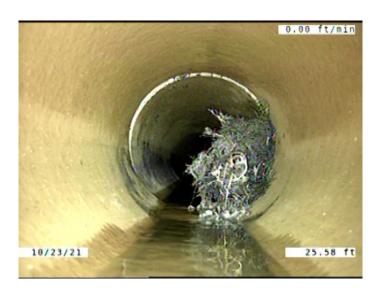
Code: RMJ

Description: Roots Medium Joint

Distance (ft): 25.6
Structural Grade: 0

O&M Grade: 3

Value Percent: **35.000**

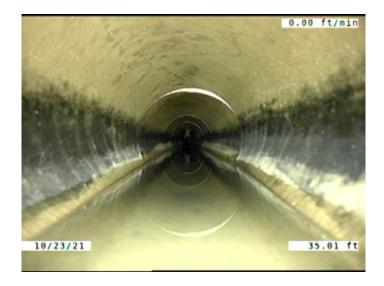
Code: MWLS

Description: Miscellaneous Water Level Sag

Distance (ft): 35.0 Structural Grade: 2

Value Percent: 10.000
Continuous Index: S01
Within 8" of Joint: NO

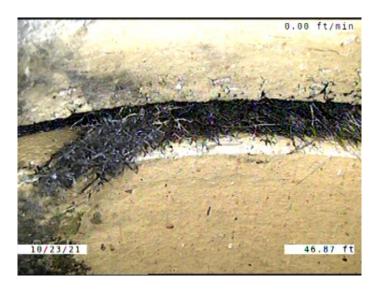
Code: RFJ

Description: Roots Fine Joint

Distance (ft): 46.9
Structural Grade: 0
O&M Grade: 1
Clock Start/From: 8
Clock To: 4
1st Value:
2nd Value:
Value Percent:
Continuous Index:

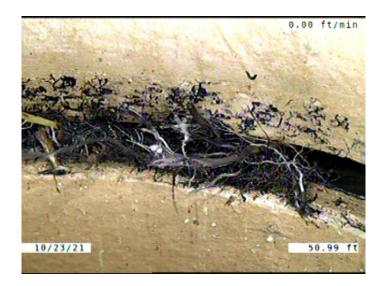
Code: RMJ

Description: Roots Medium Joint

Distance (ft): 51.0
Structural Grade: 0
O&M Grade: 3
Clock Start/From: 9
Clock To: 3

Value Percent: 5.000

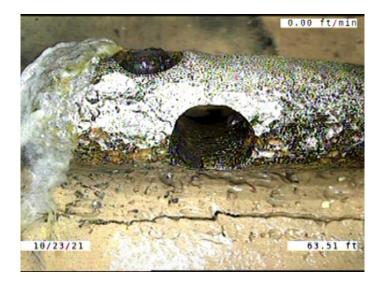
Code: OBZ

Description: Obstruction Other

Distance (ft): 63.5
Structural Grade: 0
O&M Grade: 2
Clock Start/From: 4
Clock To: 6

Remarks: LOOKS TO BE PART OF A SEWER

RODDER

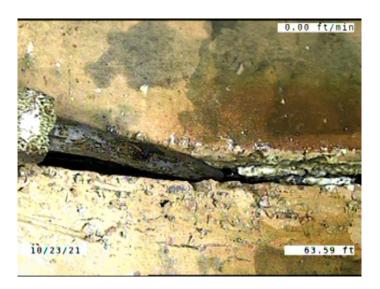
Code: IWJ

Description: Infiltration Weeper Joint

Distance (ft): 63.6
Structural Grade: 0

O&M Grade: 2

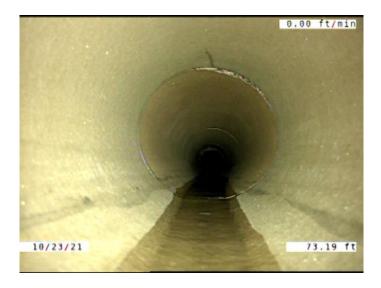
Code: **MWLS**

Description: **Miscellaneous Water Level Sag**

73.2 Distance (ft): Structural Grade: 2 0 O&M Grade:

Value Percent: 10.000 F01 Continuous Index: Within 8" of Joint: NO

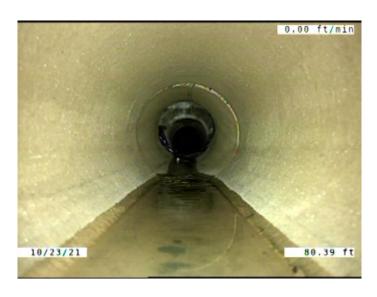
Code: **MWLS**

Description: **Miscellaneous Water Level Sag**

Distance (ft): 80.4 Structural Grade: 2 O&M Grade: 0

Value Percent: 5.000

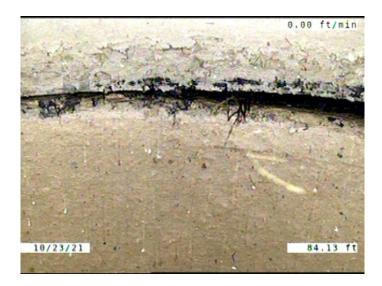
Code: RFJ

Description: Roots Fine Joint

Distance (ft): 84.1
Structural Grade: 0

O&M Grade: 1

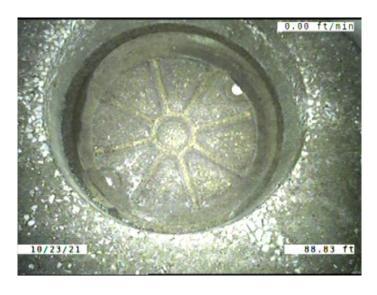
Code: AMH
Description: Manhole

Distance (ft): 88.8
Structural Grade: 0
O&M Grade: 0

Remarks: M-404-011
