Profile/Photo Observation Report

Street:	ALLEY BETWEEN DEARBORN ST & N	Flow Control:	Not Controlled
City:	Hobart, IN	Year Renewed:	
Location:	Light Highway	Tape/Media #:	
Purpose:	Not Known	Dia/Height:	8"
Use:	Sanitary	Material:	VCP
Drain Area:	NA	Lining:	
Category:	NA		
Comment:

Location Details:		Direction of Survey:	Downstream
US MH:	M-404-012	DS MH:	M-404-011
		Total Length Surveyed (ft):	27.3

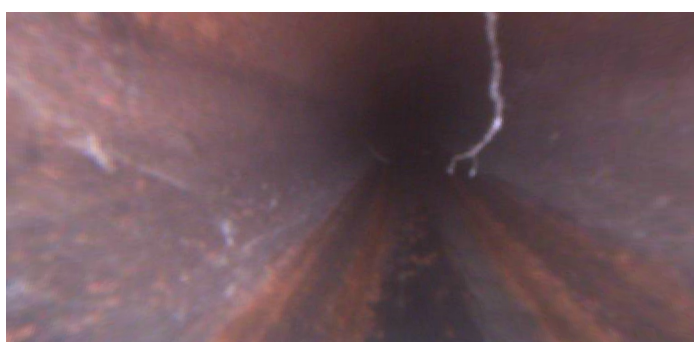
Code: **AMH**
Description: **Manhole**

Distance (ft): **.0**
Structural Grade: **0**
O&M Grade: **0**
Clock Start/From:
Clock To:
1st Value:
2nd Value:
Value Percent:
Continuous Index:
Within 8" of Joint: **NO**
Remarks: **M-404-012**

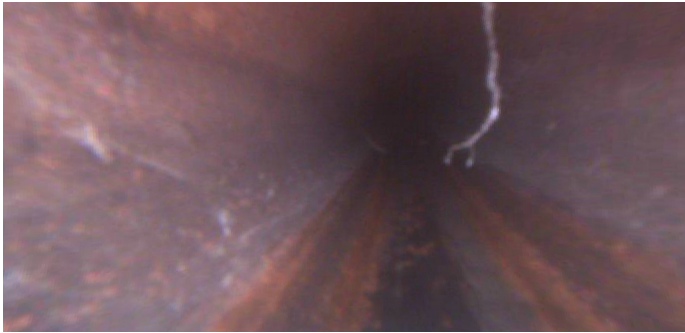
Code:	MWL
Description:	Water Level

Distance (ft):	.0
Structural Grade:	0
O&M Grade:	0
Clock Start/From:	
Clock To:	
1st Value:	
2nd Value:	
Value Percent:	5.000
Continuous Index:	
Within 8" of Joint:	NO
Remarks:

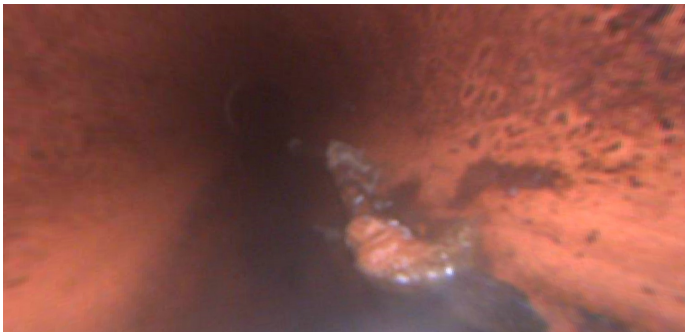
Code:	OBR
Description:	Obstacle Rocks

Distance (ft):	26.1
Structural Grade:	0
O&M Grade:	2
Clock Start/From:	6
Clock To:	
1st Value:	
2nd Value:	
Value Percent:	5.000
Continuous Index:	
Within 8" of Joint:	NO
Remarks:	rock?
