## Profile/Photo Observation Report

| Street: | <b>Summerlin</b> | Flow Control: | <b>Not Controlled</b> |
| City: | <b>Hobart, IN</b> | Year Renewed: | |

| US MH: | <b>M-404-012</b> | DS MH: | <b>M-404-011</b> |

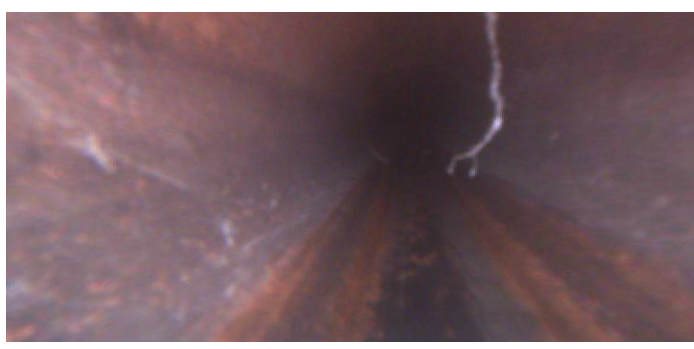
Code: **AMH**  
Description: **Manhole**

Distance (ft): **.0**  
Structural Grade: **0**  
O&M Grade: **0**  
Clock Start/From:  
Clock To:  
1st Value:  
2nd Value:  
Value Percent:  
Continuous Index:  
Within 8" of Joint: **NO**  
Remarks: **M-404-012**

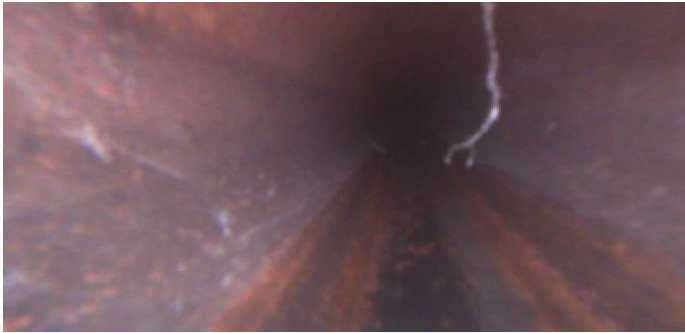
| Code: | <b>MWL</b> |
| Description: | <b>Water Level</b> |

| Value Percent: | <b>5.000</b> |

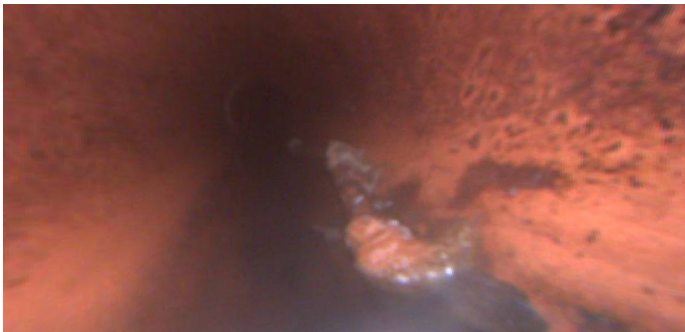
| | Position | Code | Observation | Video (sec) | Grade |
|--|---|---|---|---|---|
| | 26.1 | OBR | Obstacle Rocks | 85 | M 2 |

| Code: | <b>OBR</b> |
| Description: | <b>Obstacle Rocks</b> |

| Distance (ft): | <b>26.1</b> |
| O&M Grade: | <b>2</b> |
| Clock Start/From: | <b>6</b> |
| Remarks: | <b>rock?</b> |
