Profile/Photo Observation Report

Date:	10/23/2021	Weather:		Coding:	PACP 7.0
Pipe Length (ft):	197.2	Owner:	City of Hobart	Pre Clean:	Heavy Cleaning
P.O.#:	YES502259	Surveyor:	S. Bucklin	PSR:	P-404-012-011
Customer:	City of Hobart	Clean Date:	10/22/2021	Shape:	C

Street:	North Wabash Street	Flow Control:	Not Controlled
City:	Hobart, IN	Year Renewed:	
Location:	Woods	Tape/Media #:	
Purpose:	Routine Assessment	Dia/Height:	8"
Use:	Sanitary Sewage Pipe	Material:	VCP
Drain Area:		Lining:	None
Category:	NA		
Comment:			
Location Details:		Direction of Survey:	Upstream
US MH:	M-404-012	DS MH:	M-404-011
		Total Length Surveyed (ft):	197.2

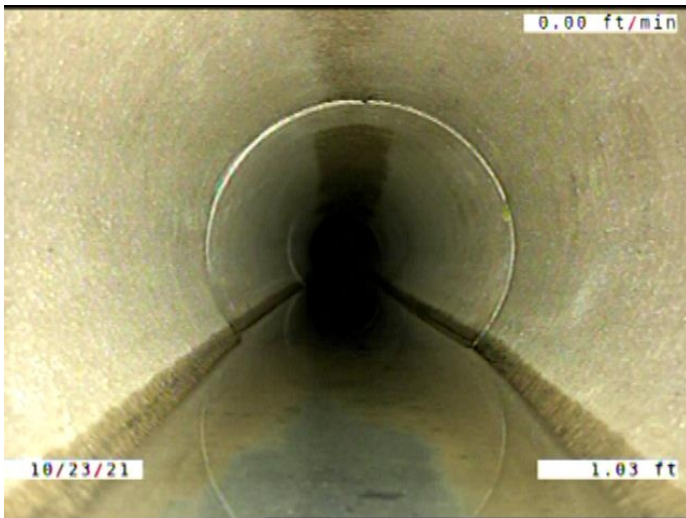
Code: **DSF**
Description: **Deposits Settled Fine**

Distance (ft): **1.0**
Structural Grade: **0**
O&M Grade: **2**
Clock Start/From: **5**
Clock To: **7**
1st Value:
2nd Value:
Value Percent: **5.000**
Continuous Index: **S01**
Within 8" of Joint: **YES**
Remarks:

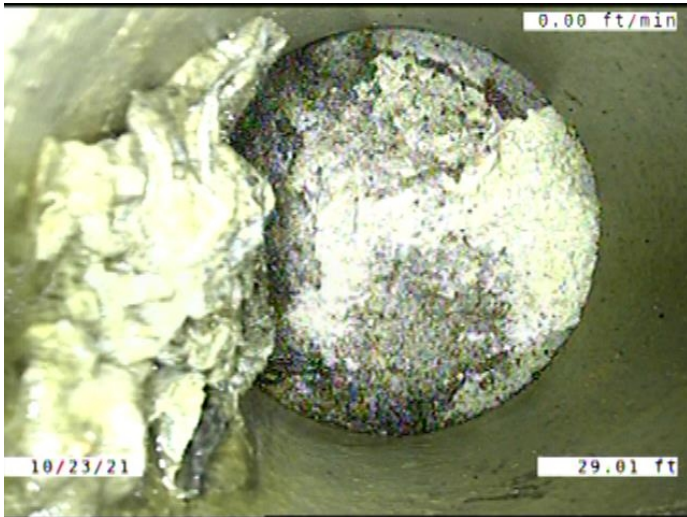
Code: **TFD**
Description: **Tap Factory Defective**

Distance (ft): **29.0**
Structural Grade: **0**
O&M Grade: **3**
Clock Start/From: **9**
Clock To:
1st Value: **4.000**
2nd Value:
Value Percent:
Continuous Index:
Within 8" of Joint: **YES**
Remarks: **ENCrustATION AROUND THE CAP.
CONSTANTLY LEAKING WATER**

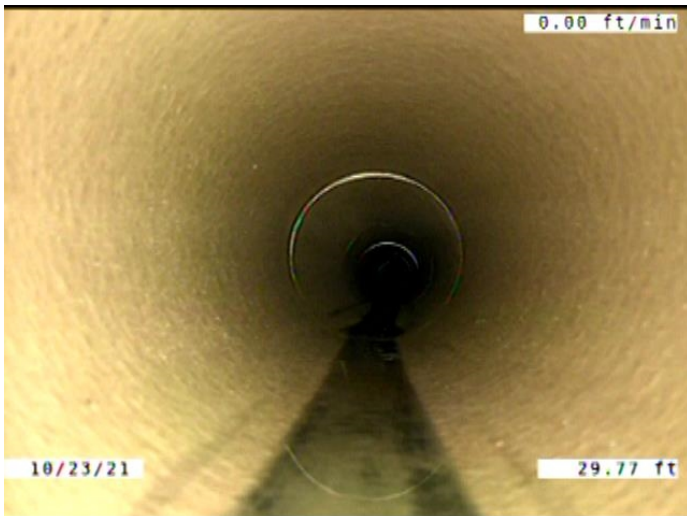
Code: **DSF**
Description: **Deposits Settled Fine**

Distance (ft): **29.8**
Structural Grade: **0**
O&M Grade: **2**
Clock Start/From: **5**
Clock To: **7**
1st Value:
2nd Value:
Value Percent: **5.000**
Continuous Index: **F01**
Within 8" of Joint: **YES**
Remarks:

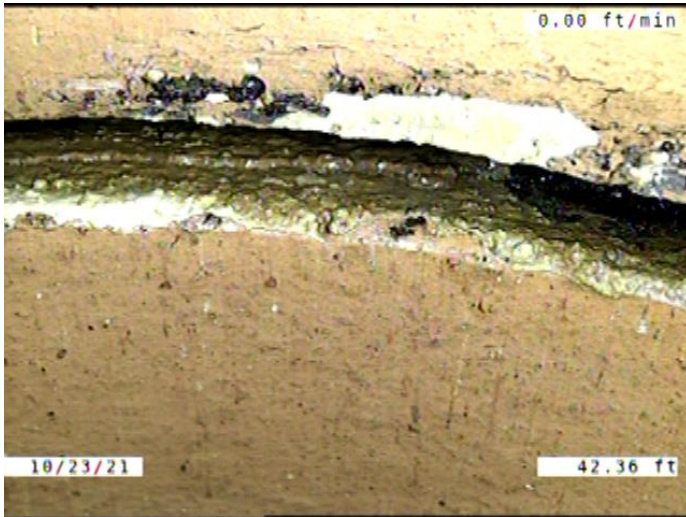
Code: **DAE**
Description: **Deposits Attached Encrustation**

Distance (ft): **42.4**
Structural Grade: **0**
O&M Grade: **2**
Clock Start/From: **9**
Clock To: **3**
1st Value:
2nd Value:
Value Percent: **5.000**
Continuous Index:
Within 8" of Joint: **YES**
Remarks:

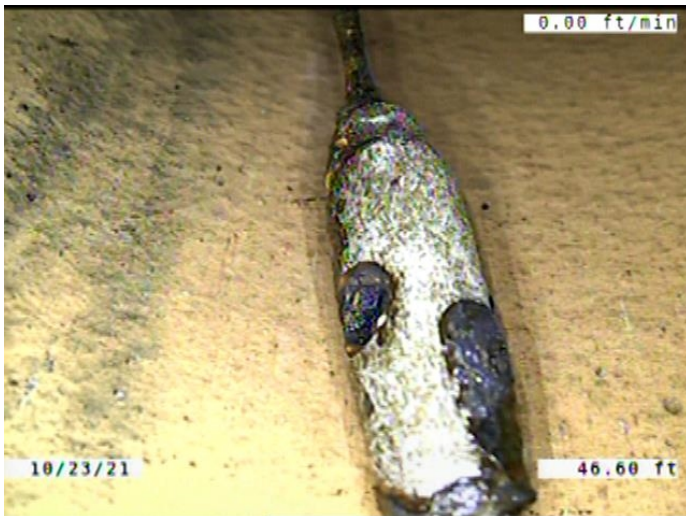
Code: **OBZ**
Description: **Obstruction Other**

Distance (ft): **46.6**
Structural Grade: **0**
O&M Grade: **2**
Clock Start/From: **5**
Clock To: **9**
1st Value:
2nd Value:
Value Percent: **5.000**
Continuous Index: **S02**
Within 8" of Joint: **YES**
Remarks: **LOOKS LIKE A SEWER RODDER**

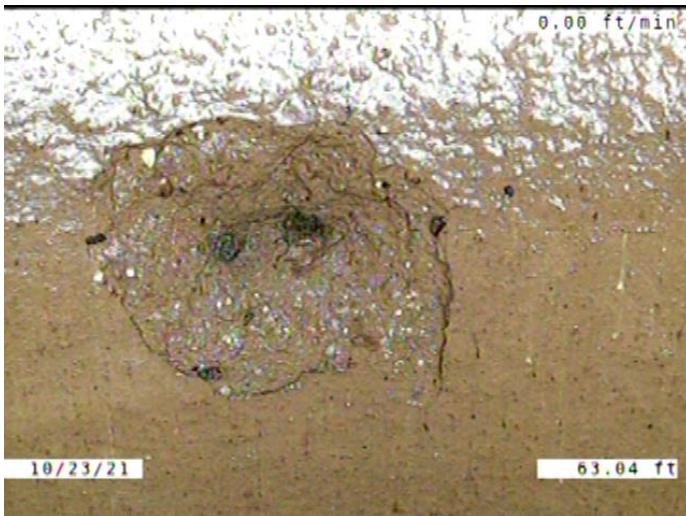
Code: **SSS**
Description: **Surface Damage Surface Spalling**

Distance (ft): **63.0**
Structural Grade: **2**
O&M Grade: **0**
Clock Start/From: **12**
Clock To:
1st Value:
2nd Value:
Value Percent:
Continuous Index:
Within 8" of Joint: **YES**
Remarks:

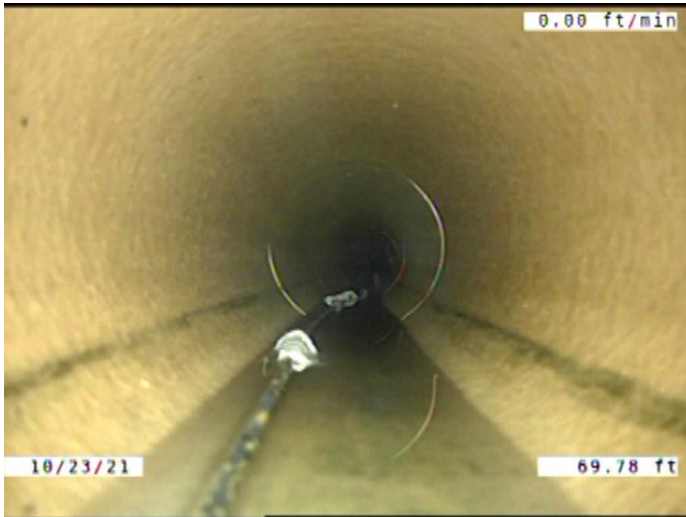
Code: **MWLS**
 Description: **Miscellaneous Water Level Sag**

Distance (ft): **69.8**
 Structural Grade: **2**
 O&M Grade: **0**
 Clock Start/From:
 Clock To:
 1st Value:
 2nd Value:
 Value Percent: **5.000**
 Continuous Index:
 Within 8" of Joint: **NO**
 Remarks:

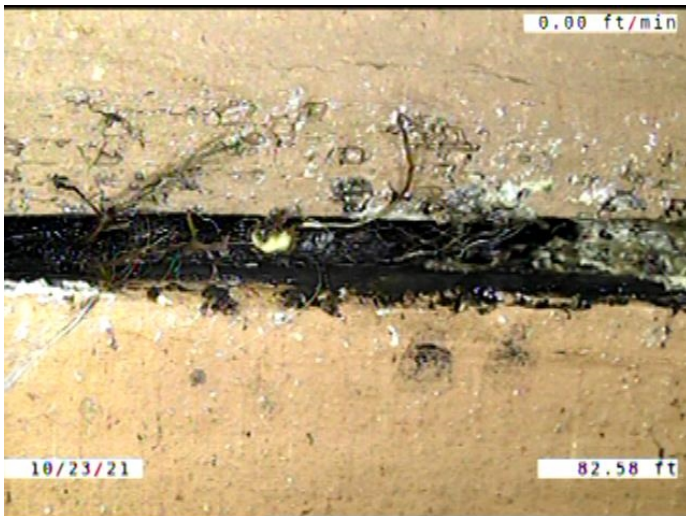
Code: **RFJ**
 Description: **Roots Fine Joint**

Distance (ft): **82.6**
 Structural Grade: **0**
 O&M Grade: **1**
 Clock Start/From: **9**
 Clock To: **3**
 1st Value:
 2nd Value:
 Value Percent:
 Continuous Index: **S03**
 Within 8" of Joint: **YES**
 Remarks:

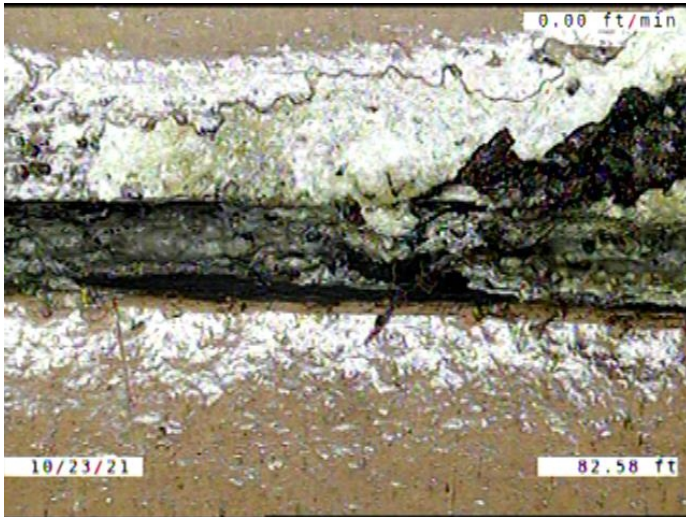
Code: **DAE**
 Description: **Deposits Attached Encrustation**

Distance (ft): **82.6**
 Structural Grade: **0**
 O&M Grade: **2**
 Clock Start/From: **9**
 Clock To: **3**
 1st Value:
 2nd Value:
 Value Percent: **5.000**
 Continuous Index:
 Within 8" of Joint: **YES**
 Remarks:

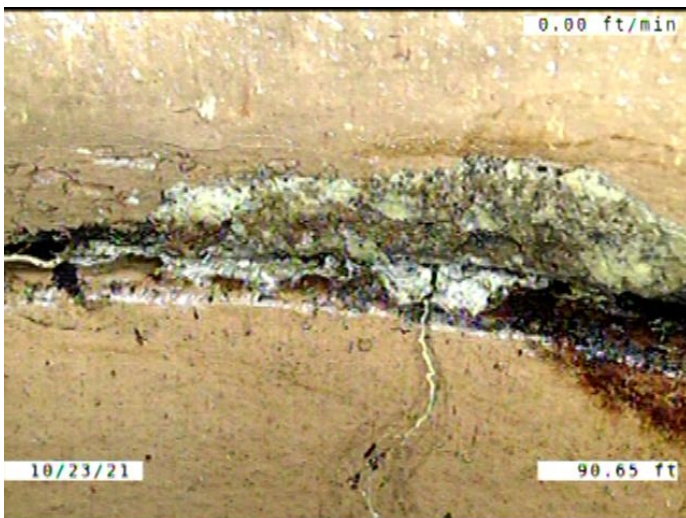
Code: **DAE**
 Description: **Deposits Attached Encrustation**

Distance (ft): **90.7**
 Structural Grade: **0**
 O&M Grade: **2**
 Clock Start/From: **9**
 Clock To: **3**
 1st Value:
 2nd Value:
 Value Percent: **5.000**
 Continuous Index:
 Within 8" of Joint: **YES**
 Remarks:

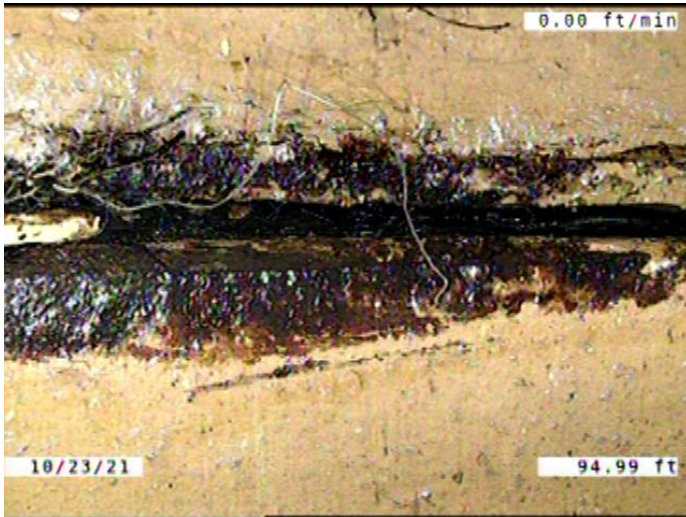
Code: **ISJ**
 Description: **Infiltration Stain Joint**

Distance (ft): **95.0**
 Structural Grade: **0**
 O&M Grade: **1**
 Clock Start/From: **9**
 Clock To: **11**
 1st Value:
 2nd Value:
 Value Percent:
 Continuous Index:
 Within 8" of Joint: **YES**
 Remarks:

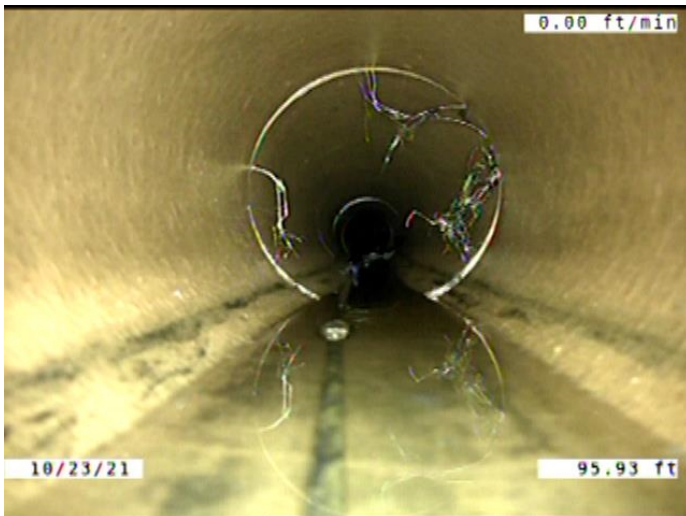
Code: **MWLS**
 Description: **Miscellaneous Water Level Sag**

Distance (ft): **95.9**
 Structural Grade: **2**
 O&M Grade: **0**
 Clock Start/From:
 Clock To:
 1st Value:
 2nd Value:
 Value Percent: **5.000**
 Continuous Index:
 Within 8" of Joint: **NO**
 Remarks:

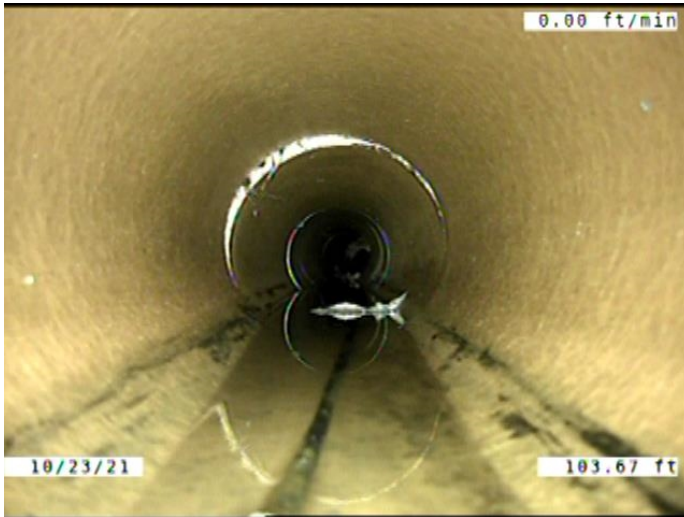
Code: **MWLS**
Description: **Miscellaneous Water Level Sag**

Distance (ft): **103.7**
Structural Grade: **2**
O&M Grade: **0**
Clock Start/From:
Clock To:
1st Value:
2nd Value:
Value Percent: **5.000**
Continuous Index: **S04**
Within 8" of Joint: **NO**
Remarks:

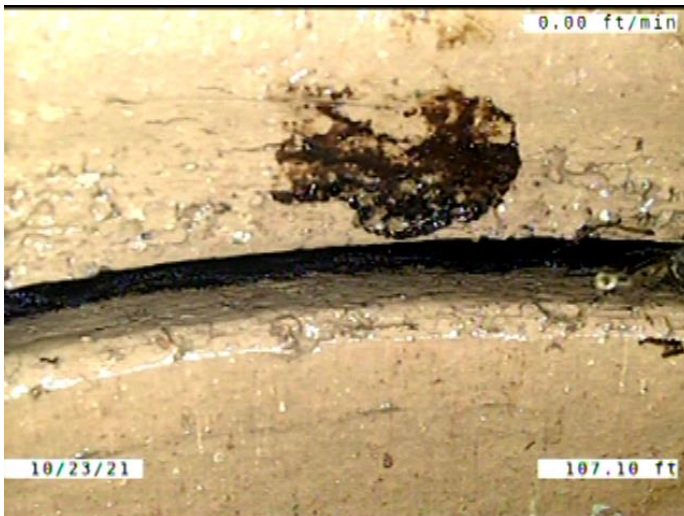
Code: **ISJ**
Description: **Infiltration Stain Joint**

Distance (ft): **107.1**
Structural Grade: **0**
O&M Grade: **1**
Clock Start/From: **10**
Clock To: **3**
1st Value:
2nd Value:
Value Percent:
Continuous Index:
Within 8" of Joint: **YES**
Remarks:

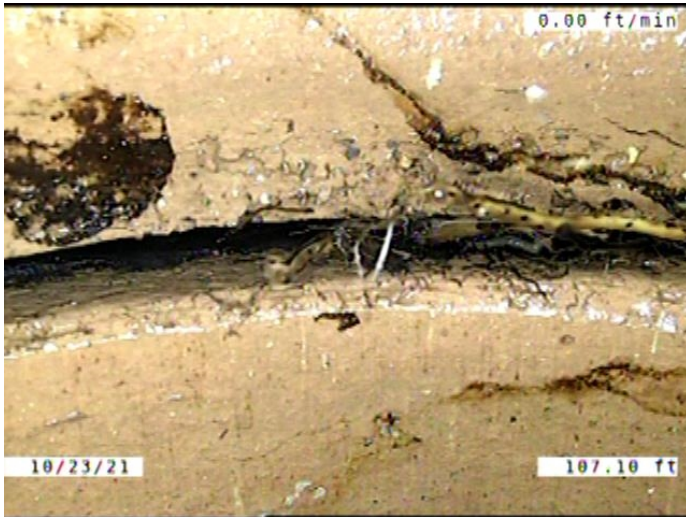
Code: **IDJ**
Description: **Infiltration Dripper Joint**

Distance (ft): **107.1**
Structural Grade: **0**
O&M Grade: **3**
Clock Start/From: **10**
Clock To: **11**
1st Value:
2nd Value:
Value Percent:
Continuous Index:
Within 8" of Joint: **YES**
Remarks:

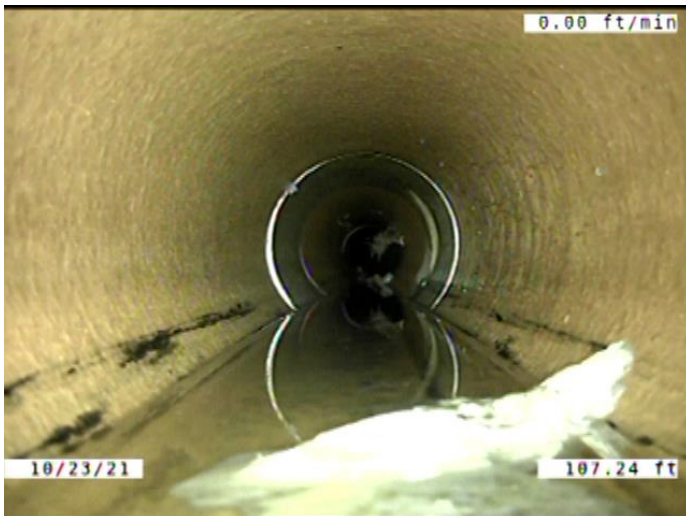
Code: **DSF**
Description: **Deposits Settled Fine**

Distance (ft): **107.2**
Structural Grade: **0**
O&M Grade: **2**
Clock Start/From: **5**
Clock To: **7**
1st Value:
2nd Value:
Value Percent: **5.000**
Continuous Index: **S05**
Within 8" of Joint: **YES**
Remarks:

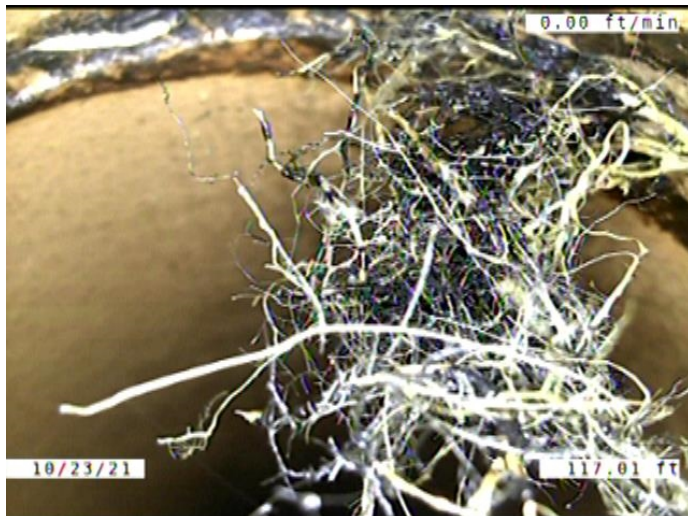
Code: **RMJ**
 Description: **Roots Medium Joint**

Distance (ft): **117.0**
 Structural Grade: **0**
 O&M Grade: **3**
 Clock Start/From: **10**
 Clock To: **3**
 1st Value:
 2nd Value:
 Value Percent: **5.000**
 Continuous Index:
 Within 8" of Joint: **YES**
 Remarks:

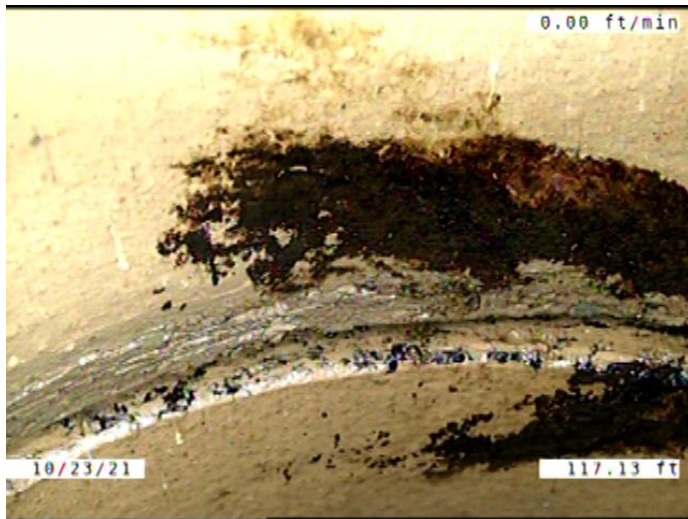
Code: **ISJ**
Description: **Infiltration Stain Joint**

Distance (ft): **117.1**
Structural Grade: **0**
O&M Grade: **1**
Clock Start/From: **9**
Clock To: **3**
1st Value:
2nd Value:
Value Percent:
Continuous Index:
Within 8" of Joint: **YES**
Remarks:

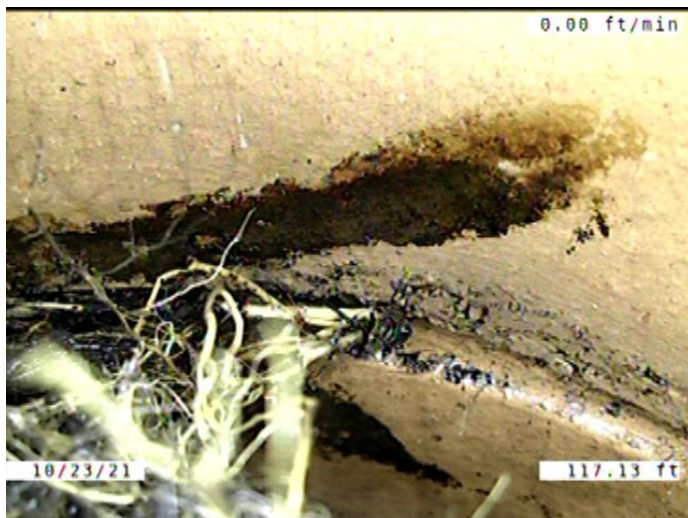
Code: **IWJ**
Description: **Infiltration Weeper Joint**

Distance (ft): **117.1**
Structural Grade: **0**
O&M Grade: **2**
Clock Start/From: **2**
Clock To:
1st Value:
2nd Value:
Value Percent:
Continuous Index:
Within 8" of Joint: **YES**
Remarks:

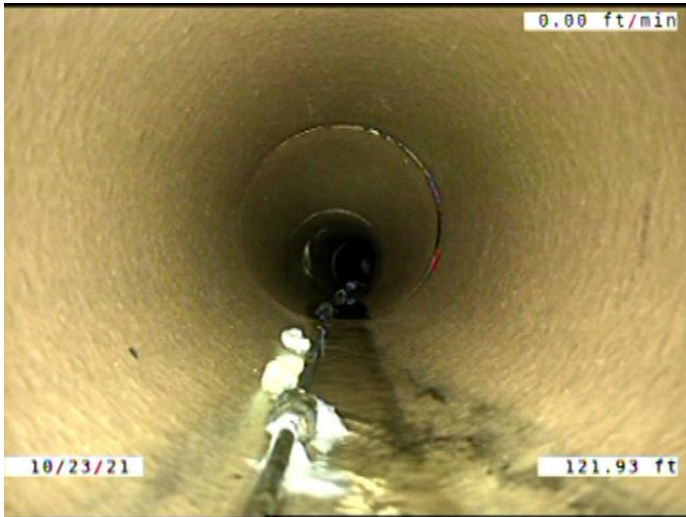
Code: **MWLS**
 Description: **Miscellaneous Water Level Sag**

Distance (ft): **121.9**
 Structural Grade: **2**
 O&M Grade: **0**
 Clock Start/From:
 Clock To:
 1st Value:
 2nd Value:
 Value Percent: **5.000**
 Continuous Index: **F04**
 Within 8" of Joint: **NO**
 Remarks:

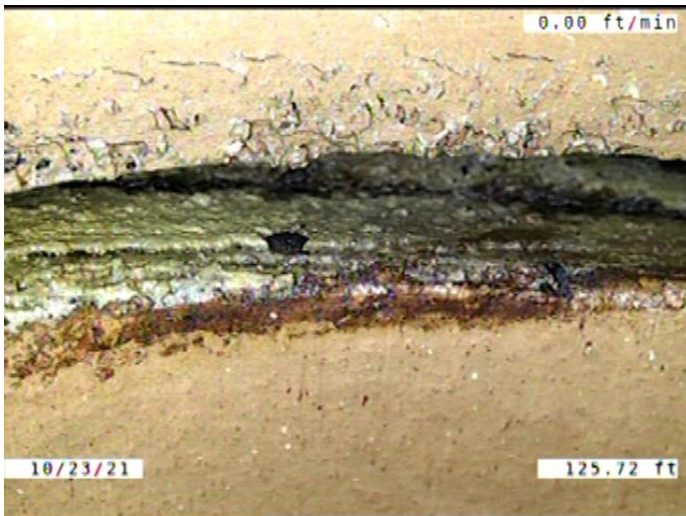
Code: **ISJ**
 Description: **Infiltration Stain Joint**

Distance (ft): **125.7**
 Structural Grade: **0**
 O&M Grade: **1**
 Clock Start/From: **9**
 Clock To: **4**
 1st Value:
 2nd Value:
 Value Percent:
 Continuous Index: **S06**
 Within 8" of Joint: **YES**
 Remarks:

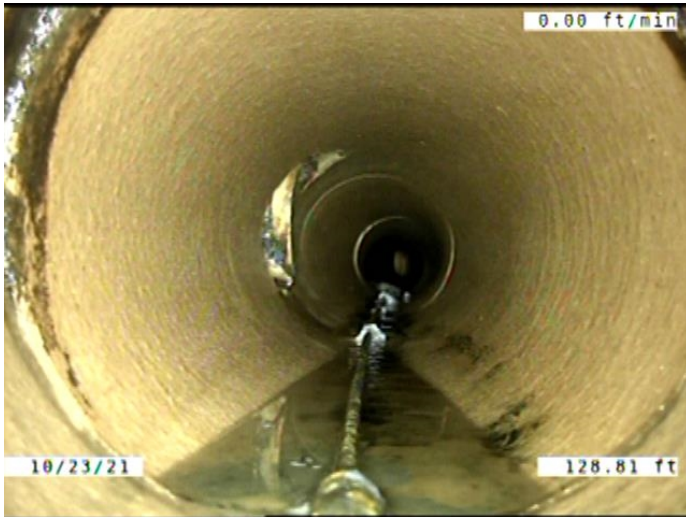
Code: **MWLS**
Description: **Miscellaneous Water Level Sag**

Distance (ft): **128.8**
Structural Grade: **2**
O&M Grade: **0**
Clock Start/From:
Clock To:
1st Value:
2nd Value:
Value Percent: **5.000**
Continuous Index:
Within 8" of Joint: **NO**
Remarks:

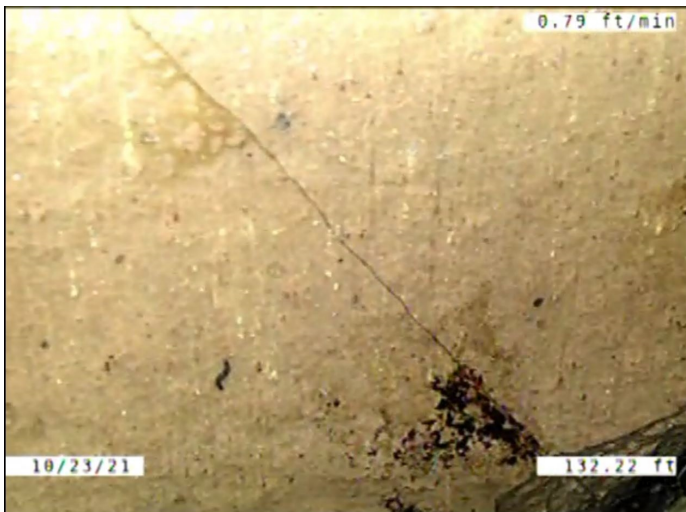
Code: **CL**
Description: **Crack Longitudinal**

Distance (ft): **132.2**
Structural Grade: **2**
O&M Grade: **0**
Clock Start/From: **8**
Clock To:
1st Value:
2nd Value:
Value Percent:
Continuous Index:
Within 8" of Joint: **NO**
Remarks:

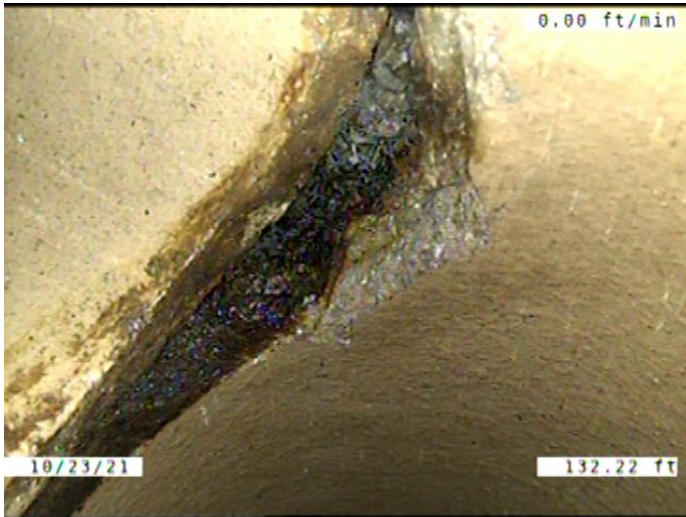
Code: **SSS**
Description: **Surface Damage Surface Spalling**

Distance (ft): **132.2**
Structural Grade: **2**
O&M Grade: **0**
Clock Start/From: **7**
Clock To: **11**
1st Value:
2nd Value:
Value Percent:
Continuous Index:
Within 8" of Joint: **YES**
Remarks:

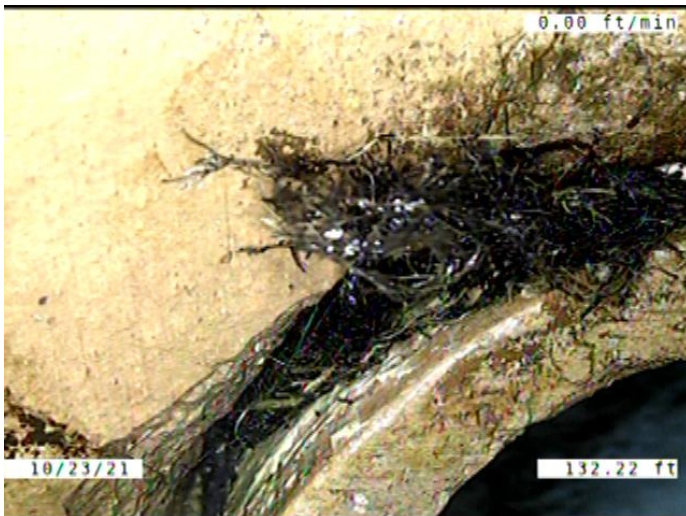
Code: **RFC**
Description: **Roots Fine Connection**

Distance (ft): **132.2**
Structural Grade: **0**
O&M Grade: **1**
Clock Start/From: **9**
Clock To: **11**
1st Value:
2nd Value:
Value Percent:
Continuous Index:
Within 8" of Joint: **NO**
Remarks:

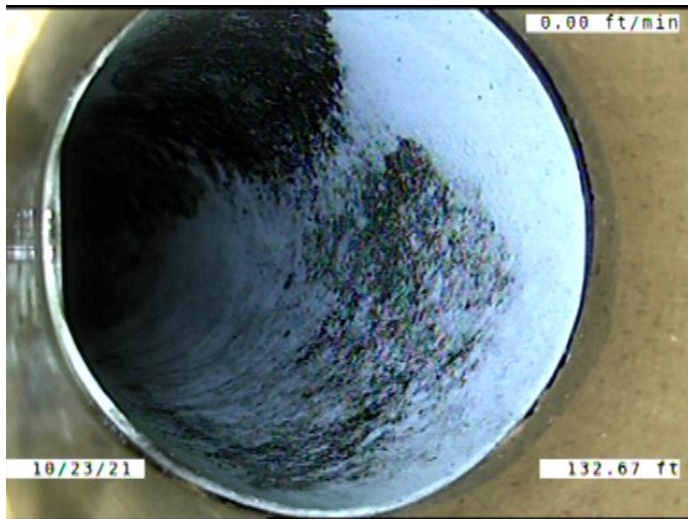
Code: **TBI**
 Description: **Tap Break-in Intruding**

Distance (ft): **132.7**
 Structural Grade: **0**
 O&M Grade: **2**
 Clock Start/From: **10**
 Clock To:
 1st Value: **4.000**
 2nd Value: **1.000**
 Value Percent:
 Continuous Index:
 Within 8" of Joint: **YES**
 Remarks:

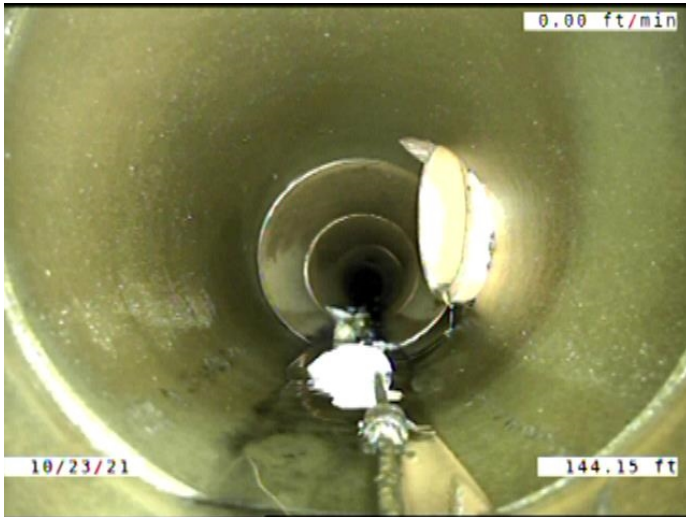
Code: **ISJ**
 Description: **Infiltration Stain Joint**

Distance (ft): **144.2**
 Structural Grade: **0**
 O&M Grade: **1**
 Clock Start/From: **9**
 Clock To: **4**
 1st Value:
 2nd Value:
 Value Percent:
 Continuous Index: **F06**
 Within 8" of Joint: **YES**
 Remarks:

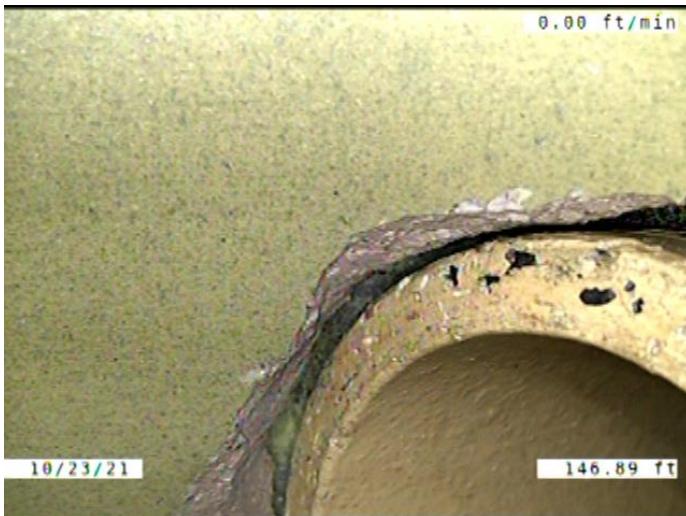
Code: **SSS**
 Description: **Surface Damage Surface Spalling**

Distance (ft): **146.9**
 Structural Grade: **2**
 O&M Grade: **0**
 Clock Start/From: **1**
 Clock To: **4**
 1st Value:
 2nd Value:
 Value Percent:
 Continuous Index:
 Within 8" of Joint: **YES**
 Remarks:

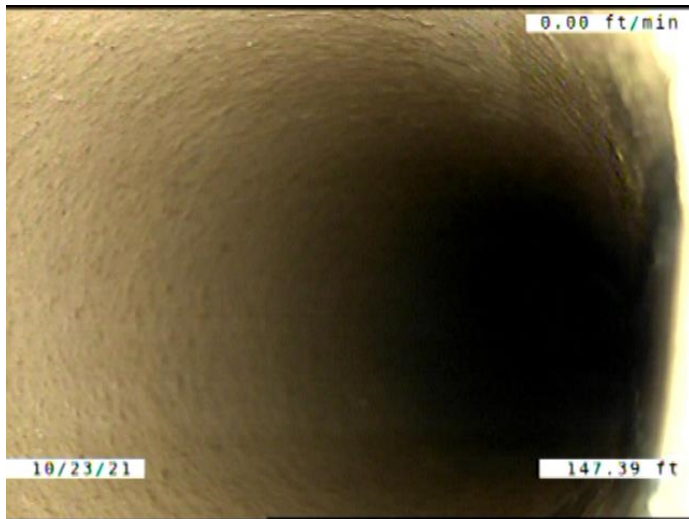
Code: **TBI**
 Description: **Tap Break-in Intruding**

Distance (ft): **147.4**
 Structural Grade: **0**
 O&M Grade: **2**
 Clock Start/From: **2**
 Clock To:
 1st Value: **6.000**
 2nd Value: **2.000**
 Value Percent:
 Continuous Index:
 Within 8" of Joint: **YES**
 Remarks:

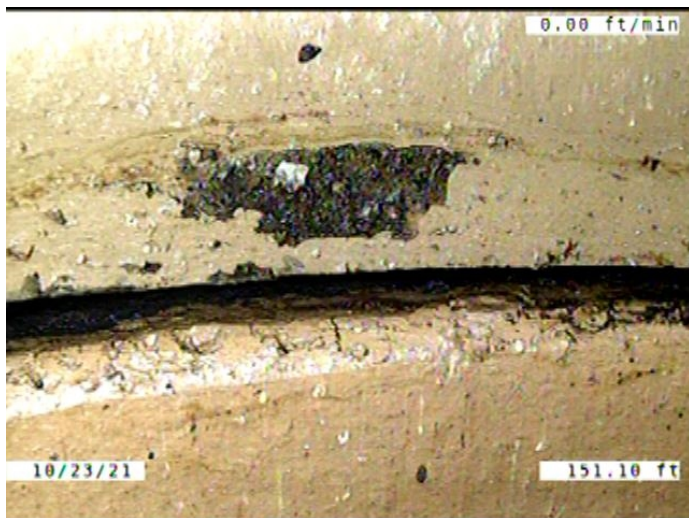
Code: **ISJ**
 Description: **Infiltration Stain Joint**

Distance (ft): **151.1**
 Structural Grade: **0**
 O&M Grade: **1**
 Clock Start/From: **8**
 Clock To: **3**
 1st Value:
 2nd Value:
 Value Percent:
 Continuous Index:
 Within 8" of Joint: **YES**
 Remarks:

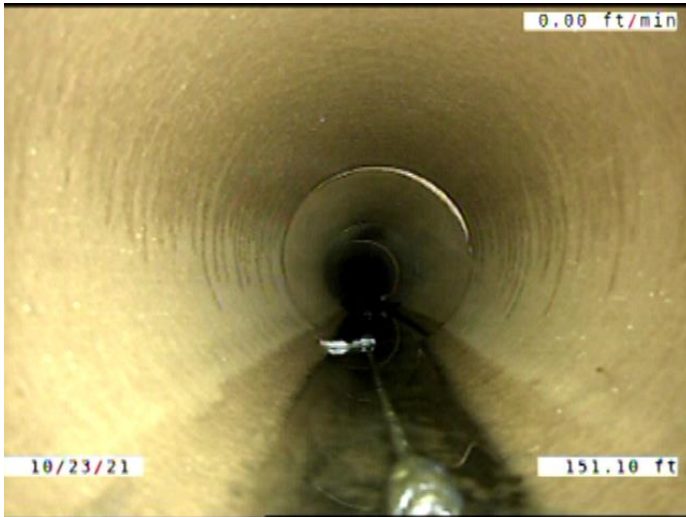
Code: **RFJ**
 Description: **Roots Fine Joint**

Distance (ft): **151.1**
 Structural Grade: **0**
 O&M Grade: **1**
 Clock Start/From: **9**
 Clock To: **3**
 1st Value:
 2nd Value:
 Value Percent:
 Continuous Index: **F03**
 Within 8" of Joint: **YES**
 Remarks:

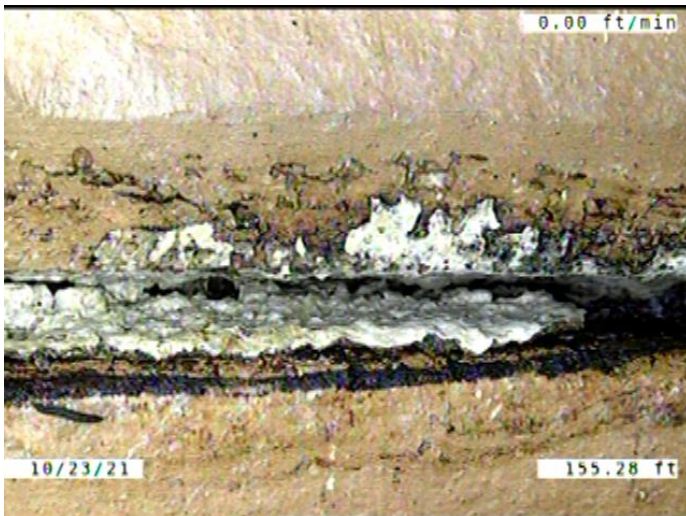
Code: **DAE**
 Description: **Deposits Attached Encrustation**

Distance (ft): **155.3**
 Structural Grade: **0**
 O&M Grade: **2**
 Clock Start/From: **9**
 Clock To: **11**
 1st Value:
 2nd Value:
 Value Percent: **5.000**
 Continuous Index:
 Within 8" of Joint: **YES**
 Remarks:

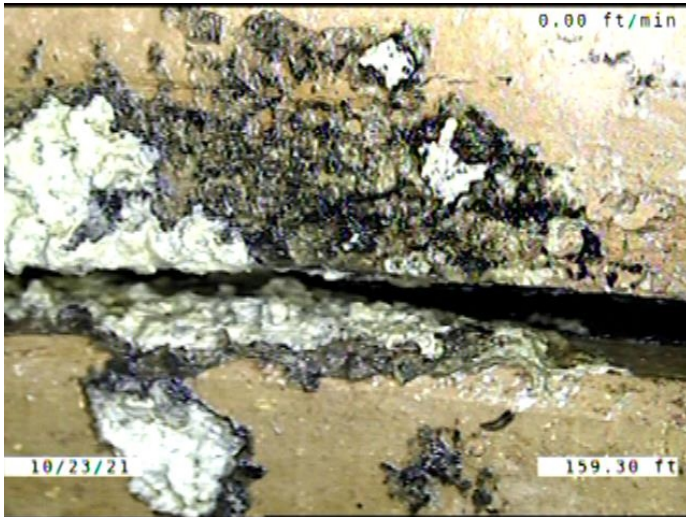
Code: **DAE**
 Description: **Deposits Attached Encrustation**

Distance (ft): **159.3**
 Structural Grade: **0**
 O&M Grade: **2**
 Clock Start/From: **9**
 Clock To: **4**
 1st Value:
 2nd Value:
 Value Percent: **5.000**
 Continuous Index:
 Within 8" of Joint: **YES**
 Remarks:

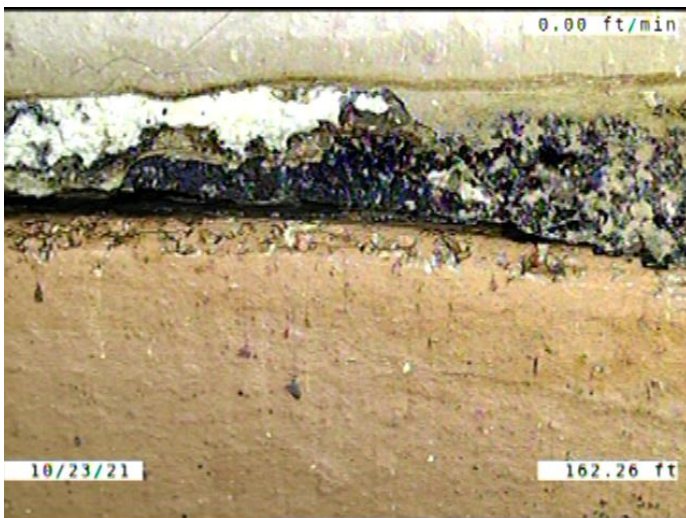
Code: **DAE**
 Description: **Deposits Attached Encrustation**

Distance (ft): **162.3**
 Structural Grade: **0**
 O&M Grade: **2**
 Clock Start/From: **8**
 Clock To: **4**
 1st Value:
 2nd Value:
 Value Percent: **5.000**
 Continuous Index:
 Within 8" of Joint: **YES**
 Remarks:

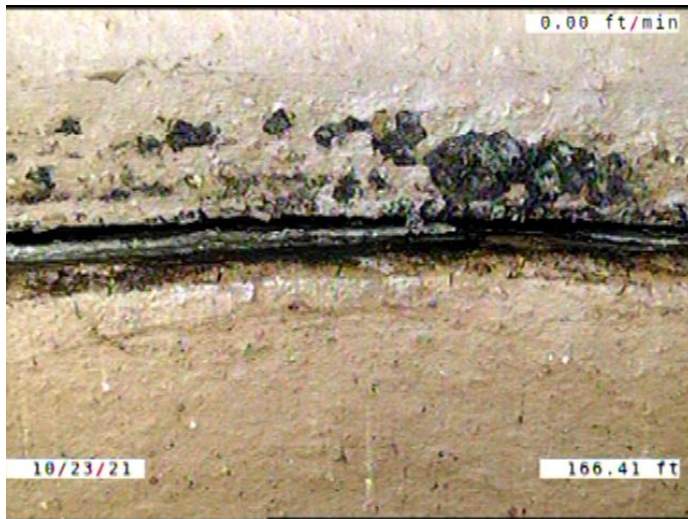
Code: **DAE**
 Description: **Deposits Attached Encrustation**

Distance (ft): **166.4**
 Structural Grade: **0**
 O&M Grade: **2**
 Clock Start/From: **9**
 Clock To: **3**
 1st Value:
 2nd Value:
 Value Percent: **5.000**
 Continuous Index:
 Within 8" of Joint: **YES**
 Remarks:

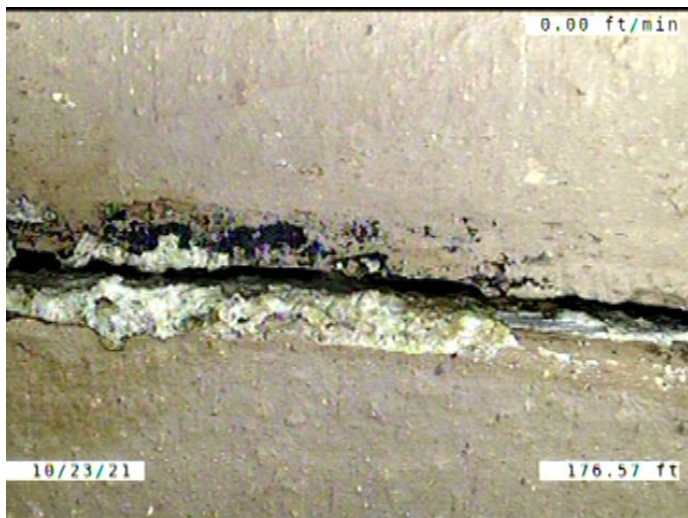
Code: **DAE**
 Description: **Deposits Attached Encrustation**

Distance (ft): **176.6**
 Structural Grade: **0**
 O&M Grade: **2**
 Clock Start/From: **9**
 Clock To: **3**
 1st Value:
 2nd Value:
 Value Percent: **5.000**
 Continuous Index: **S07**
 Within 8" of Joint: **YES**
 Remarks:

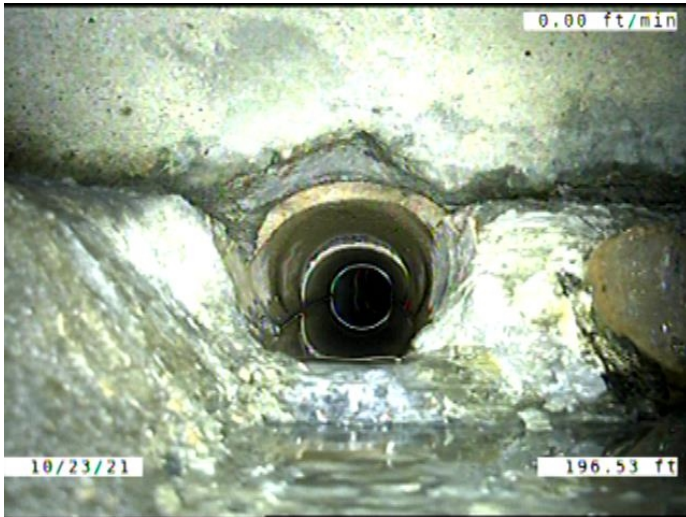
Code: **OBZ**
Description: **Obstruction Other**

Distance (ft): **196.5**
Structural Grade: **0**
O&M Grade: **2**
Clock Start/From: **5**
Clock To: **9**
1st Value:
2nd Value:
Value Percent: **5.000**
Continuous Index: **F02**
Within 8" of Joint: **YES**
Remarks: **LOOKS LIKE A SEWER RODDER**

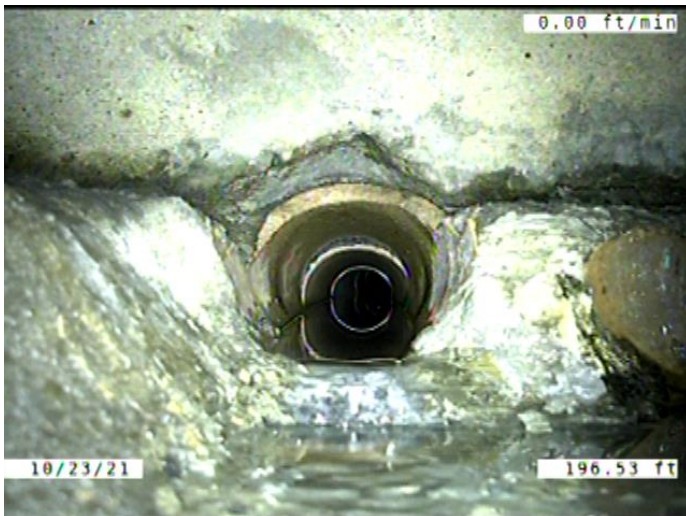
Code: **DSF**
Description: **Deposits Settled Fine**

Distance (ft): **196.5**
Structural Grade: **0**
O&M Grade: **2**
Clock Start/From: **5**
Clock To: **7**
1st Value:
2nd Value:
Value Percent: **5.000**
Continuous Index: **F05**
Within 8" of Joint: **YES**
Remarks:

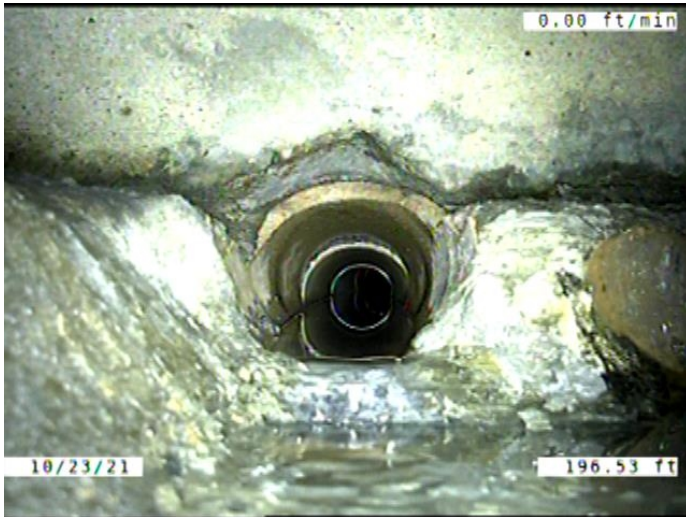
Code: **DAE**
 Description: **Deposits Attached Encrustation**

Distance (ft): **196.5**
 Structural Grade: **0**
 O&M Grade: **2**
 Clock Start/From: **9**
 Clock To: **3**
 1st Value:
 2nd Value:
 Value Percent: **5.000**
 Continuous Index: **F07**
 Within 8" of Joint: **YES**
 Remarks:
