Profile/Photo Observation Report

| Pipe Length (ft): | 197.2 | Owner: | City of Hobart | Pre Clean: | Heavy Cleaning |

| Street: | North Wabash Street | Flow Control: | Not Controlled |
| US MH: | M-404-012 | DS MH: | M-404-011 |

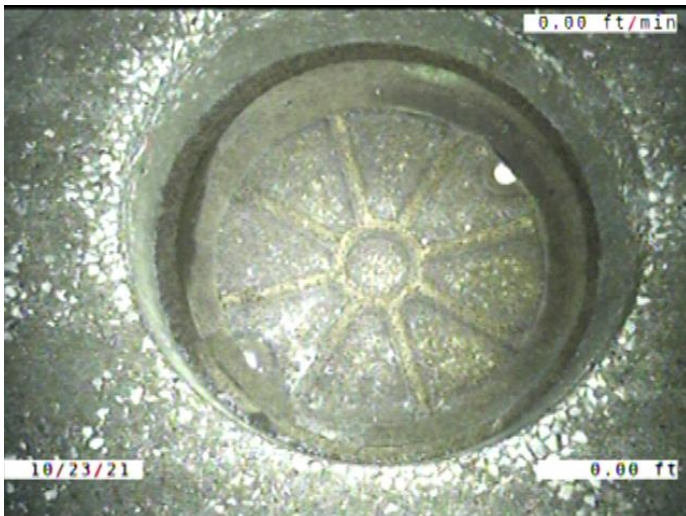
Code: **AMH**
Description: **Manhole**

Distance (ft): **.0**
Structural Grade: **0**
O&M Grade: **0**
Clock Start/From:
Clock To:
1st Value:
2nd Value:
Value Percent:
Continuous Index:
Within 8" of Joint: **NO**
Remarks: **M-404-011**

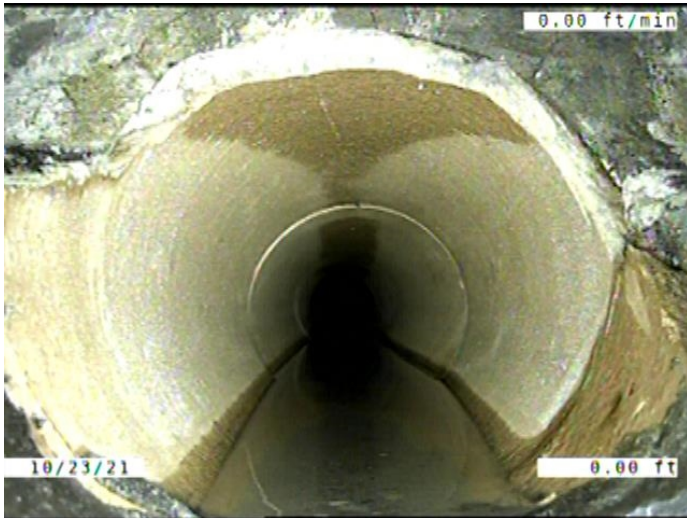
Code: **MWL**
Description: **Miscellaneous Water Level**

Distance (ft): **.0**
Structural Grade: **0**
O&M Grade: **0**
Clock Start/From:
Clock To:
1st Value:
2nd Value:
Value Percent: **5.000**
Continuous Index:
Within 8" of Joint: **NO**
Remarks:

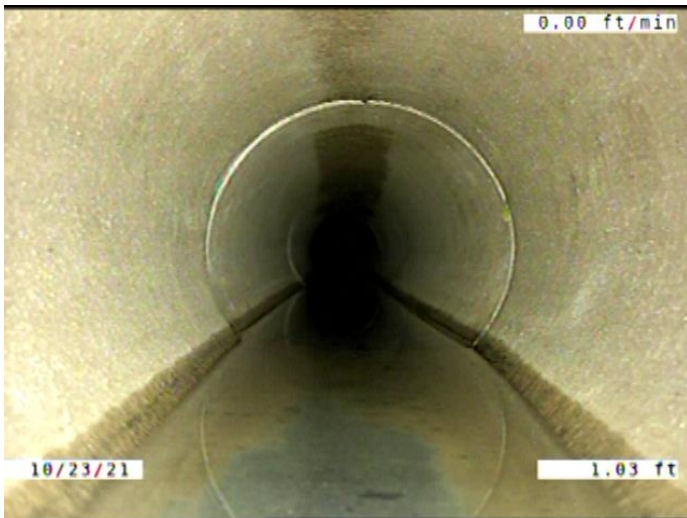
Code: **DSF**
Description: **Deposits Settled Fine**

Distance (ft): **1.0**
Structural Grade: **0**
O&M Grade: **2**
Clock Start/From: **5**
Clock To: **7**
1st Value:
2nd Value:
Value Percent: **5.000**
Continuous Index: **S01**
Within 8" of Joint: **YES**
Remarks:

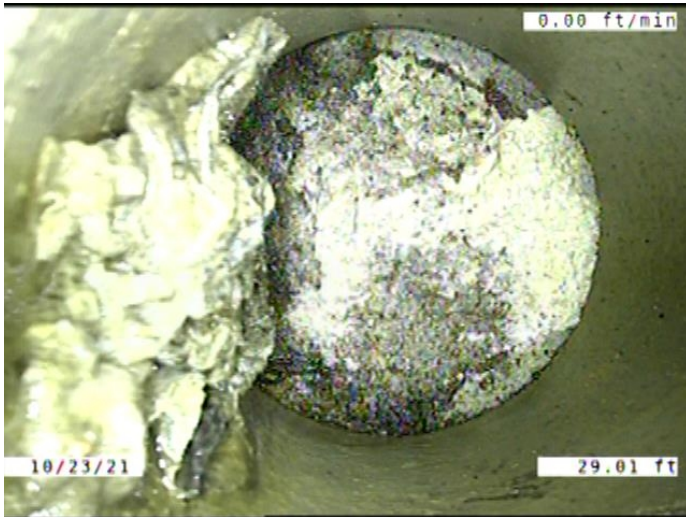
Code: **TFD**
 Description: **Tap Factory Defective**

Distance (ft): **29.0**
 Structural Grade: **0**
 O&M Grade: **3**
 Clock Start/From: **9**
 Clock To:
 1st Value: **4.000**
 2nd Value:
 Value Percent:
 Continuous Index:
 Within 8" of Joint: **YES**
 Remarks: **ENCrustATION AROUND THE CAP.
 CONSTANTLY LEAKING WATER**

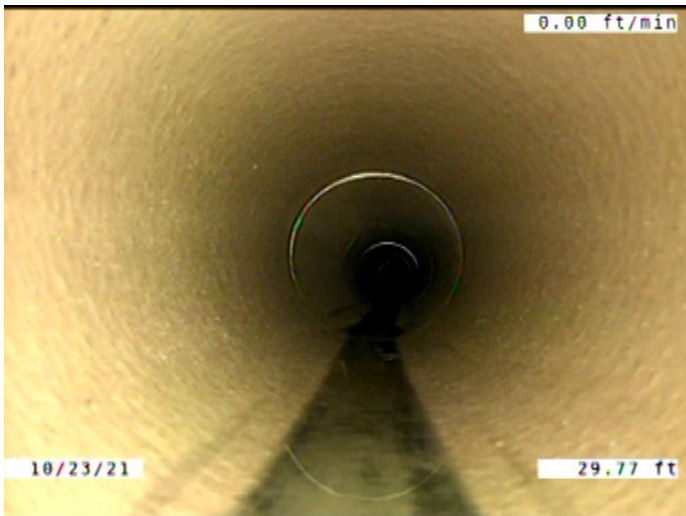
Code: **DSF**
 Description: **Deposits Settled Fine**

Distance (ft): **29.8**
 Structural Grade: **0**
 O&M Grade: **2**
 Clock Start/From: **5**
 Clock To: **7**
 1st Value:
 2nd Value:
 Value Percent: **5.000**
 Continuous Index: **F01**
 Within 8" of Joint: **YES**
 Remarks:

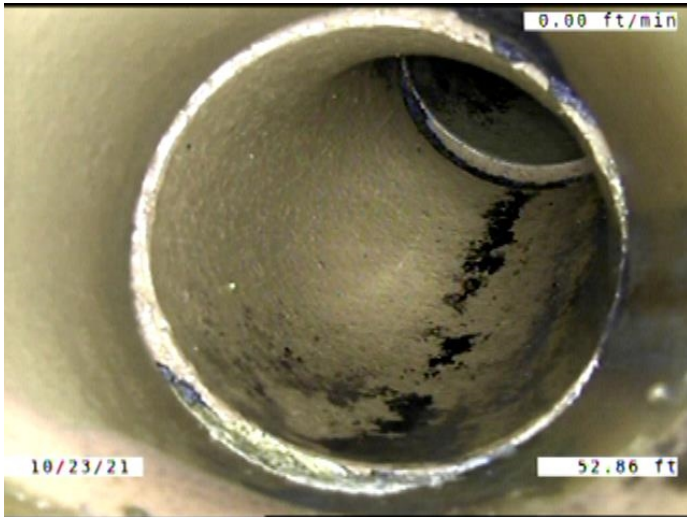
Code: **TF**
Description: **Tap Factory**

Distance (ft): **52.9**
Structural Grade: **0**
O&M Grade: **0**
Clock Start/From: **2**
Clock To:
1st Value: **4.000**
2nd Value:
Value Percent:
Continuous Index:
Within 8" of Joint: **YES**
Remarks:

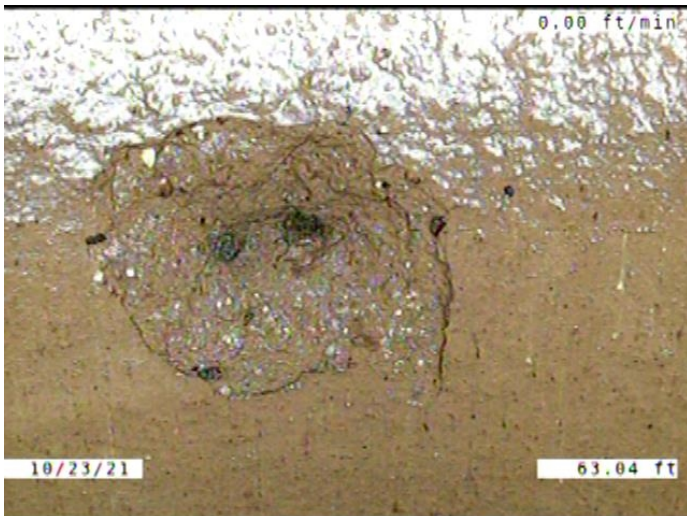
Code: **SSS**
Description: **Surface Damage Surface Spalling**

Distance (ft): **63.0**
Structural Grade: **2**
O&M Grade: **0**
Clock Start/From: **12**
Clock To:
1st Value:
2nd Value:
Value Percent:
Continuous Index:
Within 8" of Joint: **YES**
Remarks:

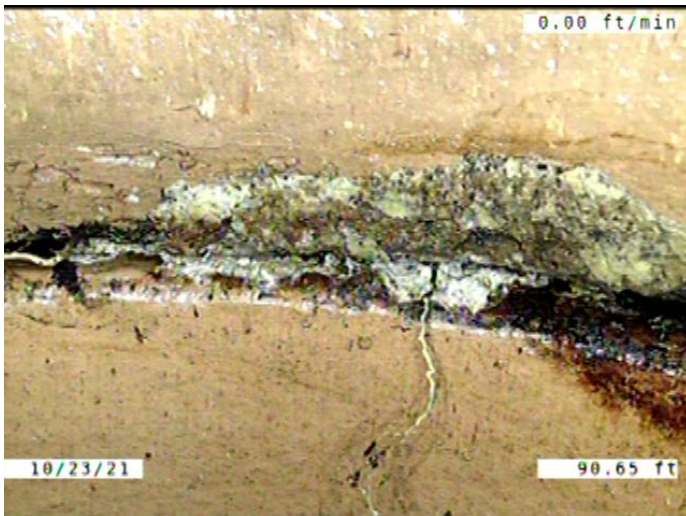
Code: **DAE**
 Description: **Deposits Attached Encrustation**

Distance (ft): **90.7**
 Structural Grade: **0**
 O&M Grade: **2**
 Clock Start/From: **9**
 Clock To: **3**
 1st Value:
 2nd Value:
 Value Percent: **5.000**
 Continuous Index:
 Within 8" of Joint: **YES**
 Remarks:

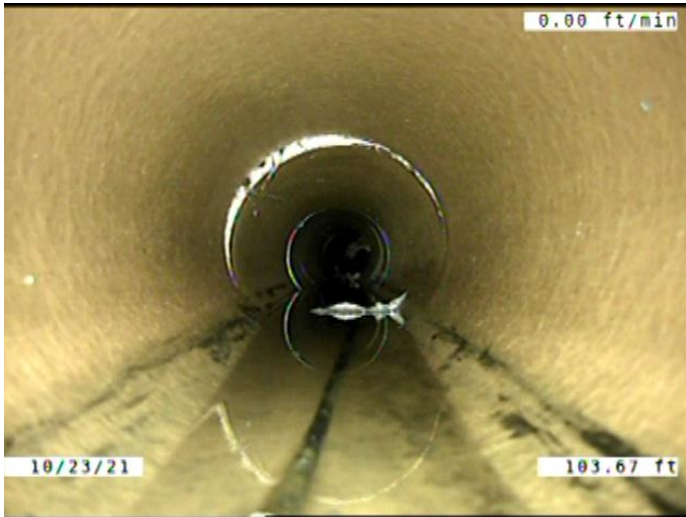
Code: **MWLS**
 Description: **Miscellaneous Water Level Sag**

Distance (ft): **103.7**
 Structural Grade: **2**
 O&M Grade: **0**
 Clock Start/From:
 Clock To:
 1st Value:
 2nd Value:
 Value Percent: **5.000**
 Continuous Index: **S04**
 Within 8" of Joint: **NO**
 Remarks:

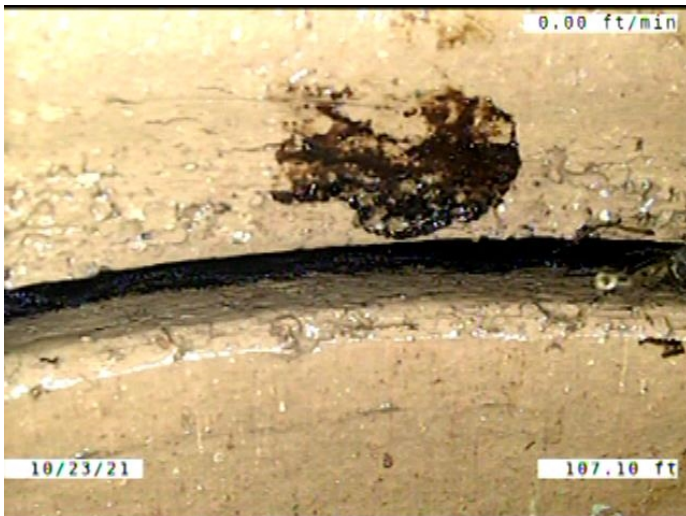
Code: **ISJ**
 Description: **Infiltration Stain Joint**

Distance (ft): **107.1**
 Structural Grade: **0**
 O&M Grade: **1**
 Clock Start/From: **10**
 Clock To: **3**
 1st Value:
 2nd Value:
 Value Percent:
 Continuous Index:
 Within 8" of Joint: **YES**
 Remarks:

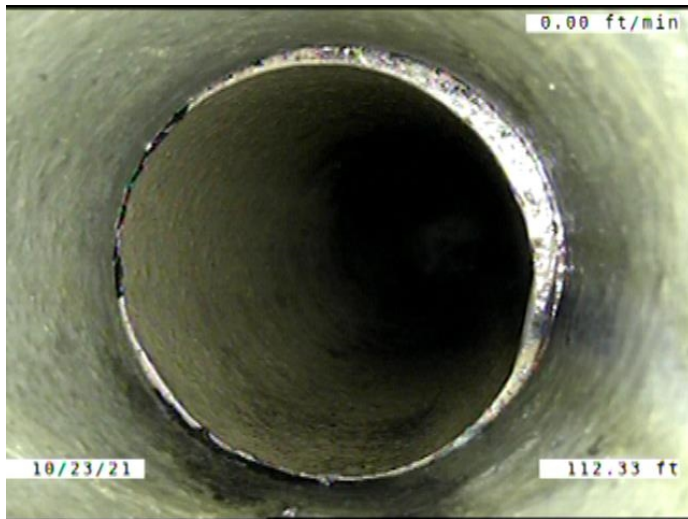
Code: **TF**
 Description: **Tap Factory**

Distance (ft): **112.3**
 Structural Grade: **0**
 O&M Grade: **0**
 Clock Start/From: **2**
 Clock To:
 1st Value: **4.000**
 2nd Value:
 Value Percent:
 Continuous Index:
 Within 8" of Joint: **YES**
 Remarks:

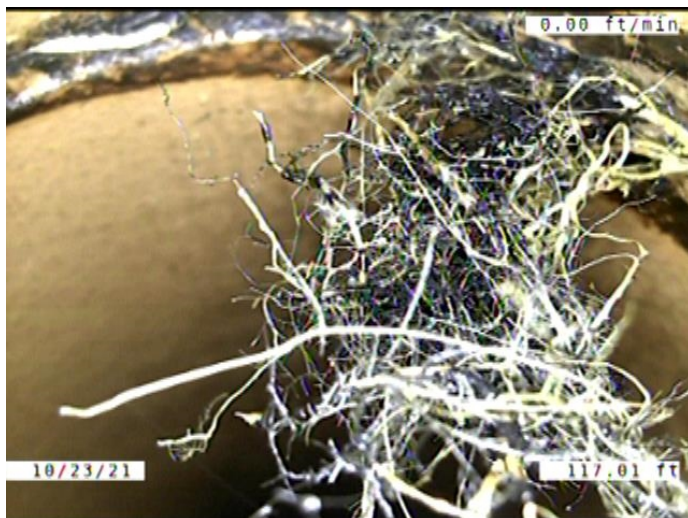
Code: **RMJ**
 Description: **Roots Medium Joint**

Distance (ft): **117.0**
 Structural Grade: **0**
 O&M Grade: **3**
 Clock Start/From: **10**
 Clock To: **3**
 1st Value:
 2nd Value:
 Value Percent: **5.000**
 Continuous Index:
 Within 8" of Joint: **YES**
 Remarks:

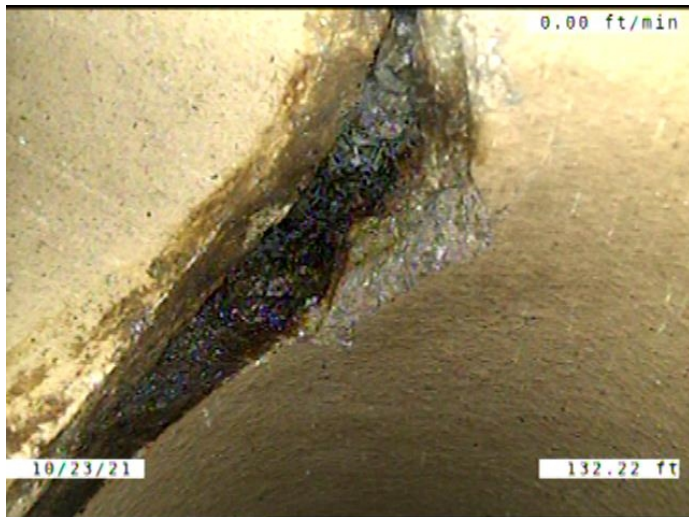
Code: **SSS**
 Description: **Surface Damage Surface Spalling**

Distance (ft): **132.2**
 Structural Grade: **2**
 O&M Grade: **0**
 Clock Start/From: **7**
 Clock To: **11**
 1st Value:
 2nd Value:
 Value Percent:
 Continuous Index:
 Within 8" of Joint: **YES**
 Remarks:

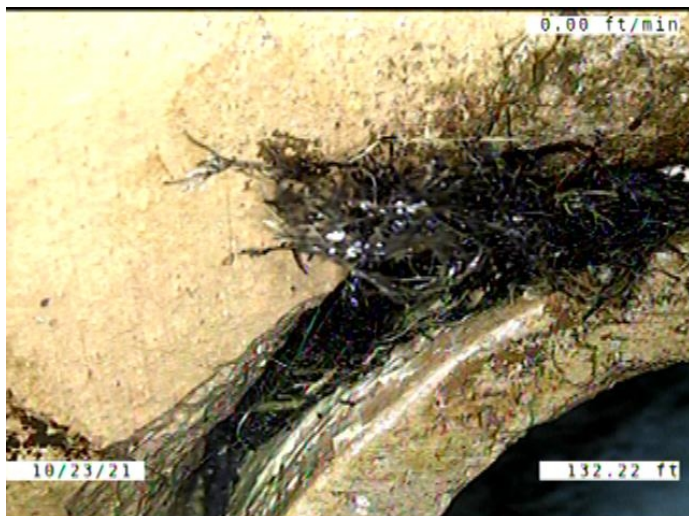
Code: **RFC**
 Description: **Roots Fine Connection**

Distance (ft): **132.2**
 Structural Grade: **0**
 O&M Grade: **1**
 Clock Start/From: **9**
 Clock To: **11**
 1st Value:
 2nd Value:
 Value Percent:
 Continuous Index:
 Within 8" of Joint: **NO**
 Remarks:

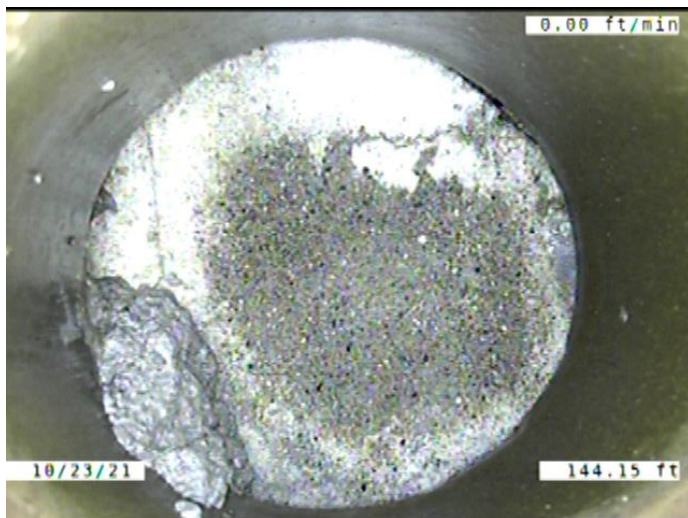
Code: **TFC**
 Description: **Tap Factory Capped**

Distance (ft): **144.2**
 Structural Grade: **0**
 O&M Grade: **0**
 Clock Start/From: **10**
 Clock To:
 1st Value: **4.000**
 2nd Value:
 Value Percent:
 Continuous Index:
 Within 8" of Joint: **YES**
 Remarks:

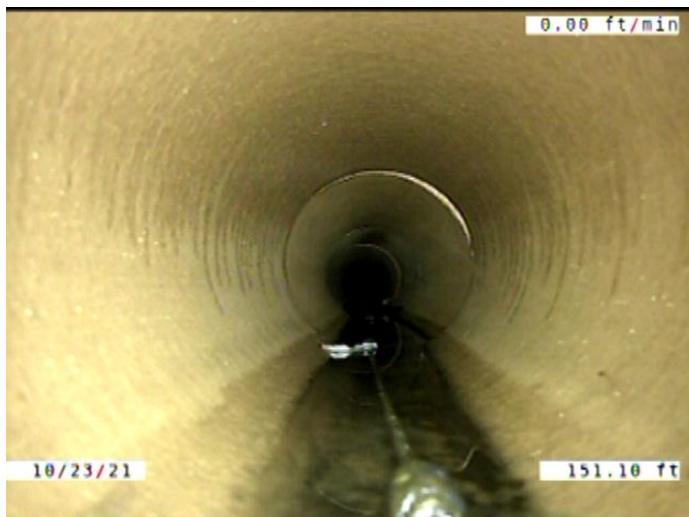
Code: **RFJ**
 Description: **Roots Fine Joint**

Distance (ft): **151.1**
 Structural Grade: **0**
 O&M Grade: **1**
 Clock Start/From: **9**
 Clock To: **3**
 1st Value:
 2nd Value:
 Value Percent:
 Continuous Index: **F03**
 Within 8" of Joint: **YES**
 Remarks:

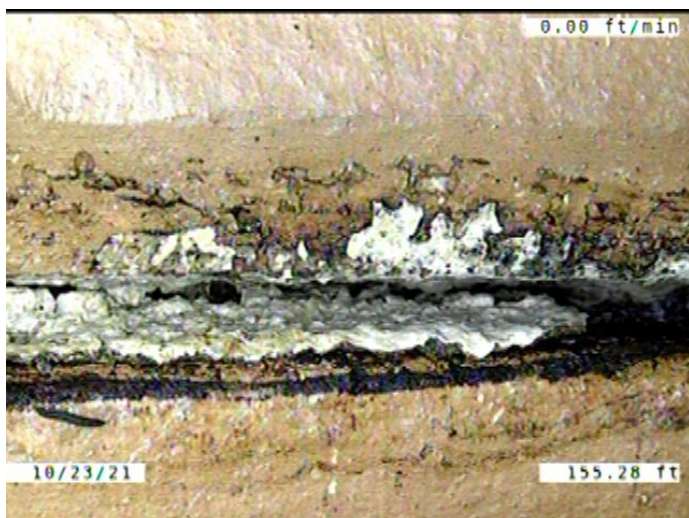
Code: **DAE**
 Description: **Deposits Attached Encrustation**

Distance (ft): **155.3**
 Structural Grade: **0**
 O&M Grade: **2**
 Clock Start/From: **9**
 Clock To: **11**
 1st Value:
 2nd Value:
 Value Percent: **5.000**
 Continuous Index:
 Within 8" of Joint: **YES**
 Remarks:

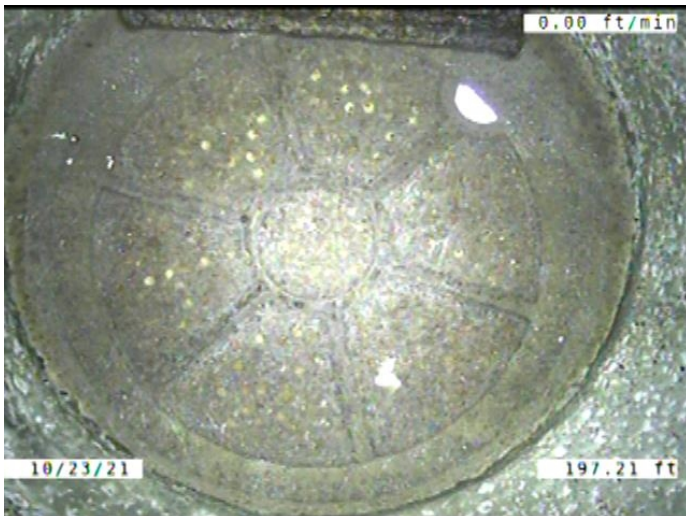
Code: **AMH**
 Description: **Manhole**

Distance (ft): **197.2**
 Structural Grade: **0**
 O&M Grade: **0**
 Clock Start/From:
 Clock To:
 1st Value:
 2nd Value:
 Value Percent:
 Continuous Index:
 Within 8" of Joint: **NO**
 Remarks: **M-404-012**
