Profile/Photo Observation Report

Date:	04/08/2018	Weather:		Coding:	PACP 6.0
Pipe Length (ft):		Owner:	City of Hobart	Pre Clean:	No Pre-Cleaning
P.O.#:	20-2	Surveyor:	M. Pielacha	PSR:	M-404-013-M-504-065
Customer:	City of Hobart	Clean Date:		Shape:	C

Street:	Old Ridge Road	Flow Control:	Not Controlled
City:	Hobart, IN	Year Renewed:	
Location:	Light Highway	Tape/Media #:	DEP 20
Purpose:	Routine Assessment	Dia/Height:	24"
Use:	Sanitary	Material:	CP
Drain Area:		Lining:

US MH: **M-404-013** DS MH: **M-504-065** Total Length Surveyed (ft): **112.9**

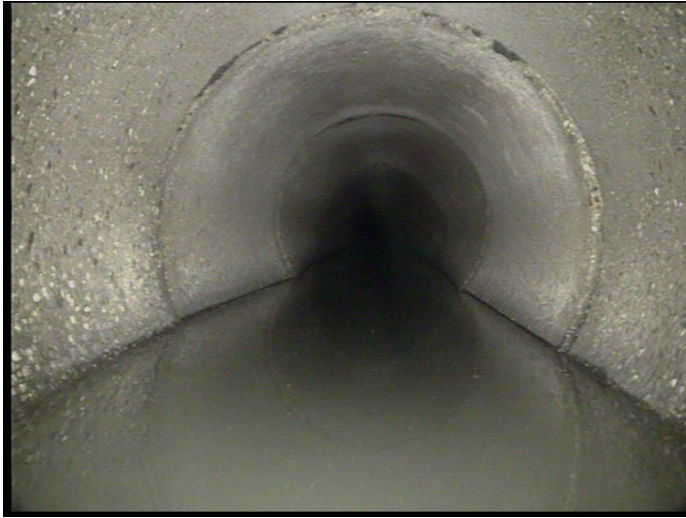
Code: **MWL**
Description: **Water Level**

Distance (ft): **.0**
Structural Grade: **0**
O&M Grade: **0**
Clock Start/From:
Clock To:
1st Value:
2nd Value:
Value Percent: **10.000**
Continuous Index:
Within 8" of Joint: **NO**
Remarks:

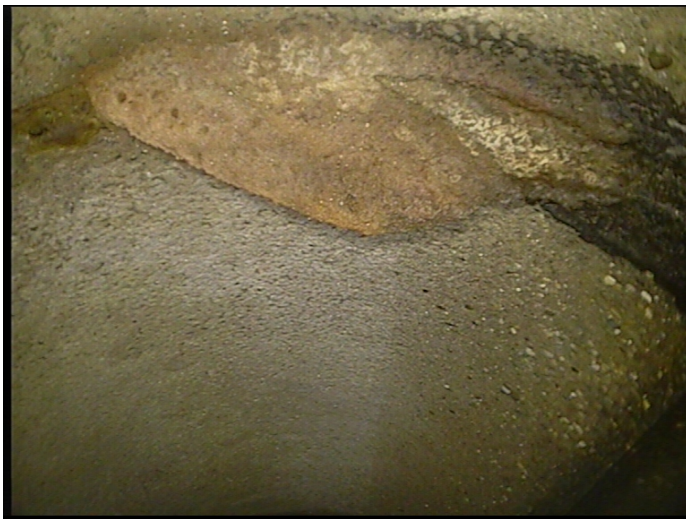
Code: **DAE**
Description: **Deposits Attached Encrustation**

Distance (ft): **97.1**
Structural Grade: **0**
O&M Grade: **2**
Clock Start/From: **1**
Clock To: **4**
1st Value:
2nd Value:
Value Percent: **5.000**
Continuous Index:
Within 8" of Joint: **YES**
Remarks:

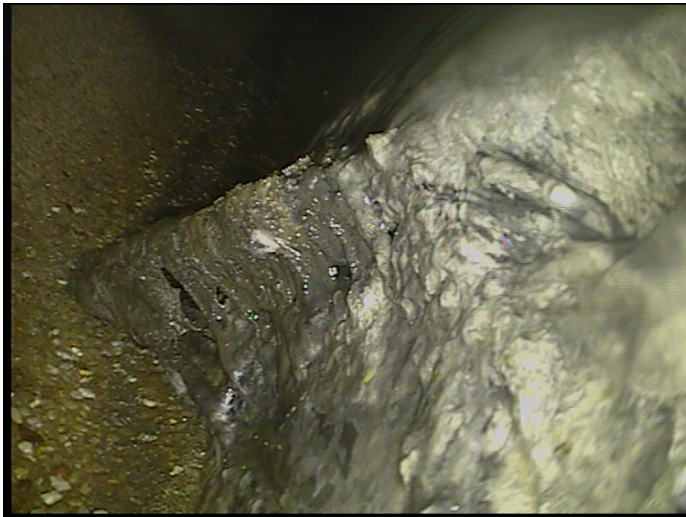
Code: **OBZ**
 Description: **Obstacle Other**

Distance (ft): **112.8**
 Structural Grade: **0**
 O&M Grade: **3**
 Clock Start/From: **5**
 Clock To: **8**
 1st Value:
 2nd Value:
 Value Percent: **20.000**
 Continuous Index:
 Within 8" of Joint: **NO**
 Remarks: **Debris**

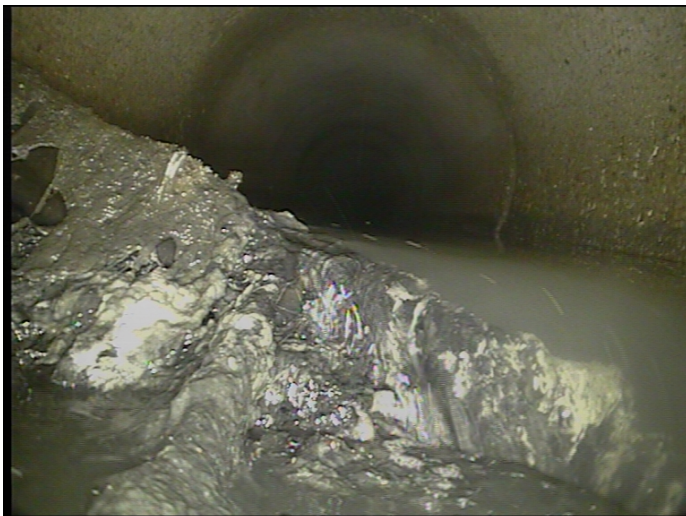
Code: **MSA**
 Description: **Abandoned Survey**

Distance (ft): **112.9**
 Structural Grade: **0**
 O&M Grade: **0**
 Clock Start/From:
 Clock To:
 1st Value:
 2nd Value:
 Value Percent:
 Continuous Index:
 Within 8" of Joint: **NO**
 Remarks: **heavy debris**
