Profile/Photo Observation Report

Profile/Photo Observation Report								
Date: Pipe Length (ft	04/08/2018	Weather: Owner:	City of H	obart	Coding: Pre Clean:	PACP 6.0 No Pre-Cleaning		
P.O.#:	20-2	Surveyor:	M. Piela	cha	PSR:	M-404-013-M-504-065		
Customer:	City of Hobart	Clean Date:			Shape:	С		
Street:	Old Ridge Road		Flow Cont	rol:	Not Controlled			
City:	Hobart, IN		Year Rene	wed:				
Location:	Light Highway		Tape/Med	lia #:	DEP 20			
Purpose:	Routine Assessment		Dia/Heigh	t:	24"			
Use:	Sanitary		Material:		СР			
Drain Area:			Lining:					
Category:	NA							
Comment:								
Location Detai	ls:		Direction	of Survey:	Upstream			
US MH:	M-404-013	DS MH:	M-504-065		Total Length Surveyed (ft)	: 112.9		
O&M Index:	2.50	O&M Quick:		3121	O&M Rating:	5.00		
Structural Index:	0.00	Structural Qu	ıick:	0000	Structural Rating:	0.00		
Overall Index:	2.50	Overall Quick		3121	Overall Rating:	5.00

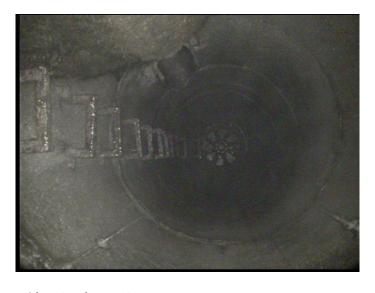
Code:	АМН
Description:	Manhole
Distance (ft):	.0
Structural Grade:	0
O&M Grade:	0
Clock Start/From:	
Clock To:	
1st Value:	
2nd Value:	
Value Percent:	
Continuous Index:	
Within 8" of Joint:	NO
Remarks:	M-504-065

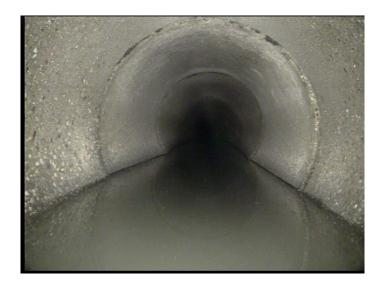
Code: MWL
Description: Water Level

Value Percent: 10.000

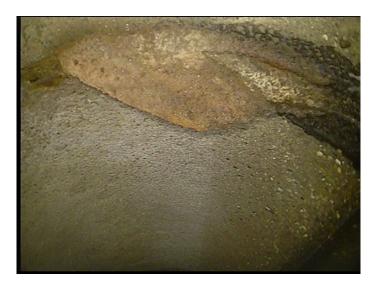
Code: DAE

Description: Deposits Attached Encrustation

Distance (ft): 97.1
Structural Grade: 0

O&M Grade: 2

Clock Start/From: 1

Clock To: 4

Value Percent: 5.000

Within 8" of Joint: YES

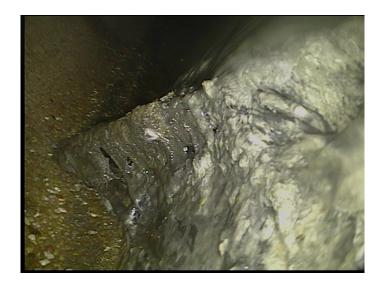
Code: OBZ

Description: Obstacle Other

Distance (ft): 112.8
Structural Grade: 0
O&M Grade: 3
Clock Start/From: 5
Clock To: 8

Value Percent: 20.000

Within 8" of Joint: NO
Remarks: Debris

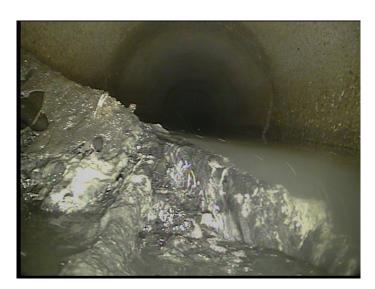
Code: MSA

Description: Abandoned Survey

Distance (ft): 112.9
Structural Grade: 0

Remarks: heavy debris
