Profile/Photo Observation Report

Date:	04/08/2018	Weather:		Coding:	PACP 6.0
Pipe Length (ft):		Owner:	City of Hobart	Pre Clean:	No Pre-Cleaning
P.O.#:	19-2	Surveyor:	M. Pielacha	PSR:	M-404-014-M-404-013
Customer:	City of Hobart	Clean Date:		Shape:	C

Street:	Old Ridge Road	Flow Control:	Not Controlled
City:	Hobart, IN	Year Renewed:	
Location:	Light Highway	Tape/Media #:	DEP 19
Purpose:	Routine Assessment	Dia/Height:	18"
Use:	Sanitary	Material:	VCP
Drain Area:		Lining:

US MH: **M-404-014** DS MH: **M-404-013** Total Length Surveyed (ft): **286.7**

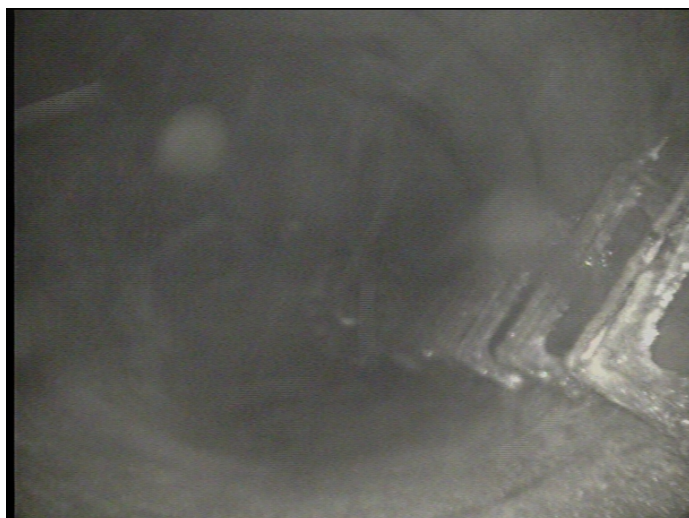
Code: **AMH**
 Description: **Manhole**

Distance (ft): **.0**
 Structural Grade: **0**
 O&M Grade: **0**
 Clock Start/From:
 Clock To:
 1st Value:
 2nd Value:
 Value Percent:
 Continuous Index:
 Within 8" of Joint: **NO**
 Remarks: **M-404-014**

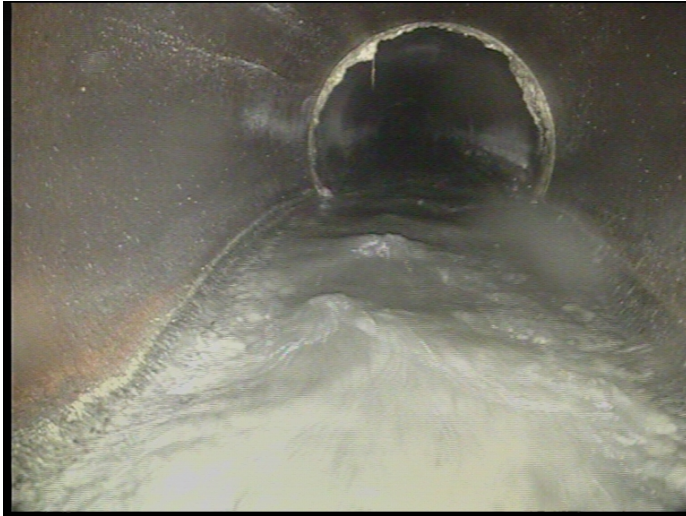
Code: **MWL**
Description: **Water Level**

Distance (ft): **.0**
Structural Grade: **0**
O&M Grade: **0**
Clock Start/From:
Clock To:
1st Value:
2nd Value:
Value Percent: **10.000**
Continuous Index:
Within 8" of Joint: **NO**
Remarks:

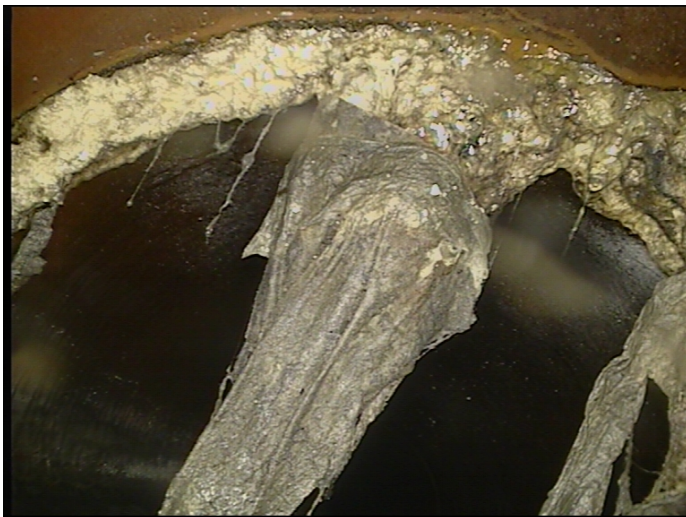
Code: **DAE**
Description: **Deposits Attached Encrustation**

Distance (ft): **34.1**
Structural Grade: **0**
O&M Grade: **2**
Clock Start/From: **8**
Clock To: **4**
1st Value:
2nd Value:
Value Percent: **10.000**
Continuous Index:
Within 8" of Joint: **YES**
Remarks:

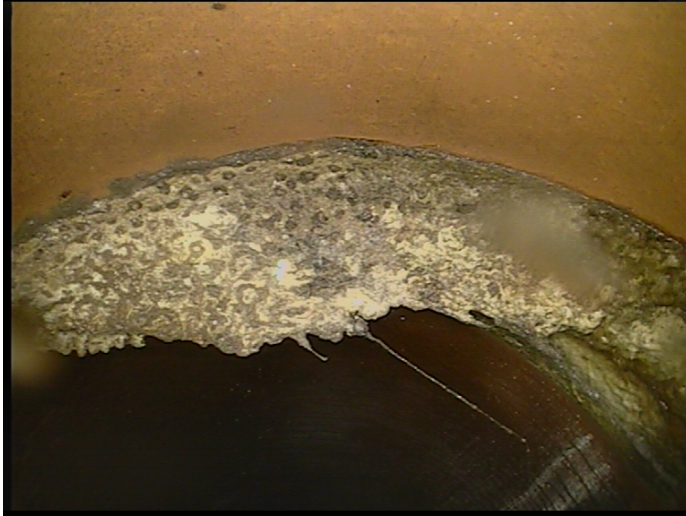
Code: **DAE**
Description: **Deposits Attached Encrustation**

Distance (ft): **64.5**
Structural Grade: **0**
O&M Grade: **2**
Clock Start/From: **1**
Clock To: **4**
1st Value:
2nd Value:
Value Percent: **5.000**
Continuous Index:
Within 8" of Joint: **YES**
Remarks:

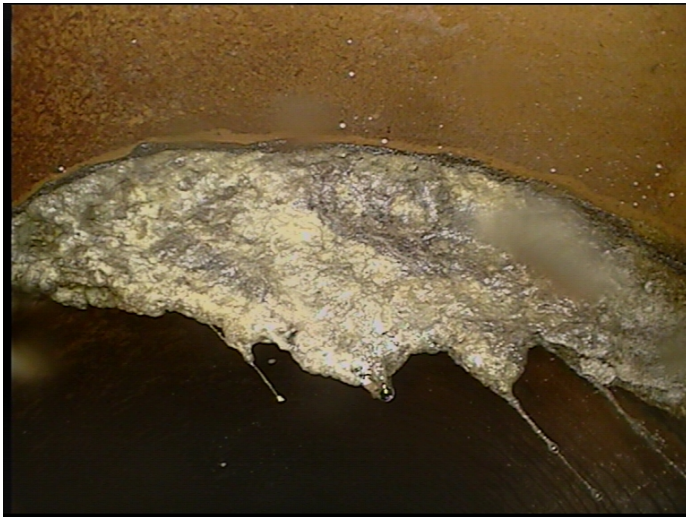
Code: **DAE**
Description: **Deposits Attached Encrustation**

Distance (ft): **74.9**
Structural Grade: **0**
O&M Grade: **2**
Clock Start/From: **1**
Clock To: **4**
1st Value:
2nd Value:
Value Percent: **5.000**
Continuous Index:
Within 8" of Joint: **YES**
Remarks:

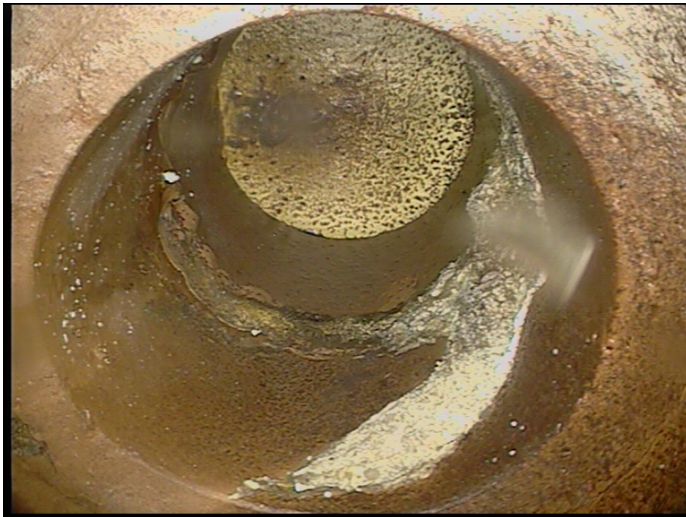
Code: **TFC**
Description: **Tap Factory Capped**

Distance (ft): **101.6**
Structural Grade: **0**
O&M Grade: **0**
Clock Start/From: **10**
Clock To:
1st Value: **4.000**
2nd Value:
Value Percent:
Continuous Index:
Within 8" of Joint: **NO**
Remarks:

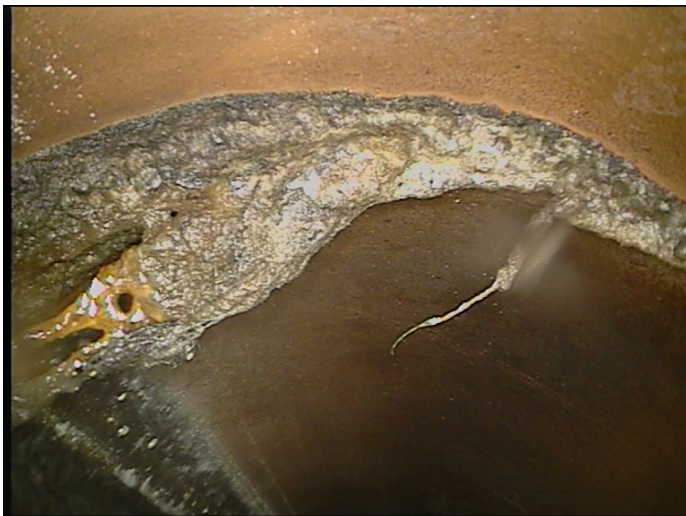
Code: **DAE**
Description: **Deposits Attached Encrustation**

Distance (ft): **163.6**
Structural Grade: **0**
O&M Grade: **2**
Clock Start/From: **7**
Clock To: **11**
1st Value:
2nd Value:
Value Percent: **5.000**
Continuous Index:
Within 8" of Joint: **YES**
Remarks:

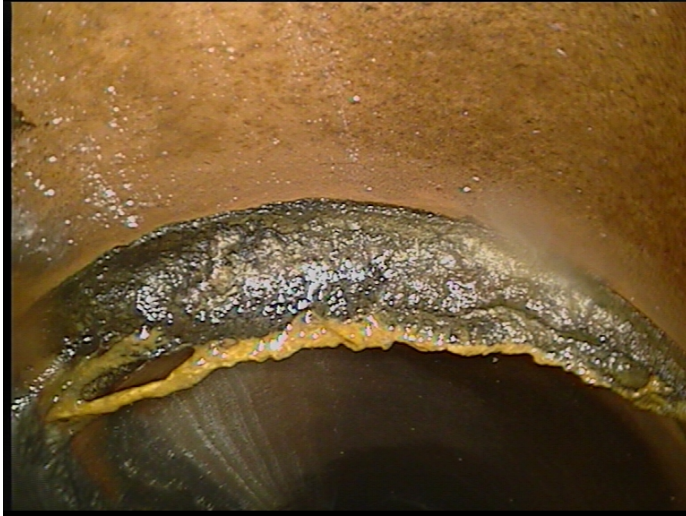
Code: **DAE**
Description: **Deposits Attached Encrustation**

Distance (ft): **273.9**
Structural Grade: **0**
O&M Grade: **2**
Clock Start/From: **7**
Clock To: **11**
1st Value:
2nd Value:
Value Percent: **5.000**
Continuous Index:
Within 8" of Joint: **YES**
Remarks:

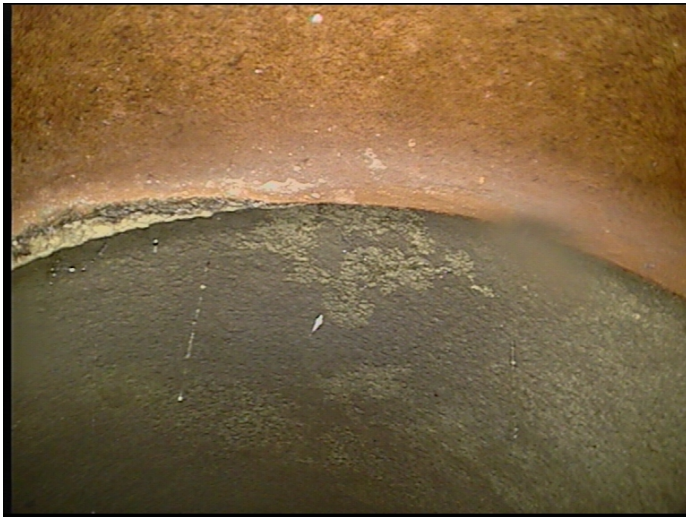
Code: **MMC**
Description: **Material Change**

Distance (ft): **279.5**
Structural Grade: **0**
O&M Grade: **0**
Clock Start/From:
Clock To:
1st Value:
2nd Value:
Value Percent:
Continuous Index:
Within 8" of Joint: **NO**
Remarks: **CP**

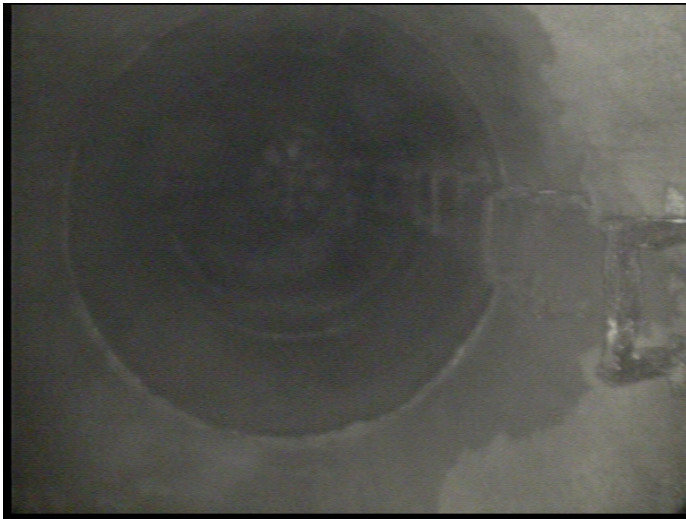
Code:	AMH
Description:	Manhole
Distance (ft):	286.7
Structural Grade:	0
O&M Grade:	0
Clock Start/From:	
Clock To:	
1st Value:	
2nd Value:	
Value Percent:	
Continuous Index:	
Within 8" of Joint:	NO
Remarks:	M-404-013
