## Profile/Photo Observation Report

Date:	<b>04/16/2018</b>	Weather:		Coding:	<b>PACP 6.0</b>
Pipe Length (ft):	<b>51.6</b>	Owner:	<b>NA</b>	Pre Clean:	<b>Not Known</b>
P.O.#:		Surveyor:	<b>Selasie Honu</b>	PSR:	<b>P-404-015-014</b>
Customer:		Clean Date:	<b>01/01/1900</b>	Shape:	<b>C</b>

Street:	<b>N WABASH ST &amp; W OLD RIDGE RD</b>	Flow Control:	<b>Not Controlled</b>
City:	<b>Hobart, IN</b>	Year Renewed:	
Location:	<b>Light Highway</b>	Tape/Media #:	
Purpose:	<b>Not Known</b>	Dia/Height:	<b>10"</b>
Use:	<b>Sanitary</b>	Material:	<b>VCP</b>
Drain Area:	<b>NA</b>	Lining:	
Category:	<b>NA</b>		
Comment:

Location Details:		Direction of Survey:	<b>Downstream</b>
US MH:	<b>M-404-014</b>	DS MH:	<b>M-404-015</b>
		Total Length Surveyed (ft):	<b>48.3</b>

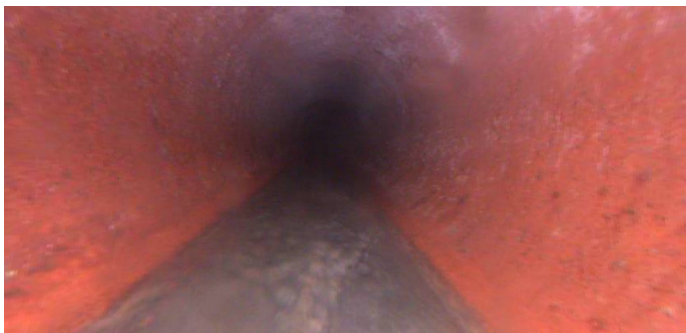
Code: **AMH**  
Description: **Manhole**

Distance (ft): **.0**  
Structural Grade: **0**  
O&M Grade: **0**  
Clock Start/From:  
Clock To:  
1st Value:  
2nd Value:  
Value Percent:  
Continuous Index:  
Within 8" of Joint: **NO**  
Remarks: **M-404-014**

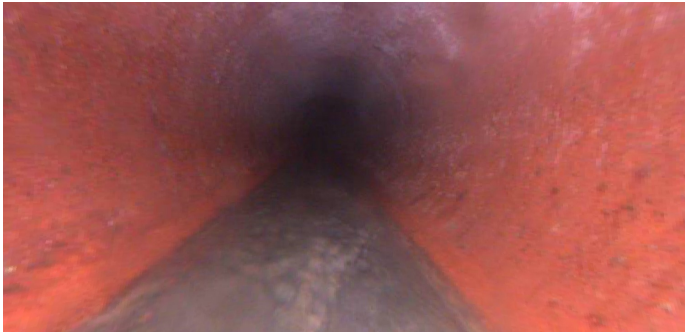
Code:	<b>MWL</b>
Description:	<b>Water Level</b>

Distance (ft):	<b>.0</b>
Structural Grade:	<b>0</b>
O&M Grade:	<b>0</b>
Clock Start/From:	
Clock To:	
1st Value:	
2nd Value:	
Value Percent:	<b>5.000</b>
Continuous Index:	
Within 8" of Joint:	<b>NO</b>
Remarks:

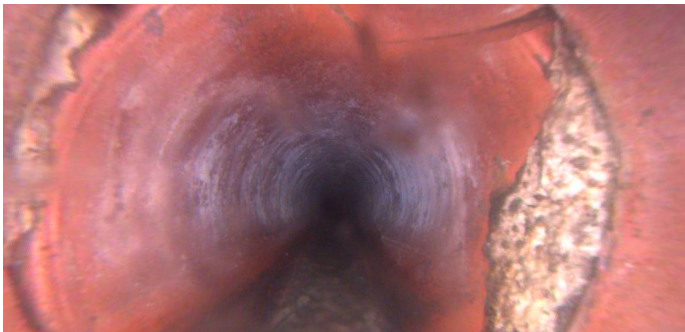
Code:	<b>DAE</b>
Description:	<b>Deposits Attached Encrustation</b>

Distance (ft):	<b>26.0</b>
Structural Grade:	<b>0</b>
O&M Grade:	<b>2</b>
Clock Start/From:	<b>8</b>
Clock To:	<b>4</b>
1st Value:	
2nd Value:	
Value Percent:	<b>5.000</b>
Continuous Index:	
Within 8" of Joint:	<b>YES</b>
Remarks:

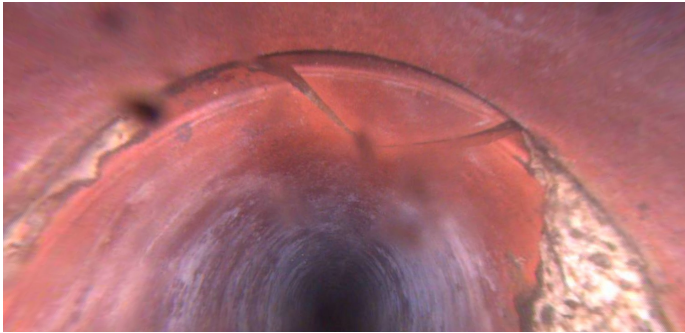
Code: **FS**  
Description: **Fracture Spiral**

Distance (ft): **26.0**  
Structural Grade: **3**  
O&M Grade: **0**  
Clock Start/From: **11**  
Clock To: **1**  
1st Value:  
2nd Value:  
Value Percent:  
Continuous Index:  
Within 8" of Joint: **YES**  
Remarks:

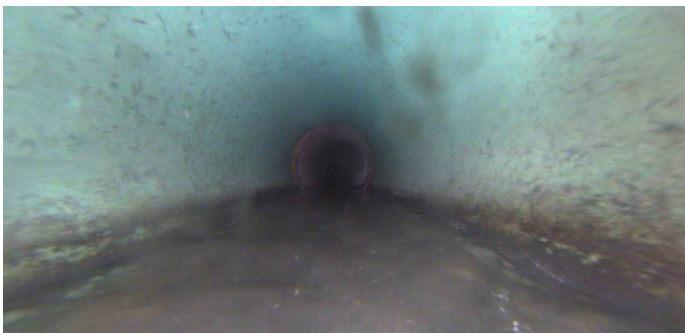
Code: **MMC**  
Description: **Material Change**

Distance (ft): **36.9**  
Structural Grade: **0**  
O&M Grade: **0**  
Clock Start/From:  
Clock To:  
1st Value:  
2nd Value:  
Value Percent:  
Continuous Index:  
Within 8" of Joint: **NO**  
Remarks: **PVC**

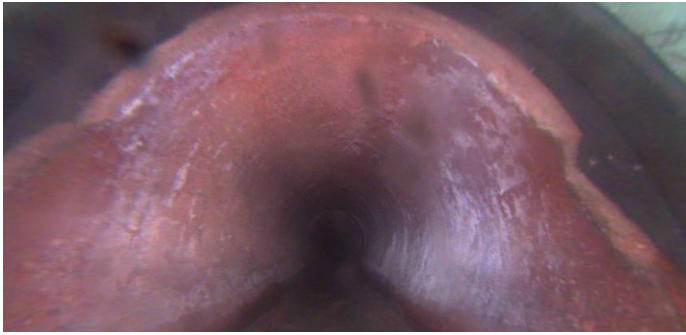
Code: **SSS**  
Description: **Surface Spalling**

Distance (ft): **39.0**  
Structural Grade: **2**  
O&M Grade: **0**  
Clock Start/From: **8**  
Clock To: **4**  
1st Value:  
2nd Value:  
Value Percent:  
Continuous Index:  
Within 8" of Joint: **YES**  
Remarks:

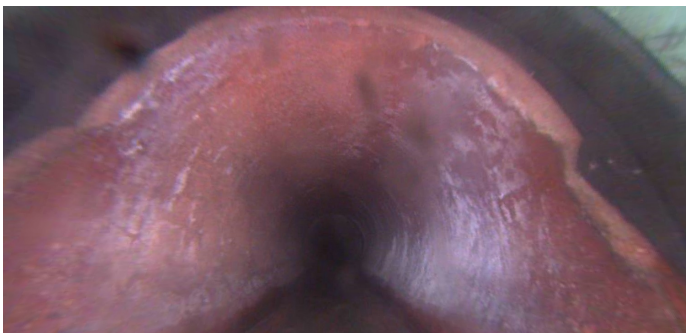
Code: **MMC**  
Description: **Material Change**

Distance (ft): **39.0**  
Structural Grade: **0**  
O&M Grade: **0**  
Clock Start/From:  
Clock To:  
1st Value:  
2nd Value:  
Value Percent:  
Continuous Index:  
Within 8" of Joint: **NO**  
Remarks: **vcp**

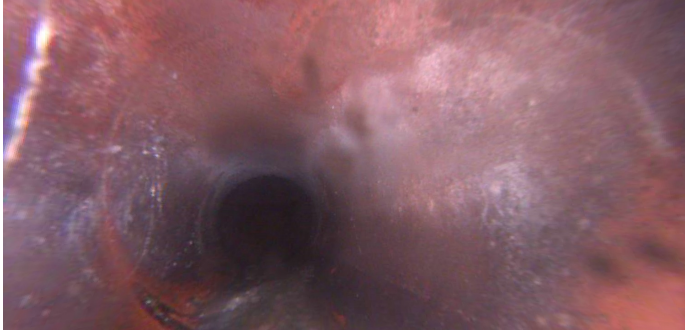
Code: **CS**  
Description: **Crack Spiral**

Distance (ft): **45.4**  
Structural Grade: **2**  
O&M Grade: **0**  
Clock Start/From: **8**  
Clock To: **4**  
1st Value:  
2nd Value:  
Value Percent:  
Continuous Index:  
Within 8" of Joint:  
Remarks:

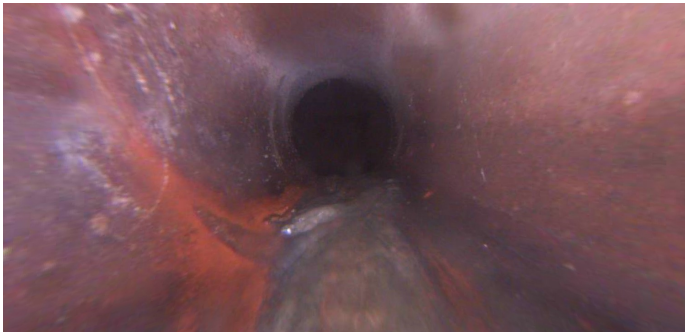
Code: **IW**  
Description: **Infil Weeper**

Distance (ft): **45.8**  
Structural Grade: **0**  
O&M Grade: **2**  
Clock Start/From: **8**  
Clock To: **9**  
1st Value:  
2nd Value:  
Value Percent:  
Continuous Index:  
Within 8" of Joint:  
Remarks:
