Profile/Photo Observation Report

Street:	Summerlin	Flow Control:	Not Controlled
City:	Hobart, IN	Year Renewed:	
Location:	Light Highway	Tape/Media #:	
Purpose:	Not Known	Dia/Height:	10"
Use:	Sanitary	Material:	VCP
Drain Area:	NA	Lining:	
Category:	NA		
Comment:

Location Details:		Direction of Survey:	Downstream
US MH:	M-404-014	DS MH:	M-404-015
		Total Length Surveyed (ft):	48.3

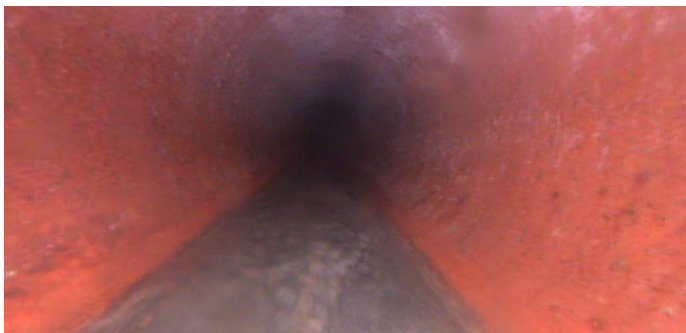
Code: **AMH**
Description: **Manhole**

Distance (ft): **.0**
Structural Grade: **0**
O&M Grade: **0**
Clock Start/From:
Clock To:
1st Value:
2nd Value:
Value Percent:
Continuous Index:
Within 8" of Joint: **NO**
Remarks: **M-404-014**

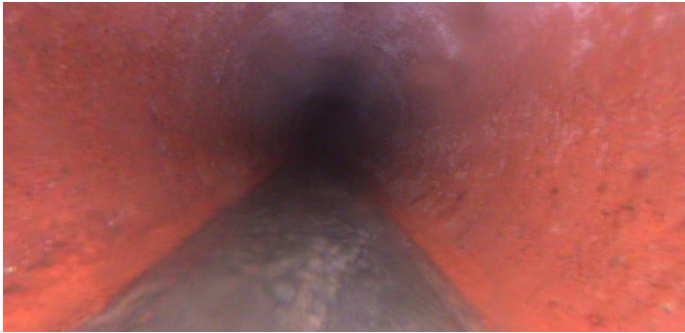
Code:	MWL
Description:	Water Level

Distance (ft):	.0
Structural Grade:	0
O&M Grade:	0
Clock Start/From:	
Clock To:	
1st Value:	
2nd Value:	
Value Percent:	5.000
Continuous Index:	
Within 8" of Joint:	NO
Remarks:

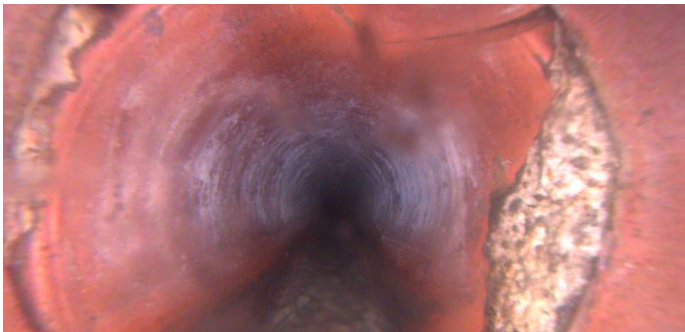
Code:	DAE
Description:	Deposits Attached Encrustation

Distance (ft):	26.0
Structural Grade:	0
O&M Grade:	2
Clock Start/From:	8
Clock To:	4
1st Value:	
2nd Value:	
Value Percent:	5.000
Continuous Index:	
Within 8" of Joint:	YES
Remarks:

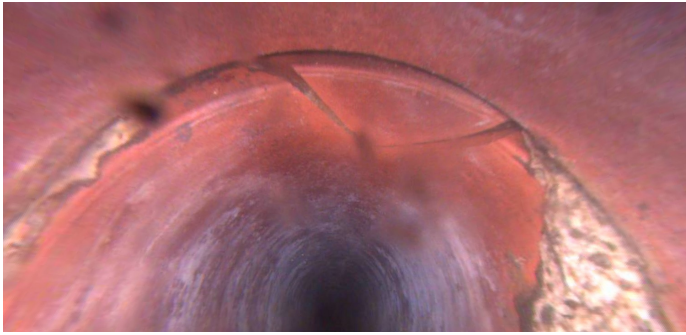
Code: **FS**
Description: **Fracture Spiral**

Distance (ft): **26.0**
Structural Grade: **3**
O&M Grade: **0**
Clock Start/From: **11**
Clock To: **1**
1st Value:
2nd Value:
Value Percent:
Continuous Index:
Within 8" of Joint: **YES**
Remarks:

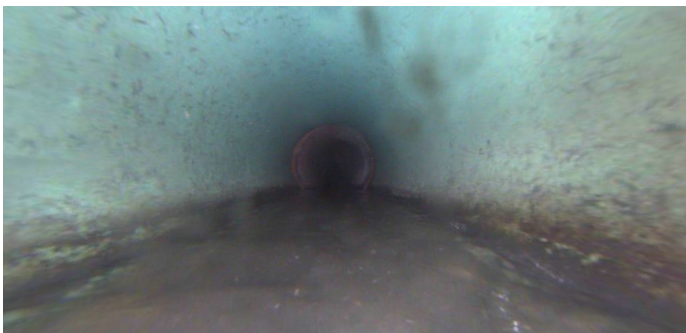
Code: **MMC**
Description: **Material Change**

Distance (ft): **36.9**
Structural Grade: **0**
O&M Grade: **0**
Clock Start/From:
Clock To:
1st Value:
2nd Value:
Value Percent:
Continuous Index:
Within 8" of Joint: **NO**
Remarks: **PVC**

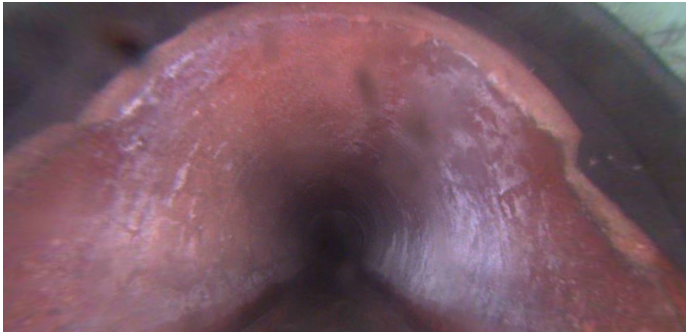
Code: **SSS**
Description: **Surface Spalling**

Distance (ft): **39.0**
Structural Grade: **2**
O&M Grade: **0**
Clock Start/From: **8**
Clock To: **4**
1st Value:
2nd Value:
Value Percent:
Continuous Index:
Within 8" of Joint: **YES**
Remarks:

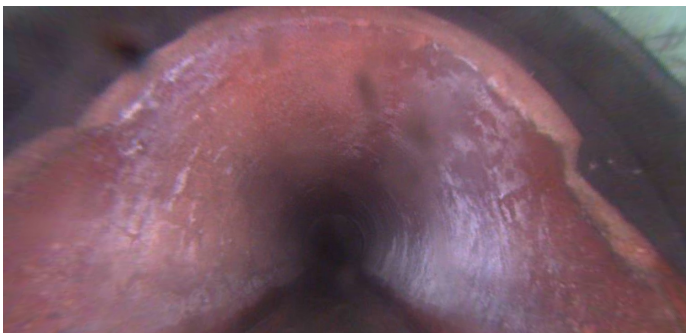
Code: **MMC**
Description: **Material Change**

Distance (ft): **39.0**
Structural Grade: **0**
O&M Grade: **0**
Clock Start/From:
Clock To:
1st Value:
2nd Value:
Value Percent:
Continuous Index:
Within 8" of Joint: **NO**
Remarks: **vcp**

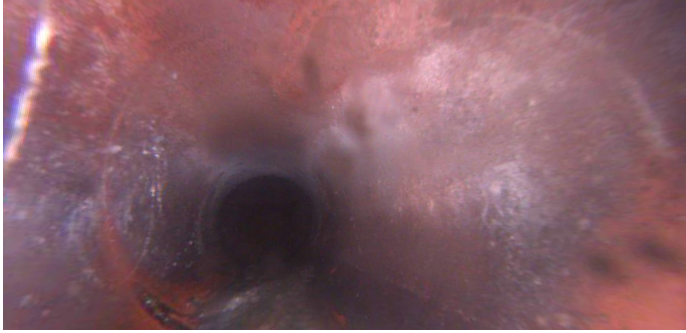
Code: **CS**
Description: **Crack Spiral**

Distance (ft): **45.4**
Structural Grade: **2**
O&M Grade: **0**
Clock Start/From: **8**
Clock To: **4**
1st Value:
2nd Value:
Value Percent:
Continuous Index:
Within 8" of Joint:
Remarks:

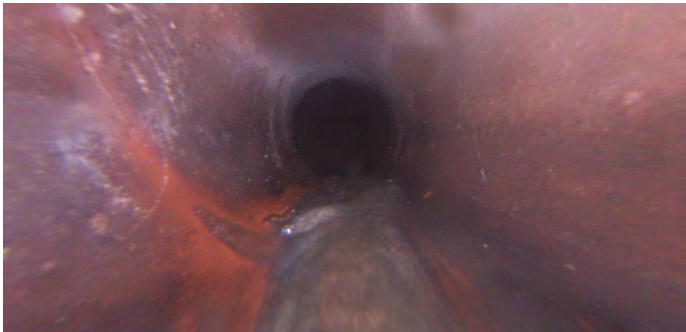
Code: **IW**
Description: **Infil Weeper**

Distance (ft): **45.8**
Structural Grade: **0**
O&M Grade: **2**
Clock Start/From: **8**
Clock To: **9**
1st Value:
2nd Value:
Value Percent:
Continuous Index:
Within 8" of Joint:
Remarks:
