## Profile/Photo Observation Report

Street:	<b>Summerlin</b>	Flow Control:	<b>Not Controlled</b>
City:	<b>Hobart, IN</b>	Year Renewed:	
Location:	<b>Light Highway</b>	Tape/Media #:	
Purpose:	<b>Not Known</b>	Dia/Height:	<b>10"</b>
Use:	<b>Sanitary</b>	Material:	<b>VCP</b>
Drain Area:	<b>NA</b>	Lining:	
Category:	<b>NA</b>		
Comment:

Location Details:		Direction of Survey:	<b>Downstream</b>
US MH:	<b>M-404-015</b>	DS MH:	<b>M-404-016</b>
		Total Length Surveyed (ft):	<b>249.7</b>

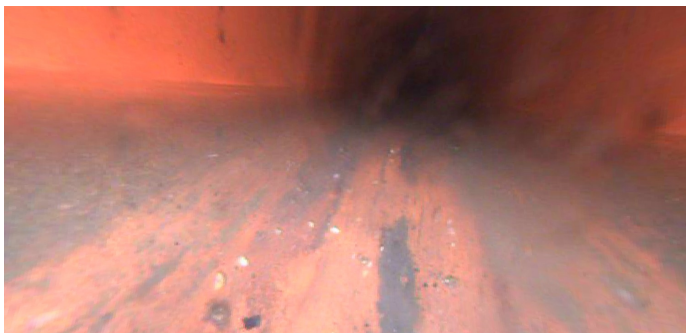
Code: **AMH**  
Description: **Manhole**

Distance (ft): **.0**  
Structural Grade: **0**  
O&M Grade: **0**  
Clock Start/From:  
Clock To:  
1st Value:  
2nd Value:  
Value Percent:  
Continuous Index:  
Within 8" of Joint: **NO**  
Remarks: **M-404-015**

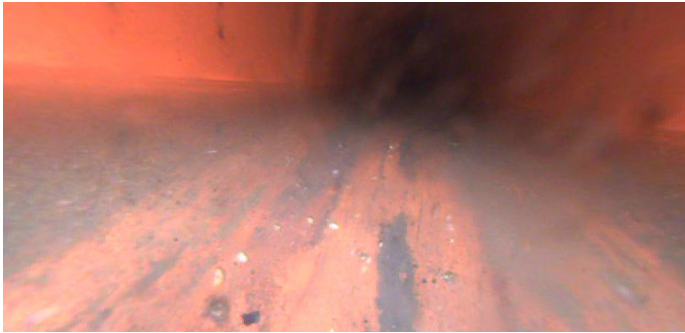
Code:	<b>MWL</b>
Description:	<b>Water Level</b>

Distance (ft):	<b>.0</b>
Structural Grade:	<b>0</b>
O&M Grade:	<b>0</b>
Clock Start/From:	
Clock To:	
1st Value:	
2nd Value:	
Value Percent:	<b>5.000</b>
Continuous Index:	
Within 8" of Joint:	<b>NO</b>
Remarks:

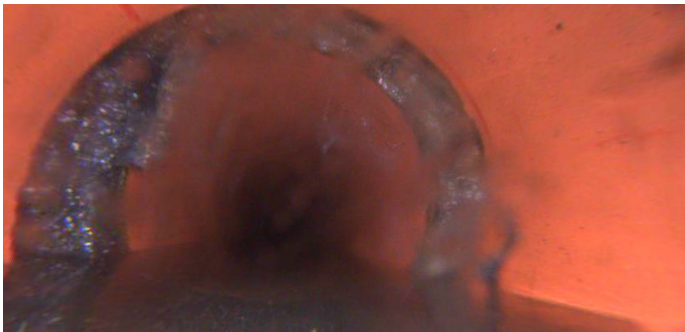
Code:	<b>DAE</b>
Description:	<b>Deposits Attached Encrustation</b>

Distance (ft):	<b>4.2</b>
Structural Grade:	<b>0</b>
O&M Grade:	<b>2</b>
Clock Start/From:	<b>8</b>
Clock To:	<b>4</b>
1st Value:	
2nd Value:	
Value Percent:	<b>10.000</b>
Continuous Index:	
Within 8" of Joint:	<b>YES</b>
Remarks:

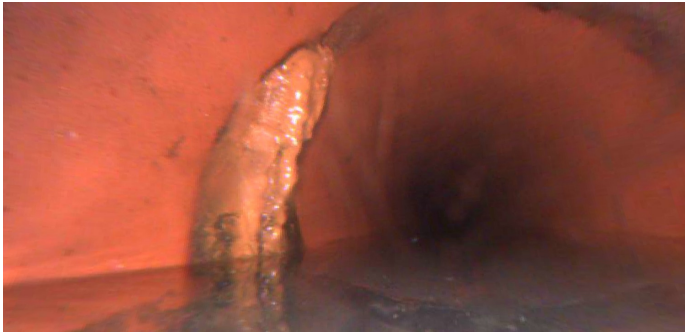
Code: **DAE**  
Description: **Deposits Attached Encrustation**

Distance (ft): **24.8**  
Structural Grade: **0**  
O&M Grade: **3**  
Clock Start/From: **7**  
Clock To: **9**  
1st Value:  
2nd Value:  
Value Percent: **20.000**  
Continuous Index:  
Within 8" of Joint: **YES**  
Remarks:

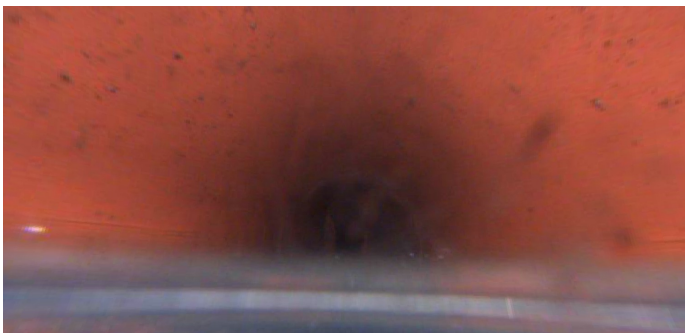
Code: **MWLS**  
Description: **Water Level Sag**

Distance (ft): **94.4**  
Structural Grade: **2**  
O&M Grade: **3**  
Clock Start/From:  
Clock To:  
1st Value:  
2nd Value:  
Value Percent: **15.000**  
Continuous Index:  
Within 8" of Joint: **NO**  
Remarks:

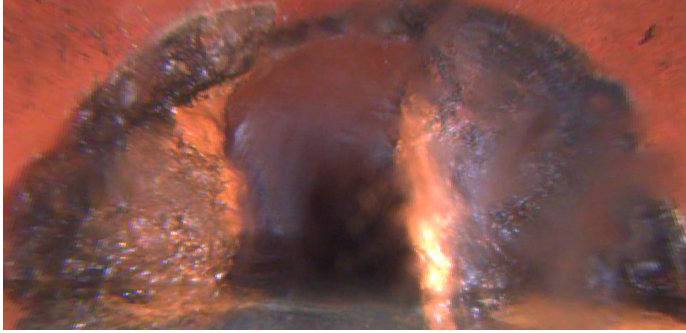
Code: **DAE**  
Description: **Deposits Attached Encrustation**

Distance (ft): **97.6**  
Structural Grade: **0**  
O&M Grade: **3**  
Clock Start/From: **7**  
Clock To: **5**  
1st Value:  
2nd Value:  
Value Percent: **20.000**  
Continuous Index:  
Within 8" of Joint: **YES**  
Remarks:

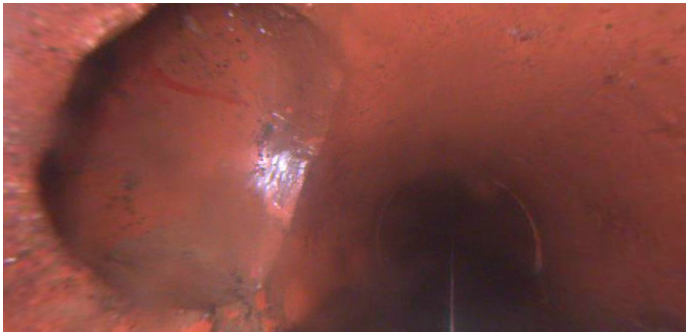
Code: **TF**  
Description: **Tap Factory**

Distance (ft): **97.7**  
Structural Grade: **0**  
O&M Grade: **0**  
Clock Start/From: **2**  
Clock To:  
1st Value: **4.000**  
2nd Value:  
Value Percent:  
Continuous Index:  
Within 8" of Joint:  
Remarks:

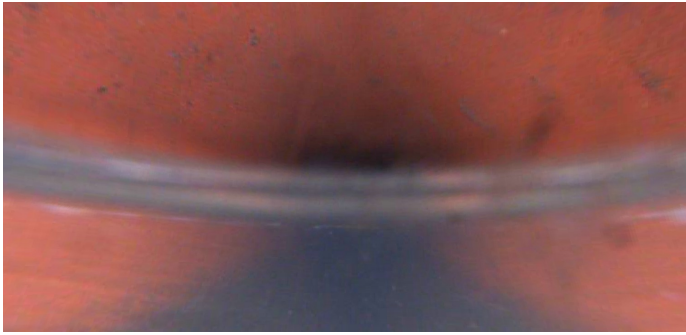
Code: **MWLS**  
Description: **Water Level Sag**

Distance (ft): **115.4**  
Structural Grade: **2**  
O&M Grade: **3**  
Clock Start/From:  
Clock To:  
1st Value:  
2nd Value:  
Value Percent: **15.000**  
Continuous Index:  
Within 8" of Joint: **NO**  
Remarks:

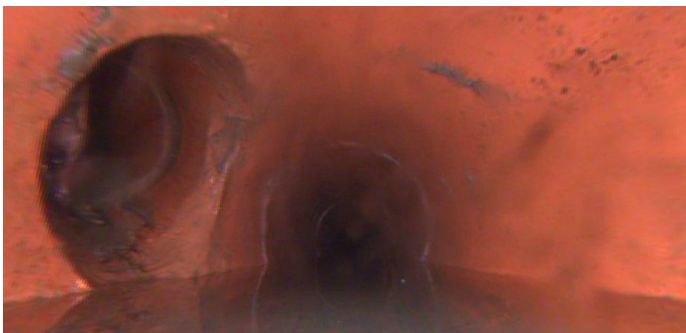
Code: **TF**  
Description: **Tap Factory**

Distance (ft): **139.1**  
Structural Grade: **0**  
O&M Grade: **0**  
Clock Start/From: **9**  
Clock To:  
1st Value: **4.000**  
2nd Value:  
Value Percent:  
Continuous Index:  
Within 8" of Joint:  
Remarks:

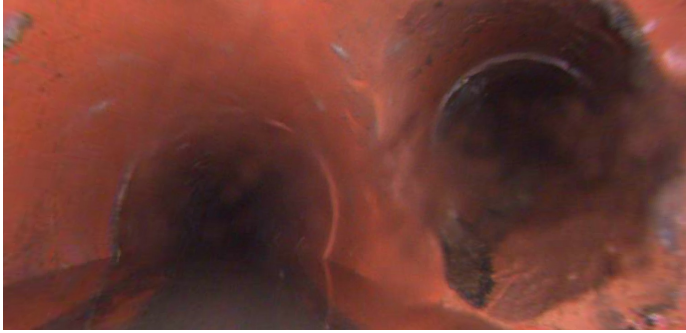
Code: **TFA**  
Description: **Tap Factory Active**

Distance (ft): **141.3**  
Structural Grade: **0**  
O&M Grade: **0**  
Clock Start/From: **3**  
Clock To:  
1st Value: **4.000**  
2nd Value:  
Value Percent:  
Continuous Index:  
Within 8" of Joint:  
Remarks:

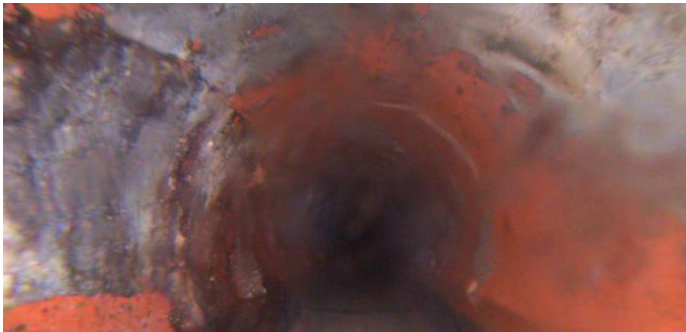
Code: **DAE**  
Description: **Deposits Attached Encrustation**

Distance (ft): **146.7**  
Structural Grade: **0**  
O&M Grade: **2**  
Clock Start/From: **8**  
Clock To: **4**  
1st Value:  
2nd Value:  
Value Percent: **5.000**  
Continuous Index:  
Within 8" of Joint: **YES**  
Remarks:

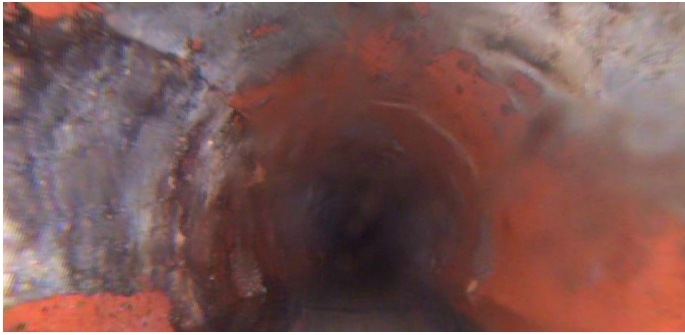
Code: **FL**  
Description: **Fracture Longitudinal**

Distance (ft): **146.7**  
Structural Grade: **3**  
O&M Grade: **0**  
Clock Start/From: **11**  
Clock To:  
1st Value:  
2nd Value:  
Value Percent:  
Continuous Index:  
Within 8" of Joint: **YES**  
Remarks:

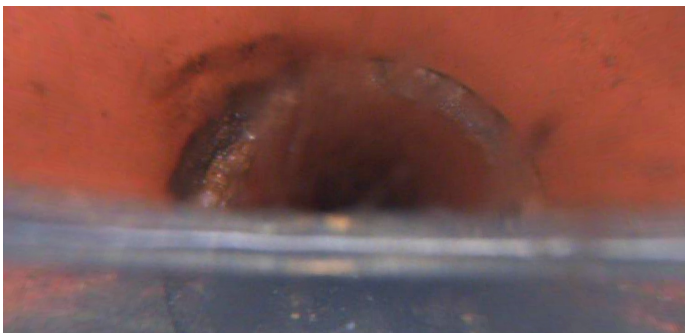
Code: **DAE**  
Description: **Deposits Attached Encrustation**

Distance (ft): **192.6**  
Structural Grade: **0**  
O&M Grade: **2**  
Clock Start/From: **7**  
Clock To: **11**  
1st Value:  
2nd Value:  
Value Percent: **10.000**  
Continuous Index:  
Within 8" of Joint: **YES**  
Remarks:

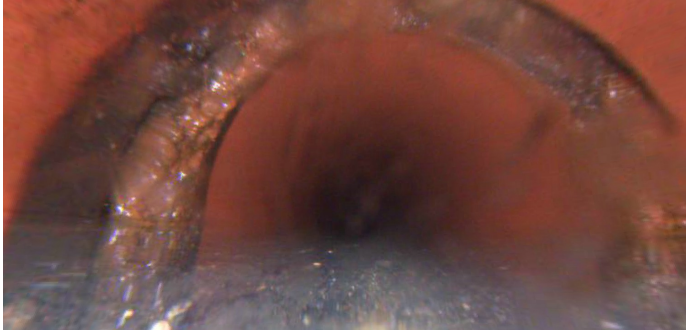
Code: **IW**  
Description: **Infil Weeper**

Distance (ft): **192.9**  
Structural Grade: **0**  
O&M Grade: **2**  
Clock Start/From: **8**  
Clock To: **4**  
1st Value:  
2nd Value:  
Value Percent:  
Continuous Index:  
Within 8" of Joint: **YES**  
Remarks:

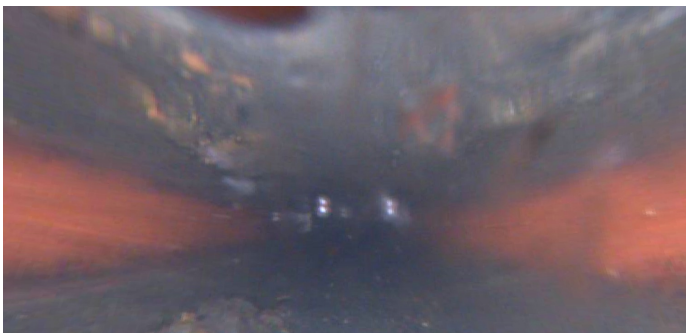
Code: **MWLS**  
Description: **Water Level Sag**

Distance (ft): **193.8**  
Structural Grade: **2**  
O&M Grade: **3**  
Clock Start/From:  
Clock To:  
1st Value:  
2nd Value:  
Value Percent: **10.000**  
Continuous Index:  
Within 8" of Joint: **NO**  
Remarks:

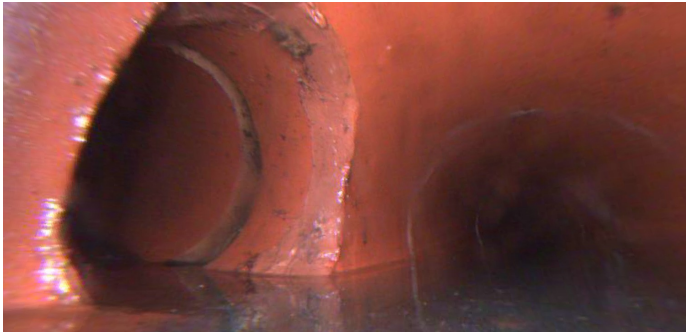
Code: **TFA**  
Description: **Tap Factory Active**

Distance (ft): **199.6**  
Structural Grade: **0**  
O&M Grade: **0**  
Clock Start/From: **9**  
Clock To:  
1st Value: **4.000**  
2nd Value:  
Value Percent:  
Continuous Index:  
Within 8" of Joint:  
Remarks:

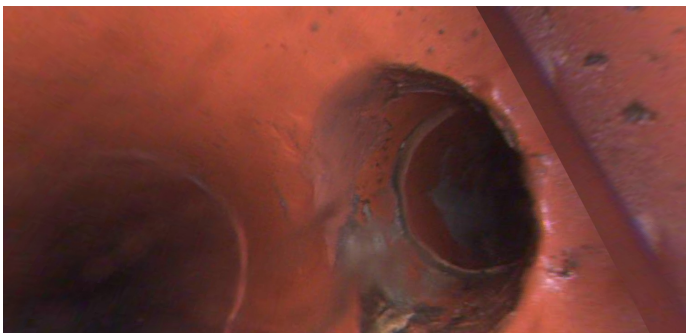
Code: **TF**  
Description: **Tap Factory**

Distance (ft): **201.4**  
Structural Grade: **0**  
O&M Grade: **0**  
Clock Start/From: **2**  
Clock To:  
1st Value: **4.000**  
2nd Value:  
Value Percent:  
Continuous Index:  
Within 8" of Joint:  
Remarks:

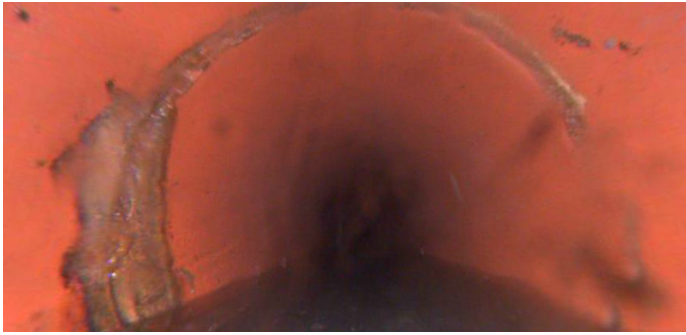
Code: **IW**  
Description: **Infil Weeper**

Distance (ft): **242.1**  
Structural Grade: **0**  
O&M Grade: **2**  
Clock Start/From: **8**  
Clock To: **4**  
1st Value:  
2nd Value:  
Value Percent:  
Continuous Index:  
Within 8" of Joint: **YES**  
Remarks:

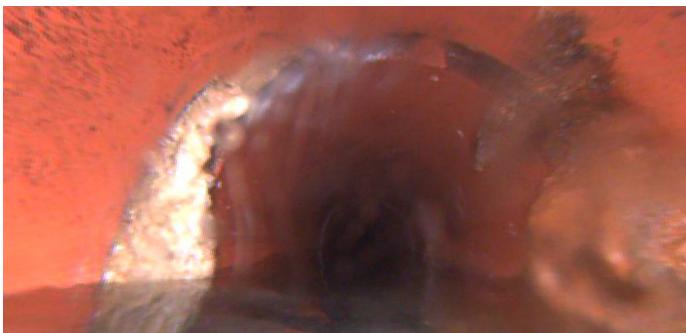
Code: **DAE**  
Description: **Deposits Attached Encrustation**

Distance (ft): **247.1**  
Structural Grade: **0**  
O&M Grade: **3**  
Clock Start/From: **7**  
Clock To: **5**  
1st Value:  
2nd Value:  
Value Percent: **20.000**  
Continuous Index:  
Within 8" of Joint: **YES**  
Remarks:

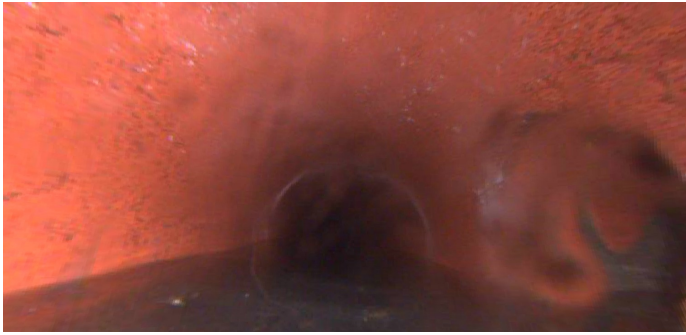
Code: **TF**  
Description: **Tap Factory**

Distance (ft): **248.3**  
Structural Grade: **0**  
O&M Grade: **0**  
Clock Start/From: **3**  
Clock To:  
1st Value: **4.000**  
2nd Value:  
Value Percent:  
Continuous Index:  
Within 8" of Joint:  
Remarks:

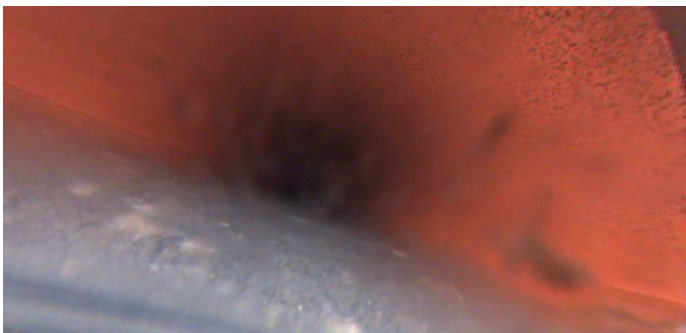
Code: **MSA**  
Description: **Abandoned Survey**

Distance (ft): **249.7**  
Structural Grade: **0**  
O&M Grade: **0**  
Clock Start/From:  
Clock To:  
1st Value:  
2nd Value:  
Value Percent:  
Continuous Index:  
Within 8" of Joint: **NO**  
Remarks: **camera stopped**
