Profile/Photo Observation Report

Date:	09/01/2021	Weather:		Coding:	PACP 7.0
Pipe Length (ft):	318.0	Owner:	City of Hobart	Pre Clean:	Light Cleaning
P.O.#:	YES502259	Surveyor:	S. Bucklin	PSR:	P-404-016-015
Customer:	City of Hobart	Clean Date:	08/29/2021	Shape:	C

Street:	North Wabash Street	Flow Control:	Not Controlled
City:	Hobart, IN	Year Renewed:	
Location:	Easement/Right of Way	Tape/Media #:	
Purpose:	Routine Assessment	Dia/Height:	10"
Use:	Sanitary Sewage Pipe	Material:	VCP
Drain Area:		Lining:	
Category:	NA		
Comment:			
Location Details:	IN FRONT OF THE HOUSE. IN THEIR	Direction of Survey:	Downstream
US MH:	M-404-015	DS MH:	M-404-016
		Total Length Surveyed (ft):	318.0

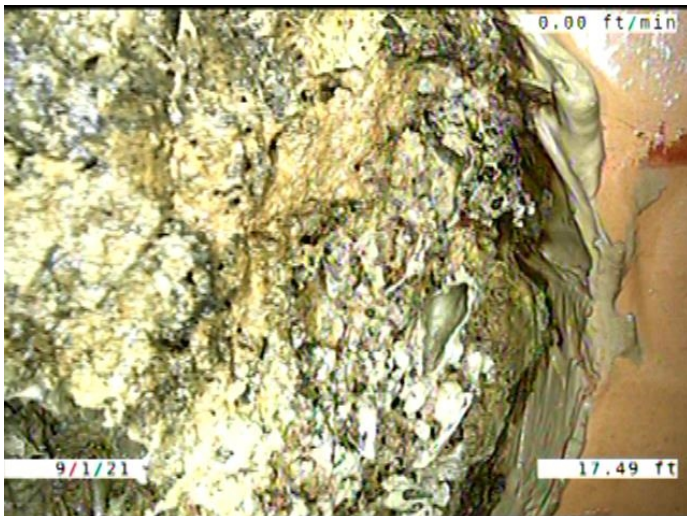
Code: **TFD**
 Description: **Tap Factory Defective**

Distance (ft): **17.5**
 Structural Grade: **0**
 O&M Grade: **3**
 Clock Start/From: **10**
 Clock To:
 1st Value: **6.000**
 2nd Value:
 Value Percent:
 Continuous Index:
 Within 8" of Joint: **YES**
 Remarks: **100% PLUGGED WITH ENCRUSTATION**

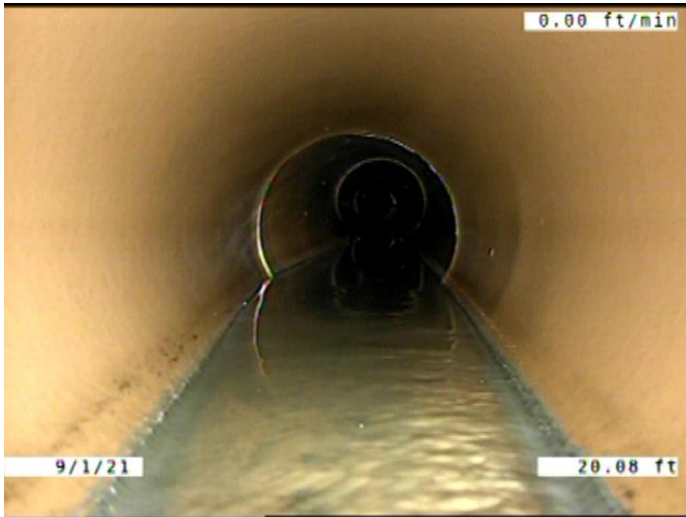
Code: **MWLS**
Description: **Miscellaneous Water Level Sag**

Distance (ft): **20.1**
Structural Grade: **2**
O&M Grade: **0**
Clock Start/From:
Clock To:
1st Value:
2nd Value:
Value Percent: **5.000**
Continuous Index: **S01**
Within 8" of Joint: **NO**
Remarks:

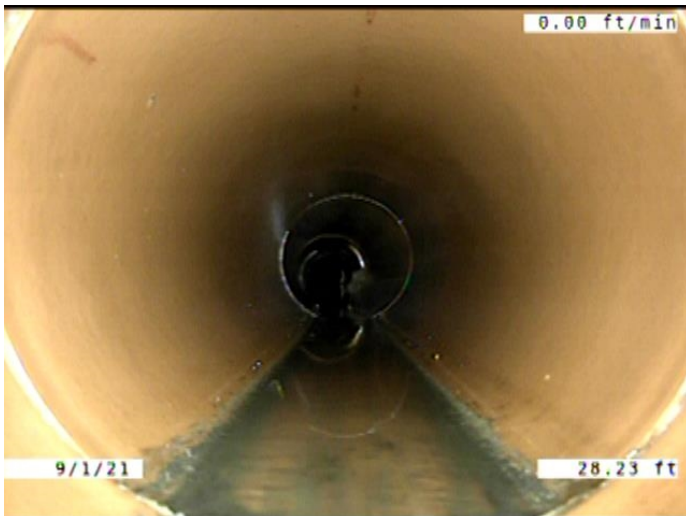
Code: **MWLS**
Description: **Miscellaneous Water Level Sag**

Distance (ft): **28.2**
Structural Grade: **2**
O&M Grade: **0**
Clock Start/From:
Clock To:
1st Value:
2nd Value:
Value Percent: **5.000**
Continuous Index: **F01**
Within 8" of Joint: **NO**
Remarks:

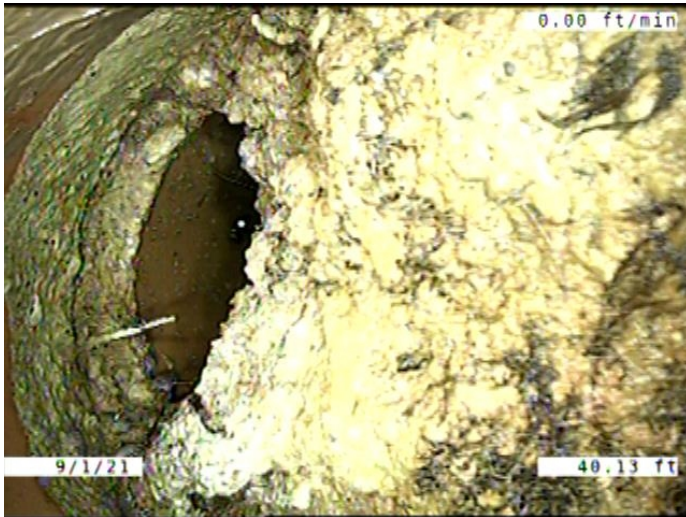
Code: **TFD**
 Description: **Tap Factory Defective**

Distance (ft): **40.1**
 Structural Grade: **0**
 O&M Grade: **3**
 Clock Start/From: **2**
 Clock To:
 1st Value: **6.000**
 2nd Value:
 Value Percent:
 Continuous Index:
 Within 8" of Joint: **YES**
 Remarks: **ENCrustATION AND ROOTS COMING INTO THE MAIN**

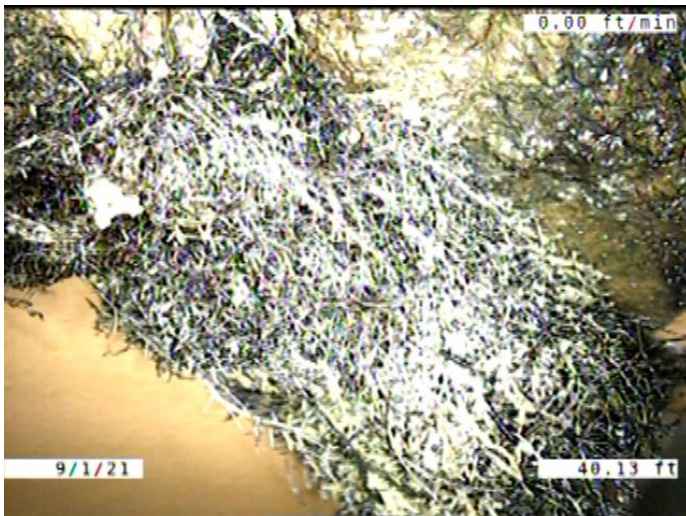
Code: **RML**
 Description: **Roots Medium Lateral**

Distance (ft): **40.1**
 Structural Grade: **0**
 O&M Grade: **3**
 Clock Start/From: **2**
 Clock To: **4**
 1st Value:
 2nd Value:
 Value Percent: **5.000**
 Continuous Index:
 Within 8" of Joint: **NO**
 Remarks:

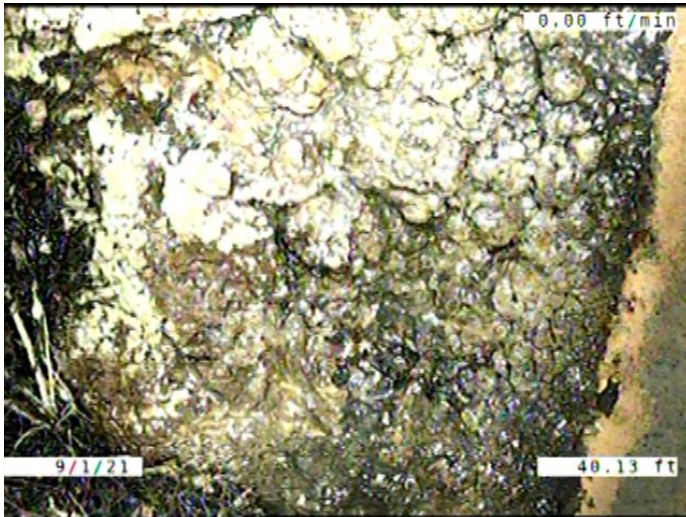
Code: **DAE**
 Description: **Deposits Attached Encrustation**

Distance (ft): **40.1**
 Structural Grade: **0**
 O&M Grade: **2**
 Clock Start/From: **3**
 Clock To: **4**
 1st Value:
 2nd Value:
 Value Percent: **5.000**
 Continuous Index:
 Within 8" of Joint: **YES**
 Remarks:

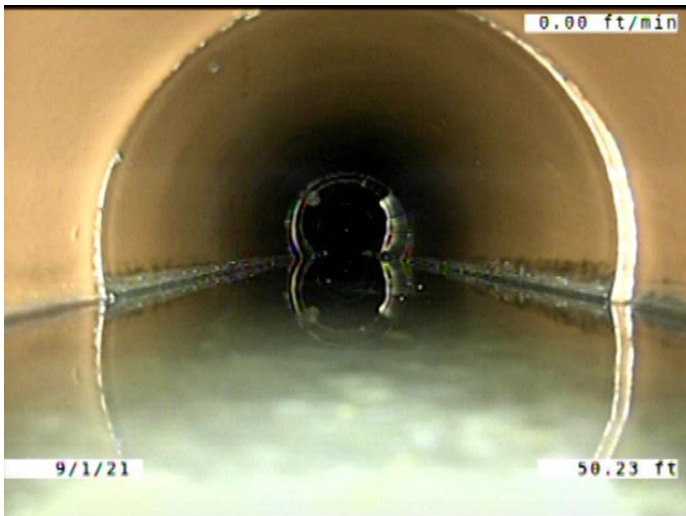
Code: **DSF**
 Description: **Deposits Settled Fine**

Distance (ft): **50.2**
 Structural Grade: **0**
 O&M Grade: **2**
 Clock Start/From: **5**
 Clock To: **7**
 1st Value:
 2nd Value:
 Value Percent: **5.000**
 Continuous Index: **S02**
 Within 8" of Joint: **YES**
 Remarks:

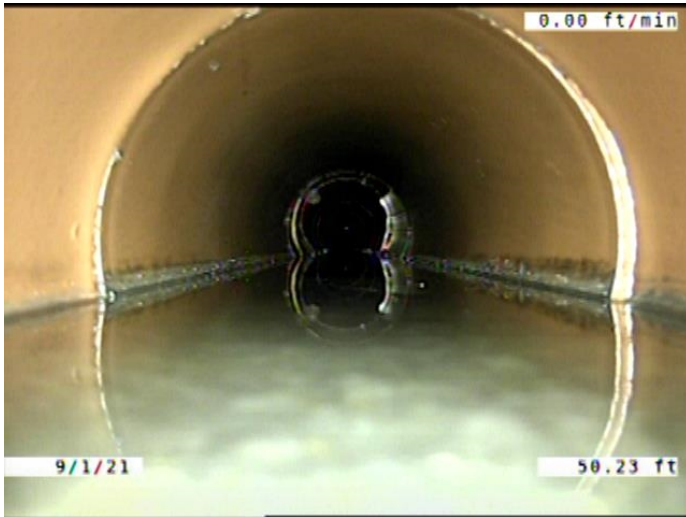
Code: **MWLS**
 Description: **Miscellaneous Water Level Sag**

Distance (ft): **50.2**
 Structural Grade: **2**
 O&M Grade: **0**
 Clock Start/From:
 Clock To:
 1st Value:
 2nd Value:
 Value Percent: **10.000**
 Continuous Index: **S03**
 Within 8" of Joint: **NO**
 Remarks:

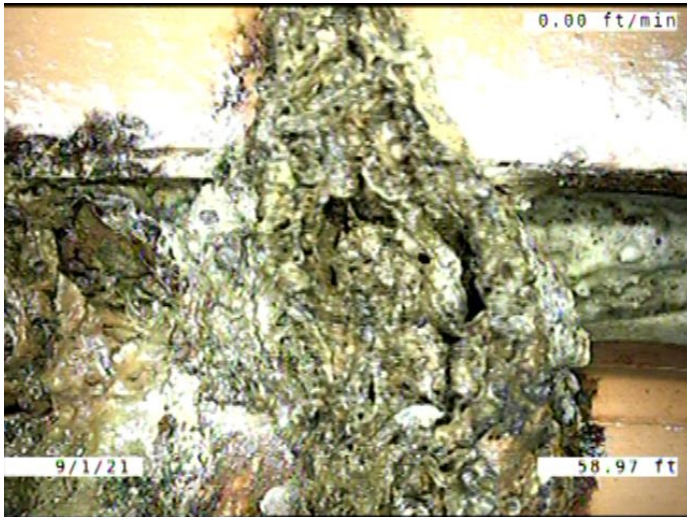
Code: **DAE**
 Description: **Deposits Attached Encrustation**

Distance (ft): **59.0**
 Structural Grade: **0**
 O&M Grade: **2**
 Clock Start/From: **8**
 Clock To: **4**
 1st Value:
 2nd Value:
 Value Percent: **5.000**
 Continuous Index:
 Within 8" of Joint: **YES**
 Remarks:

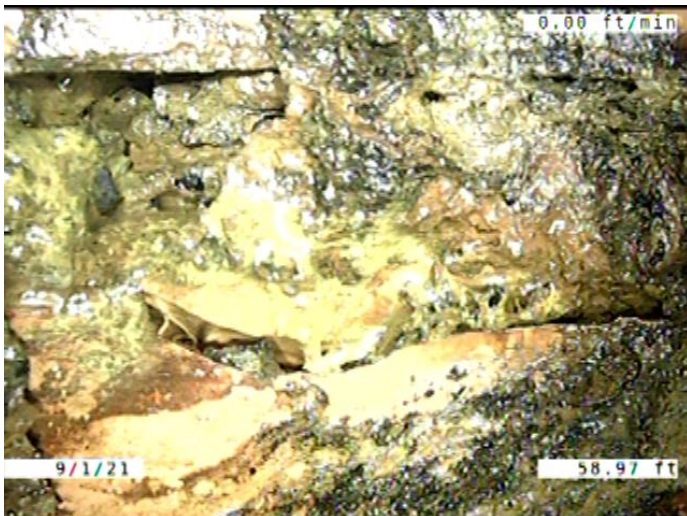
Code: **IRJ**
 Description: **Infiltration Runner Joint**

Distance (ft): **59.0**
 Structural Grade: **0**
 O&M Grade: **4**
 Clock Start/From: **9**
 Clock To:
 1st Value:
 2nd Value:
 Value Percent:
 Continuous Index:
 Within 8" of Joint: **YES**
 Remarks:

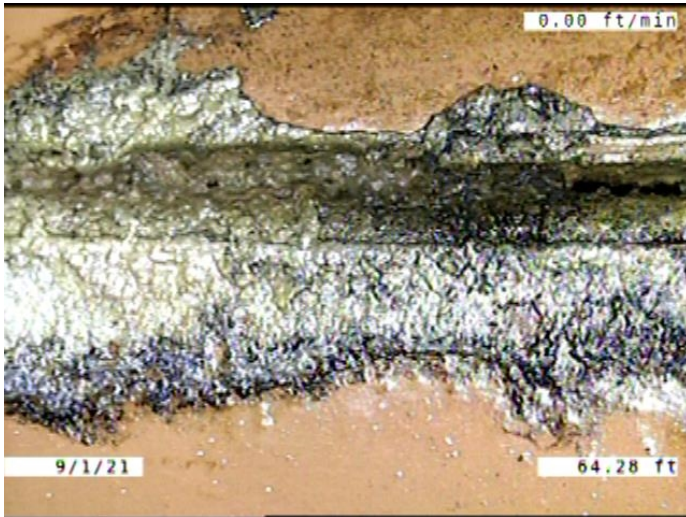
Code: **ISJ**
 Description: **Infiltration Stain Joint**

Distance (ft): **64.3**
 Structural Grade: **0**
 O&M Grade: **1**
 Clock Start/From: **8**
 Clock To: **4**
 1st Value:
 2nd Value:
 Value Percent:
 Continuous Index:
 Within 8" of Joint: **YES**
 Remarks:

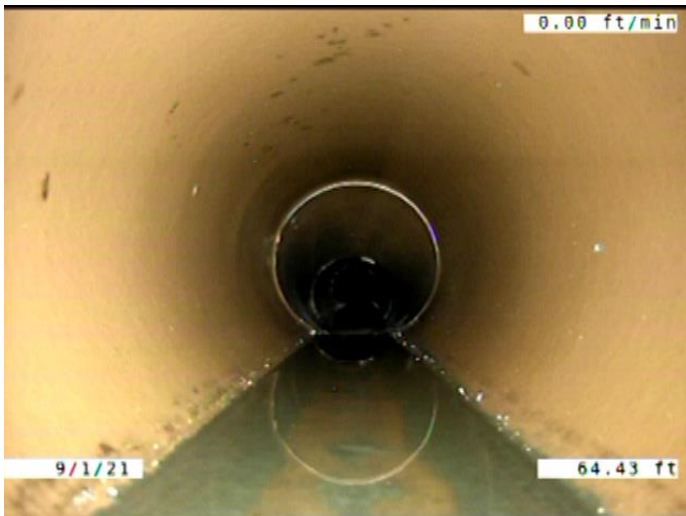
Code: **MWLS**
 Description: **Miscellaneous Water Level Sag**

Distance (ft): **64.4**
 Structural Grade: **2**
 O&M Grade: **0**
 Clock Start/From:
 Clock To:
 1st Value:
 2nd Value:
 Value Percent: **10.000**
 Continuous Index: **F03**
 Within 8" of Joint: **NO**
 Remarks:

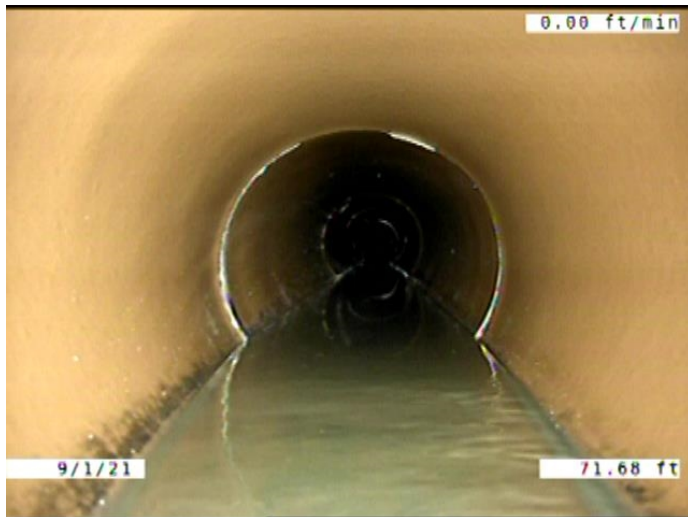
Code: **MWLS**
 Description: **Miscellaneous Water Level Sag**

Distance (ft): **71.7**
 Structural Grade: **2**
 O&M Grade: **0**
 Clock Start/From:
 Clock To:
 1st Value:
 2nd Value:
 Value Percent: **10.000**
 Continuous Index: **S04**
 Within 8" of Joint: **NO**
 Remarks:

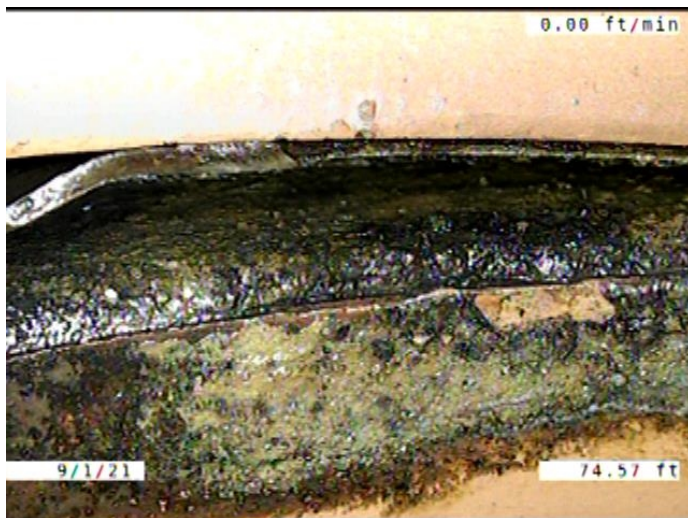
Code: **ISJ**
 Description: **Infiltration Stain Joint**

Distance (ft): **74.6**
 Structural Grade: **0**
 O&M Grade: **1**
 Clock Start/From: **8**
 Clock To: **4**
 1st Value:
 2nd Value:
 Value Percent:
 Continuous Index:
 Within 8" of Joint: **YES**
 Remarks:

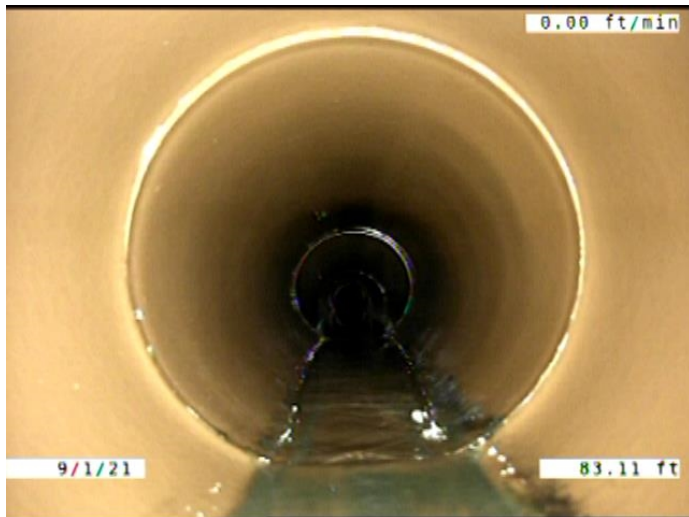
Code: **MWLS**
Description: **Miscellaneous Water Level Sag**

Distance (ft): **83.1**
Structural Grade: **2**
O&M Grade: **0**
Clock Start/From:
Clock To:
1st Value:
2nd Value:
Value Percent: **10.000**
Continuous Index: **F04**
Within 8" of Joint: **NO**
Remarks:

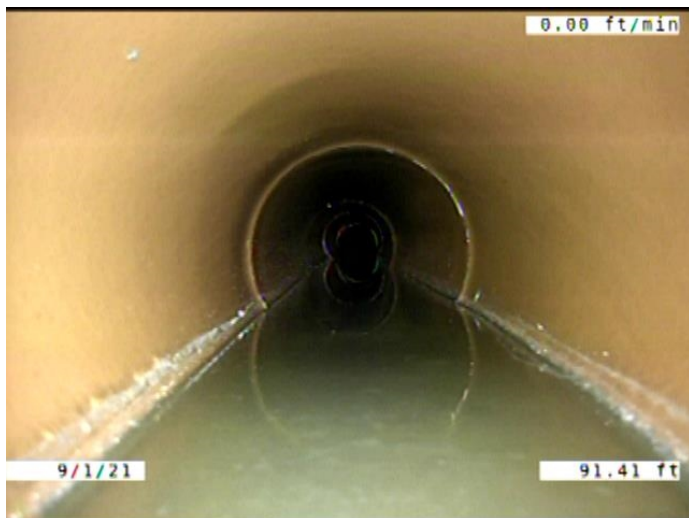
Code: **MWLS**
Description: **Miscellaneous Water Level Sag**

Distance (ft): **91.4**
Structural Grade: **2**
O&M Grade: **0**
Clock Start/From:
Clock To:
1st Value:
2nd Value:
Value Percent: **10.000**
Continuous Index: **S05**
Within 8" of Joint: **NO**
Remarks:

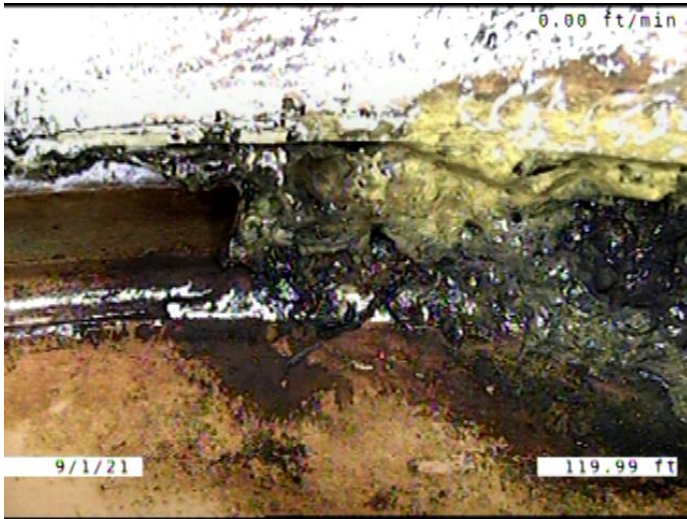
Code: **IRJ**
Description: **Infiltration Runner Joint**

Distance (ft): **120.0**
Structural Grade: **0**
O&M Grade: **4**
Clock Start/From: **1**
Clock To:
1st Value:
2nd Value:
Value Percent:
Continuous Index:
Within 8" of Joint: **YES**
Remarks:

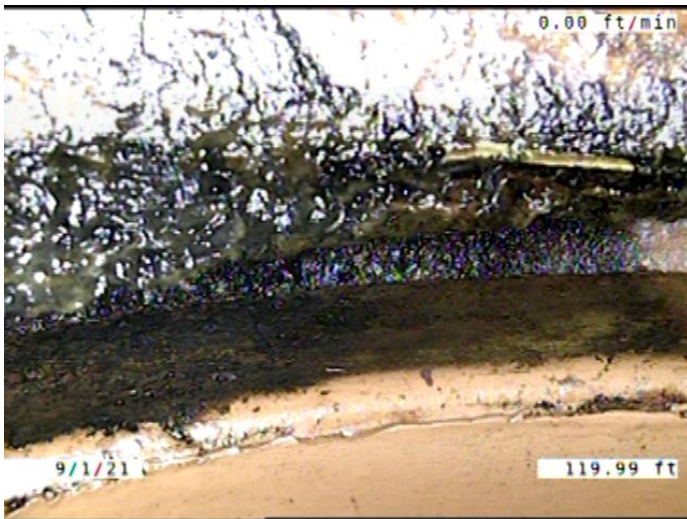
Code: **ISJ**
Description: **Infiltration Stain Joint**

Distance (ft): **120.0**
Structural Grade: **0**
O&M Grade: **1**
Clock Start/From: **8**
Clock To: **4**
1st Value:
2nd Value:
Value Percent:
Continuous Index:
Within 8" of Joint: **YES**
Remarks:

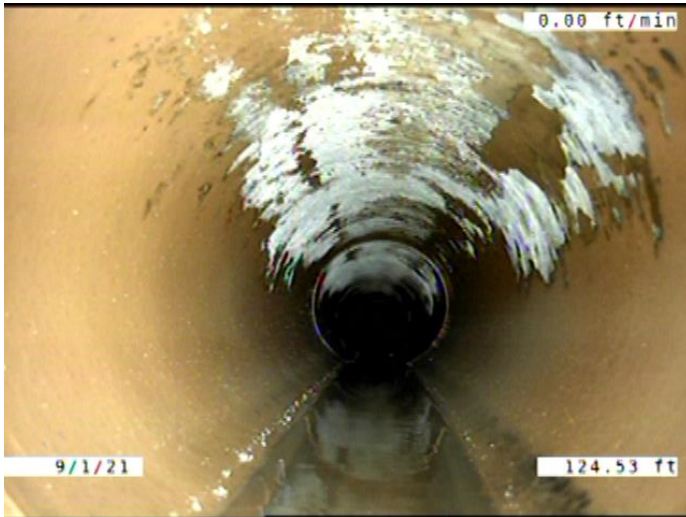
Code: **MWLS**
 Description: **Miscellaneous Water Level Sag**

Distance (ft): **124.5**
 Structural Grade: **2**
 O&M Grade: **0**
 Clock Start/From:
 Clock To:
 1st Value:
 2nd Value:
 Value Percent: **10.000**
 Continuous Index: **F05**
 Within 8" of Joint: **NO**
 Remarks:

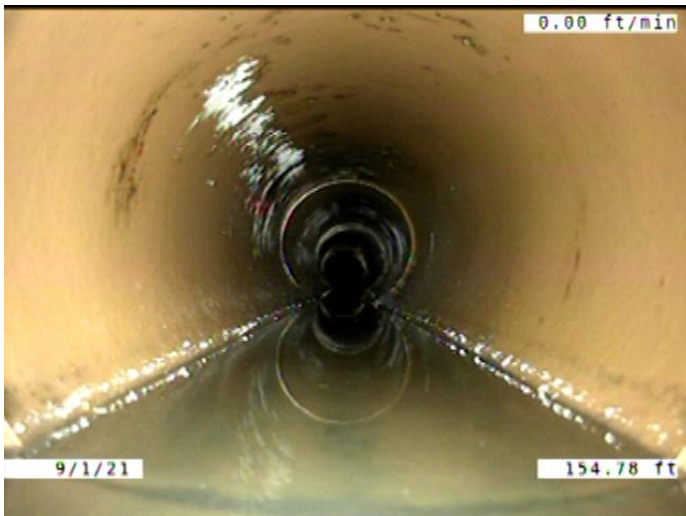
Code: **MWLS**
 Description: **Miscellaneous Water Level Sag**

Distance (ft): **154.8**
 Structural Grade: **2**
 O&M Grade: **0**
 Clock Start/From:
 Clock To:
 1st Value:
 2nd Value:
 Value Percent: **5.000**
 Continuous Index:
 Within 8" of Joint: **NO**
 Remarks:

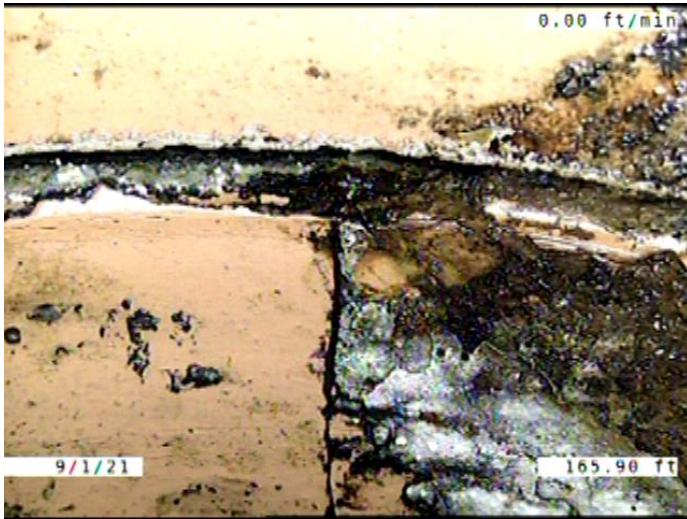
Code: **CM**
 Description: **Crack Multiple**

Distance (ft): **165.9**
 Structural Grade: **3**
 O&M Grade: **0**
 Clock Start/From: **2**
 Clock To: **4**
 1st Value:
 2nd Value:
 Value Percent:
 Continuous Index:
 Within 8" of Joint: **YES**
 Remarks:

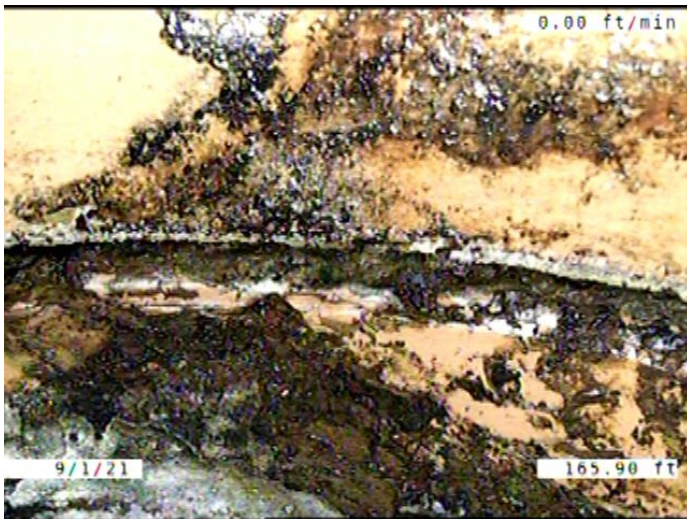
Code: **ISJ**
 Description: **Infiltration Stain Joint**

Distance (ft): **165.9**
 Structural Grade: **0**
 O&M Grade: **1**
 Clock Start/From: **7**
 Clock To: **5**
 1st Value:
 2nd Value:
 Value Percent:
 Continuous Index:
 Within 8" of Joint: **YES**
 Remarks:

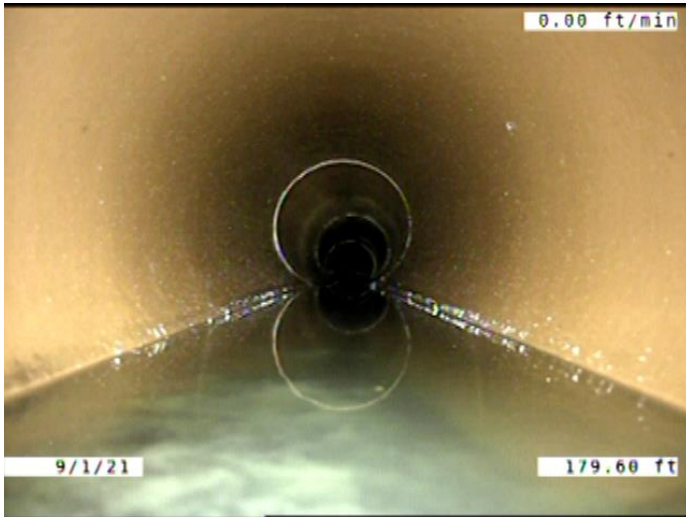
Code: **MWLS**
Description: **Miscellaneous Water Level Sag**

Distance (ft): **179.6**
Structural Grade: **2**
O&M Grade: **0**
Clock Start/From:
Clock To:
1st Value:
2nd Value:
Value Percent: **5.000**
Continuous Index:
Within 8" of Joint: **NO**
Remarks:

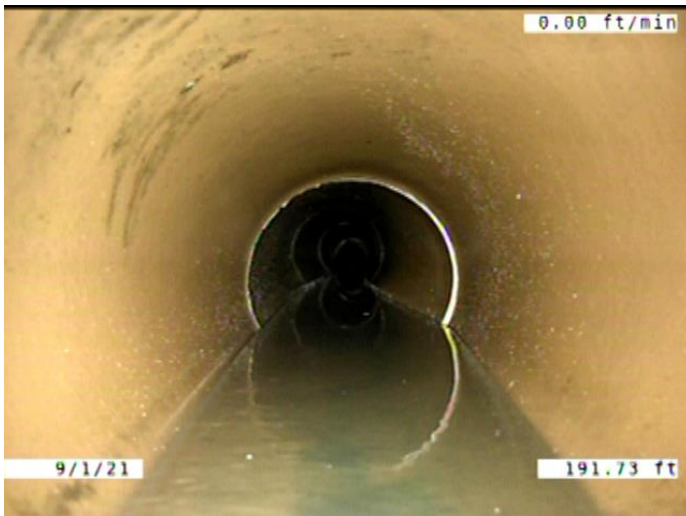
Code: **MWLS**
Description: **Miscellaneous Water Level Sag**

Distance (ft): **191.7**
Structural Grade: **2**
O&M Grade: **0**
Clock Start/From:
Clock To:
1st Value:
2nd Value:
Value Percent: **10.000**
Continuous Index: **S06**
Within 8" of Joint: **NO**
Remarks:

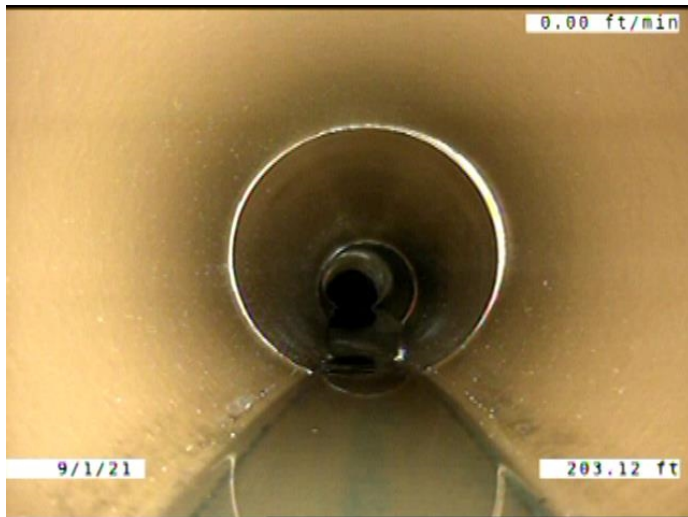
Code: **MWLS**
 Description: **Miscellaneous Water Level Sag**

Distance (ft): **203.1**
 Structural Grade: **2**
 O&M Grade: **0**
 Clock Start/From:
 Clock To:
 1st Value:
 2nd Value:
 Value Percent: **10.000**
 Continuous Index: **F06**
 Within 8" of Joint: **NO**
 Remarks:

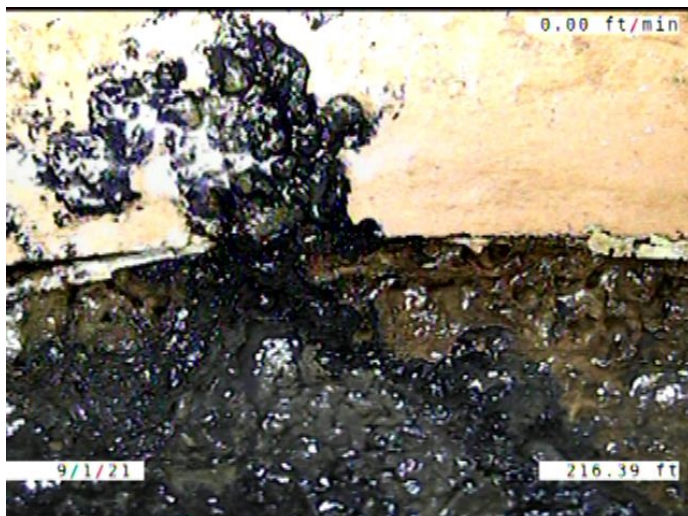
Code: **DAE**
 Description: **Deposits Attached Encrustation**

Distance (ft): **216.4**
 Structural Grade: **0**
 O&M Grade: **2**
 Clock Start/From: **7**
 Clock To: **5**
 1st Value:
 2nd Value:
 Value Percent: **5.000**
 Continuous Index:
 Within 8" of Joint: **YES**
 Remarks:

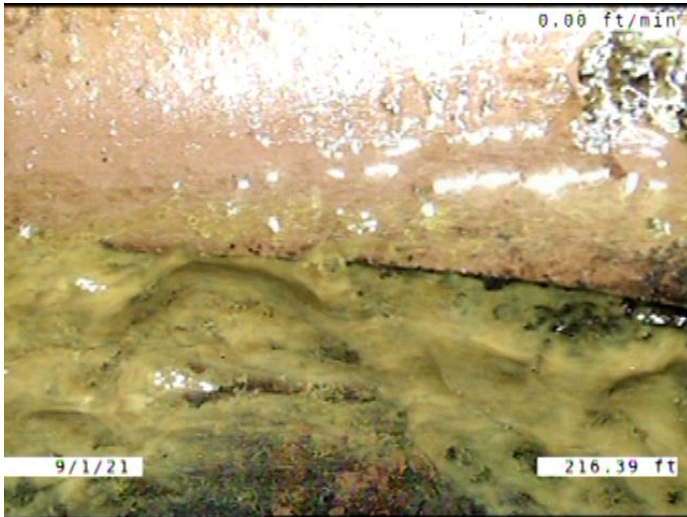
Code: **IWJ**
 Description: **Infiltration Weeper Joint**

Distance (ft): **216.4**
 Structural Grade: **0**
 O&M Grade: **2**
 Clock Start/From: **3**
 Clock To:
 1st Value:
 2nd Value:
 Value Percent:
 Continuous Index:
 Within 8" of Joint: **YES**
 Remarks:

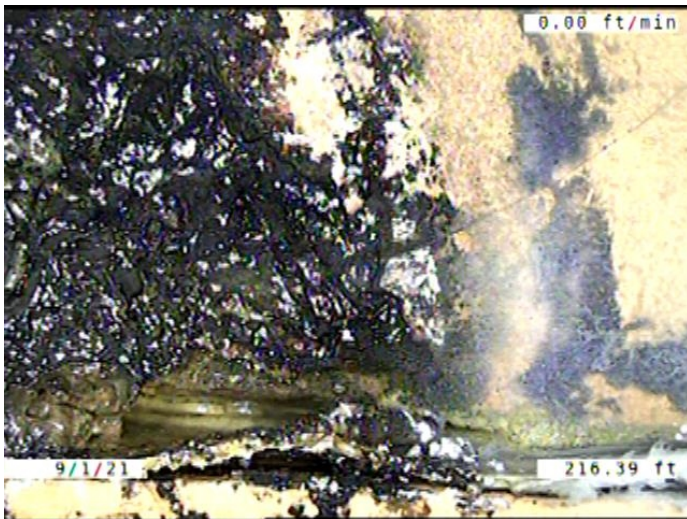
Code: **CS**
 Description: **Crack Spiral**

Distance (ft): **216.4**
 Structural Grade: **2**
 O&M Grade: **0**
 Clock Start/From: **4**
 Clock To: **7**
 1st Value:
 2nd Value:
 Value Percent:
 Continuous Index:
 Within 8" of Joint: **YES**
 Remarks:

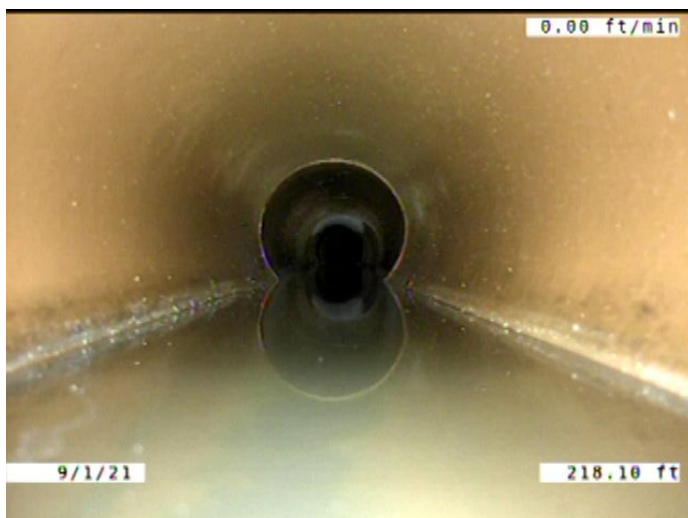
Code: **MWLS**
 Description: **Miscellaneous Water Level Sag**

Distance (ft): **218.1**
 Structural Grade: **2**
 O&M Grade: **0**
 Clock Start/From:
 Clock To:
 1st Value:
 2nd Value:
 Value Percent: **10.000**
 Continuous Index: **S07**
 Within 8" of Joint: **NO**
 Remarks:

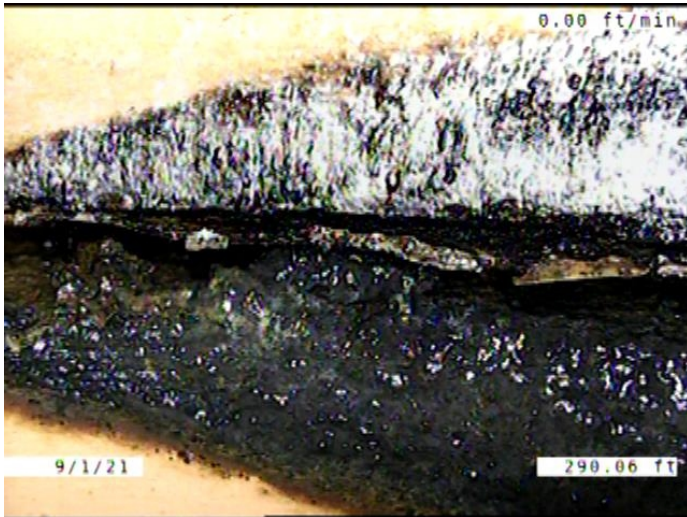
Code: **ISJ**
 Description: **Infiltration Stain Joint**

Distance (ft): **290.1**
 Structural Grade: **0**
 O&M Grade: **1**
 Clock Start/From: **8**
 Clock To: **4**
 1st Value:
 2nd Value:
 Value Percent:
 Continuous Index:
 Within 8" of Joint: **YES**
 Remarks:

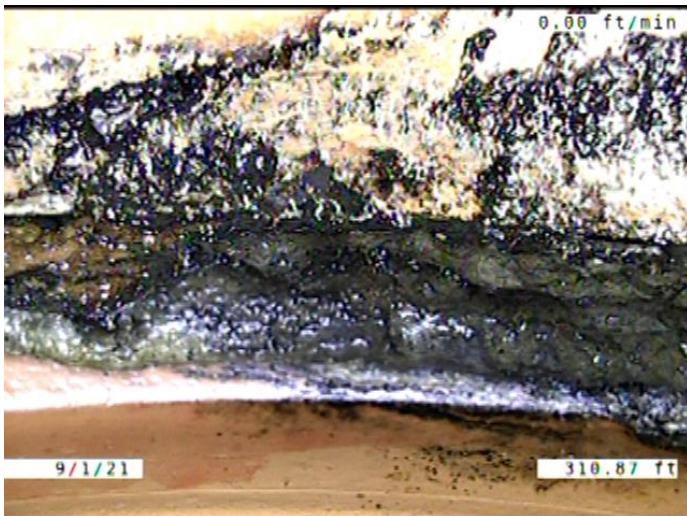
Code: **DAE**
 Description: **Deposits Attached Encrustation**

Distance (ft): **310.9**
 Structural Grade: **0**
 O&M Grade: **2**
 Clock Start/From: **7**
 Clock To: **5**
 1st Value:
 2nd Value:
 Value Percent: **5.000**
 Continuous Index:
 Within 8" of Joint: **YES**
 Remarks:

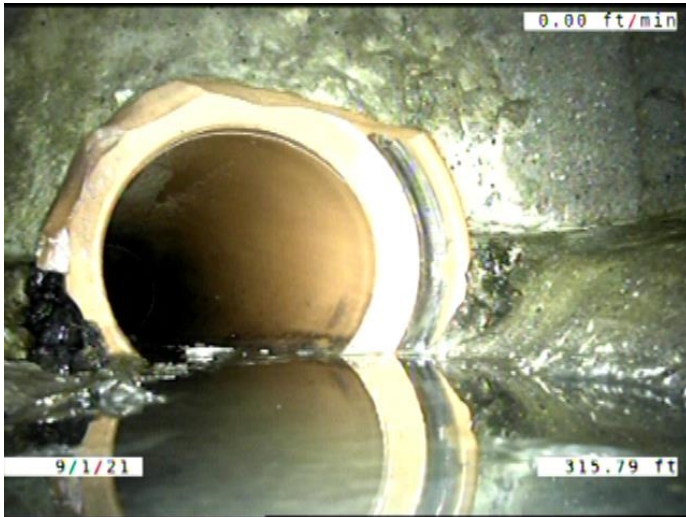
Code: **MWLS**
 Description: **Miscellaneous Water Level Sag**

Distance (ft): **315.8**
 Structural Grade: **2**
 O&M Grade: **0**
 Clock Start/From:
 Clock To:
 1st Value:
 2nd Value:
 Value Percent: **10.000**
 Continuous Index: **F07**
 Within 8" of Joint: **NO**
 Remarks:

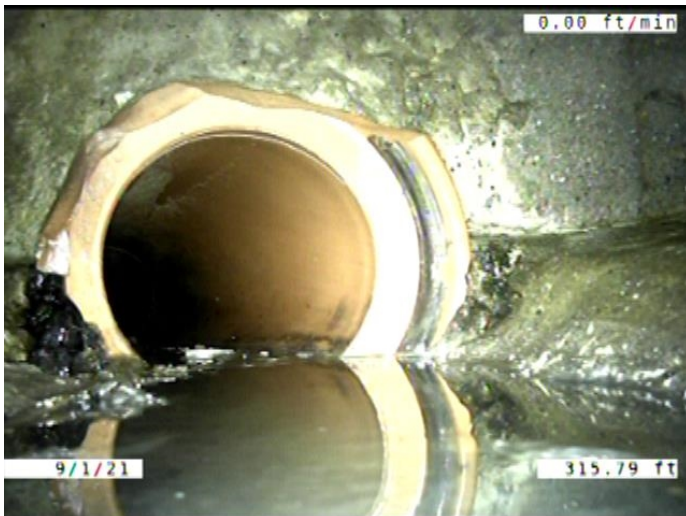
Code: **DSF**
 Description: **Deposits Settled Fine**

Distance (ft): **315.8**
 Structural Grade: **0**
 O&M Grade: **2**
 Clock Start/From: **5**
 Clock To: **7**
 1st Value:
 2nd Value:
 Value Percent: **5.000**
 Continuous Index: **F02**
 Within 8" of Joint: **YES**
 Remarks:
