Profile/Photo Observation Report

| P.O.#: | YES502259 | Surveyor: | S. Bucklin | PSR: | P-404-016-015 |

| Street: | North Wabash Street | Flow Control: | Not Controlled |
| US MH: | M-404-015 | DS MH: | M-404-016 |

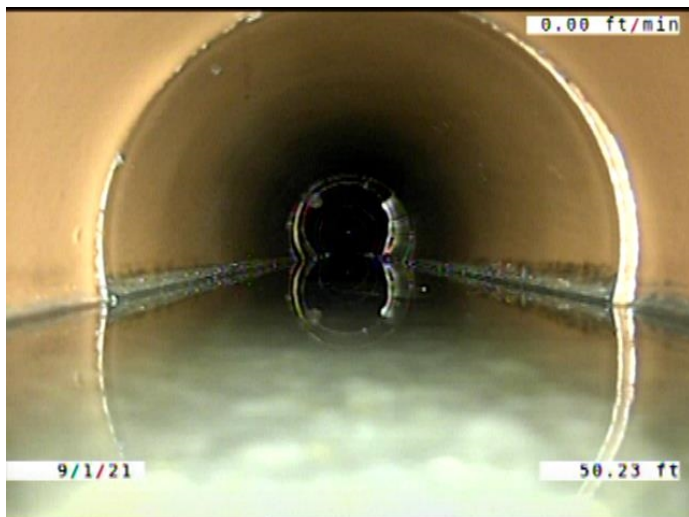
Code: **MWLS**
 Description: **Miscellaneous Water Level Sag**

Distance (ft): **50.2**
 Structural Grade: **2**
 O&M Grade: **0**
 Clock Start/From:
 Clock To:
 1st Value:
 2nd Value:
 Value Percent: **10.000**
 Continuous Index: **S03**
 Within 8" of Joint: **NO**
 Remarks:

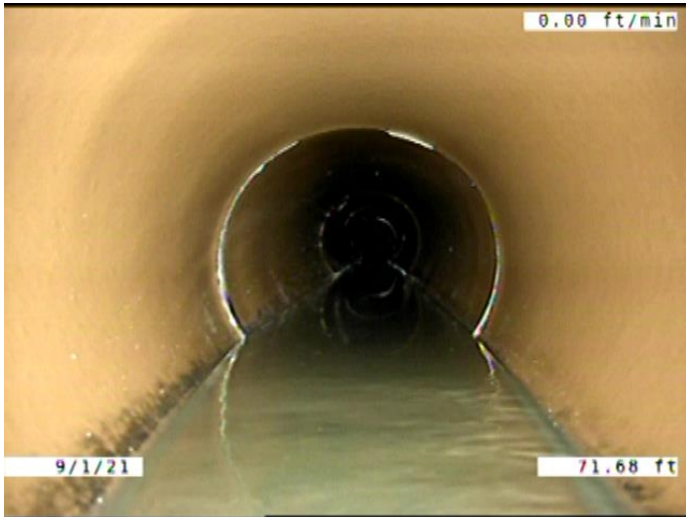
Code: **MWLS**
 Description: **Miscellaneous Water Level Sag**

Distance (ft): **71.7**
 Structural Grade: **2**
 O&M Grade: **0**
 Clock Start/From:
 Clock To:
 1st Value:
 2nd Value:
 Value Percent: **10.000**
 Continuous Index: **S04**
 Within 8" of Joint: **NO**
 Remarks:

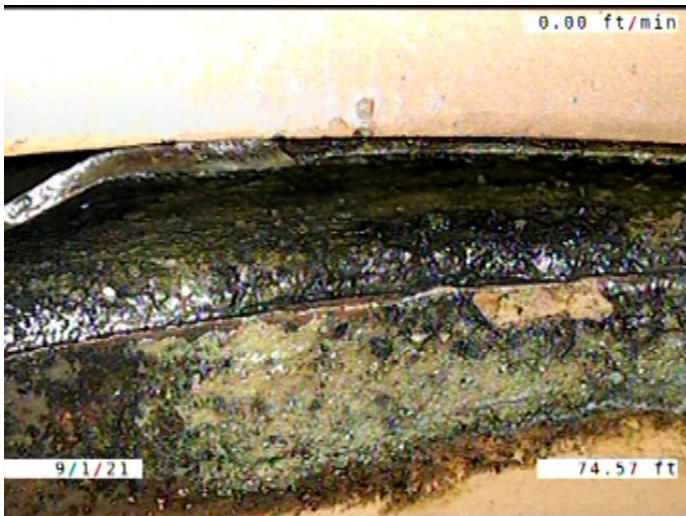
Code: **ISJ**
 Description: **Infiltration Stain Joint**

Distance (ft): **74.6**
 Structural Grade: **0**
 O&M Grade: **1**
 Clock Start/From: **8**
 Clock To: **4**
 1st Value:
 2nd Value:
 Value Percent:
 Continuous Index:
 Within 8" of Joint: **YES**
 Remarks:

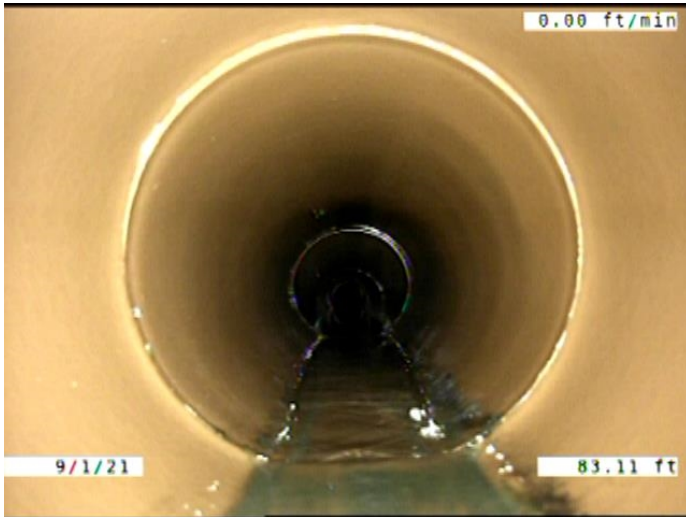
Code: **MWLS**
Description: **Miscellaneous Water Level Sag**

Distance (ft): **83.1**
Structural Grade: **2**
O&M Grade: **0**
Clock Start/From:
Clock To:
1st Value:
2nd Value:
Value Percent: **10.000**
Continuous Index: **F04**
Within 8" of Joint: **NO**
Remarks:

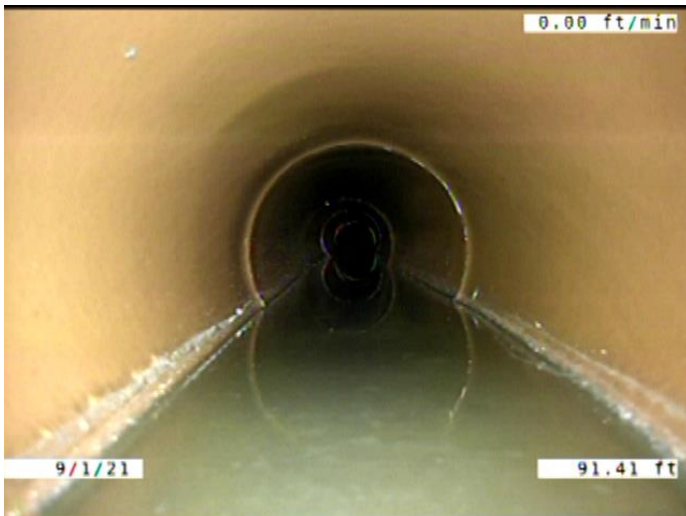
Code: **MWLS**
Description: **Miscellaneous Water Level Sag**

Distance (ft): **91.4**
Structural Grade: **2**
O&M Grade: **0**
Clock Start/From:
Clock To:
1st Value:
2nd Value:
Value Percent: **10.000**
Continuous Index: **S05**
Within 8" of Joint: **NO**
Remarks:

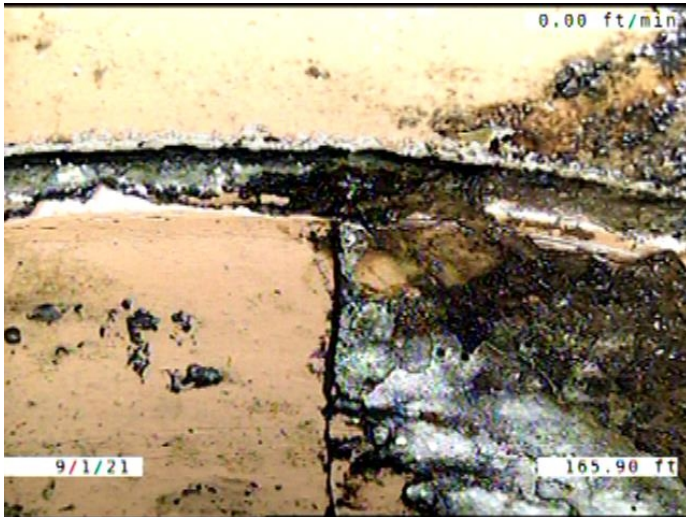
Code: **CM**
 Description: **Crack Multiple**

Distance (ft): **165.9**
 Structural Grade: **3**
 O&M Grade: **0**
 Clock Start/From: **2**
 Clock To: **4**
 1st Value:
 2nd Value:
 Value Percent:
 Continuous Index:
 Within 8" of Joint: **YES**
 Remarks:

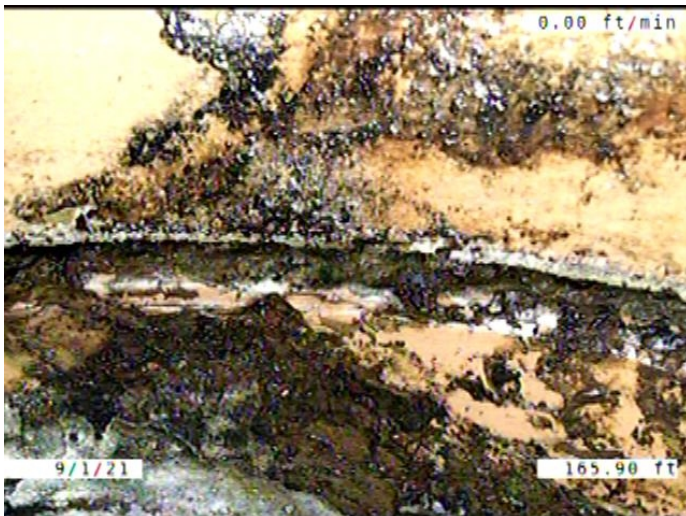
Code: **ISJ**
 Description: **Infiltration Stain Joint**

Distance (ft): **165.9**
 Structural Grade: **0**
 O&M Grade: **1**
 Clock Start/From: **7**
 Clock To: **5**
 1st Value:
 2nd Value:
 Value Percent:
 Continuous Index:
 Within 8" of Joint: **YES**
 Remarks:
