Profile/Photo Observation Report

Date:	04/16/2018	Weather:		Coding:	PACP 6.0
Pipe Length (ft):	298.3	Owner:	NA	Pre Clean:	Not Known
P.O.#:		Surveyor:	Selasie Honu	PSR:	P-404-017-016
Customer:		Clean Date:	01/01/1900	Shape:	C

Street:	N WABASH ST	Flow Control:	Not Controlled
City:	Hobart, IN	Year Renewed:	
Location:	Light Highway	Tape/Media #:	
Purpose:	Not Known	Dia/Height:	10"
Use:	Sanitary	Material:	VCP
Drain Area:	NA	Lining:	
Category:	NA		
Comment:

Location Details:		Direction of Survey:	Downstream
US MH:	M-404-016	DS MH:	M-404-017
		Total Length Surveyed (ft):	280.4

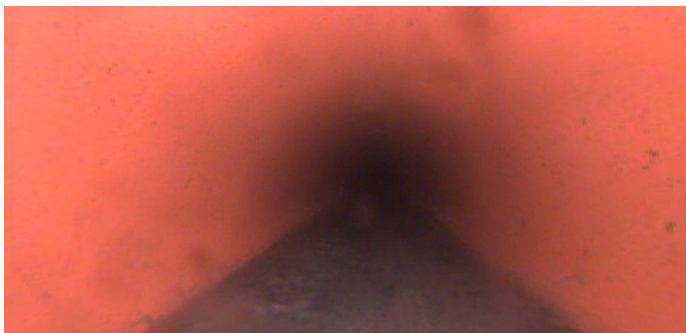
Code: **AMH**
Description: **Manhole**

Distance (ft): **.0**
Structural Grade: **0**
O&M Grade: **0**
Clock Start/From:
Clock To:
1st Value:
2nd Value:
Value Percent:
Continuous Index:
Within 8" of Joint: **NO**
Remarks: **M-404-016**

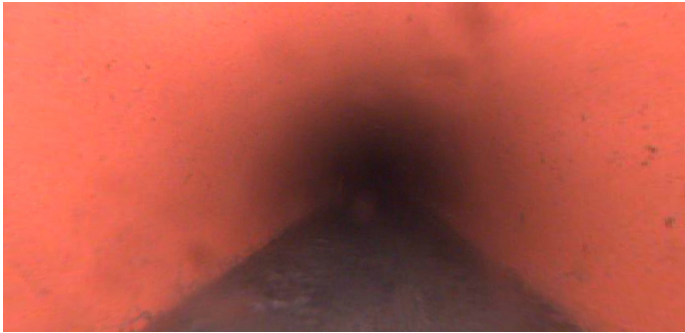
Code:	MWL
Description:	Water Level

Distance (ft):	.0
Structural Grade:	0
O&M Grade:	0
Clock Start/From:	
Clock To:	
1st Value:	
2nd Value:	
Value Percent:	5.000
Continuous Index:	
Within 8" of Joint:	NO
Remarks:

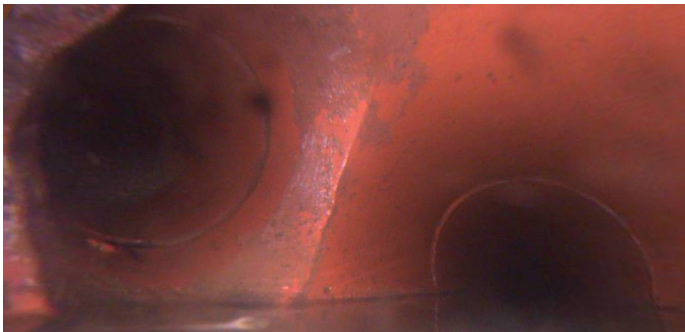
Code:	TFA
Description:	Tap Factory Active

Distance (ft):	21.0
Structural Grade:	0
O&M Grade:	0
Clock Start/From:	9
Clock To:	
1st Value:	4.000
2nd Value:	
Value Percent:	
Continuous Index:	
Within 8" of Joint:	
Remarks:

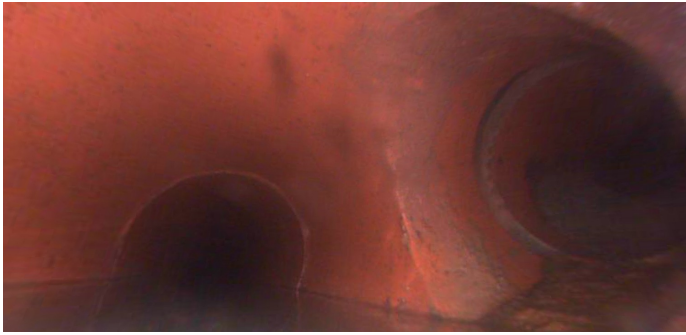
Code: **TFA**
Description: **Tap Factory Active**

Distance (ft): **28.5**
Structural Grade: **0**
O&M Grade: **0**
Clock Start/From: **3**
Clock To:
1st Value: **4.000**
2nd Value:
Value Percent:
Continuous Index:
Within 8" of Joint:
Remarks:

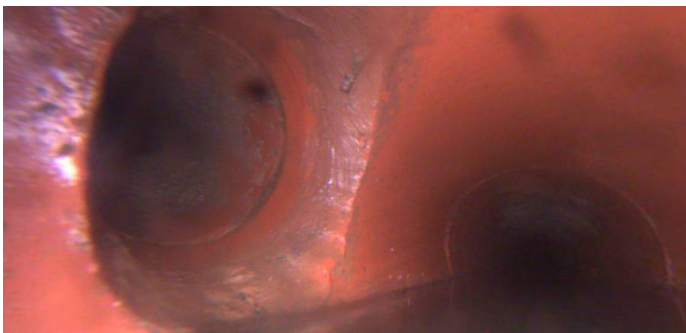
Code: **TF**
Description: **Tap Factory**

Distance (ft): **57.2**
Structural Grade: **0**
O&M Grade: **0**
Clock Start/From: **9**
Clock To:
1st Value: **4.000**
2nd Value:
Value Percent:
Continuous Index:
Within 8" of Joint:
Remarks:

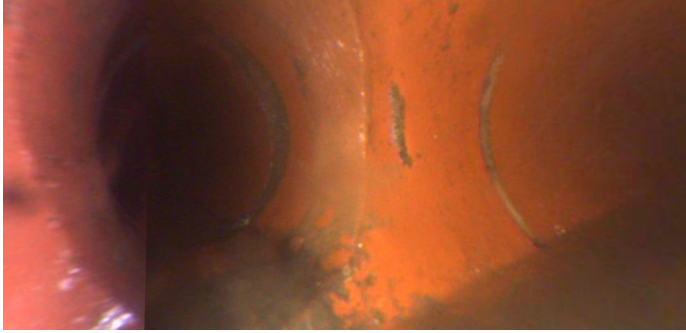
Code: **TFA**
Description: **Tap Factory Active**

Distance (ft): **107.7**
Structural Grade: **0**
O&M Grade: **0**
Clock Start/From: **3**
Clock To:
1st Value: **4.000**
2nd Value:
Value Percent:
Continuous Index:
Within 8" of Joint:
Remarks:

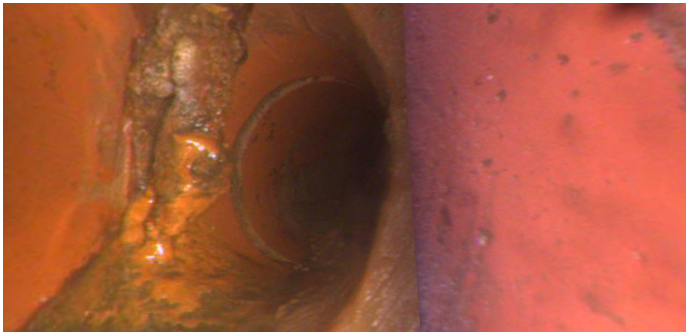
Code: **TFD**
Description: **Tap Factory Defective**

Distance (ft): **115.3**
Structural Grade: **0**
O&M Grade: **2**
Clock Start/From: **9**
Clock To:
1st Value: **4.000**
2nd Value:
Value Percent:
Continuous Index:
Within 8" of Joint:
Remarks: **DAE**

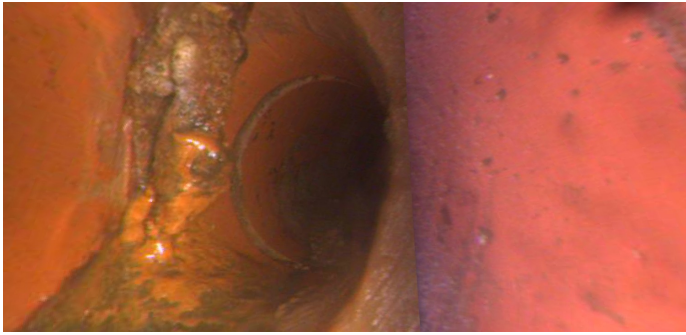
Code: **DAE**
Description: **Deposits Attached Encrustation**

Distance (ft): **115.3**
Structural Grade: **0**
O&M Grade: **2**
Clock Start/From: **8**
Clock To: **9**
1st Value:
2nd Value:
Value Percent: **5.000**
Continuous Index:
Within 8" of Joint: **NO**
Remarks:

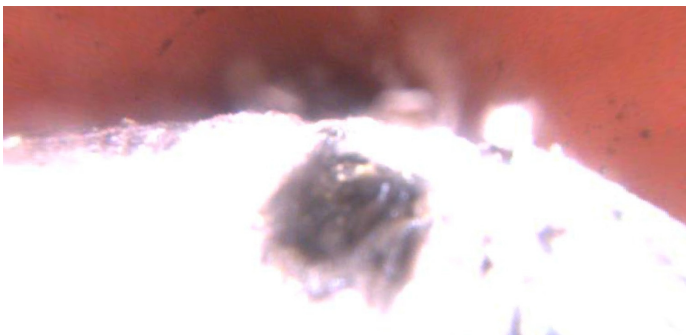
Code: **OBZ**
Description: **Obstacle Other**

Distance (ft): **132.9**
Structural Grade: **0**
O&M Grade: **5**
Clock Start/From: **3**
Clock To: **9**
1st Value:
2nd Value:
Value Percent: **40.000**
Continuous Index:
Within 8" of Joint: **NO**
Remarks: **MISC**

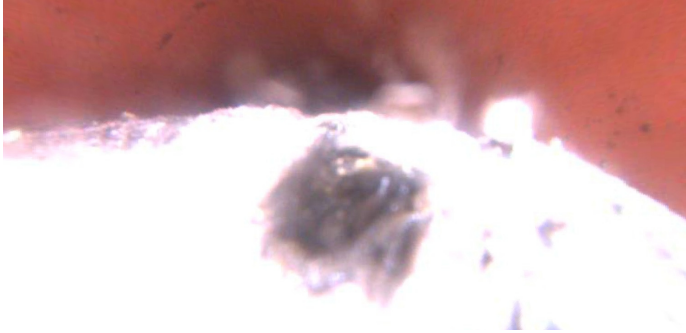
Code: **MGO**
Description: **General Observation**

Distance (ft): **132.9**
Structural Grade: **0**
O&M Grade: **0**
Clock Start/From:
Clock To:
1st Value:
2nd Value:
Value Percent:
Continuous Index:
Within 8" of Joint: **NO**
Remarks: **REAR CAMERA**

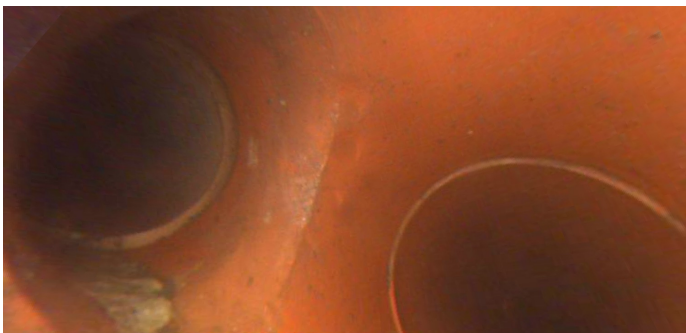
Code: **TFA**
Description: **Tap Factory Active**

Distance (ft): **160.3**
Structural Grade: **0**
O&M Grade: **0**
Clock Start/From: **3**
Clock To:
1st Value: **4.000**
2nd Value:
Value Percent:
Continuous Index:
Within 8" of Joint:
Remarks:

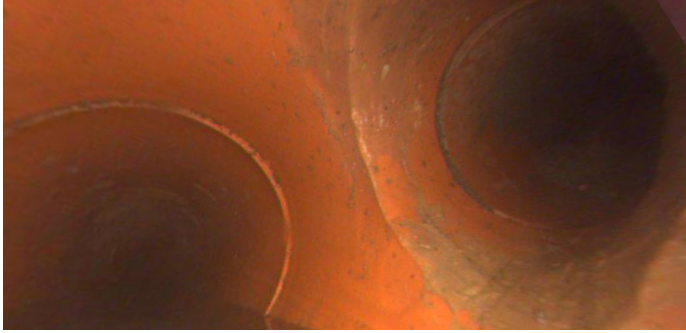
Code: **TF**
Description: **Tap Factory**

Distance (ft): **167.5**
Structural Grade: **0**
O&M Grade: **0**
Clock Start/From: **9**
Clock To:
1st Value: **4.000**
2nd Value:
Value Percent:
Continuous Index:
Within 8" of Joint:
Remarks:

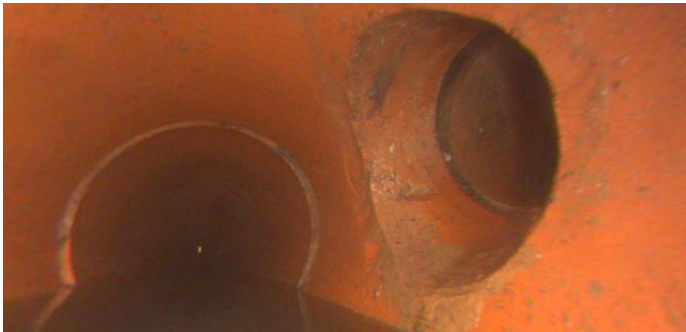
Code: **TF**
Description: **Tap Factory**

Distance (ft): **223.2**
Structural Grade: **0**
O&M Grade: **0**
Clock Start/From: **9**
Clock To:
1st Value: **4.000**
2nd Value:
Value Percent:
Continuous Index:
Within 8" of Joint:
Remarks:

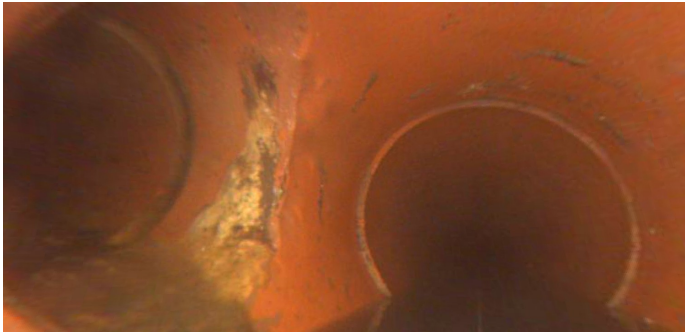
Code: **TFA**
Description: **Tap Factory Active**

Distance (ft): **230.5**
Structural Grade: **0**
O&M Grade: **0**
Clock Start/From: **3**
Clock To:
1st Value: **4.000**
2nd Value:
Value Percent:
Continuous Index:
Within 8" of Joint:
Remarks:

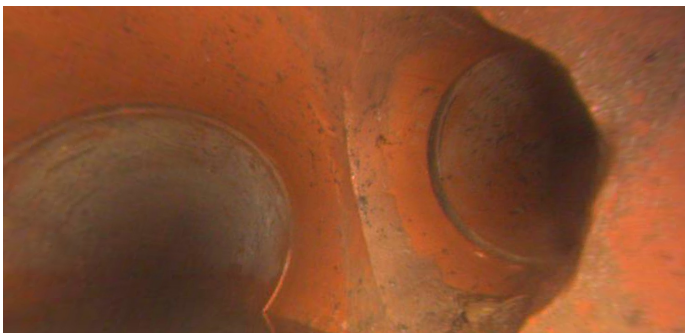
Code: **TF**
Description: **Tap Factory**

Distance (ft): **254.0**
Structural Grade: **0**
O&M Grade: **0**
Clock Start/From: **9**
Clock To:
1st Value: **4.000**
2nd Value:
Value Percent:
Continuous Index:
Within 8" of Joint:
Remarks:

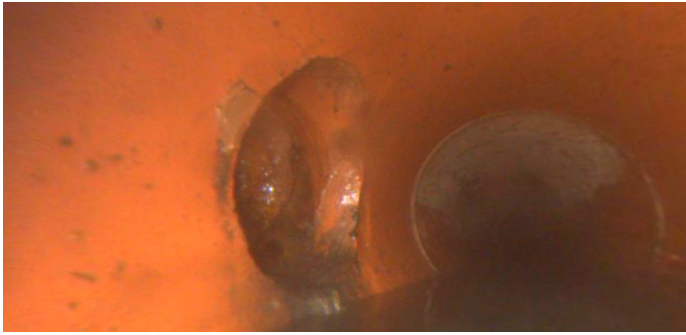
Code: **TFC**
Description: **Tap Factory Capped**

Distance (ft): **261.7**
Structural Grade: **0**
O&M Grade: **0**
Clock Start/From: **3**
Clock To:
1st Value: **4.000**
2nd Value:
Value Percent:
Continuous Index:
Within 8" of Joint:
Remarks:

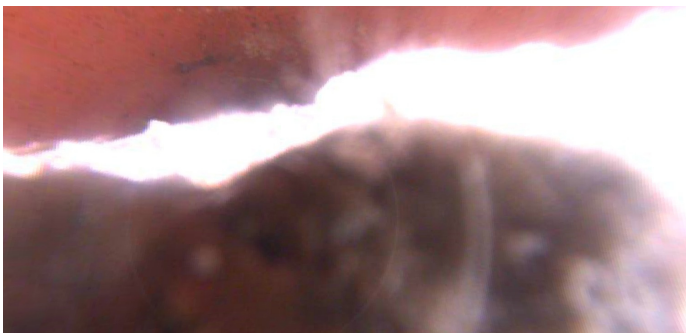
Code: **AMH**
Description: **Manhole**

Distance (ft): **280.4**
Structural Grade: **0**
O&M Grade: **0**
Clock Start/From:
Clock To:
1st Value:
2nd Value:
Value Percent:
Continuous Index:
Within 8" of Joint: **NO**
Remarks: **M-404-017**
