Profile/Photo Observation Report

| Street: | W 41ST AVE & N WABASH ST | Flow Control: | Not Controlled |
| City: | Hobart, IN | Year Renewed: | |

| US MH: | M-404-017 | DS MH: | M-404-018 |

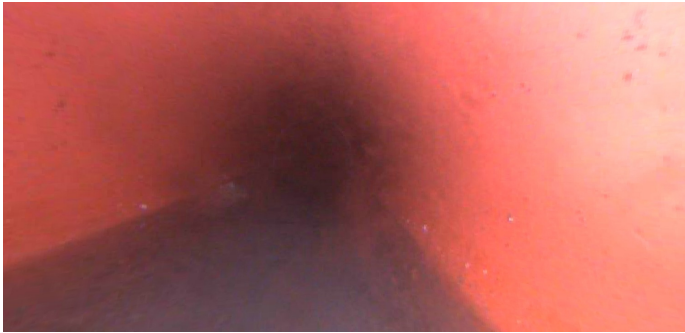
| Code: | MWL |
| Description: | Water Level |

| Value Percent: | 5.000 |

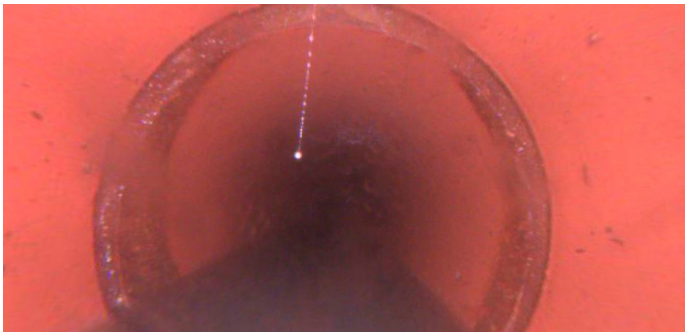
| Code: | IW |
| Description: | Infil Weeper |

| Distance (ft): | 7.9 |
| O&M Grade: | 2 |
| Clock Start/From: | 8 |
| Clock To: | 4 |
| Within 8" of Joint: | YES |

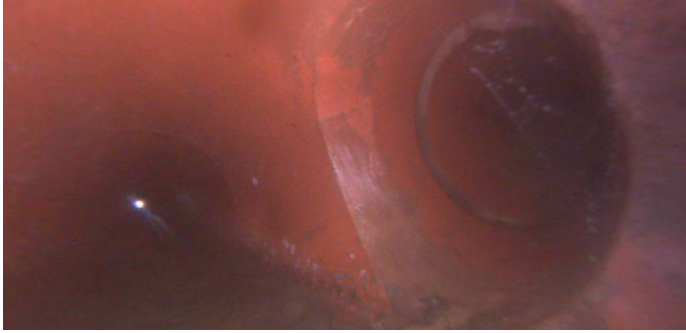
Code: **TF**
Description: **Tap Factory**

Distance (ft): **14.8**
Structural Grade: **0**
O&M Grade: **0**
Clock Start/From: **9**
Clock To:
1st Value: **4.000**
2nd Value:
Value Percent:
Continuous Index:
Within 8" of Joint:
Remarks:

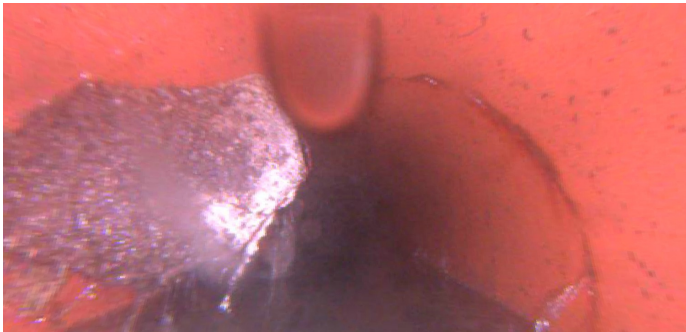
Code: **FS**
Description: **Fracture Spiral**

Distance (ft): **21.3**
Structural Grade: **3**
O&M Grade: **0**
Clock Start/From: **12**
Clock To: **5**
1st Value:
2nd Value:
Value Percent:
Continuous Index:
Within 8" of Joint:
Remarks:

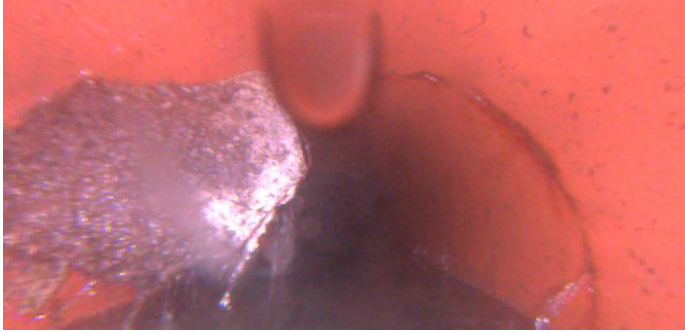
Code: **RMB**
Description: **Roots Medium Barrel**

Distance (ft): **21.3**
Structural Grade: **0**
O&M Grade: **4**
Clock Start/From: **7**
Clock To: **11**
1st Value:
2nd Value:
Value Percent: **15.000**
Continuous Index:
Within 8" of Joint: **NO**
Remarks:

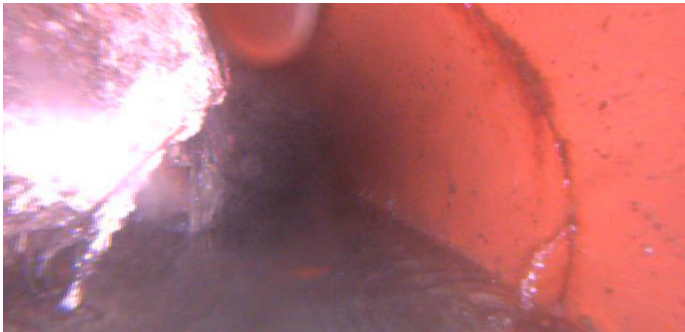
Code: **IR**
Description: **Infil Runner**

Distance (ft): **21.4**
Structural Grade: **0**
O&M Grade: **4**
Clock Start/From: **3**
Clock To:
1st Value:
2nd Value:
Value Percent:
Continuous Index:
Within 8" of Joint:
Remarks:

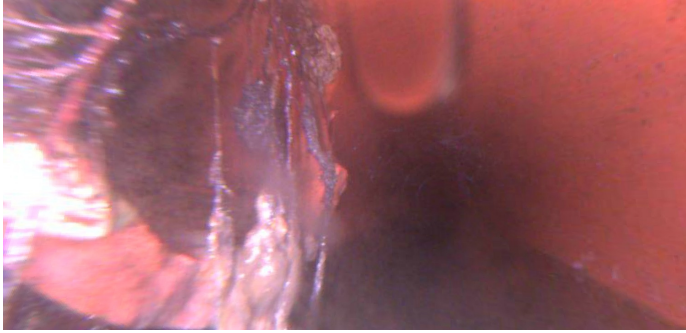
Code: **RFC**
Description: **Roots Fine Connection**

Distance (ft): **21.8**
Structural Grade: **0**
O&M Grade: **1**
Clock Start/From: **10**
Clock To:
1st Value:
2nd Value:
Value Percent:
Continuous Index:
Within 8" of Joint: **NO**
Remarks:

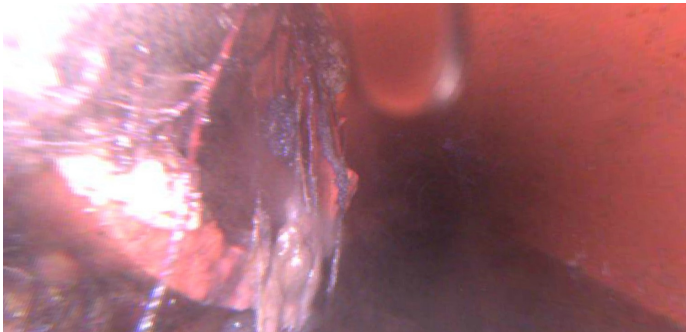
Code: **TFD**
Description: **Tap Factory Defective**

Distance (ft): **21.8**
Structural Grade: **0**
O&M Grade: **2**
Clock Start/From: **9**
Clock To:
1st Value: **4.000**
2nd Value:
Value Percent:
Continuous Index:
Within 8" of Joint:
Remarks: **ROOT INFILTRATION**

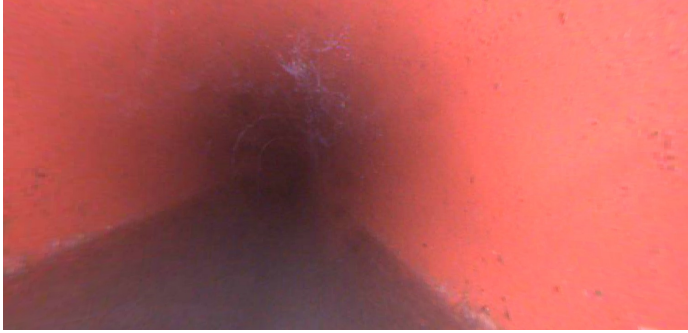
| Code: | MSA |
| Description: | Abandoned Survey |
| Distance (ft): | 22.7 |
| Remarks: | CAMERA STOPPED |
