## Profile/Photo Observation Report

Street:	<b>Summerlin</b>	Flow Control:	<b>Not Controlled</b>
City:	<b>Hobart, IN</b>	Year Renewed:	
Location:	<b>Light Highway</b>	Tape/Media #:	
Purpose:	<b>Not Known</b>	Dia/Height:	<b>12"</b>
Use:	<b>Sanitary</b>	Material:	<b>VCP</b>
Drain Area:	<b>NA</b>	Lining:	
Category:	<b>NA</b>		
Comment:

Location Details:		Direction of Survey:	<b>Downstream</b>
US MH:	<b>M-404-017</b>	DS MH:	<b>M-404-018</b>
		Total Length Surveyed (ft):	<b>22.7</b>

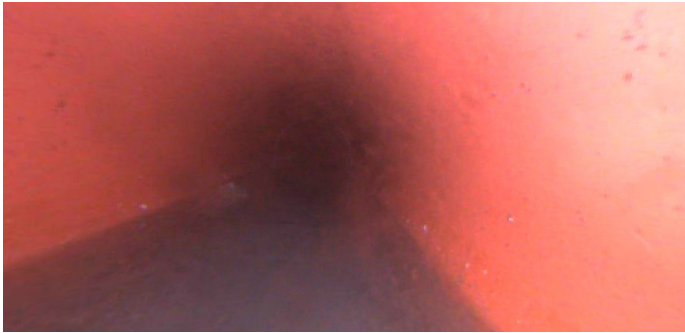
Code:	<b>MWL</b>
Description:	<b>Water Level</b>

Distance (ft):	<b>.0</b>
Structural Grade:	<b>0</b>
O&M Grade:	<b>0</b>
Clock Start/From:	
Clock To:	
1st Value:	
2nd Value:	
Value Percent:	<b>5.000</b>
Continuous Index:	
Within 8" of Joint:	<b>NO</b>
Remarks:

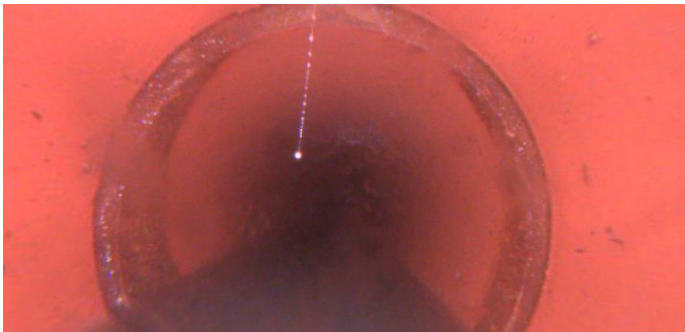
Code:	<b>IW</b>
Description:	<b>Infil Weeper</b>

Distance (ft):	<b>7.9</b>
Structural Grade:	<b>0</b>
O&M Grade:	<b>2</b>
Clock Start/From:	<b>8</b>
Clock To:	<b>4</b>
1st Value:	
2nd Value:	
Value Percent:	
Continuous Index:	
Within 8" of Joint:	<b>YES</b>
Remarks:

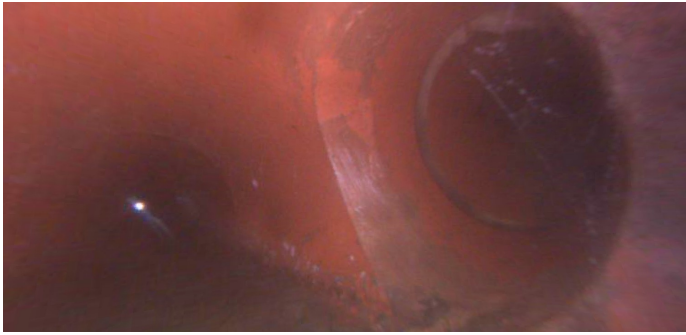
Code: **TF**  
Description: **Tap Factory**

Distance (ft): **14.8**  
Structural Grade: **0**  
O&M Grade: **0**  
Clock Start/From: **9**  
Clock To:  
1st Value: **4.000**  
2nd Value:  
Value Percent:  
Continuous Index:  
Within 8" of Joint:  
Remarks:

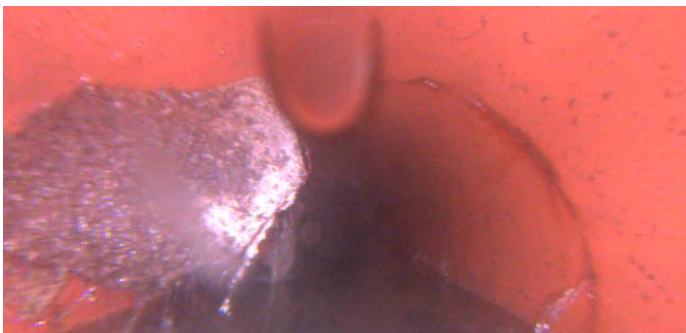
Code: **FS**  
Description: **Fracture Spiral**

Distance (ft): **21.3**  
Structural Grade: **3**  
O&M Grade: **0**  
Clock Start/From: **12**  
Clock To: **5**  
1st Value:  
2nd Value:  
Value Percent:  
Continuous Index:  
Within 8" of Joint:  
Remarks:

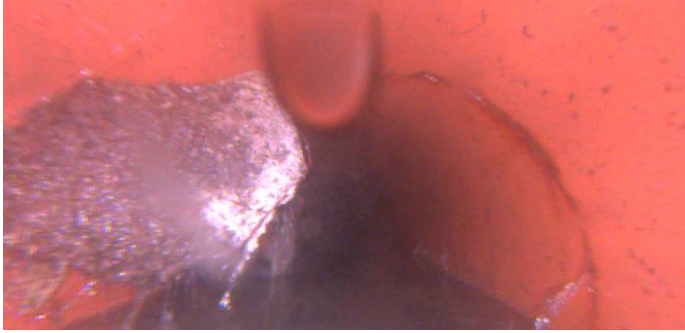
Code: **RMB**  
Description: **Roots Medium Barrel**

Distance (ft): **21.3**  
Structural Grade: **0**  
O&M Grade: **4**  
Clock Start/From: **7**  
Clock To: **11**  
1st Value:  
2nd Value:  
Value Percent: **15.000**  
Continuous Index:  
Within 8" of Joint: **NO**  
Remarks:

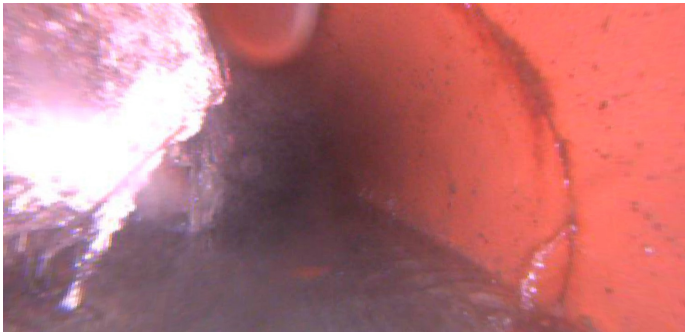
Code: **IR**  
Description: **Infil Runner**

Distance (ft): **21.4**  
Structural Grade: **0**  
O&M Grade: **4**  
Clock Start/From: **3**  
Clock To:  
1st Value:  
2nd Value:  
Value Percent:  
Continuous Index:  
Within 8" of Joint:  
Remarks:

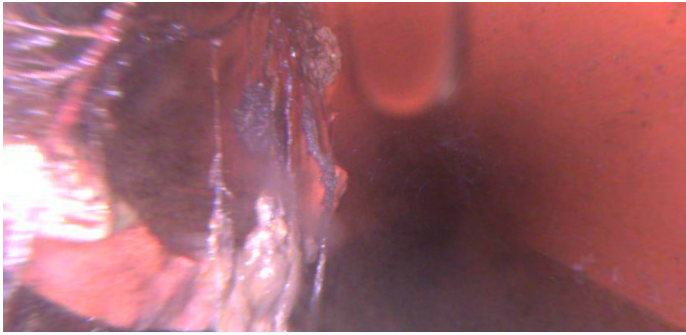
Code: **RFC**  
Description: **Roots Fine Connection**

Distance (ft): **21.8**  
Structural Grade: **0**  
O&M Grade: **1**  
Clock Start/From: **10**  
Clock To:  
1st Value:  
2nd Value:  
Value Percent:  
Continuous Index:  
Within 8" of Joint: **NO**  
Remarks:

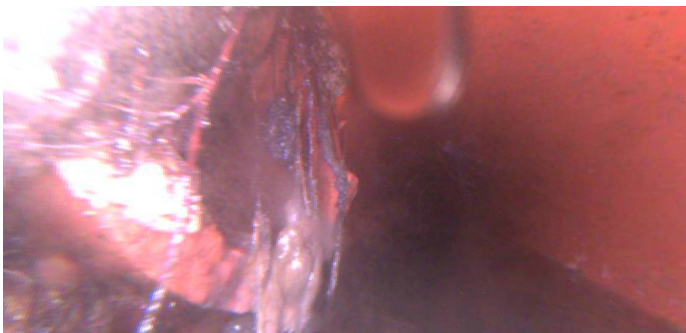
Code: **TFD**  
Description: **Tap Factory Defective**

Distance (ft): **21.8**  
Structural Grade: **0**  
O&M Grade: **2**  
Clock Start/From: **9**  
Clock To:  
1st Value: **4.000**  
2nd Value:  
Value Percent:  
Continuous Index:  
Within 8" of Joint:  
Remarks: **ROOT INFILTRATION**

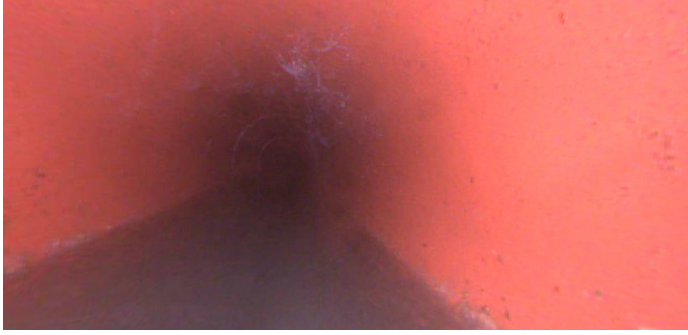
Code:	<b>MSA</b>
Description:	<b>Abandoned Survey</b>
Distance (ft):	<b>22.7</b>
Structural Grade:	<b>0</b>
O&M Grade:	<b>0</b>
Clock Start/From:	
Clock To:	
1st Value:	
2nd Value:	
Value Percent:	
Continuous Index:	
Within 8" of Joint:	<b>NO</b>
Remarks:	<b>CAMERA STOPPED</b>
