## Profile/Photo Observation Report

Street:	<b>Summerlin</b>	Flow Control:	<b>Not Controlled</b>
City:	<b>Hobart, IN</b>	Year Renewed:	
Location:	<b>Light Highway</b>	Tape/Media #:	
Purpose:	<b>Not Known</b>	Dia/Height:	<b>10"</b>
Use:	<b>Sanitary</b>	Material:	<b>VCP</b>
Drain Area:	<b>NA</b>	Lining:	
Category:	<b>NA</b>		
Comment:

Location Details:		Direction of Survey:	<b>Upstream</b>
US MH:	<b>M-404-017</b>	DS MH:	<b>M-404-018</b>
		Total Length Surveyed (ft):	<b>17.7</b>

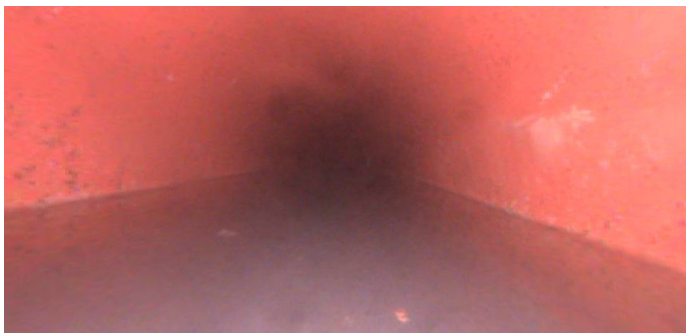
Code: **AMH**  
Description: **Manhole**

Distance (ft): **.0**  
Structural Grade: **0**  
O&M Grade: **0**  
Clock Start/From:  
Clock To:  
1st Value:  
2nd Value:  
Value Percent:  
Continuous Index:  
Within 8" of Joint: **NO**  
Remarks: **M-404-017**

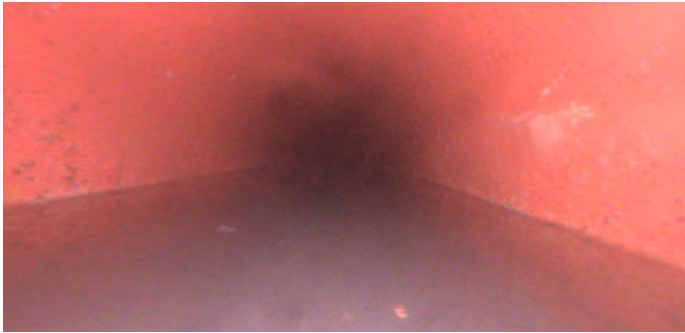
Code:	<b>MWL</b>
Description:	<b>Water Level</b>

Distance (ft):	<b>.0</b>
Structural Grade:	<b>0</b>
O&M Grade:	<b>0</b>
Clock Start/From:	
Clock To:	
1st Value:	
2nd Value:	
Value Percent:	<b>5.000</b>
Continuous Index:	
Within 8" of Joint:	<b>NO</b>
Remarks:

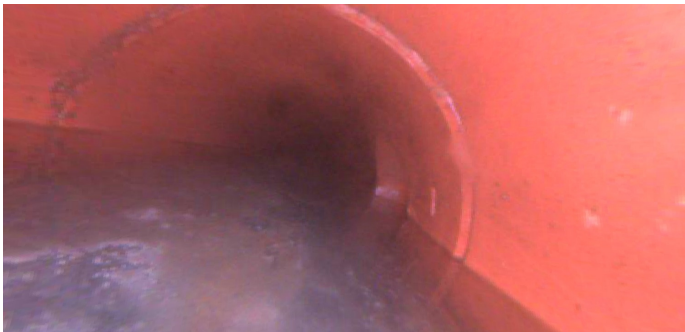
Code:	<b>TF</b>
Description:	<b>Tap Factory</b>

Distance (ft):	<b>3.3</b>
Structural Grade:	<b>0</b>
O&M Grade:	<b>0</b>
Clock Start/From:	<b>3</b>
Clock To:	
1st Value:	<b>4.000</b>
2nd Value:	
Value Percent:	
Continuous Index:	
Within 8" of Joint:	
Remarks:

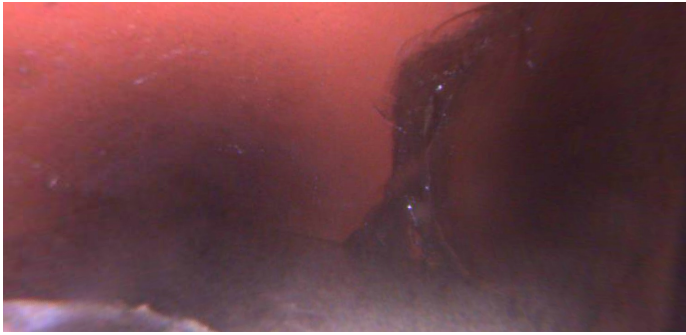
Code: **TBA**  
Description: **Tap Break-in Active**

Distance (ft): **16.7**  
Structural Grade: **0**  
O&M Grade: **0**  
Clock Start/From: **3**  
Clock To:  
1st Value: **4.000**  
2nd Value:  
Value Percent:  
Continuous Index:  
Within 8" of Joint:  
Remarks:

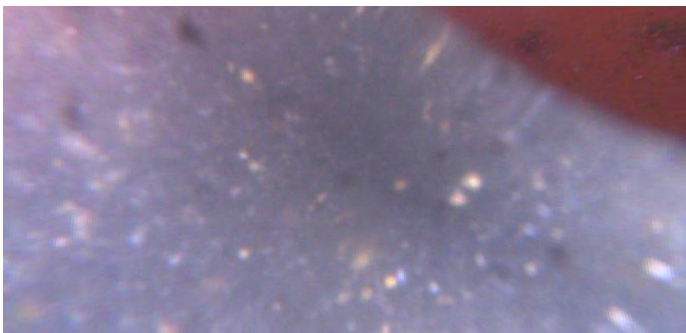
Code: **MSA**  
Description: **Abandoned Survey**

Distance (ft): **17.7**  
Structural Grade: **0**  
O&M Grade: **0**  
Clock Start/From:  
Clock To:  
1st Value:  
2nd Value:  
Value Percent:  
Continuous Index:  
Within 8" of Joint: **NO**  
Remarks: **camera underwater**
