Profile/Photo Observation Report

Date:	09/01/2021	Weather:		Coding:	PACP 7.0
Pipe Length (ft):	237.0	Owner:	City of Hobart	Pre Clean:	Light Cleaning
P.O.#:	YES502259	Surveyor:	S. Bucklin	PSR:	P-404-018-017
Customer:	City of Hobart	Clean Date:	08/29/2021	Shape:	C

Street:	North Wabash Street	Flow Control:	Not Controlled
City:	Hobart, IN	Year Renewed:	
Location:	Yard	Tape/Media #:	
Purpose:	Routine Assessment	Dia/Height:	10"
Use:	Sanitary Sewage Pipe	Material:	VCP
Drain Area:		Lining:	
Category:	NA		
Comment:			
Location Details:		Direction of Survey:	Upstream
US MH:	M-404-017	DS MH:	M-404-018
		Total Length Surveyed (ft):	23.9

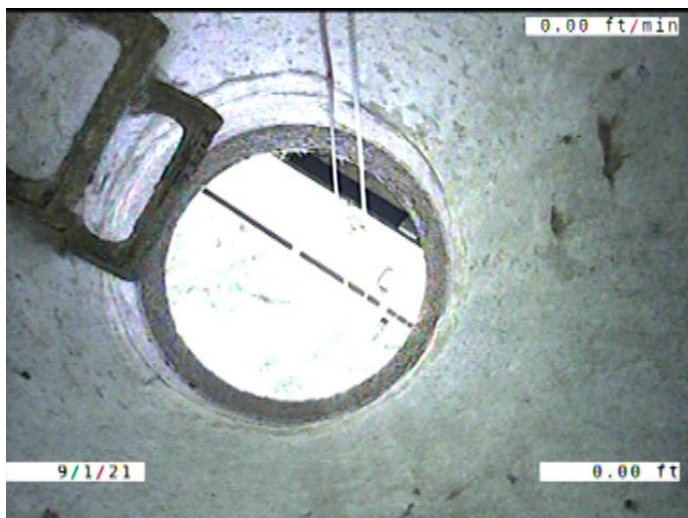
Code: **AMH**
 Description: **Manhole**

Distance (ft): **.0**
 Structural Grade: **0**
 O&M Grade: **0**
 Clock Start/From:
 Clock To:
 1st Value:
 2nd Value:
 Value Percent:
 Continuous Index:
 Within 8" of Joint: **NO**
 Remarks: **M-404-018**

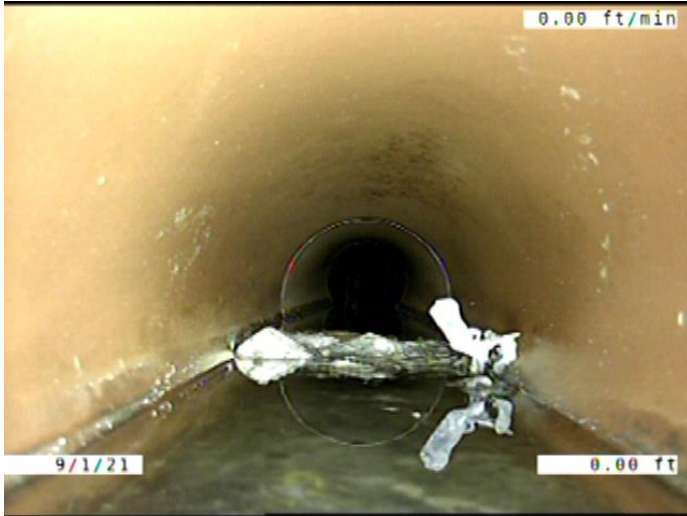
Code: **MWL**
Description: **Miscellaneous Water Level**

Distance (ft): **.0**
Structural Grade: **0**
O&M Grade: **0**
Clock Start/From:
Clock To:
1st Value:
2nd Value:
Value Percent: **5.000**
Continuous Index:
Within 8" of Joint: **NO**
Remarks:

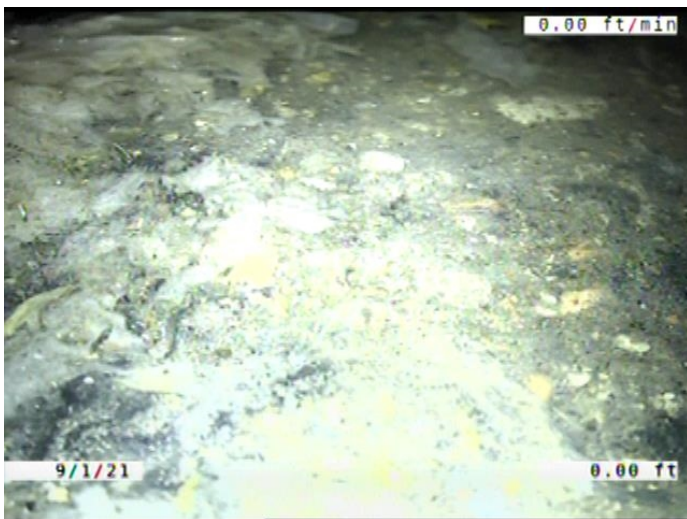
Code: **DSC**
Description: **Deposits Settled Hard/Compacted**

Distance (ft): **.0**
Structural Grade: **0**
O&M Grade: **2**
Clock Start/From: **5**
Clock To: **7**
1st Value:
2nd Value:
Value Percent: **5.000**
Continuous Index: **S01**
Within 8" of Joint: **YES**
Remarks:

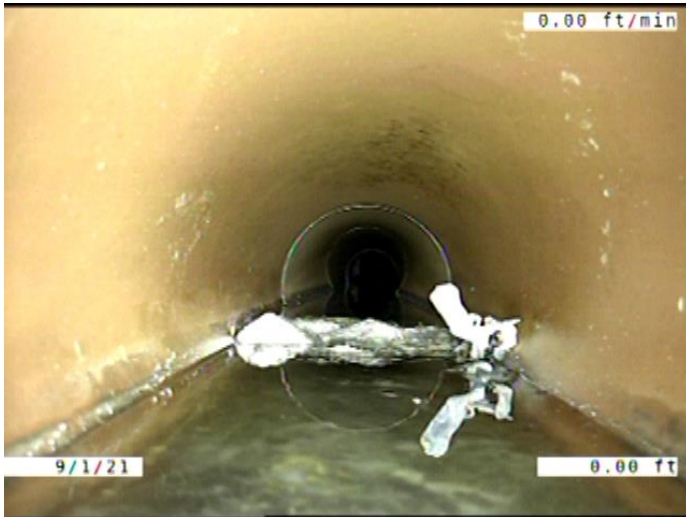
Code: **DSF**
 Description: **Deposits Settled Fine**

Distance (ft): **.0**
 Structural Grade: **0**
 O&M Grade: **2**
 Clock Start/From: **5**
 Clock To: **7**
 1st Value:
 2nd Value:
 Value Percent: **5.000**
 Continuous Index: **S02**
 Within 8" of Joint: **YES**
 Remarks:

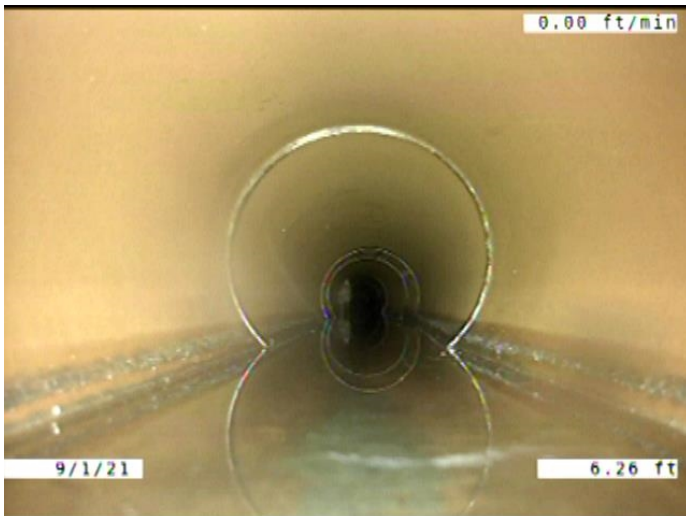
Code: **DSC**
 Description: **Deposits Settled Hard/Compacted**

Distance (ft): **6.3**
 Structural Grade: **0**
 O&M Grade: **2**
 Clock Start/From: **5**
 Clock To: **7**
 1st Value:
 2nd Value:
 Value Percent: **5.000**
 Continuous Index: **F01**
 Within 8" of Joint: **YES**
 Remarks:

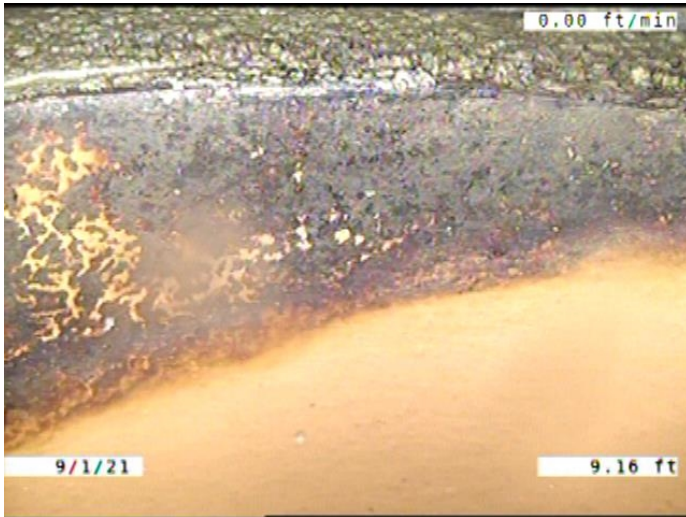
Code: **ISJ**
 Description: **Infiltration Stain Joint**

Distance (ft): **9.2**
 Structural Grade: **0**
 O&M Grade: **1**
 Clock Start/From: **8**
 Clock To: **11**
 1st Value:
 2nd Value:
 Value Percent:
 Continuous Index:
 Within 8" of Joint: **YES**
 Remarks:

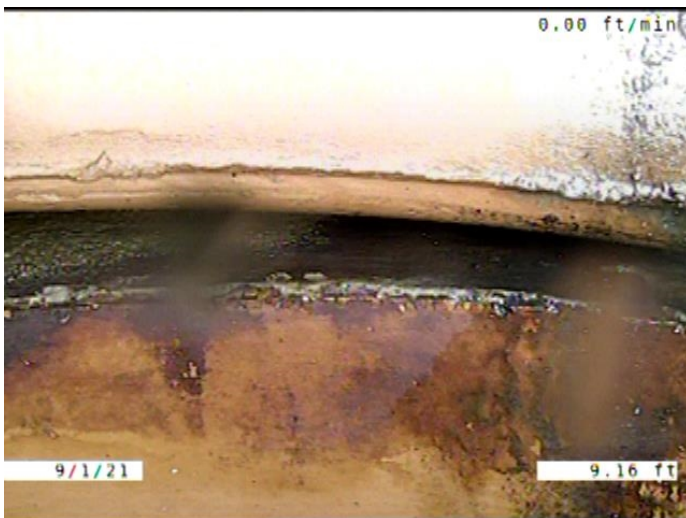
Code: **ISJ**
 Description: **Infiltration Stain Joint**

Distance (ft): **9.2**
 Structural Grade: **0**
 O&M Grade: **1**
 Clock Start/From: **1**
 Clock To: **4**
 1st Value:
 2nd Value:
 Value Percent:
 Continuous Index:
 Within 8" of Joint: **YES**
 Remarks:

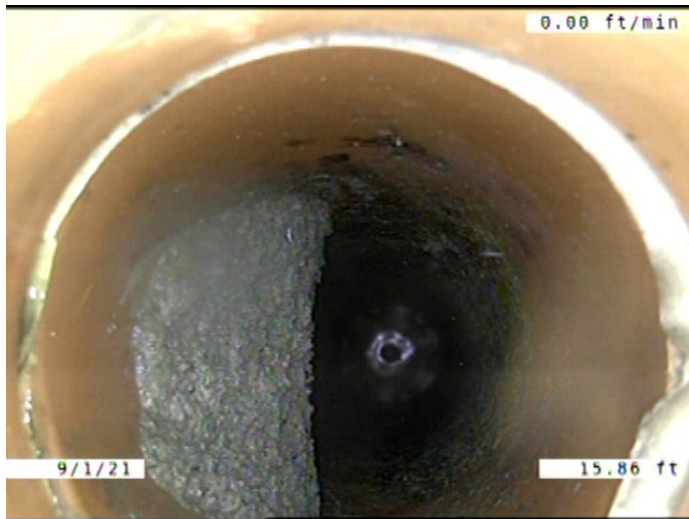
Code: **TFC**
 Description: **Tap Factory Capped**

Distance (ft): **15.9**
 Structural Grade: **0**
 O&M Grade: **0**
 Clock Start/From: **10**
 Clock To:
 1st Value: **6.000**
 2nd Value:
 Value Percent:
 Continuous Index:
 Within 8" of Joint: **YES**
 Remarks:

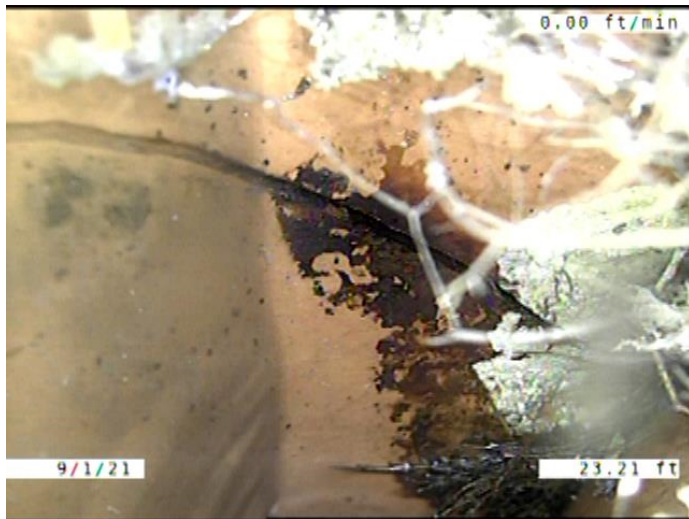
Code: **FM**
 Description: **Fracture Multiple**

Distance (ft): **23.2**
 Structural Grade: **4**
 O&M Grade: **0**
 Clock Start/From: **12**
 Clock To: **12**
 1st Value:
 2nd Value:
 Value Percent:
 Continuous Index:
 Within 8" of Joint: **NO**
 Remarks:

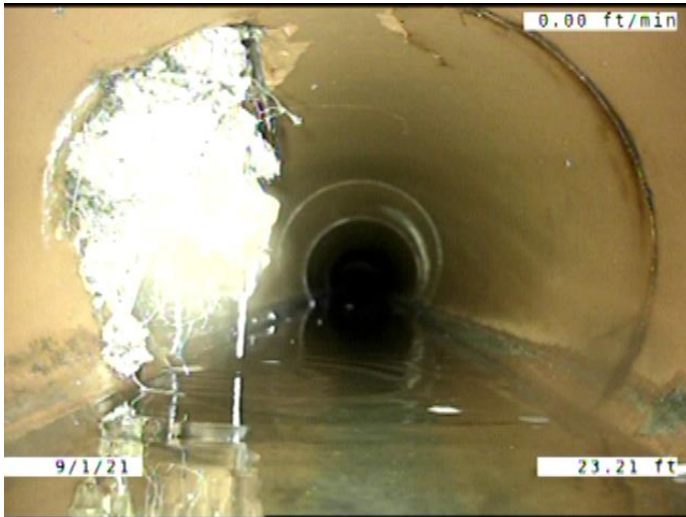
Code: **RML**
Description: **Roots Medium Lateral**

Distance (ft): **23.2**
Structural Grade: **0**
O&M Grade: **3**
Clock Start/From: **8**
Clock To: **11**
1st Value:
2nd Value:
Value Percent: **5.000**
Continuous Index:
Within 8" of Joint: **NO**
Remarks:

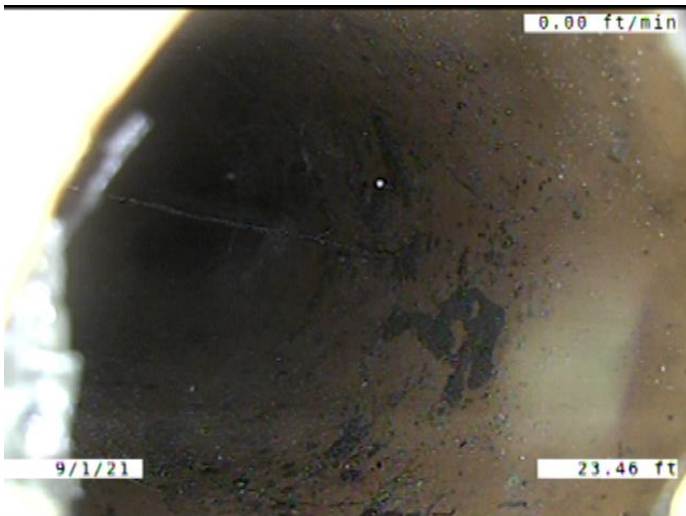
Code: **TBI**
Description: **Tap Break-in Intruding**

Distance (ft): **23.5**
Structural Grade: **0**
O&M Grade: **2**
Clock Start/From: **10**
Clock To:
1st Value: **4.000**
2nd Value: **2.000**
Value Percent:
Continuous Index:
Within 8" of Joint: **NO**
Remarks:

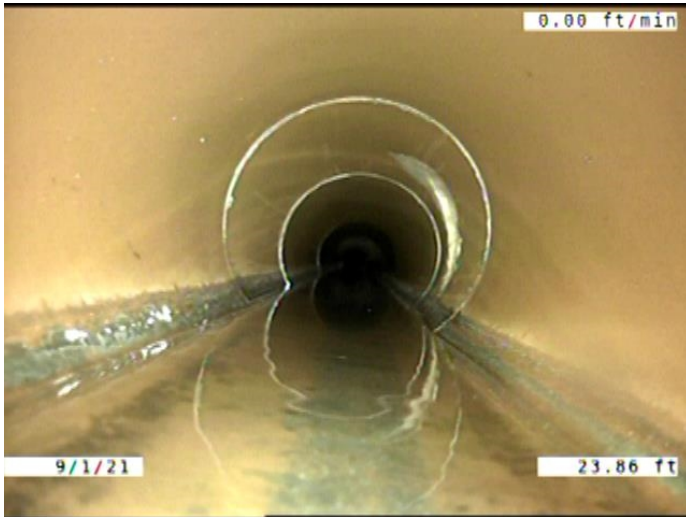
Code: **DSF**
 Description: **Deposits Settled Fine**

Distance (ft): **23.9**
 Structural Grade: **0**
 O&M Grade: **2**
 Clock Start/From: **5**
 Clock To: **7**
 1st Value:
 2nd Value:
 Value Percent: **5.000**
 Continuous Index: **F02**
 Within 8" of Joint: **YES**
 Remarks:

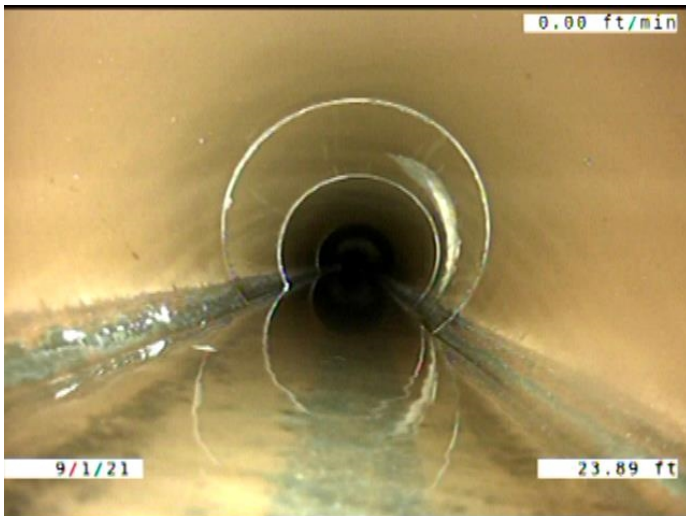
Code: **MSA**
 Description: **Miscellaneous Survey Abandoned**

Distance (ft): **23.9**
 Structural Grade: **0**
 O&M Grade: **0**
 Clock Start/From:
 Clock To:
 1st Value:
 2nd Value:
 Value Percent:
 Continuous Index:
 Within 8" of Joint: **NO**
 Remarks: **CAMERA CANT MAKE IT PAST PROTRUDING TAP**
