## Profile/Photo Observation Report

Date:	<b>09/01/2021</b>	Weather:		Coding:	<b>PACP 7.0</b>
Pipe Length (ft):	<b>237.0</b>	Owner:	<b>City of Hobart</b>	Pre Clean:	<b>Light Cleaning</b>
P.O.#:	<b>YES502259</b>	Surveyor:	<b>S. Bucklin</b>	PSR:	<b>P-404-018-017</b>
Customer:	<b>City of Hobart</b>	Clean Date:	<b>08/29/2021</b>	Shape:	<b>C</b>

Street:	<b>North Wabash Street</b>	Flow Control:	<b>Not Controlled</b>
City:	<b>Hobart, IN</b>	Year Renewed:	
Location:	<b>Yard</b>	Tape/Media #:	
Purpose:	<b>Routine Assessment</b>	Dia/Height:	<b>10"</b>
Use:	<b>Sanitary Sewage Pipe</b>	Material:	<b>VCP</b>
Drain Area:		Lining:	
Category:	<b>NA</b>		
Comment:			
Location Details:		Direction of Survey:	<b>Upstream</b>
US MH:	<b>M-404-017</b>	DS MH:	<b>M-404-018</b>
		Total Length Surveyed (ft):	<b>23.9</b>

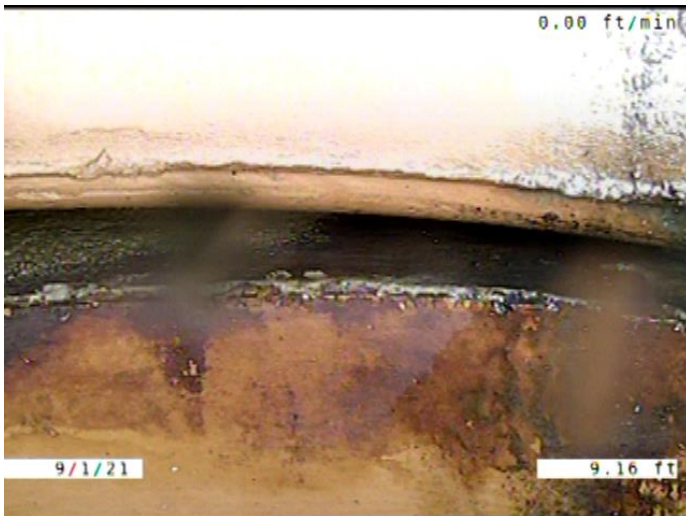
Code: **ISJ**  
 Description: **Infiltration Stain Joint**

Distance (ft): **9.2**  
 Structural Grade: **0**  
 O&M Grade: **1**  
 Clock Start/From: **1**  
 Clock To: **4**  
 1st Value:  
 2nd Value:  
 Value Percent:  
 Continuous Index:  
 Within 8" of Joint: **YES**  
 Remarks:
