# Profile/Photo Observation Report

Date:	09/02/2021	Weather:		Coding:	PACP 7.0
Pipe Length (ft):	237.0	Owner:	City of Hobart	Pre Clean:	Light Cleaning
P.O.#:	YES502259	Surveyor:	S. Bucklin	PSR:	P-404-018-017
Customer:	City of Hobart	Clean Date:	08/29/2021	Shape:	C

Street:	North Wabash Street	Flow Control:	Not Controlled
City:	Hobart, IN	Year Renewed:	
Location:	Yard	Tape/Media #:	
Purpose:	Routine Assessment	Dia/Height:	10"
Use:	Sanitary Sewage Pipe	Material:	VCP
Drain Area:		Lining:	
Category:	NA		
Comment:			
Location Details:		Direction of Survey:	Downstream
US MH:	M-404-017	DS MH:	M-404-018
		Total Length Surveyed (ft):	193.5

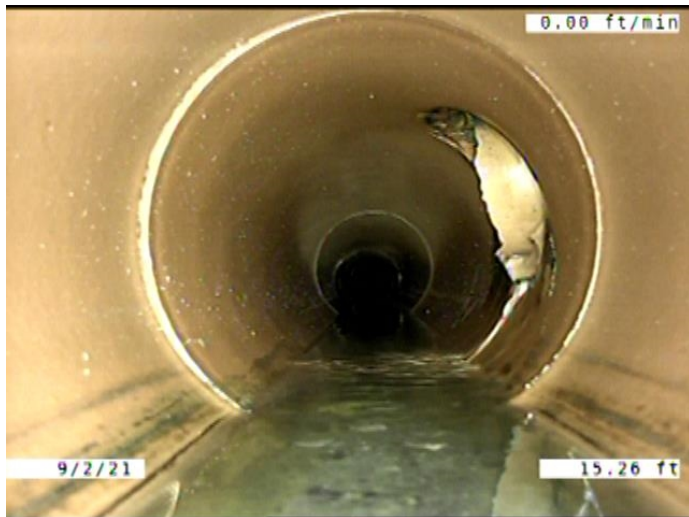
Code: **OBN**  
 Description: **Obstruction Construction Debris**

Distance (ft): **15.3**  
 Structural Grade: **0**  
 O&M Grade: **2**  
 Clock Start/From: **5**  
 Clock To: **7**  
 1st Value:  
 2nd Value:  
 Value Percent: **5.000**  
 Continuous Index: **F02**  
 Within 8" of Joint: **YES**  
 Remarks:

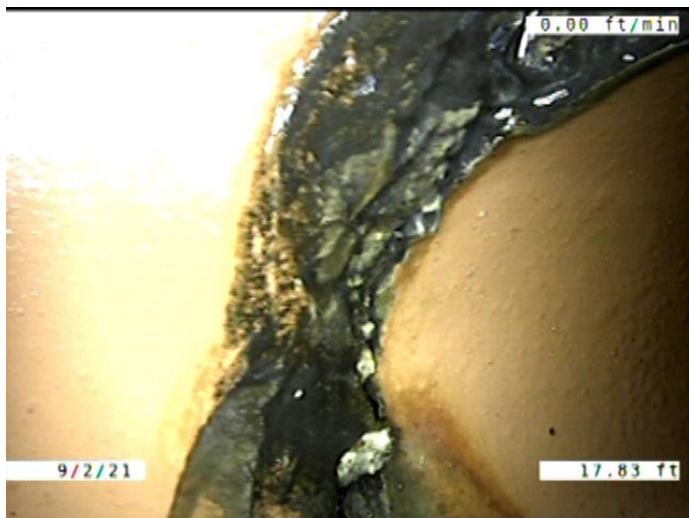
Code: **IRC**  
 Description: **Infiltration Runner Connection**

Distance (ft): **17.8**  
 Structural Grade: **0**  
 O&M Grade: **4**  
 Clock Start/From: **1**  
 Clock To:  
 1st Value:  
 2nd Value:  
 Value Percent:  
 Continuous Index:  
 Within 8" of Joint: **NO**  
 Remarks:

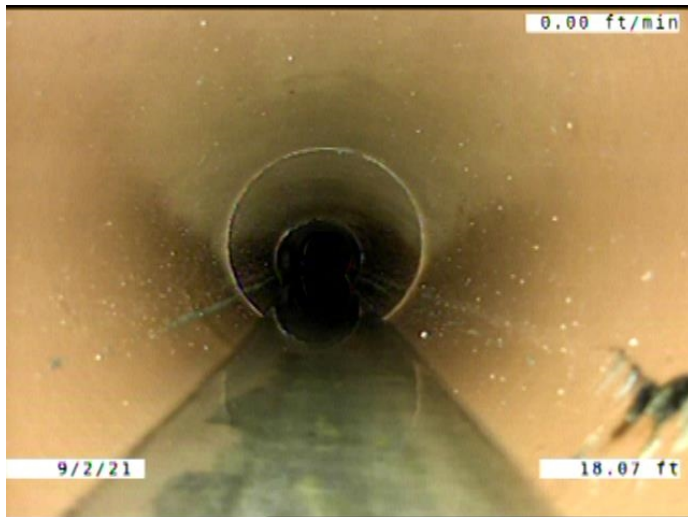
Code: **DSC**  
Description: **Deposits Settled Hard/Compacted**

Distance (ft): **18.1**  
Structural Grade: **0**  
O&M Grade: **2**  
Clock Start/From: **5**  
Clock To: **7**  
1st Value:  
2nd Value:  
Value Percent: **5.000**  
Continuous Index: **F01**  
Within 8" of Joint: **YES**  
Remarks:

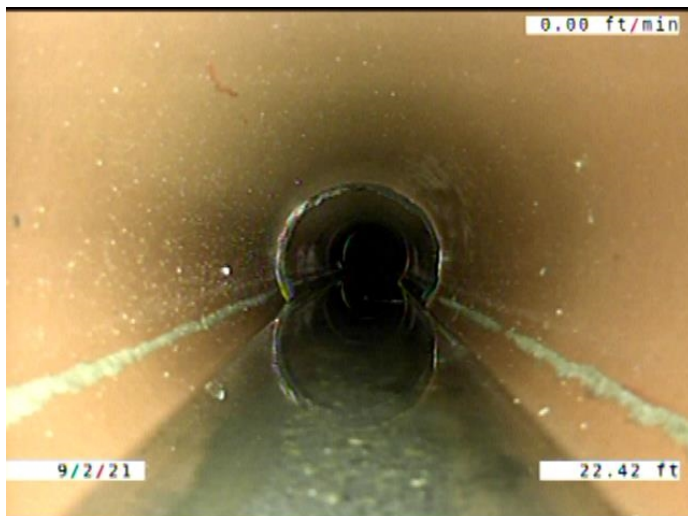
Code: **DSF**  
Description: **Deposits Settled Fine**

Distance (ft): **22.4**  
Structural Grade: **0**  
O&M Grade: **2**  
Clock Start/From: **5**  
Clock To: **7**  
1st Value:  
2nd Value:  
Value Percent: **5.000**  
Continuous Index: **S03**  
Within 8" of Joint: **YES**  
Remarks:

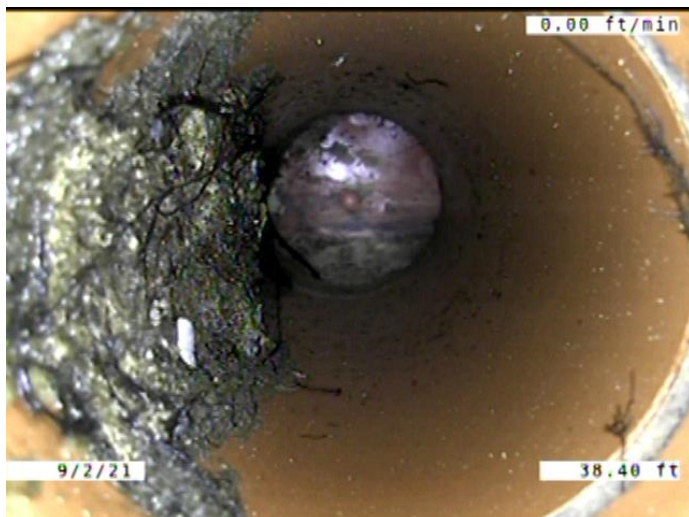
Code:	<b>TFC</b>
Description:	<b>Tap Factory Capped</b>
Distance (ft):	<b>38.4</b>
Structural Grade:	<b>0</b>
O&M Grade:	<b>0</b>
Clock Start/From:	<b>10</b>
Clock To:	
1st Value:	<b>6.000</b>
2nd Value:	
Value Percent:	
Continuous Index:	
Within 8" of Joint:	<b>YES</b>
Remarks:	<b>ROOTS GROWING IN AROUND THE CAP</b>

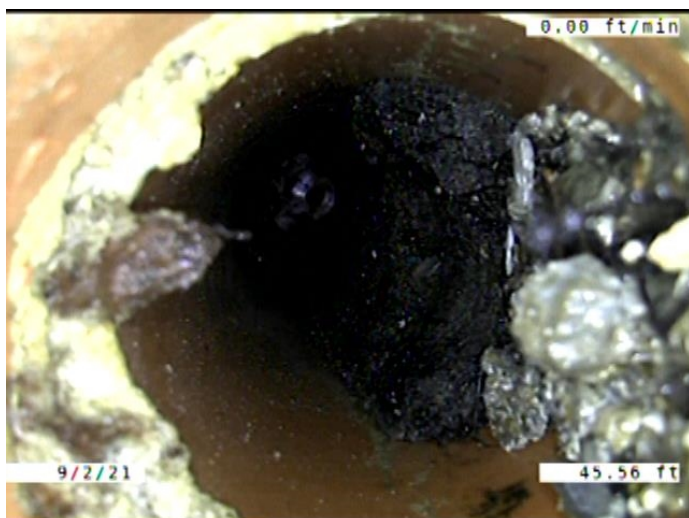
Code:	<b>TFC</b>
Description:	<b>Tap Factory Capped</b>
Distance (ft):	<b>45.6</b>
Structural Grade:	<b>0</b>
O&M Grade:	<b>0</b>
Clock Start/From:	<b>3</b>
Clock To:	
1st Value:	<b>6.000</b>
2nd Value:	
Value Percent:	
Continuous Index:	
Within 8" of Joint:	<b>YES</b>
Remarks:	<b>ENCRUSTATION AT THE FIRST JOINT BACK AND ROOTS GROWING IN THE</b>

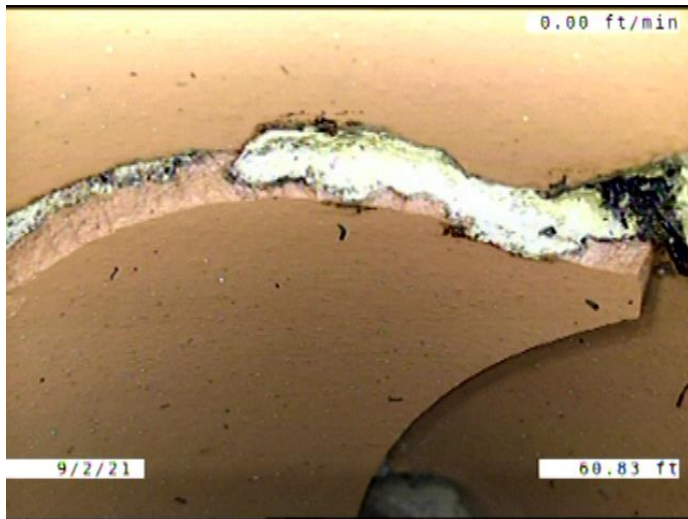
Code: **B**  
 Description: **Broken**

Distance (ft): **60.8**  
 Structural Grade: **4**  
 O&M Grade: **0**  
 Clock Start/From: **10**  
 Clock To: **6**  
 1st Value:  
 2nd Value:  
 Value Percent:  
 Continuous Index:  
 Within 8" of Joint: **YES**  
 Remarks:

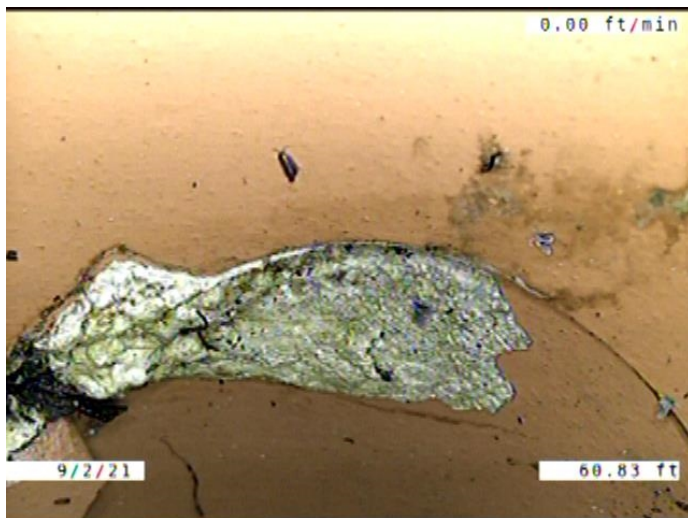
Code: **DAE**  
 Description: **Deposits Attached Encrustation**

Distance (ft): **60.8**  
 Structural Grade: **0**  
 O&M Grade: **2**  
 Clock Start/From: **10**  
 Clock To: **5**  
 1st Value:  
 2nd Value:  
 Value Percent: **5.000**  
 Continuous Index:  
 Within 8" of Joint: **YES**  
 Remarks:

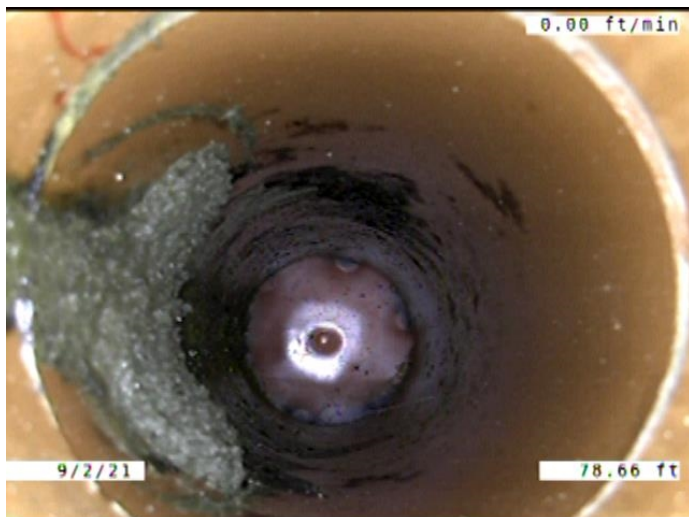
Code: **TFC**  
 Description: **Tap Factory Capped**

Distance (ft): **78.6**  
 Structural Grade: **0**  
 O&M Grade: **0**  
 Clock Start/From: **10**  
 Clock To:  
 1st Value: **6.000**  
 2nd Value:  
 Value Percent:  
 Continuous Index:  
 Within 8" of Joint: **YES**  
 Remarks:

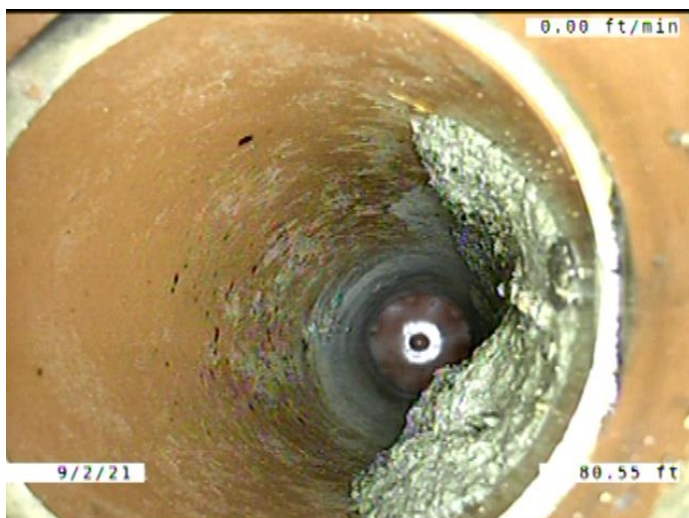
Code: **TFC**  
 Description: **Tap Factory Capped**

Distance (ft): **80.6**  
 Structural Grade: **0**  
 O&M Grade: **0**  
 Clock Start/From: **2**  
 Clock To:  
 1st Value: **6.000**  
 2nd Value:  
 Value Percent:  
 Continuous Index:  
 Within 8" of Joint: **YES**  
 Remarks:

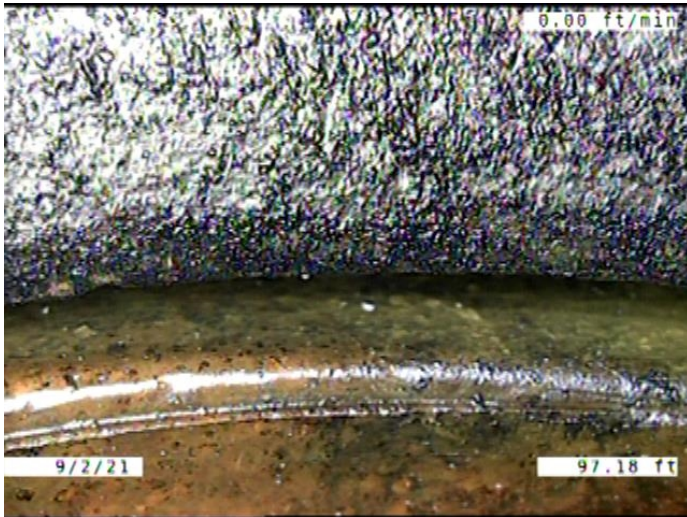
Code: **ISJ**  
 Description: **Infiltration Stain Joint**

Distance (ft): **97.2**  
 Structural Grade: **0**  
 O&M Grade: **1**  
 Clock Start/From: **8**  
 Clock To: **4**  
 1st Value:  
 2nd Value:  
 Value Percent:  
 Continuous Index:  
 Within 8" of Joint: **YES**  
 Remarks:

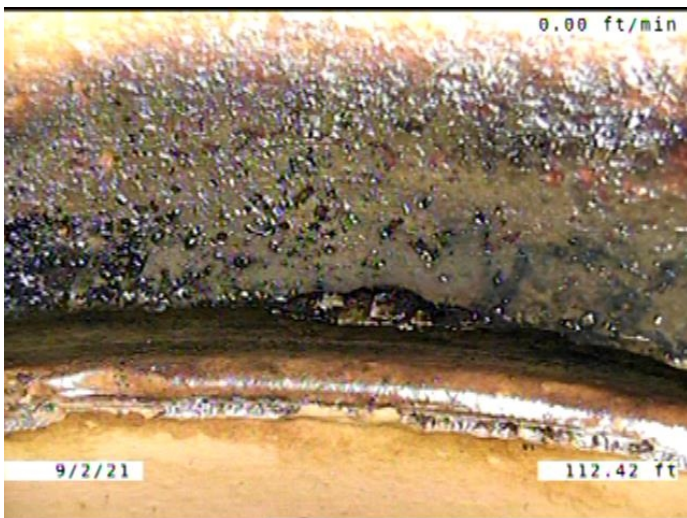
Code: **ISJ**  
 Description: **Infiltration Stain Joint**

Distance (ft): **112.4**  
 Structural Grade: **0**  
 O&M Grade: **1**  
 Clock Start/From: **8**  
 Clock To: **4**  
 1st Value:  
 2nd Value:  
 Value Percent:  
 Continuous Index:  
 Within 8" of Joint: **YES**  
 Remarks:

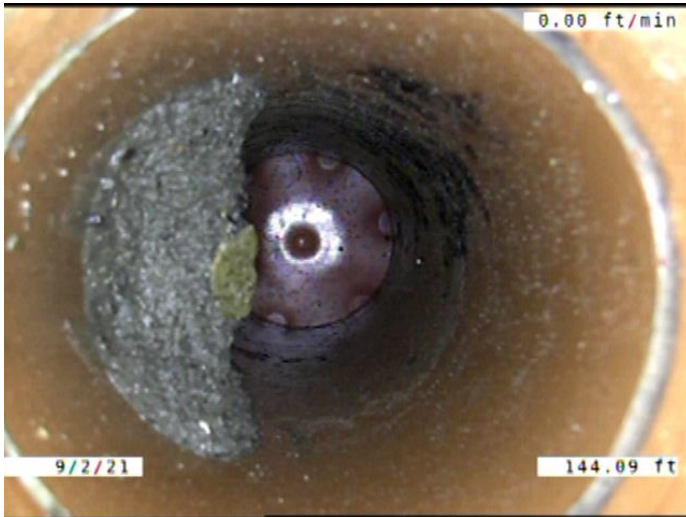
Code: **TFC**  
 Description: **Tap Factory Capped**

Distance (ft): **144.1**  
 Structural Grade: **0**  
 O&M Grade: **0**  
 Clock Start/From: **9**  
 Clock To:  
 1st Value: **6.000**  
 2nd Value:  
 Value Percent:  
 Continuous Index:  
 Within 8" of Joint: **YES**  
 Remarks:

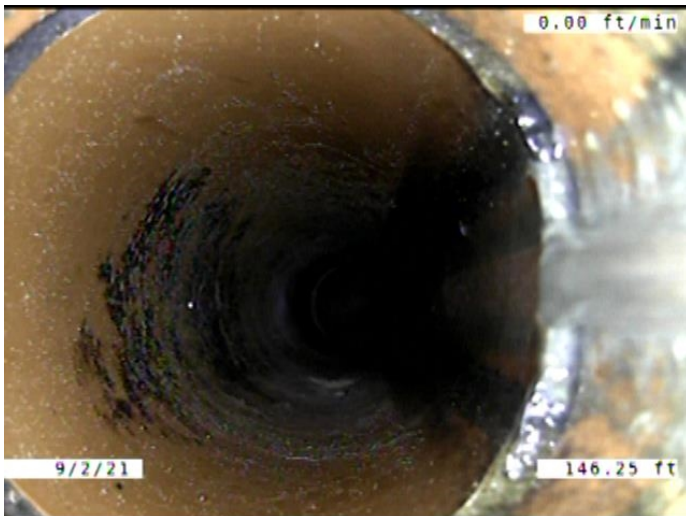
Code: **TFA**  
 Description: **Tap Factory Activity**

Distance (ft): **146.3**  
 Structural Grade: **0**  
 O&M Grade: **0**  
 Clock Start/From: **2**  
 Clock To:  
 1st Value: **6.000**  
 2nd Value:  
 Value Percent:  
 Continuous Index:  
 Within 8" of Joint: **YES**  
 Remarks:

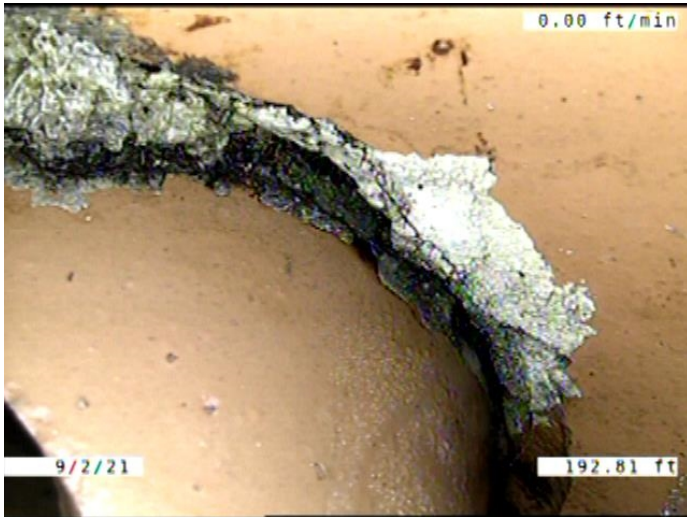
Code: **DAE**  
 Description: **Deposits Attached Encrustation**

Distance (ft): **192.8**  
 Structural Grade: **0**  
 O&M Grade: **2**  
 Clock Start/From: **9**  
 Clock To: **3**  
 1st Value:  
 2nd Value:  
 Value Percent: **5.000**  
 Continuous Index:  
 Within 8" of Joint: **NO**  
 Remarks:

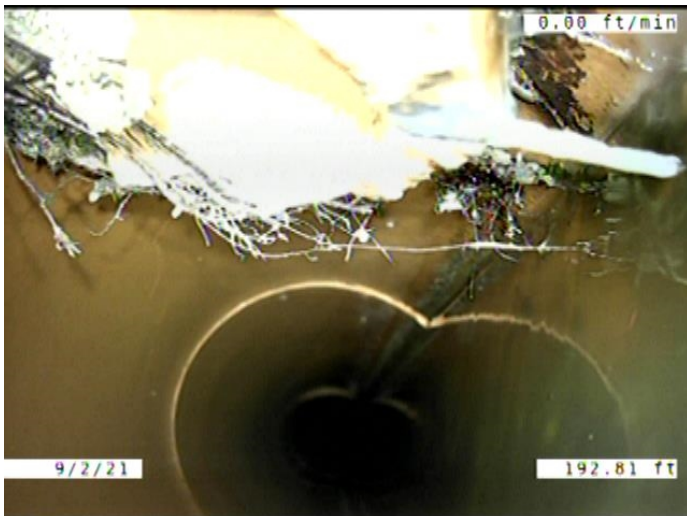
Code: **RML**  
 Description: **Roots Medium Lateral**

Distance (ft): **192.8**  
 Structural Grade: **0**  
 O&M Grade: **3**  
 Clock Start/From: **1**  
 Clock To: **4**  
 1st Value:  
 2nd Value:  
 Value Percent: **5.000**  
 Continuous Index:  
 Within 8" of Joint: **NO**  
 Remarks:

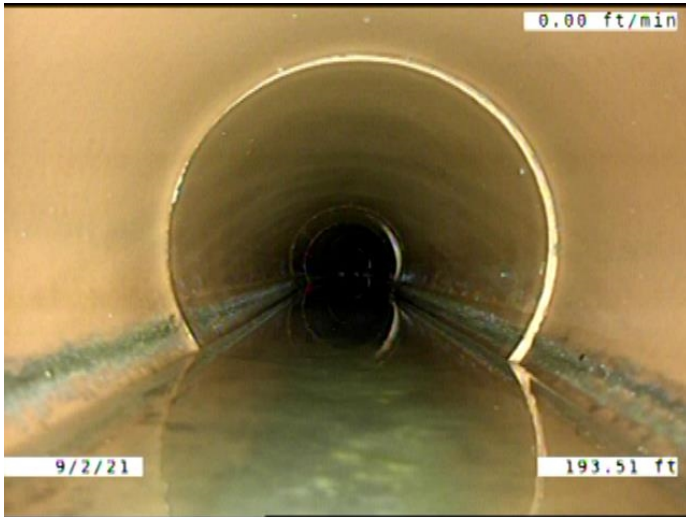
Code: **DSF**  
 Description: **Deposits Settled Fine**

Distance (ft): **193.5**  
 Structural Grade: **0**  
 O&M Grade: **2**  
 Clock Start/From: **5**  
 Clock To: **7**  
 1st Value:  
 2nd Value:  
 Value Percent: **5.000**  
 Continuous Index: **F03**  
 Within 8" of Joint: **YES**  
 Remarks:

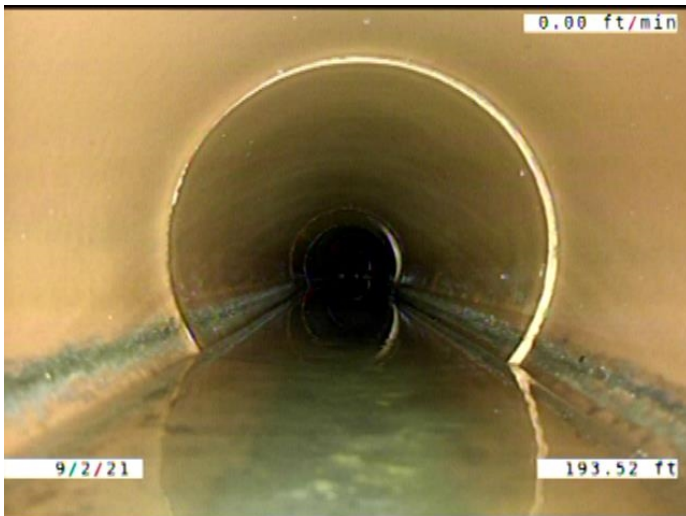
Code: **MSA**  
 Description: **Miscellaneous Survey Abandoned**

Distance (ft): **193.5**  
 Structural Grade: **0**  
 O&M Grade: **0**  
 Clock Start/From:  
 Clock To:  
 1st Value:  
 2nd Value:  
 Value Percent:  
 Continuous Index:  
 Within 8" of Joint: **NO**  
 Remarks: **CAMERA CANT MAKE IT PAST PROTRUDING TAP. MADE IT TO THE**
