# Profile/Photo Observation Report

Date:	09/02/2021	Weather:		Coding:	PACP 7.0
Pipe Length (ft):	237.0	Owner:	City of Hobart	Pre Clean:	Light Cleaning
P.O.#:	YES502259	Surveyor:	S. Bucklin	PSR:	P-404-018-017
Customer:	City of Hobart	Clean Date:	08/29/2021	Shape:	C

Street:	North Wabash Street	Flow Control:	Not Controlled
City:	Hobart, IN	Year Renewed:	
Location:	Yard	Tape/Media #:	
Purpose:	Routine Assessment	Dia/Height:	10"
Use:	Sanitary Sewage Pipe	Material:	VCP
Drain Area:		Lining:	
Category:	NA		
Comment:			
Location Details:		Direction of Survey:	Downstream
US MH:	M-404-017	DS MH:	M-404-018
		Total Length Surveyed (ft):	193.5

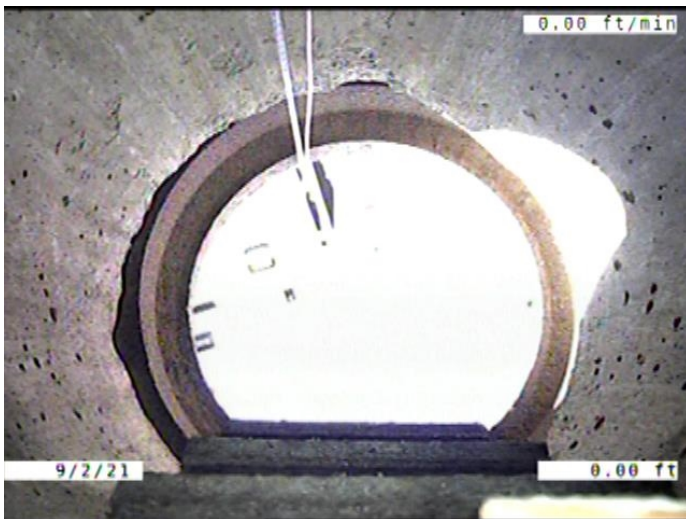
Code: **AMH**  
Description: **Manhole**

Distance (ft): **.0**  
Structural Grade: **0**  
O&M Grade: **0**  
Clock Start/From:  
Clock To:  
1st Value:  
2nd Value:  
Value Percent:  
Continuous Index:  
Within 8" of Joint: **NO**  
Remarks: **M-404-017**

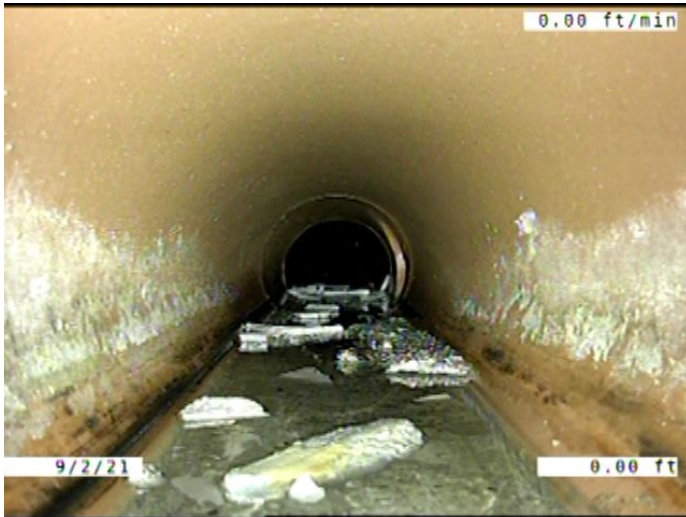
Code:	<b>MWL</b>
Description:	<b>Miscellaneous Water Level</b>
Distance (ft):	<b>.0</b>
Structural Grade:	<b>0</b>
O&M Grade:	<b>0</b>
Clock Start/From:	
Clock To:	
1st Value:	
2nd Value:	
Value Percent:	<b>5.000</b>
Continuous Index:	
Within 8" of Joint:	<b>NO</b>
Remarks:

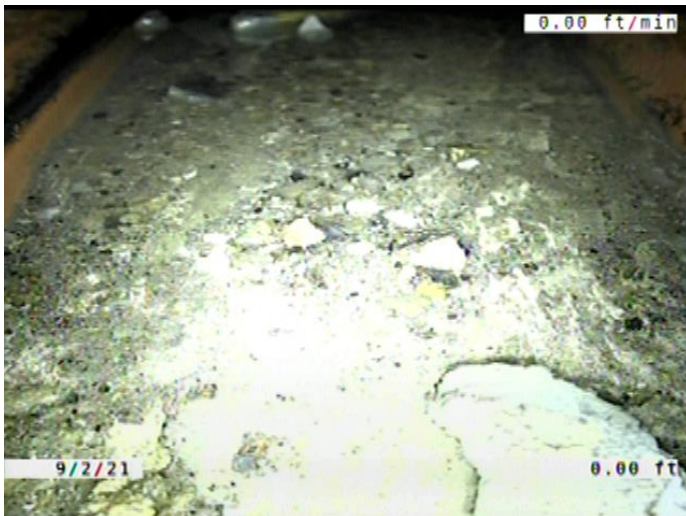
Code:	<b>DSC</b>
Description:	<b>Deposits Settled Hard/Compacted</b>
Distance (ft):	<b>.0</b>
Structural Grade:	<b>0</b>
O&M Grade:	<b>2</b>
Clock Start/From:	<b>5</b>
Clock To:	<b>7</b>
1st Value:	
2nd Value:	
Value Percent:	<b>5.000</b>
Continuous Index:	<b>S01</b>
Within 8" of Joint:	<b>YES</b>
Remarks:

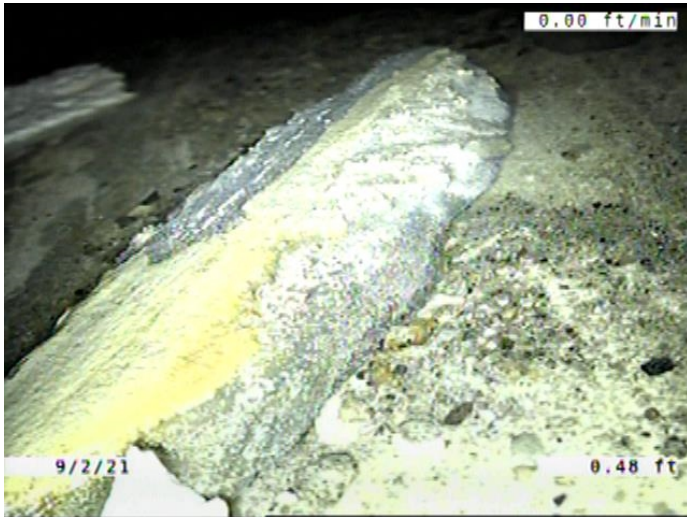
Code: **OBN**  
 Description: **Obstruction Construction Debris**

Distance (ft): **.5**  
 Structural Grade: **0**  
 O&M Grade: **2**  
 Clock Start/From: **5**  
 Clock To: **7**  
 1st Value:  
 2nd Value:  
 Value Percent: **5.000**  
 Continuous Index: **S02**  
 Within 8" of Joint: **YES**  
 Remarks:

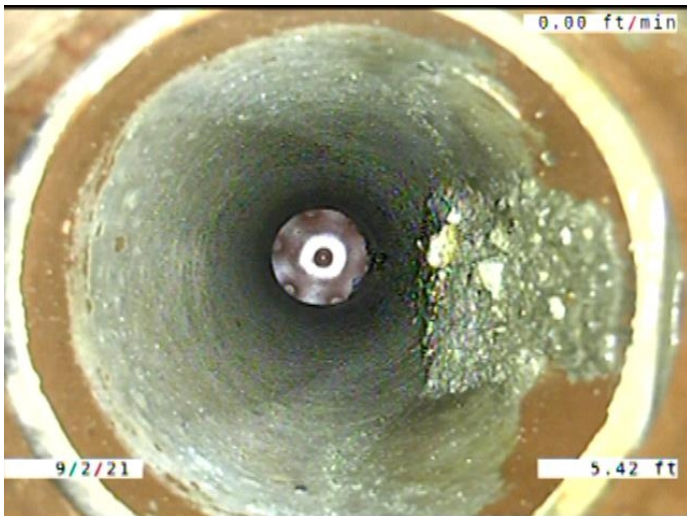
Code: **TFC**  
 Description: **Tap Factory Capped**

Distance (ft): **5.4**  
 Structural Grade: **0**  
 O&M Grade: **0**  
 Clock Start/From: **3**  
 Clock To:  
 1st Value: **4.000**  
 2nd Value:  
 Value Percent:  
 Continuous Index:  
 Within 8" of Joint: **YES**  
 Remarks:

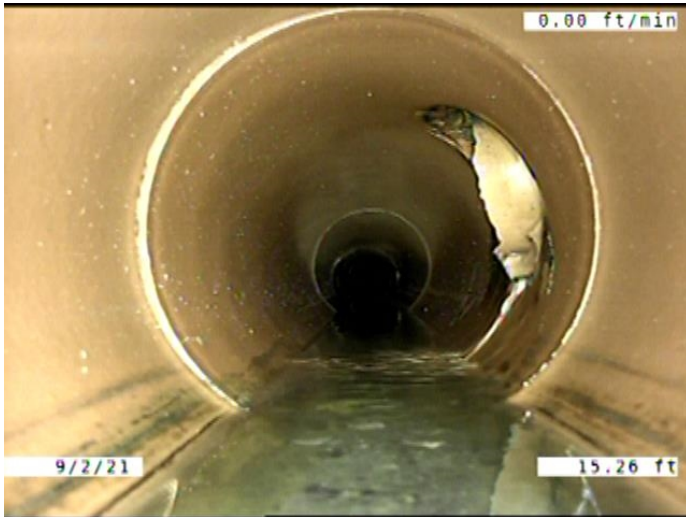
Code: **OBN**  
 Description: **Obstruction Construction Debris**

Distance (ft): **15.3**  
 Structural Grade: **0**  
 O&M Grade: **2**  
 Clock Start/From: **5**  
 Clock To: **7**  
 1st Value:  
 2nd Value:  
 Value Percent: **5.000**  
 Continuous Index: **F02**  
 Within 8" of Joint: **YES**  
 Remarks:

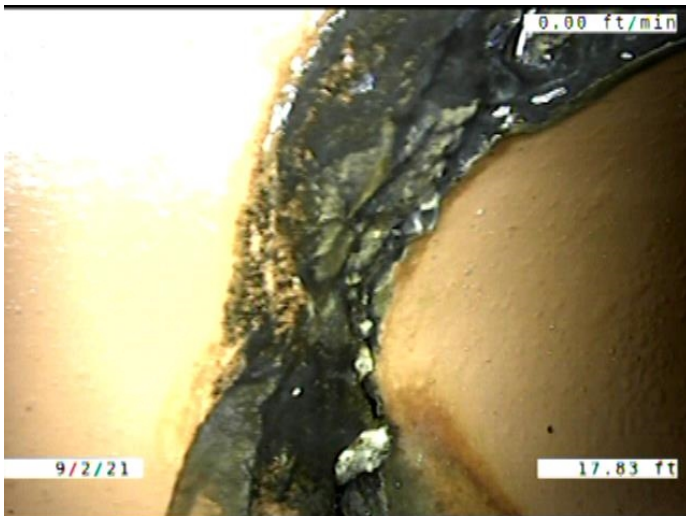
Code: **IRC**  
 Description: **Infiltration Runner Connection**

Distance (ft): **17.8**  
 Structural Grade: **0**  
 O&M Grade: **4**  
 Clock Start/From: **1**  
 Clock To:  
 1st Value:  
 2nd Value:  
 Value Percent:  
 Continuous Index:  
 Within 8" of Joint: **NO**  
 Remarks:

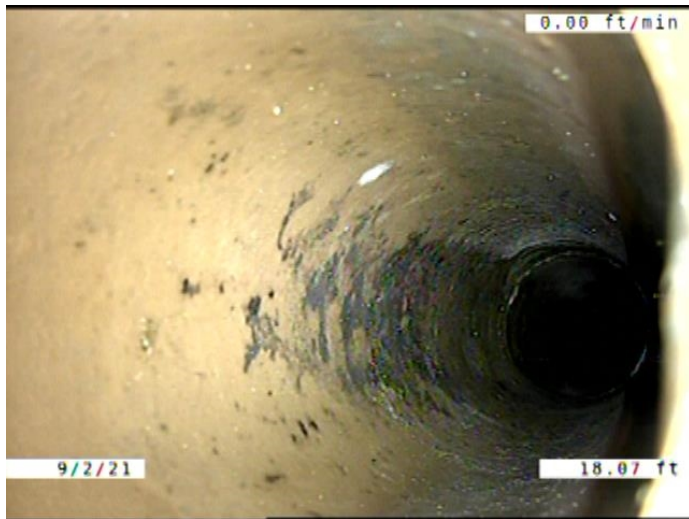
Code: **TBD**  
 Description: **Tap Break-in/Hammer Defective**

Distance (ft): **18.1**  
 Structural Grade: **0**  
 O&M Grade: **3**  
 Clock Start/From: **2**  
 Clock To:  
 1st Value: **6.000**  
 2nd Value:  
 Value Percent:  
 Continuous Index:  
 Within 8" of Joint: **NO**  
 Remarks: **Debris**

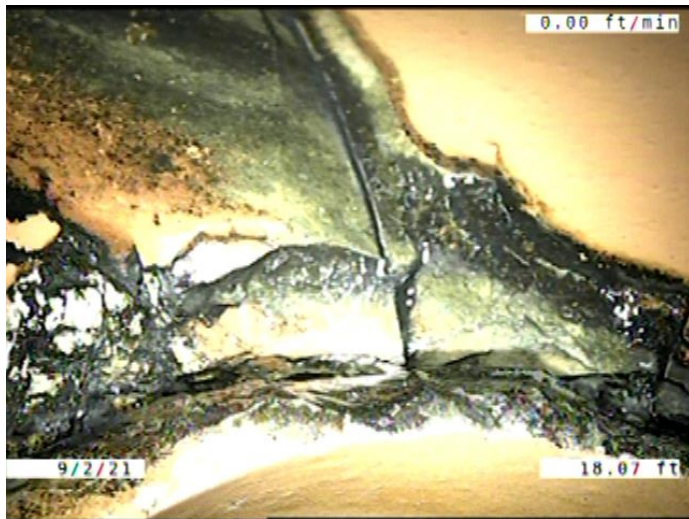
Code: **FM**  
 Description: **Fracture Multiple**

Distance (ft): **18.1**  
 Structural Grade: **4**  
 O&M Grade: **0**  
 Clock Start/From: **1**  
 Clock To: **5**  
 1st Value:  
 2nd Value:  
 Value Percent:  
 Continuous Index:  
 Within 8" of Joint: **NO**  
 Remarks:

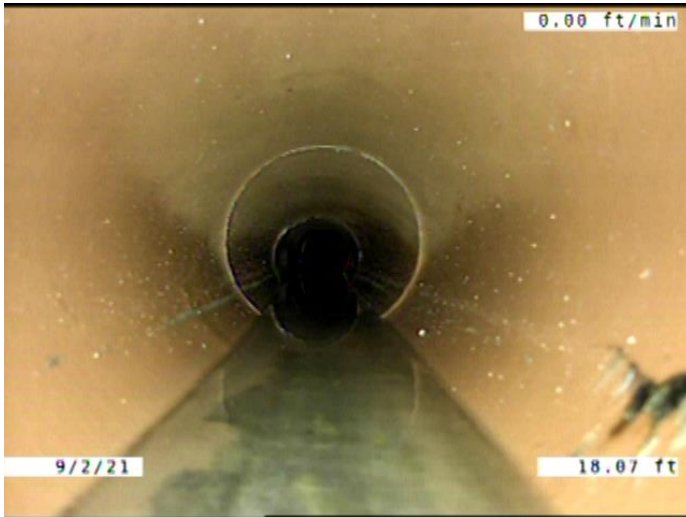
Code: **DSC**  
Description: **Deposits Settled Hard/Compacted**

Distance (ft): **18.1**  
Structural Grade: **0**  
O&M Grade: **2**  
Clock Start/From: **5**  
Clock To: **7**  
1st Value:  
2nd Value:  
Value Percent: **5.000**  
Continuous Index: **F01**  
Within 8" of Joint: **YES**  
Remarks:

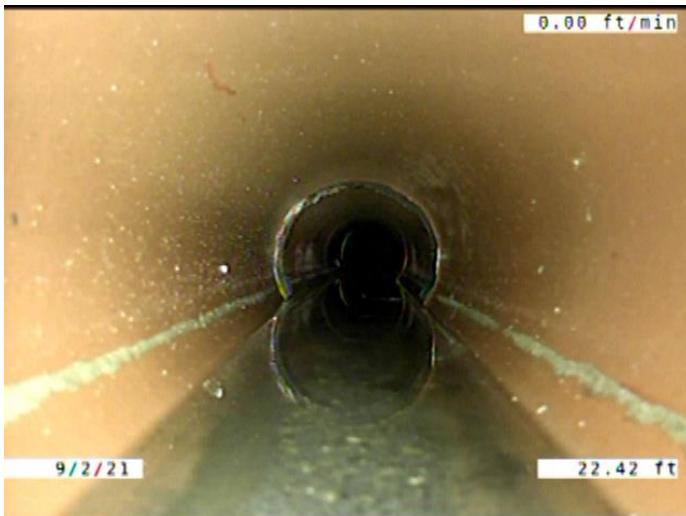
Code: **DSF**  
Description: **Deposits Settled Fine**

Distance (ft): **22.4**  
Structural Grade: **0**  
O&M Grade: **2**  
Clock Start/From: **5**  
Clock To: **7**  
1st Value:  
2nd Value:  
Value Percent: **5.000**  
Continuous Index: **S03**  
Within 8" of Joint: **YES**  
Remarks:

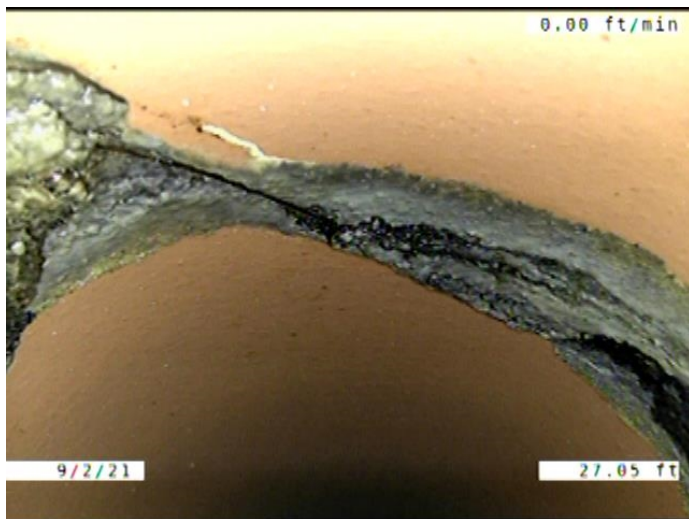
Code: **FS**  
 Description: **Fracture Spiral**

Distance (ft): **27.1**  
 Structural Grade: **3**  
 O&M Grade: **0**  
 Clock Start/From: **11**  
 Clock To: **2**  
 1st Value:  
 2nd Value:  
 Value Percent:  
 Continuous Index:  
 Within 8" of Joint: **YES**  
 Remarks:

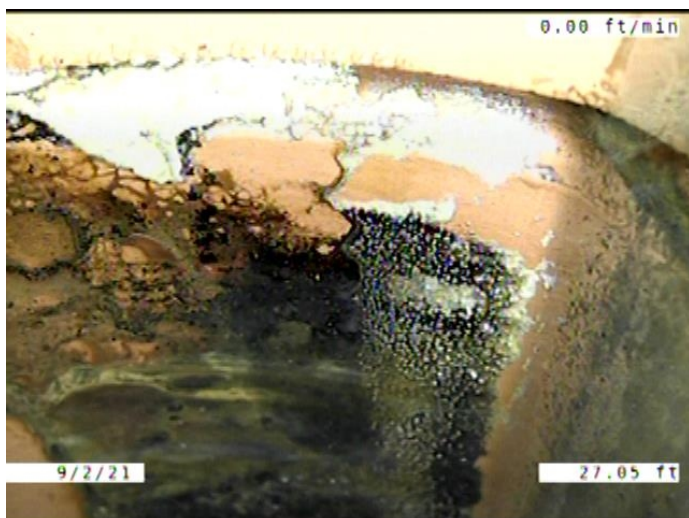
Code: **DAE**  
 Description: **Deposits Attached Encrustation**

Distance (ft): **27.1**  
 Structural Grade: **0**  
 O&M Grade: **2**  
 Clock Start/From: **8**  
 Clock To: **4**  
 1st Value:  
 2nd Value:  
 Value Percent: **5.000**  
 Continuous Index:  
 Within 8" of Joint: **YES**  
 Remarks:

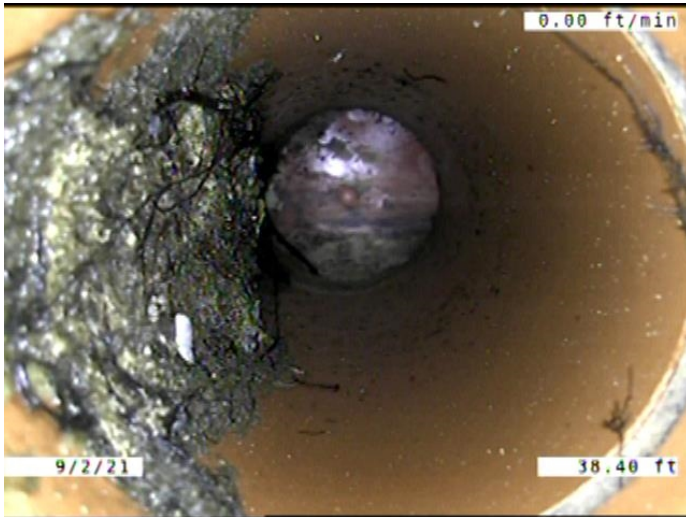
Code:	<b>TFC</b>
Description:	<b>Tap Factory Capped</b>
Distance (ft):	<b>38.4</b>
Structural Grade:	<b>0</b>
O&M Grade:	<b>0</b>
Clock Start/From:	<b>10</b>
Clock To:	
1st Value:	<b>6.000</b>
2nd Value:	
Value Percent:	
Continuous Index:	
Within 8" of Joint:	<b>YES</b>
Remarks:	<b>ROOTS GROWING IN AROUND THE CAP</b>

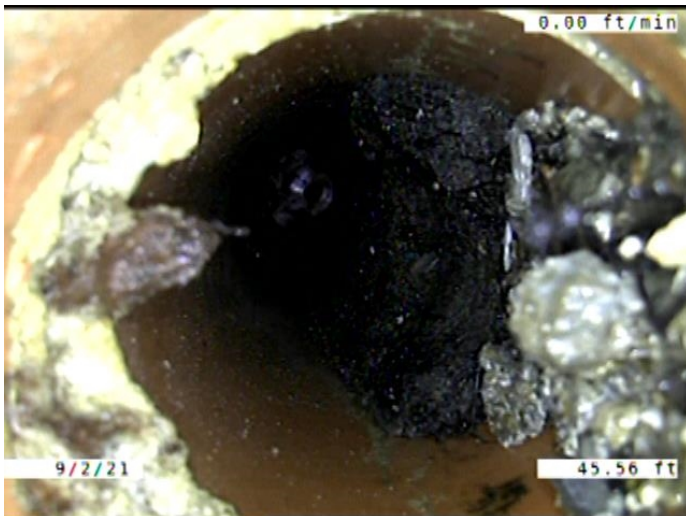
Code:	<b>TFC</b>
Description:	<b>Tap Factory Capped</b>
Distance (ft):	<b>45.6</b>
Structural Grade:	<b>0</b>
O&M Grade:	<b>0</b>
Clock Start/From:	<b>3</b>
Clock To:	
1st Value:	<b>6.000</b>
2nd Value:	
Value Percent:	
Continuous Index:	
Within 8" of Joint:	<b>YES</b>
Remarks:	<b>ENCRUSTATION AT THE FIRST JOINT BACK AND ROOTS GROWING IN THE</b>

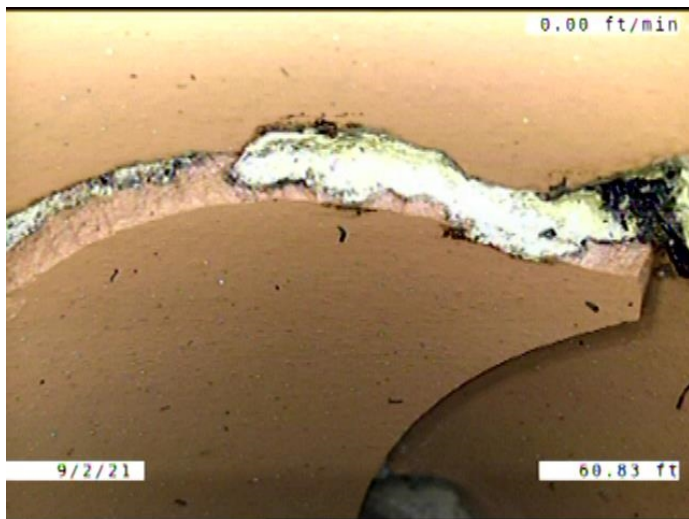
Code: **B**  
 Description: **Broken**

Distance (ft): **60.8**  
 Structural Grade: **4**  
 O&M Grade: **0**  
 Clock Start/From: **10**  
 Clock To: **6**  
 1st Value:  
 2nd Value:  
 Value Percent:  
 Continuous Index:  
 Within 8" of Joint: **YES**  
 Remarks:

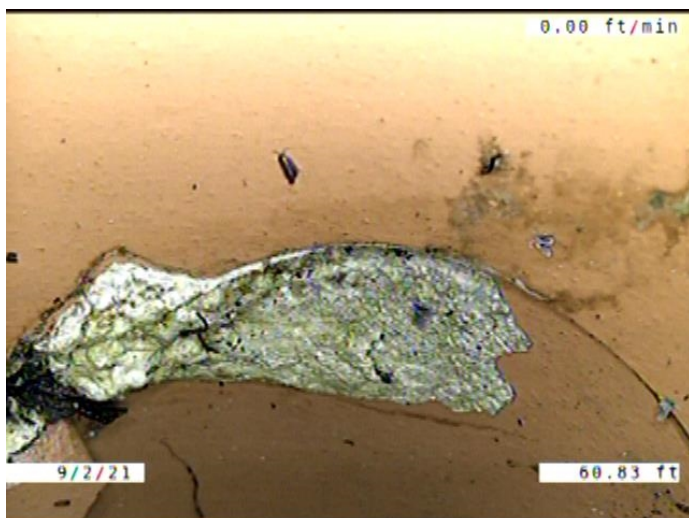
Code: **DAE**  
 Description: **Deposits Attached Encrustation**

Distance (ft): **60.8**  
 Structural Grade: **0**  
 O&M Grade: **2**  
 Clock Start/From: **10**  
 Clock To: **5**  
 1st Value:  
 2nd Value:  
 Value Percent: **5.000**  
 Continuous Index:  
 Within 8" of Joint: **YES**  
 Remarks:

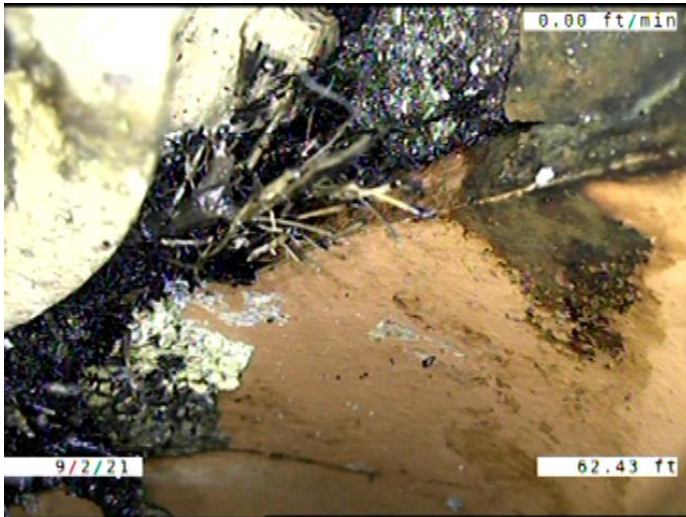
Code: **RFL**  
 Description: **Roots Fine Lateral**

Distance (ft): **62.4**  
 Structural Grade: **0**  
 O&M Grade: **1**  
 Clock Start/From: **1**  
 Clock To: **4**  
 1st Value:  
 2nd Value:  
 Value Percent:  
 Continuous Index:  
 Within 8" of Joint: **NO**  
 Remarks:

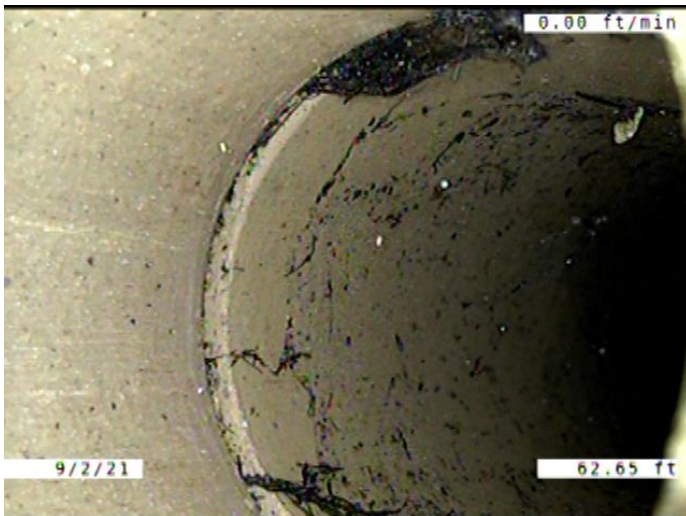
Code: **TBI**  
 Description: **Tap Break-in Intruding**

Distance (ft): **62.6**  
 Structural Grade: **0**  
 O&M Grade: **2**  
 Clock Start/From: **2**  
 Clock To:  
 1st Value: **6.000**  
 2nd Value: **1.000**  
 Value Percent:  
 Continuous Index:  
 Within 8" of Joint: **YES**  
 Remarks:

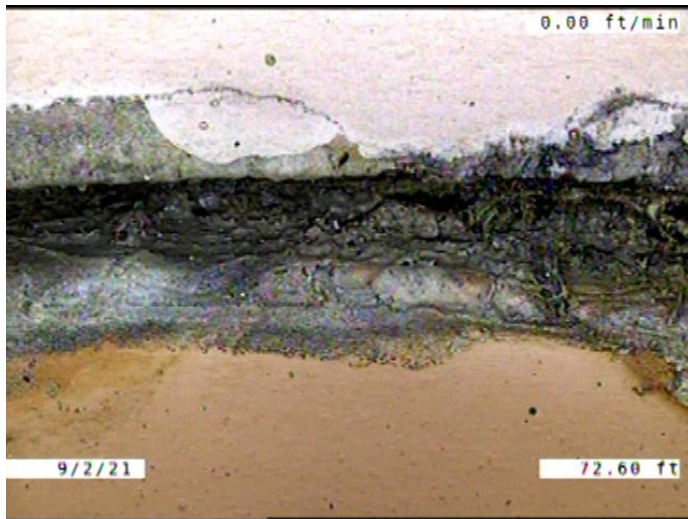
Code: **ISJ**  
 Description: **Infiltration Stain Joint**

Distance (ft): **72.6**  
 Structural Grade: **0**  
 O&M Grade: **1**  
 Clock Start/From: **8**  
 Clock To: **4**  
 1st Value:  
 2nd Value:  
 Value Percent:  
 Continuous Index:  
 Within 8" of Joint: **YES**  
 Remarks:

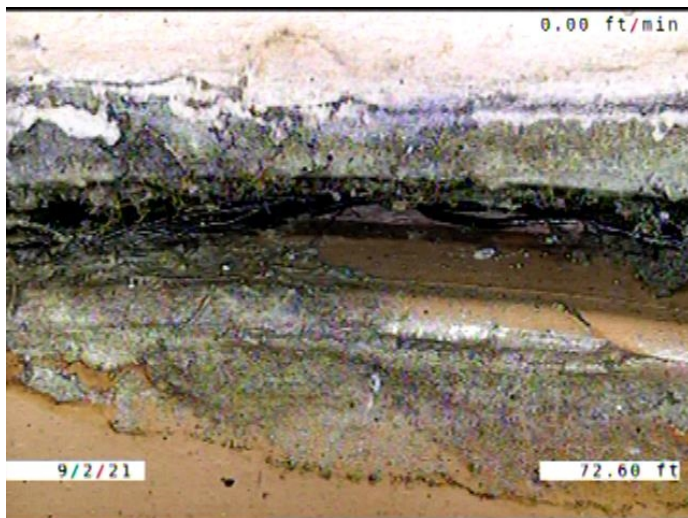
Code: **RFJ**  
 Description: **Roots Fine Joint**

Distance (ft): **72.6**  
 Structural Grade: **0**  
 O&M Grade: **1**  
 Clock Start/From: **1**  
 Clock To: **2**  
 1st Value:  
 2nd Value:  
 Value Percent:  
 Continuous Index:  
 Within 8" of Joint: **YES**  
 Remarks:

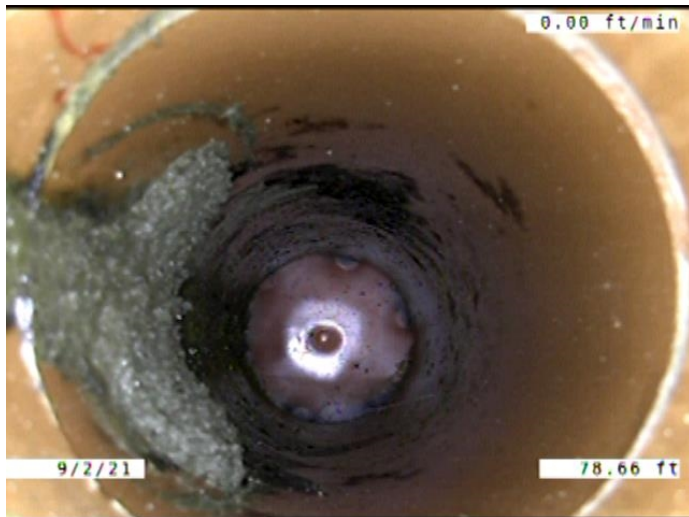
Code: **TFC**  
 Description: **Tap Factory Capped**

Distance (ft): **78.6**  
 Structural Grade: **0**  
 O&M Grade: **0**  
 Clock Start/From: **10**  
 Clock To:  
 1st Value: **6.000**  
 2nd Value:  
 Value Percent:  
 Continuous Index:  
 Within 8" of Joint: **YES**  
 Remarks:

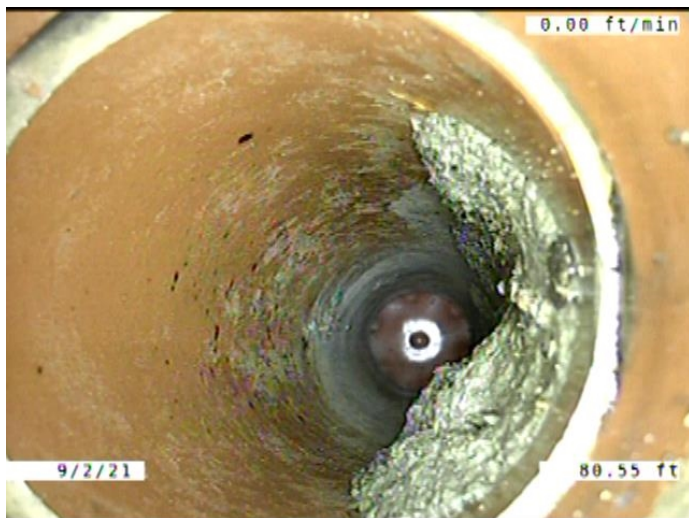
Code: **TFC**  
 Description: **Tap Factory Capped**

Distance (ft): **80.6**  
 Structural Grade: **0**  
 O&M Grade: **0**  
 Clock Start/From: **2**  
 Clock To:  
 1st Value: **6.000**  
 2nd Value:  
 Value Percent:  
 Continuous Index:  
 Within 8" of Joint: **YES**  
 Remarks:

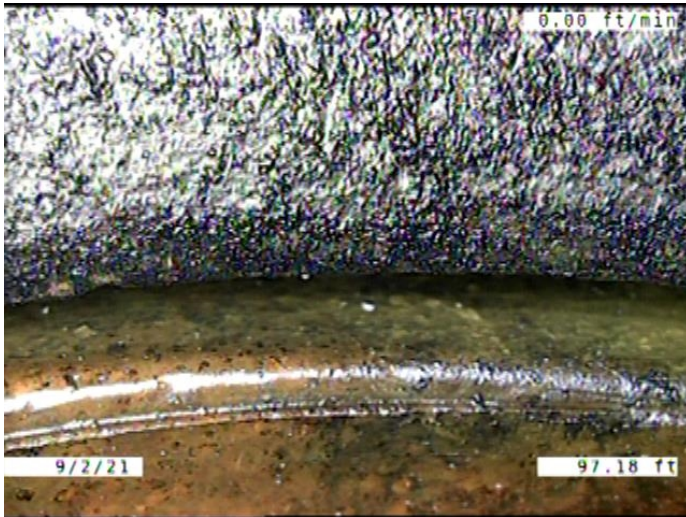
Code: **ISJ**  
 Description: **Infiltration Stain Joint**

Distance (ft): **97.2**  
 Structural Grade: **0**  
 O&M Grade: **1**  
 Clock Start/From: **8**  
 Clock To: **4**  
 1st Value:  
 2nd Value:  
 Value Percent:  
 Continuous Index:  
 Within 8" of Joint: **YES**  
 Remarks:

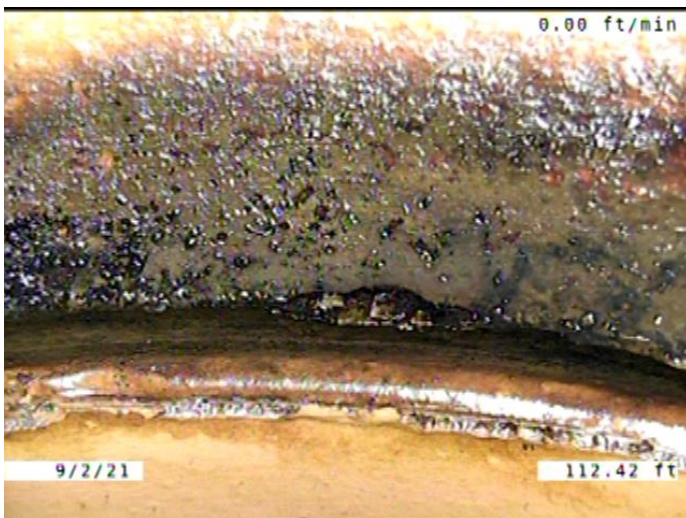
Code: **ISJ**  
 Description: **Infiltration Stain Joint**

Distance (ft): **112.4**  
 Structural Grade: **0**  
 O&M Grade: **1**  
 Clock Start/From: **8**  
 Clock To: **4**  
 1st Value:  
 2nd Value:  
 Value Percent:  
 Continuous Index:  
 Within 8" of Joint: **YES**  
 Remarks:

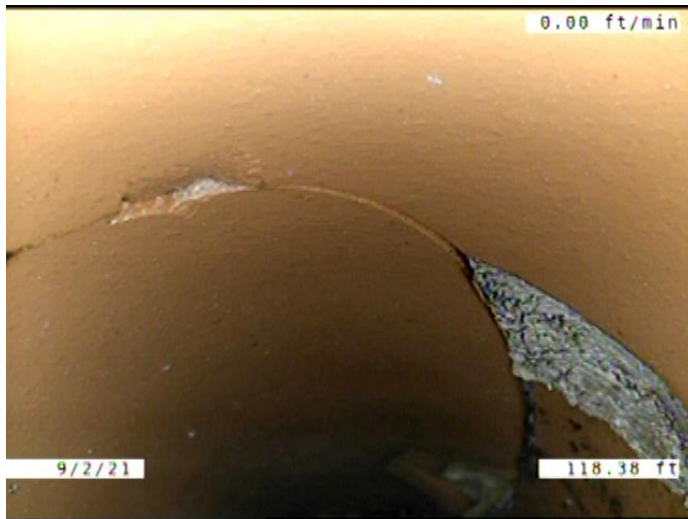
Code: **BSV**  
Description: **Broken Soil Visible**

Distance (ft): **118.4**  
Structural Grade: **5**  
O&M Grade: **0**  
Clock Start/From: **9**  
Clock To: **3**  
1st Value:  
2nd Value:  
Value Percent:  
Continuous Index: **S04**  
Within 8" of Joint: **YES**  
Remarks:

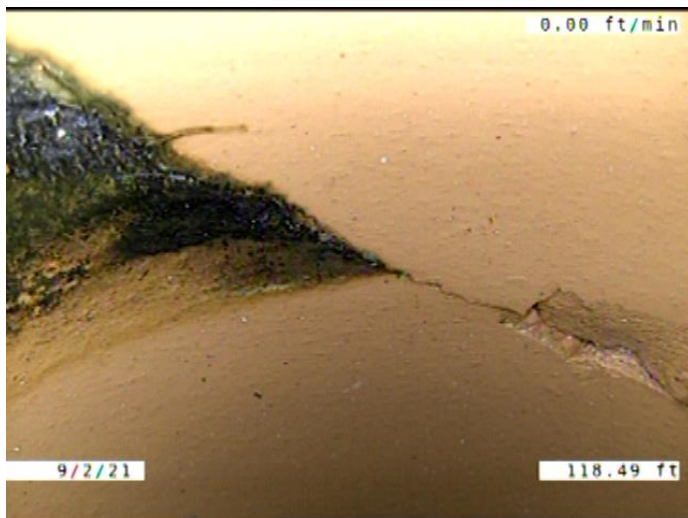
Code: **ISB**  
Description: **Infiltration Stain Barrel**

Distance (ft): **118.5**  
Structural Grade: **0**  
O&M Grade: **1**  
Clock Start/From: **9**  
Clock To: **3**  
1st Value:  
2nd Value:  
Value Percent:  
Continuous Index:  
Within 8" of Joint: **YES**  
Remarks:

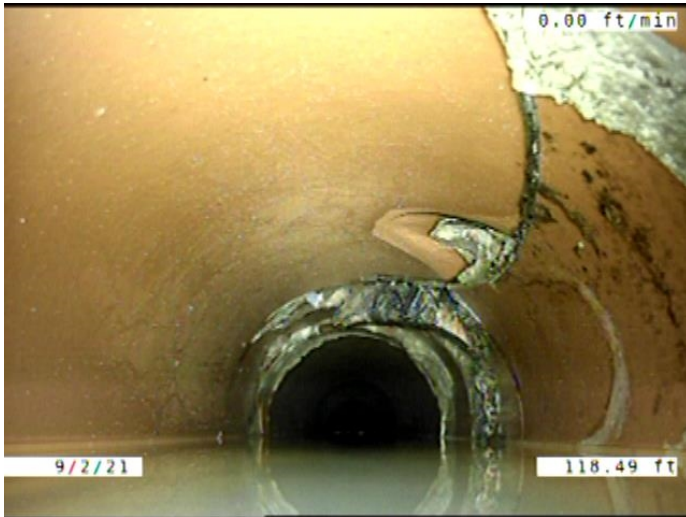
Code: **MWL**  
 Description: **Miscellaneous Water Level**

Distance (ft): **118.5**  
 Structural Grade: **0**  
 O&M Grade: **0**  
 Clock Start/From:  
 Clock To:  
 1st Value:  
 2nd Value:  
 Value Percent: **15.000**  
 Continuous Index:  
 Within 8" of Joint: **NO**  
 Remarks:

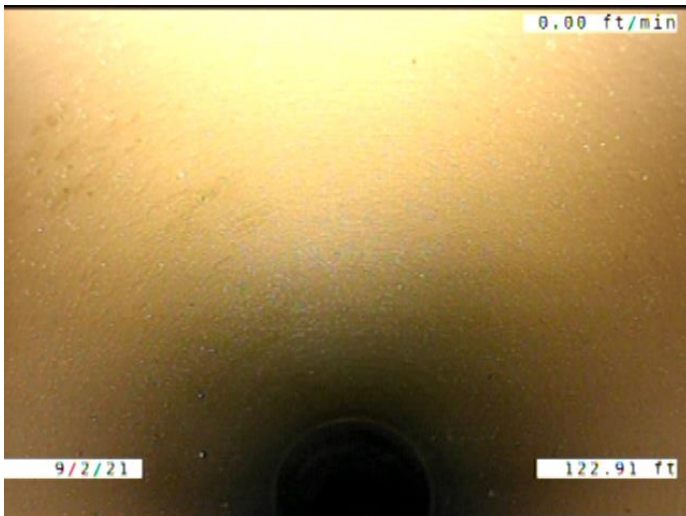
Code: **BSV**  
 Description: **Broken Soil Visible**

Distance (ft): **122.9**  
 Structural Grade: **5**  
 O&M Grade: **0**  
 Clock Start/From: **9**  
 Clock To: **3**  
 1st Value:  
 2nd Value:  
 Value Percent:  
 Continuous Index: **F04**  
 Within 8" of Joint: **YES**  
 Remarks:

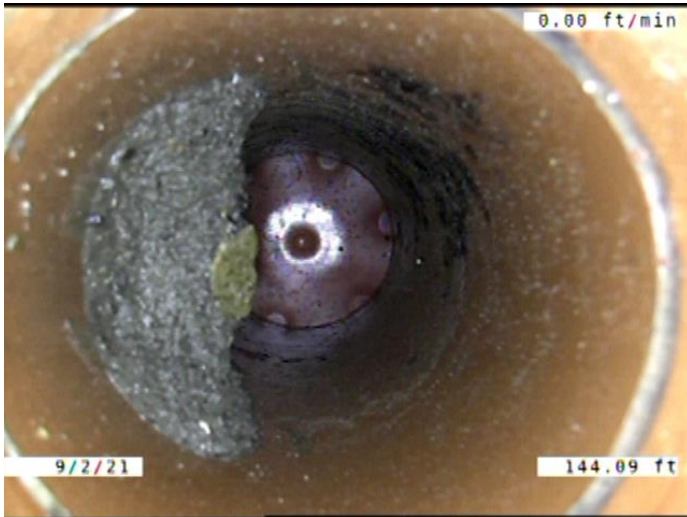
Code: **TFC**  
 Description: **Tap Factory Capped**

Distance (ft): **144.1**  
 Structural Grade: **0**  
 O&M Grade: **0**  
 Clock Start/From: **9**  
 Clock To:  
 1st Value: **6.000**  
 2nd Value:  
 Value Percent:  
 Continuous Index:  
 Within 8" of Joint: **YES**  
 Remarks:

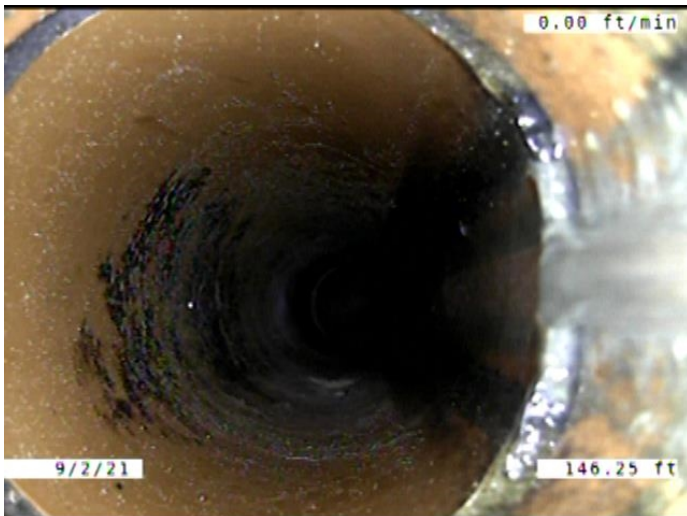
Code: **TFA**  
 Description: **Tap Factory Activity**

Distance (ft): **146.3**  
 Structural Grade: **0**  
 O&M Grade: **0**  
 Clock Start/From: **2**  
 Clock To:  
 1st Value: **6.000**  
 2nd Value:  
 Value Percent:  
 Continuous Index:  
 Within 8" of Joint: **YES**  
 Remarks:

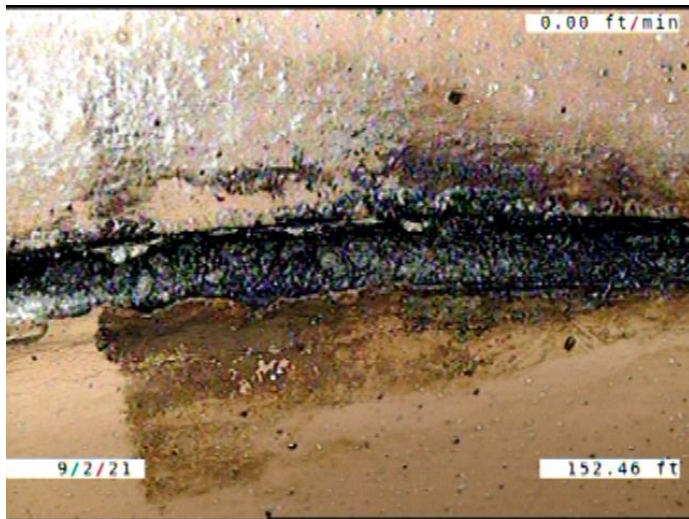
Code: **ISJ**  
 Description: **Infiltration Stain Joint**

Distance (ft): **152.5**  
 Structural Grade: **0**  
 O&M Grade: **1**  
 Clock Start/From: **9**  
 Clock To: **3**  
 1st Value:  
 2nd Value:  
 Value Percent:  
 Continuous Index:  
 Within 8" of Joint: **YES**  
 Remarks:

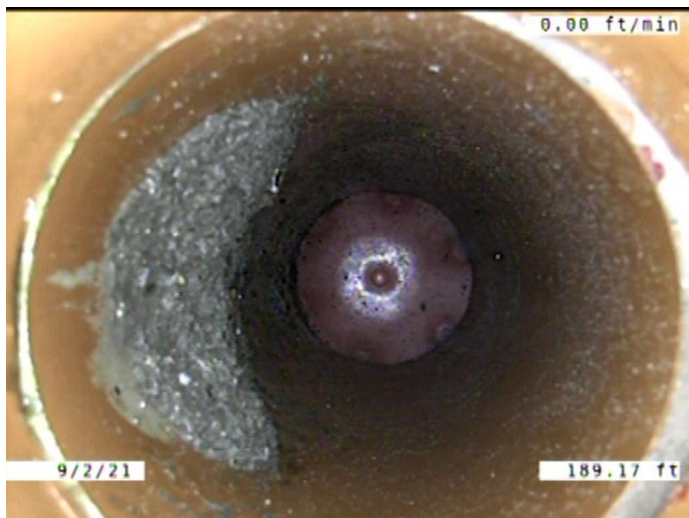
Code: **TFC**  
 Description: **Tap Factory Capped**

Distance (ft): **189.2**  
 Structural Grade: **0**  
 O&M Grade: **0**  
 Clock Start/From: **10**  
 Clock To:  
 1st Value: **4.000**  
 2nd Value:  
 Value Percent:  
 Continuous Index:  
 Within 8" of Joint: **YES**  
 Remarks:

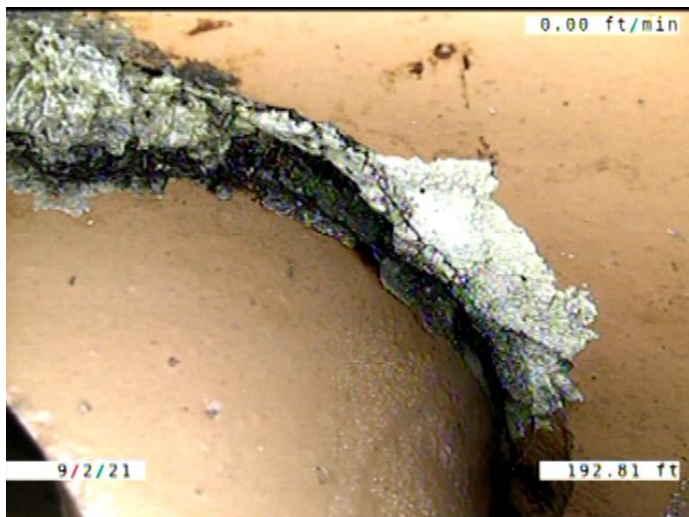
Code: **DAE**  
 Description: **Deposits Attached Encrustation**

Distance (ft): **192.8**  
 Structural Grade: **0**  
 O&M Grade: **2**  
 Clock Start/From: **9**  
 Clock To: **3**  
 1st Value:  
 2nd Value:  
 Value Percent: **5.000**  
 Continuous Index:  
 Within 8" of Joint: **NO**  
 Remarks:

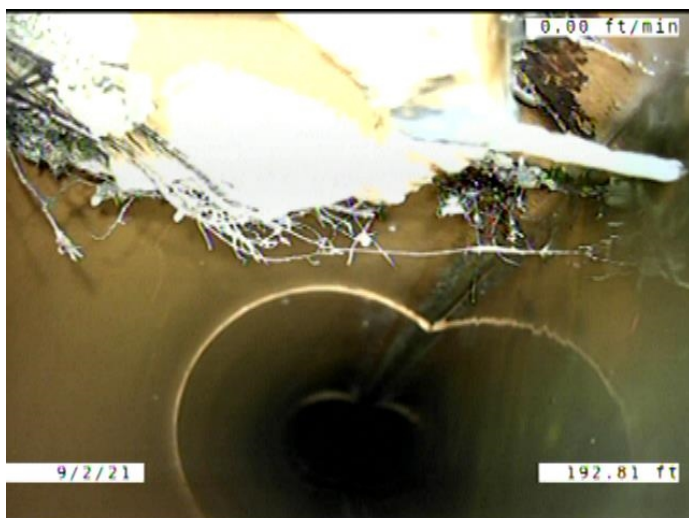
Code: **RML**  
 Description: **Roots Medium Lateral**

Distance (ft): **192.8**  
 Structural Grade: **0**  
 O&M Grade: **3**  
 Clock Start/From: **1**  
 Clock To: **4**  
 1st Value:  
 2nd Value:  
 Value Percent: **5.000**  
 Continuous Index:  
 Within 8" of Joint: **NO**  
 Remarks:

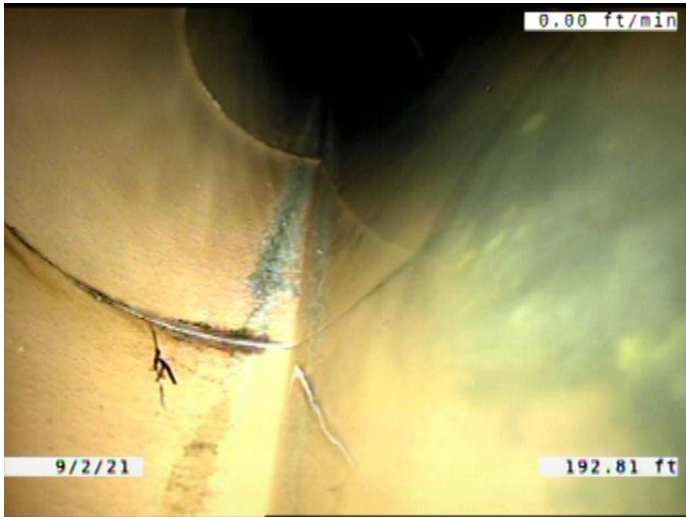
Code: **FM**  
 Description: **Fracture Multiple**

Distance (ft): **192.8**  
 Structural Grade: **4**  
 O&M Grade: **0**  
 Clock Start/From: **12**  
 Clock To: **12**  
 1st Value:  
 2nd Value:  
 Value Percent:  
 Continuous Index:  
 Within 8" of Joint: **NO**  
 Remarks:

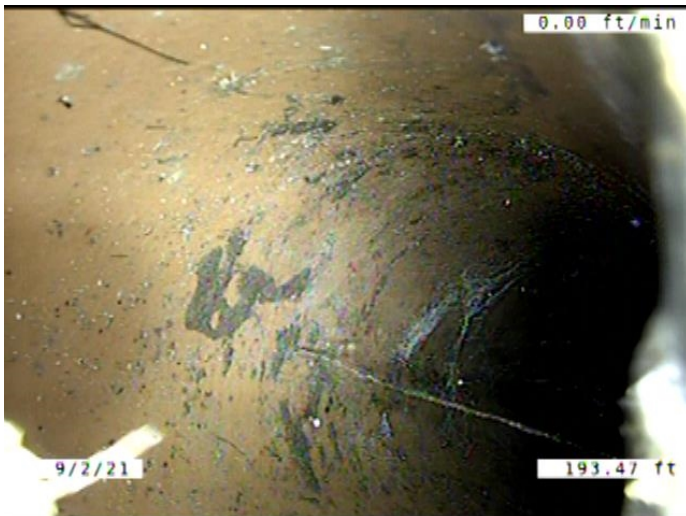
Code: **TBI**  
 Description: **Tap Break-in Intruding**

Distance (ft): **193.5**  
 Structural Grade: **0**  
 O&M Grade: **2**  
 Clock Start/From: **2**  
 Clock To:  
 1st Value: **6.000**  
 2nd Value: **3.000**  
 Value Percent:  
 Continuous Index:  
 Within 8" of Joint: **NO**  
 Remarks:

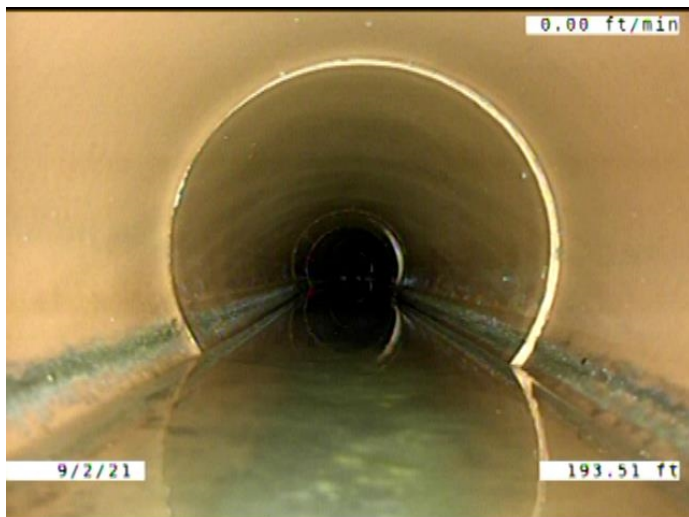
Code: **DSF**  
 Description: **Deposits Settled Fine**

Distance (ft): **193.5**  
 Structural Grade: **0**  
 O&M Grade: **2**  
 Clock Start/From: **5**  
 Clock To: **7**  
 1st Value:  
 2nd Value:  
 Value Percent: **5.000**  
 Continuous Index: **F03**  
 Within 8" of Joint: **YES**  
 Remarks:

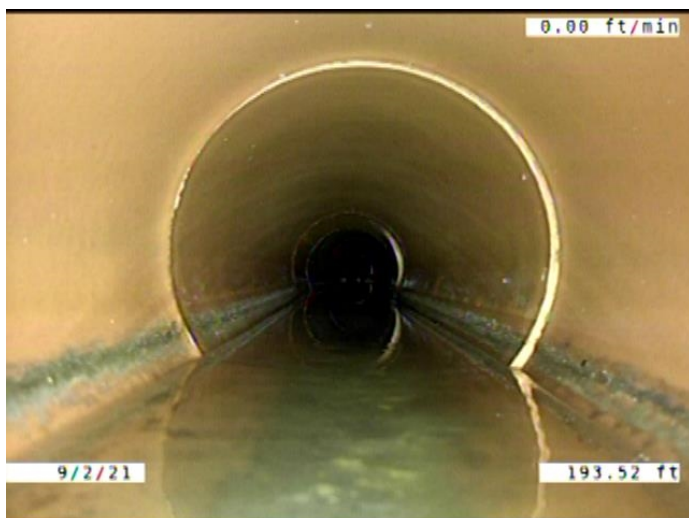
Code: **MSA**  
 Description: **Miscellaneous Survey Abandoned**

Distance (ft): **193.5**  
 Structural Grade: **0**  
 O&M Grade: **0**  
 Clock Start/From:  
 Clock To:  
 1st Value:  
 2nd Value:  
 Value Percent:  
 Continuous Index:  
 Within 8" of Joint: **NO**  
 Remarks: **CAMERA CANT MAKE IT PAST PROTRUDING TAP. MADE IT TO THE**
