Profile/Photo Observation Report

Street:	ALLEY BETWEEN N WABASH ST & N	Flow Control:	Not Controlled
City:	Hobart, IN	Year Renewed:	
Location:	Light Highway	Tape/Media #:	
Purpose:	Not Known	Dia/Height:	10"
Use:	Sanitary	Material:	PVC
Drain Area:	NA	Lining:	
Category:	NA		
Comment:

Location Details:		Direction of Survey:	Downstream
US MH:	M-404-019	DS MH:	M-404-020
		Total Length Surveyed (ft):	156.2

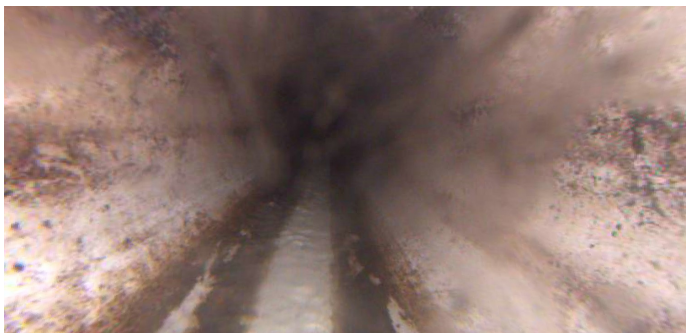
Code: **AMH**
Description: **Manhole**

Distance (ft): **.0**
Structural Grade: **0**
O&M Grade: **0**
Clock Start/From:
Clock To:
1st Value:
2nd Value:
Value Percent:
Continuous Index:
Within 8" of Joint: **NO**
Remarks: **M-404-019**

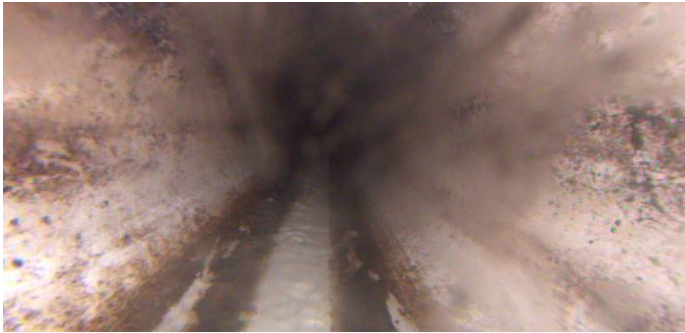
Code:	MWL
Description:	Water Level

Distance (ft):	.0
Structural Grade:	0
O&M Grade:	0
Clock Start/From:	
Clock To:	
1st Value:	
2nd Value:	
Value Percent:	5.000
Continuous Index:	
Within 8" of Joint:	NO
Remarks:

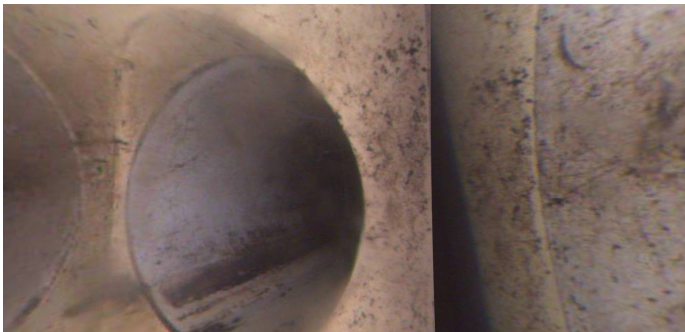
Code:	TF
Description:	Tap Factory

Distance (ft):	18.7
Structural Grade:	0
O&M Grade:	0
Clock Start/From:	9
Clock To:	
1st Value:	4.000
2nd Value:	
Value Percent:	
Continuous Index:	
Within 8" of Joint:	
Remarks:

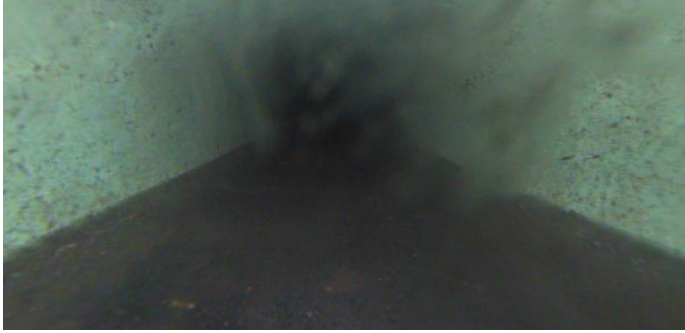
Code: **MWL**
Description: **Water Level**

Distance (ft): **45.1**
Structural Grade: **0**
O&M Grade: **0**
Clock Start/From:
Clock To:
1st Value:
2nd Value:
Value Percent: **30.000**
Continuous Index:
Within 8" of Joint: **NO**
Remarks:

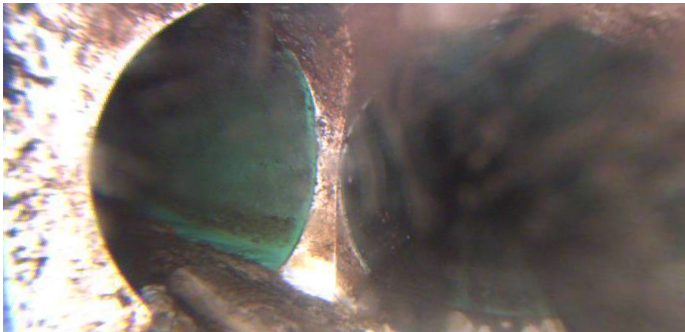
Code: **TFD**
Description: **Tap Factory Defective**

Distance (ft): **68.2**
Structural Grade: **0**
O&M Grade: **2**
Clock Start/From: **9**
Clock To:
1st Value: **4.000**
2nd Value:
Value Percent:
Continuous Index:
Within 8" of Joint:
Remarks: **roots**

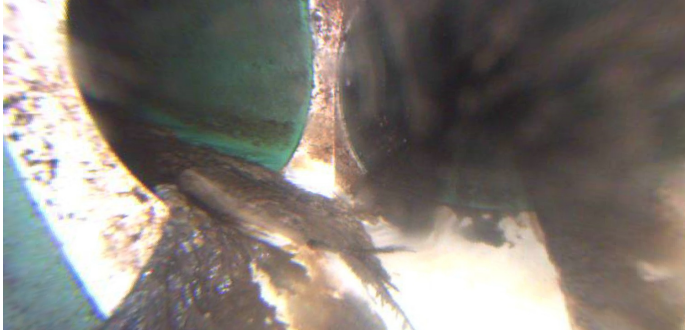
Code: **RFL**
Description: **Roots Fine Lateral**

Distance (ft): **68.2**
Structural Grade: **0**
O&M Grade: **1**
Clock Start/From: **9**
Clock To:
1st Value:
2nd Value:
Value Percent:
Continuous Index:
Within 8" of Joint: **NO**
Remarks:

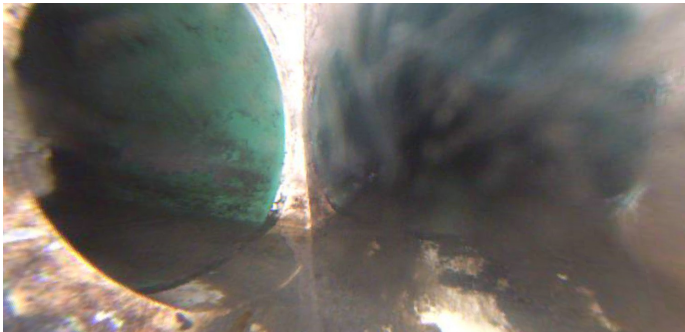
Code: **TFA**
Description: **Tap Factory Active**

Distance (ft): **128.4**
Structural Grade: **0**
O&M Grade: **0**
Clock Start/From: **9**
Clock To:
1st Value: **4.000**
2nd Value:
Value Percent:
Continuous Index:
Within 8" of Joint:
Remarks:

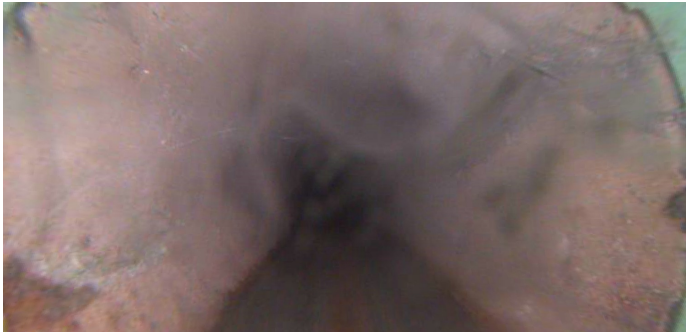
Code: **MMC**
Description: **Material Change**

Distance (ft): **152.6**
Structural Grade: **0**
O&M Grade: **0**
Clock Start/From:
Clock To:
1st Value:
2nd Value:
Value Percent:
Continuous Index:
Within 8" of Joint: **NO**
Remarks: **VCP**

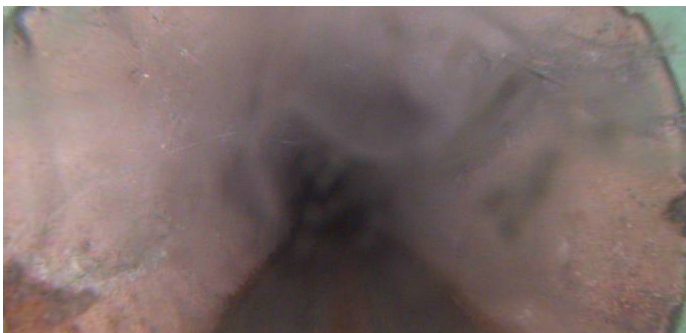
Code: **RFJ**
Description: **Roots Fine Joint**

Distance (ft): **152.6**
Structural Grade: **0**
O&M Grade: **1**
Clock Start/From: **10**
Clock To:
1st Value:
2nd Value:
Value Percent:
Continuous Index:
Within 8" of Joint: **YES**
Remarks:

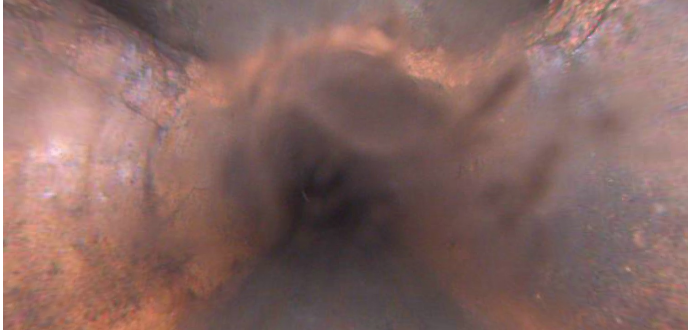
Code:	AMH
Description:	Manhole
Distance (ft):	156.2
Structural Grade:	0
O&M Grade:	0
Clock Start/From:	
Clock To:	
1st Value:	
2nd Value:	
Value Percent:	
Continuous Index:	
Within 8" of Joint:	NO
Remarks:	M-404-020
