Profile/Photo Observation Report

Date:	04/16/2018	Weather:		Coding:	PACP 6.0
Pipe Length (ft):	160.3	Owner:	NA	Pre Clean:	Not Known
P.O.#:		Surveyor:	Mark Ruby	PSR:	P-404-019-020
Customer:		Clean Date:	01/01/1900	Shape:	C

Location Details:		Direction of Survey:	Downstream
US MH:	M-404-019	DS MH:	M-404-020
		Total Length Surveyed (ft):	156.2

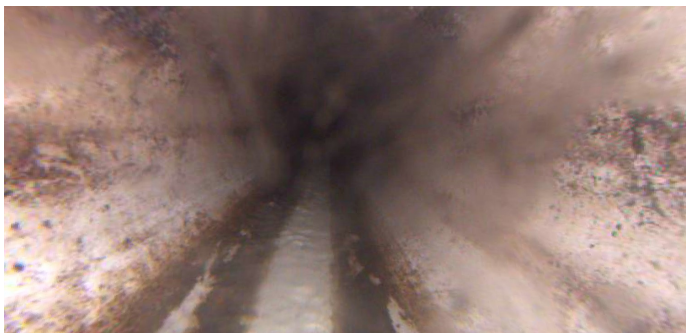
Code: **AMH**
Description: **Manhole**

Distance (ft): **.0**
Structural Grade: **0**
O&M Grade: **0**
Clock Start/From:
Clock To:
1st Value:
2nd Value:
Value Percent:
Continuous Index:
Within 8" of Joint: **NO**
Remarks: **M-404-019**

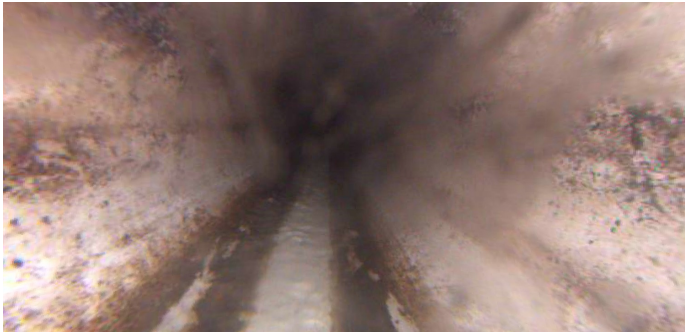
Code:	MWL
Description:	Water Level

Distance (ft):	.0
Structural Grade:	0
O&M Grade:	0
Clock Start/From:	
Clock To:	
1st Value:	
2nd Value:	
Value Percent:	5.000
Continuous Index:	
Within 8" of Joint:	NO
Remarks:

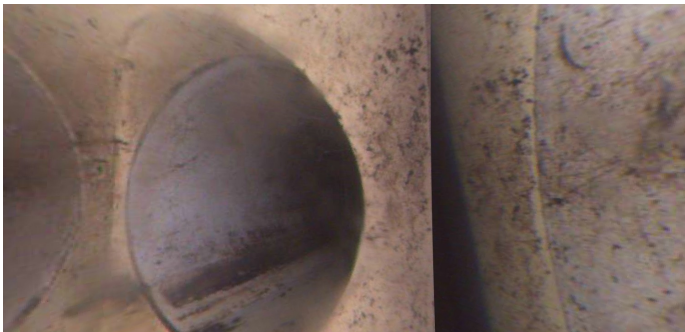
Code:	TF
Description:	Tap Factory

Distance (ft):	18.7
Structural Grade:	0
O&M Grade:	0
Clock Start/From:	9
Clock To:	
1st Value:	4.000
2nd Value:	
Value Percent:	
Continuous Index:	
Within 8" of Joint:	
Remarks:

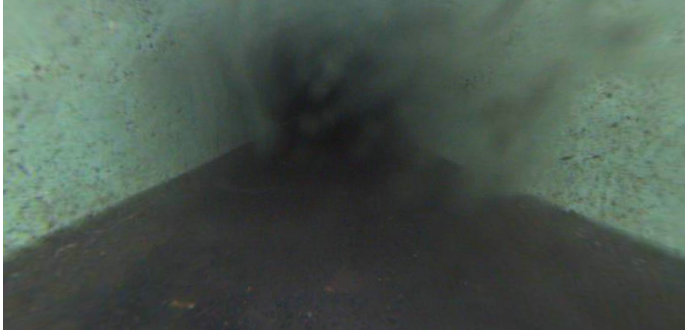
Code: **MWL**
Description: **Water Level**

Distance (ft): **45.1**
Structural Grade: **0**
O&M Grade: **0**
Clock Start/From:
Clock To:
1st Value:
2nd Value:
Value Percent: **30.000**
Continuous Index:
Within 8" of Joint: **NO**
Remarks:

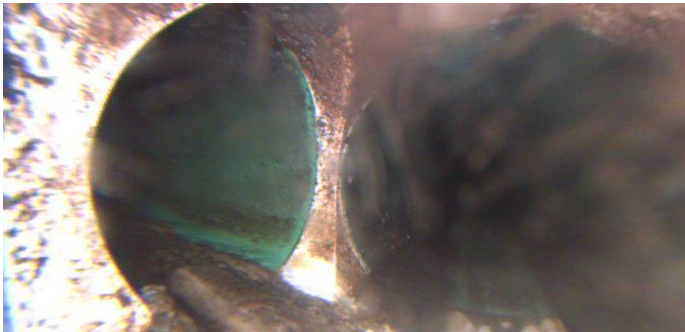
Code: **TFD**
Description: **Tap Factory Defective**

Distance (ft): **68.2**
Structural Grade: **0**
O&M Grade: **2**
Clock Start/From: **9**
Clock To:
1st Value: **4.000**
2nd Value:
Value Percent:
Continuous Index:
Within 8" of Joint:
Remarks: **roots**

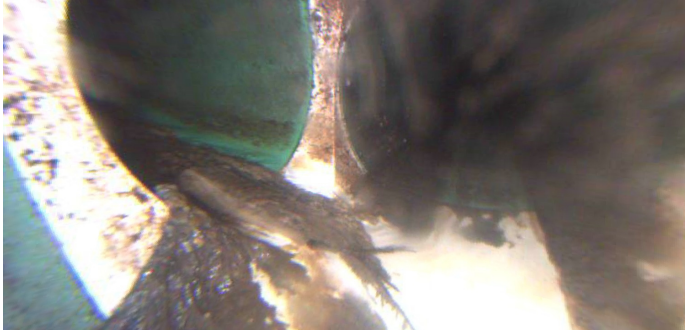
Code: **RFL**
Description: **Roots Fine Lateral**

Distance (ft): **68.2**
Structural Grade: **0**
O&M Grade: **1**
Clock Start/From: **9**
Clock To:
1st Value:
2nd Value:
Value Percent:
Continuous Index:
Within 8" of Joint: **NO**
Remarks:

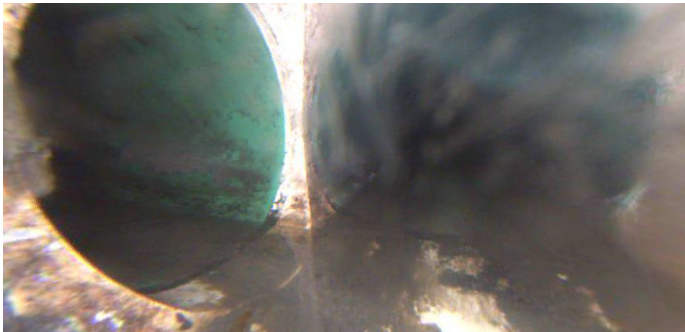
Code: **TFA**
Description: **Tap Factory Active**

Distance (ft): **128.4**
Structural Grade: **0**
O&M Grade: **0**
Clock Start/From: **9**
Clock To:
1st Value: **4.000**
2nd Value:
Value Percent:
Continuous Index:
Within 8" of Joint:
Remarks:

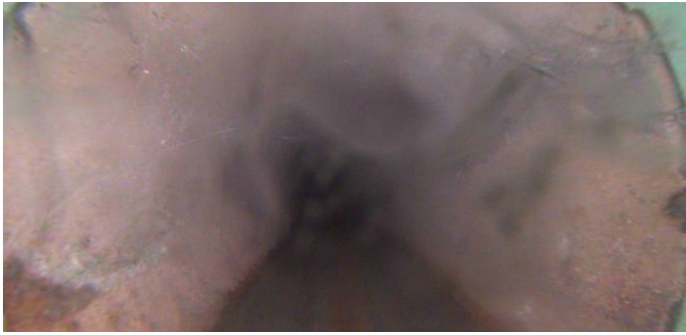
Code: **MMC**
Description: **Material Change**

Distance (ft): **152.6**
Structural Grade: **0**
O&M Grade: **0**
Clock Start/From:
Clock To:
1st Value:
2nd Value:
Value Percent:
Continuous Index:
Within 8" of Joint: **NO**
Remarks: **VCP**

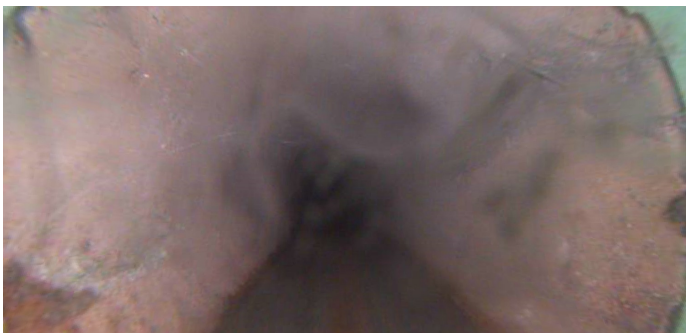
Code: **RFJ**
Description: **Roots Fine Joint**

Distance (ft): **152.6**
Structural Grade: **0**
O&M Grade: **1**
Clock Start/From: **10**
Clock To:
1st Value:
2nd Value:
Value Percent:
Continuous Index:
Within 8" of Joint: **YES**
Remarks:

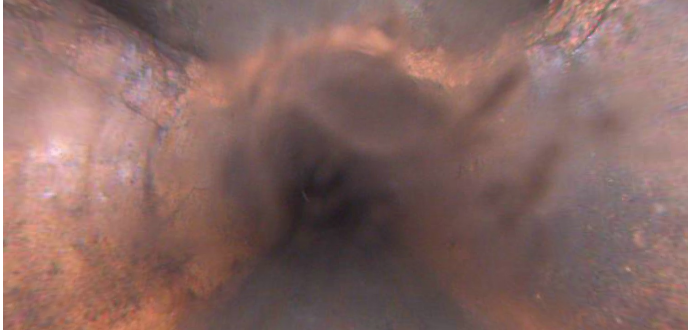
Code:	AMH
Description:	Manhole
Distance (ft):	156.2
Structural Grade:	0
O&M Grade:	0
Clock Start/From:	
Clock To:	
1st Value:	
2nd Value:	
Value Percent:	
Continuous Index:	
Within 8" of Joint:	NO
Remarks:	M-404-020
