## Profile/Photo Observation Report

Date:	<b>04/16/2018</b>	Weather:		Coding:	<b>PACP 6.0</b>
Pipe Length (ft):	<b>184.7</b>	Owner:	<b>NA</b>	Pre Clean:	<b>Not Known</b>
P.O.#:		Surveyor:	<b>Selasie Honu</b>	PSR:	<b>P-404-020-021</b>
Customer:		Clean Date:	<b>01/01/1900</b>	Shape:	<b>C</b>

Street:	<b>Summerlin</b>	Flow Control:	<b>Not Controlled</b>
City:	<b>Hobart, IN</b>	Year Renewed:	
Location:	<b>Light Highway</b>	Tape/Media #:	
Purpose:	<b>Not Known</b>	Dia/Height:	<b>10"</b>
Use:	<b>Sanitary</b>	Material:	<b>VCP</b>
Drain Area:	<b>NA</b>	Lining:	
Category:	<b>NA</b>		
Comment:

Location Details:		Direction of Survey:	<b>Upstream</b>
US MH:	<b>M-404-020</b>	DS MH:	<b>M-404-021</b>
		Total Length Surveyed (ft):	<b>66.2</b>

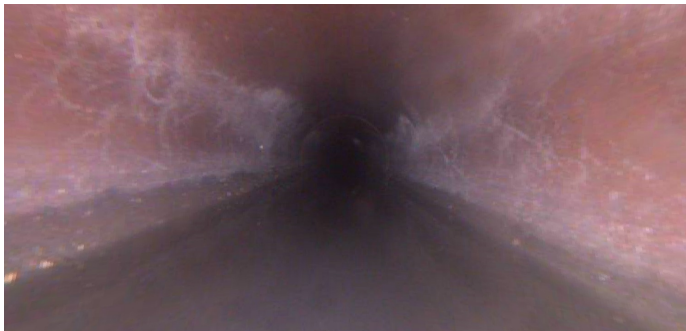
Code: **AMH**  
Description: **Manhole**

Distance (ft): **.0**  
Structural Grade: **0**  
O&M Grade: **0**  
Clock Start/From:  
Clock To:  
1st Value:  
2nd Value:  
Value Percent:  
Continuous Index:  
Within 8" of Joint: **NO**  
Remarks: **M-404-020**

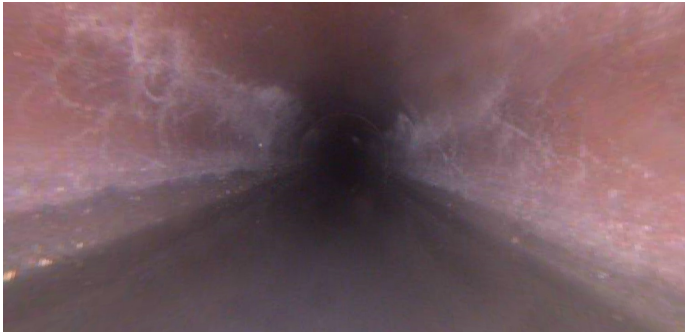
Code:	<b>MWL</b>
Description:	<b>Water Level</b>

Distance (ft):	<b>.0</b>
Structural Grade:	<b>0</b>
O&M Grade:	<b>0</b>
Clock Start/From:	
Clock To:	
1st Value:	
2nd Value:	
Value Percent:	<b>5.000</b>
Continuous Index:	
Within 8" of Joint:	<b>NO</b>
Remarks:

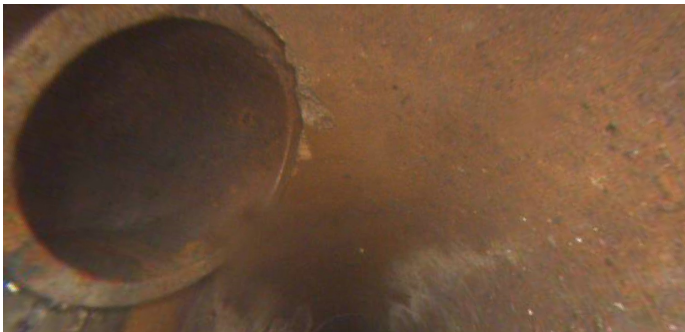
Code:	<b>TBI</b>
Description:	<b>Tap Break-in Intruding</b>

Distance (ft):	<b>6.6</b>
Structural Grade:	<b>0</b>
O&M Grade:	<b>2</b>
Clock Start/From:	<b>1</b>
Clock To:	
1st Value:	<b>4.000</b>
2nd Value:	<b>2.000</b>
Value Percent:	
Continuous Index:	
Within 8" of Joint:	
Remarks:

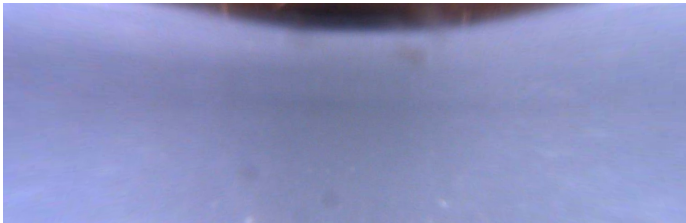
Code: **MWLS**  
Description: **Water Level Sag**

Distance (ft): **22.0**  
Structural Grade: **2**  
O&M Grade: **3**  
Clock Start/From:  
Clock To:  
1st Value:  
2nd Value:  
Value Percent: **10.000**  
Continuous Index:  
Within 8" of Joint: **NO**  
Remarks:

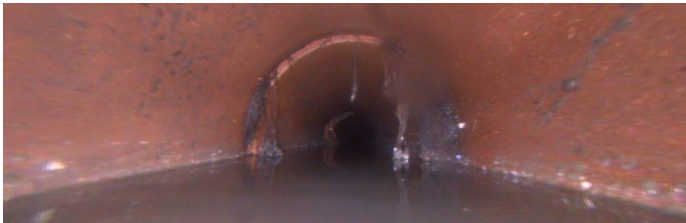
Code: **RMJ**  
Description: **Roots Medium Joint**

Distance (ft): **28.3**  
Structural Grade: **0**  
O&M Grade: **3**  
Clock Start/From: **8**  
Clock To: **4**  
1st Value:  
2nd Value:  
Value Percent: **20.000**  
Continuous Index:  
Within 8" of Joint: **YES**  
Remarks:

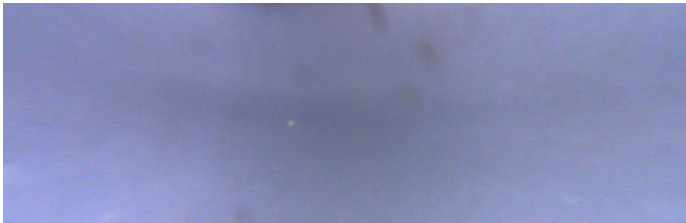
Code: **MWLS**  
Description: **Water Level Sag**

Distance (ft): **31.3**  
Structural Grade: **2**  
O&M Grade: **3**  
Clock Start/From:  
Clock To:  
1st Value:  
2nd Value:  
Value Percent: **10.000**  
Continuous Index: **S01**  
Within 8" of Joint: **NO**  
Remarks:

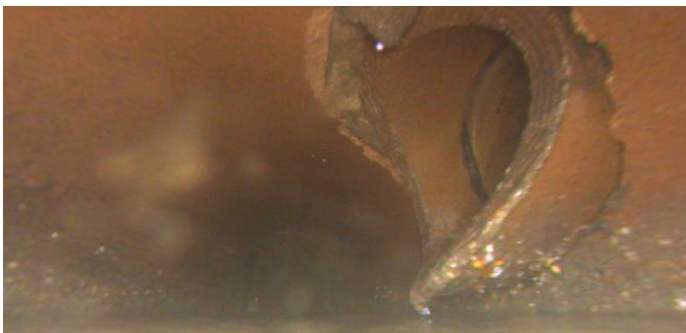
Code: **TBI**  
Description: **Tap Break-in Intruding**

Distance (ft): **32.0**  
Structural Grade: **0**  
O&M Grade: **2**  
Clock Start/From: **9**  
Clock To:  
1st Value: **4.000**  
2nd Value: **1.000**  
Value Percent:  
Continuous Index:  
Within 8" of Joint:  
Remarks:

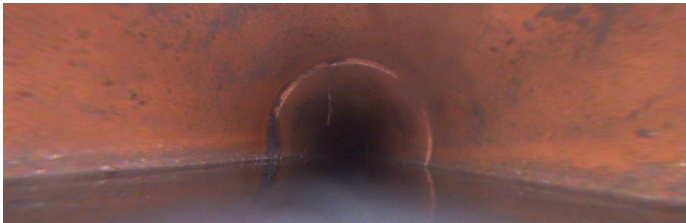
Code: **RFJ**  
Description: **Roots Fine Joint**

Distance (ft): **44.5**  
Structural Grade: **0**  
O&M Grade: **1**  
Clock Start/From: **8**  
Clock To: **4**  
1st Value:  
2nd Value:  
Value Percent:  
Continuous Index:  
Within 8" of Joint: **YES**  
Remarks:

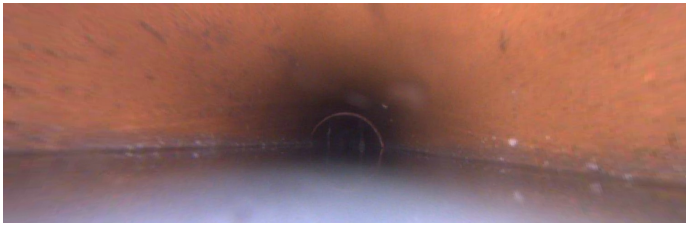
Code: **RFJ**  
Description: **Roots Fine Joint**

Distance (ft): **49.5**  
Structural Grade: **0**  
O&M Grade: **1**  
Clock Start/From: **8**  
Clock To: **4**  
1st Value:  
2nd Value:  
Value Percent:  
Continuous Index: **S02**  
Within 8" of Joint: **YES**  
Remarks:

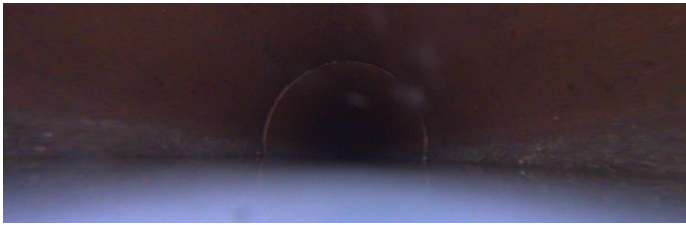
Code: **RFJ**  
Description: **Roots Fine Joint**

Distance (ft): **63.6**  
Structural Grade: **0**  
O&M Grade: **1**  
Clock Start/From: **8**  
Clock To: **4**  
1st Value:  
2nd Value:  
Value Percent:  
Continuous Index: **F02**  
Within 8" of Joint: **YES**  
Remarks:

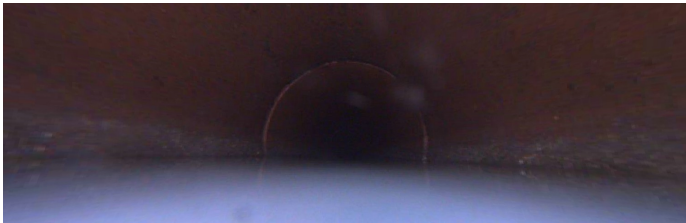
Code: **MWLS**  
Description: **Water Level Sag**

Distance (ft): **63.6**  
Structural Grade: **2**  
O&M Grade: **3**  
Clock Start/From:  
Clock To:  
1st Value:  
2nd Value:  
Value Percent: **10.000**  
Continuous Index: **F03**  
Within 8" of Joint: **NO**  
Remarks:

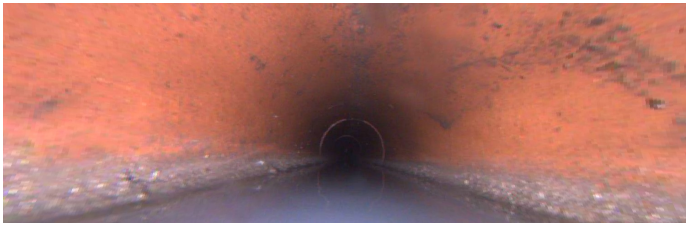
Code: **MSA**  
Description: **Abandoned Survey**

Distance (ft): **66.2**  
Structural Grade: **0**  
O&M Grade: **0**  
Clock Start/From:  
Clock To:  
1st Value:  
2nd Value:  
Value Percent:  
Continuous Index:  
Within 8" of Joint: **NO**  
Remarks: **camera stopped**
