Profile/Photo Observation Report

Street:	North Wabash Street	Flow Control:	Not Controlled
City:	Hobart, IN	Year Renewed:	
Location:	Alley	Tape/Media #:	
Purpose:	Routine Assessment	Dia/Height:	10"
Use:	Sanitary Sewage Pipe	Material:	VCP
Drain Area:		Lining:	
Category:	NA		
Comment:			
Location Details:		Direction of Survey:	Downstream
US MH:	M-404-020	DS MH:	M-404-021
		Total Length Surveyed (ft):	185.7

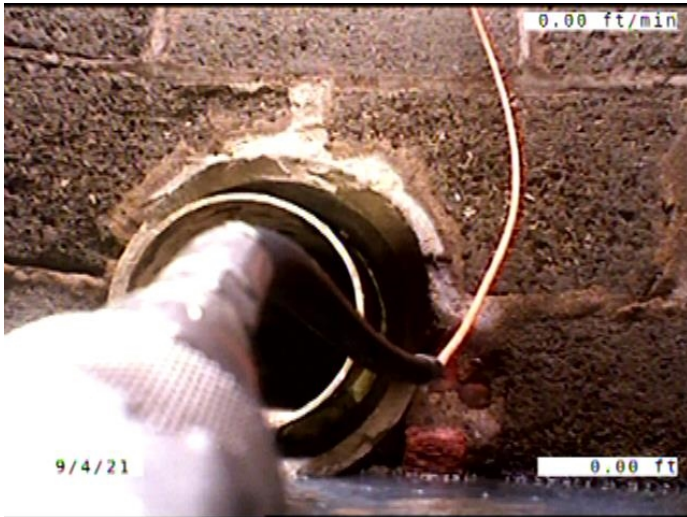
Code: **AMH**
Description: **Manhole**

Distance (ft): **.0**
Structural Grade: **0**
O&M Grade: **0**
Clock Start/From:
Clock To:
1st Value:
2nd Value:
Value Percent:
Continuous Index:
Within 8" of Joint: **NO**
Remarks: **M-404-020**

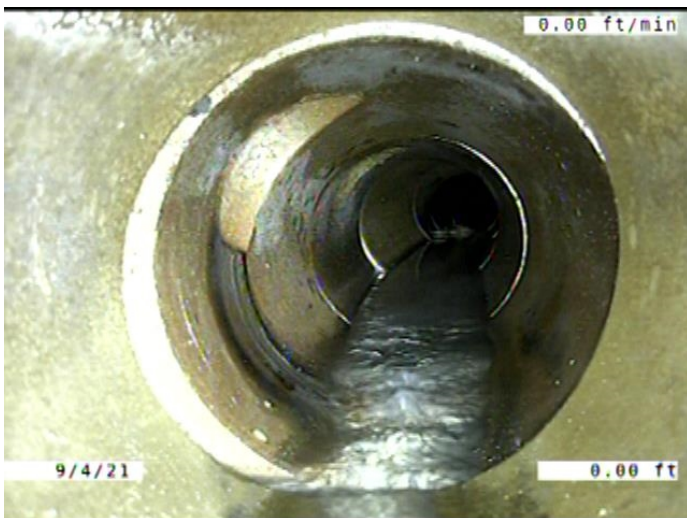
Code: **MWL**
Description: **Miscellaneous Water Level**

Distance (ft): **.0**
Structural Grade: **0**
O&M Grade: **0**
Clock Start/From:
Clock To:
1st Value:
2nd Value:
Value Percent: **5.000**
Continuous Index:
Within 8" of Joint: **NO**
Remarks:

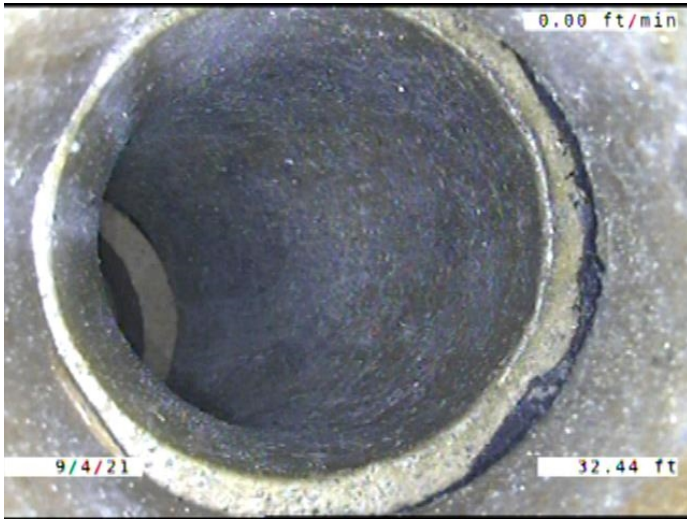
Code: **TF**
Description: **Tap Factory**

Distance (ft): **32.4**
Structural Grade: **0**
O&M Grade: **0**
Clock Start/From: **10**
Clock To:
1st Value: **6.000**
2nd Value:
Value Percent:
Continuous Index:
Within 8" of Joint: **YES**
Remarks:

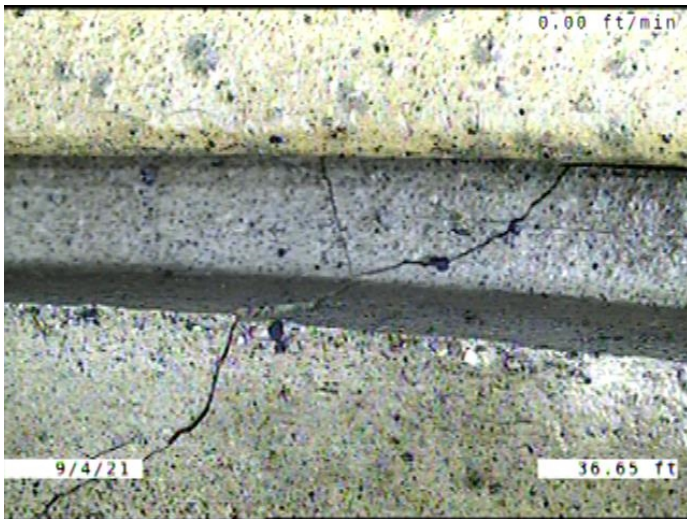
Code: **CM**
Description: **Crack Multiple**

Distance (ft): **36.6**
Structural Grade: **3**
O&M Grade: **0**
Clock Start/From: **12**
Clock To: **3**
1st Value:
2nd Value:
Value Percent:
Continuous Index:
Within 8" of Joint: **YES**
Remarks:

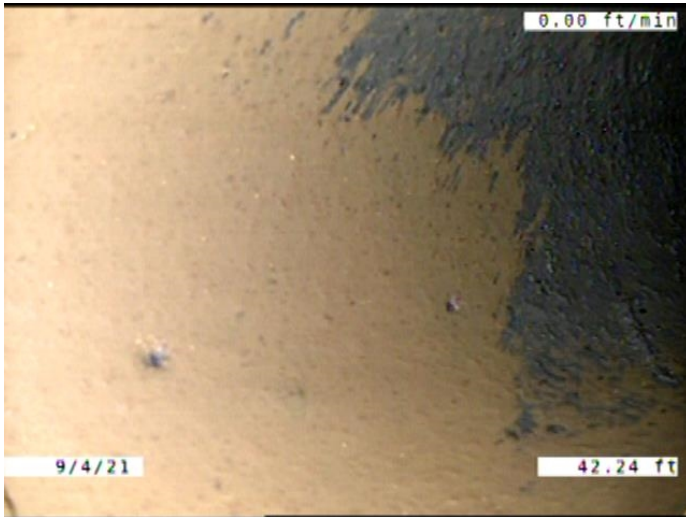
Code: **TBI**
Description: **Tap Break-in Intruding**

Distance (ft): **42.2**
Structural Grade: **0**
O&M Grade: **2**
Clock Start/From: **1**
Clock To:
1st Value: **6.000**
2nd Value: **3.000**
Value Percent:
Continuous Index:
Within 8" of Joint: **YES**
Remarks:

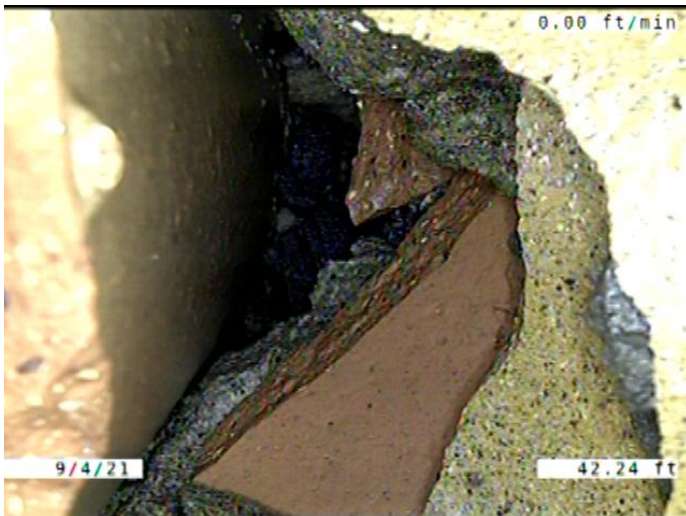
Code: **BSV**
Description: **Broken Soil Visible**

Distance (ft): **42.2**
Structural Grade: **5**
O&M Grade: **0**
Clock Start/From: **10**
Clock To: **3**
1st Value:
2nd Value:
Value Percent:
Continuous Index:
Within 8" of Joint: **YES**
Remarks:

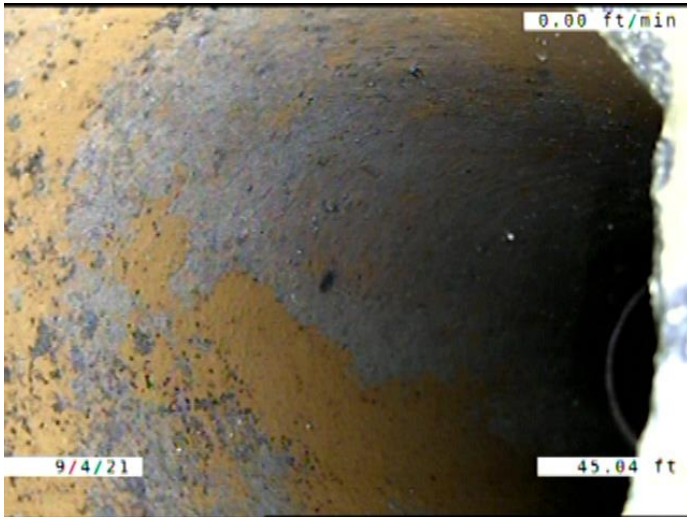
Code: **TBI**
 Description: **Tap Break-in Intruding**

Distance (ft): **45.0**
 Structural Grade: **0**
 O&M Grade: **2**
 Clock Start/From: **2**
 Clock To:
 1st Value: **6.000**
 2nd Value: **1.000**
 Value Percent:
 Continuous Index:
 Within 8" of Joint: **YES**
 Remarks:

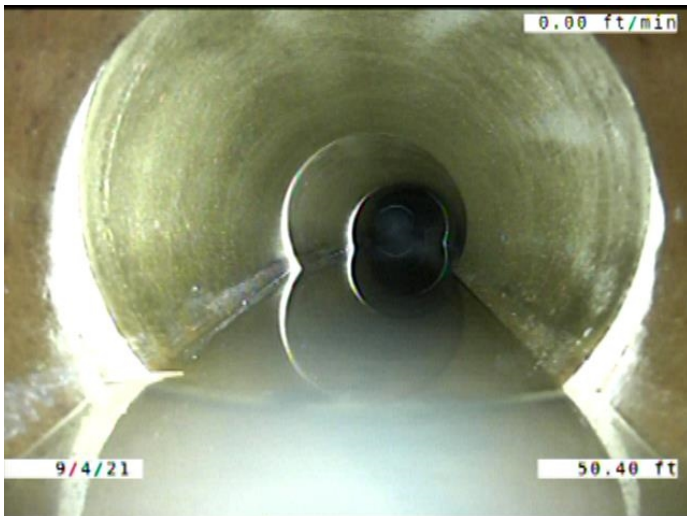
Code: **MWLS**
 Description: **Miscellaneous Water Level Sag**

Distance (ft): **50.4**
 Structural Grade: **2**
 O&M Grade: **0**
 Clock Start/From:
 Clock To:
 1st Value:
 2nd Value:
 Value Percent: **20.000**
 Continuous Index: **S03**
 Within 8" of Joint: **NO**
 Remarks:

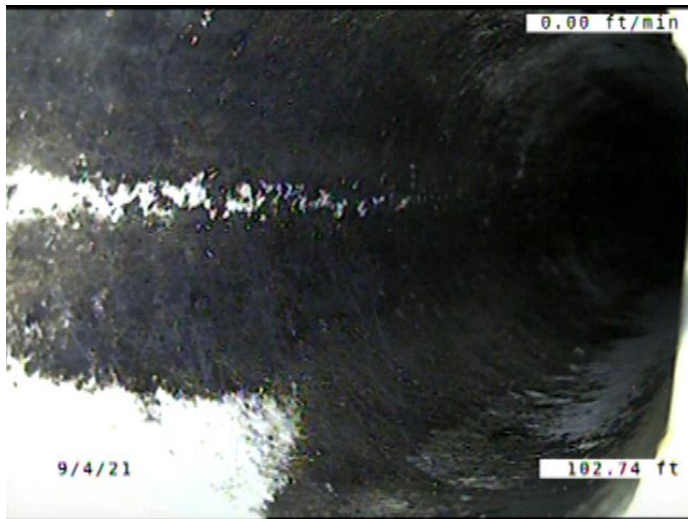
Code: **TFI**
 Description: **Tap Factory Intruding**

Distance (ft): **102.7**
 Structural Grade: **0**
 O&M Grade: **2**
 Clock Start/From: **2**
 Clock To:
 1st Value: **4.000**
 2nd Value: **1.000**
 Value Percent:
 Continuous Index:
 Within 8" of Joint: **NO**
 Remarks:

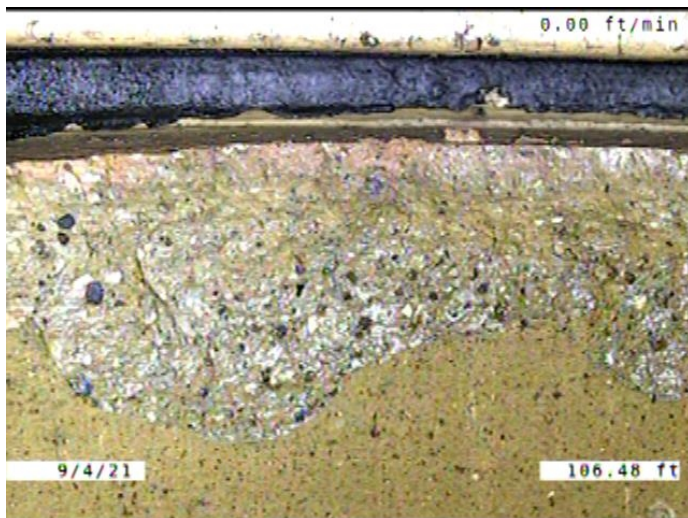
Code: **SZ**
 Description: **Surface Damage Other**

Distance (ft): **106.5**
 Structural Grade: **0**
 O&M Grade: **0**
 Clock Start/From: **10**
 Clock To: **11**
 1st Value:
 2nd Value:
 Value Percent:
 Continuous Index:
 Within 8" of Joint: **YES**
 Remarks: **PART OF THE JOINT CHIPPED AWAY**

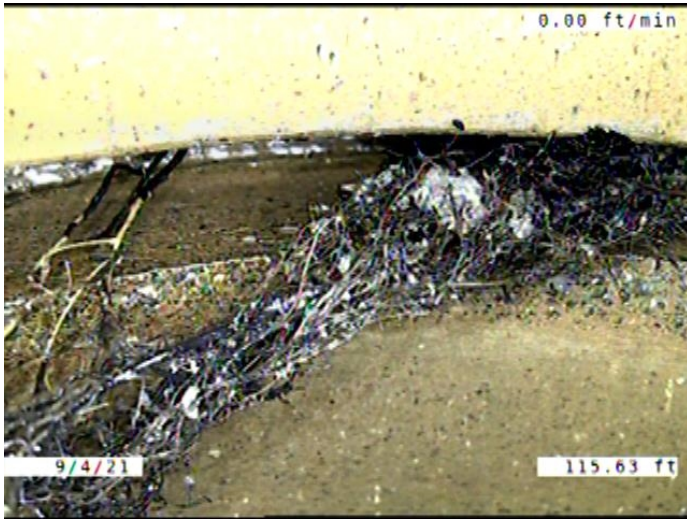
Code: **RFJ**
 Description: **Roots Fine Joint**

Distance (ft): **115.6**
 Structural Grade: **0**
 O&M Grade: **1**
 Clock Start/From: **9**
 Clock To: **12**
 1st Value:
 2nd Value:
 Value Percent:
 Continuous Index:
 Within 8" of Joint: **YES**
 Remarks:

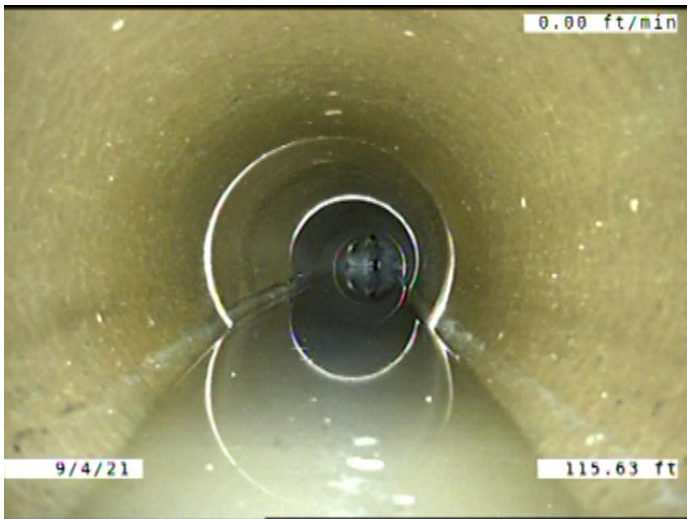
Code: **MWLS**
 Description: **Miscellaneous Water Level Sag**

Distance (ft): **115.6**
 Structural Grade: **2**
 O&M Grade: **0**
 Clock Start/From:
 Clock To:
 1st Value:
 2nd Value:
 Value Percent: **10.000**
 Continuous Index: **S04**
 Within 8" of Joint: **NO**
 Remarks:

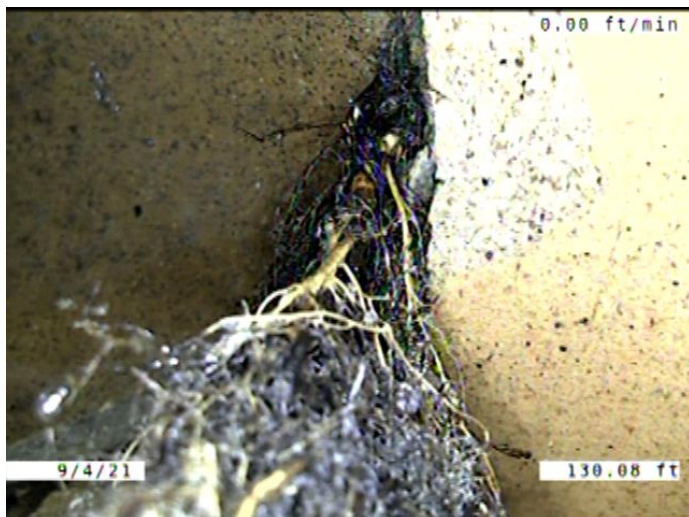
Code: **RMJ**
 Description: **Roots Medium Joint**

Distance (ft): **130.1**
 Structural Grade: **0**
 O&M Grade: **3**
 Clock Start/From: **9**
 Clock To: **12**
 1st Value:
 2nd Value:
 Value Percent: **10.000**
 Continuous Index:
 Within 8" of Joint: **YES**
 Remarks:

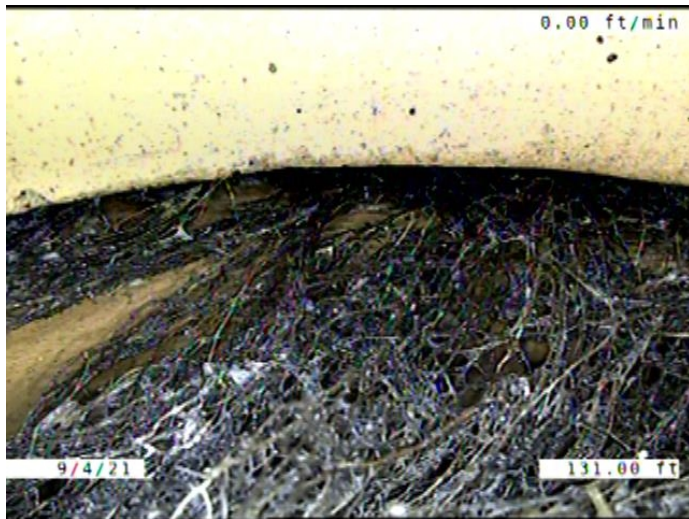
Code: **RMJ**
 Description: **Roots Medium Joint**

Distance (ft): **131.0**
 Structural Grade: **0**
 O&M Grade: **3**
 Clock Start/From: **9**
 Clock To: **3**
 1st Value:
 2nd Value:
 Value Percent: **35.000**
 Continuous Index:
 Within 8" of Joint: **YES**
 Remarks:

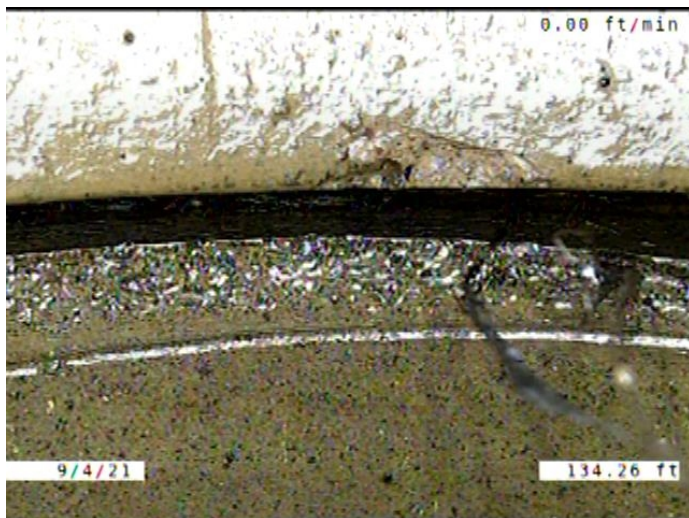
Code: **RFJ**
 Description: **Roots Fine Joint**

Distance (ft): **134.3**
 Structural Grade: **0**
 O&M Grade: **1**
 Clock Start/From: **11**
 Clock To: **1**
 1st Value:
 2nd Value:
 Value Percent:
 Continuous Index:
 Within 8" of Joint: **YES**
 Remarks:

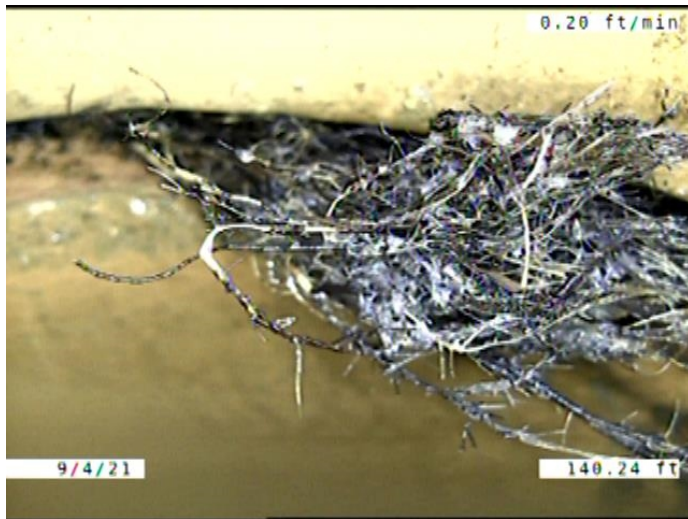
Code: **RFJ**
 Description: **Roots Fine Joint**

Distance (ft): **140.2**
 Structural Grade: **0**
 O&M Grade: **1**
 Clock Start/From: **2**
 Clock To: **3**
 1st Value:
 2nd Value:
 Value Percent:
 Continuous Index:
 Within 8" of Joint: **YES**
 Remarks:

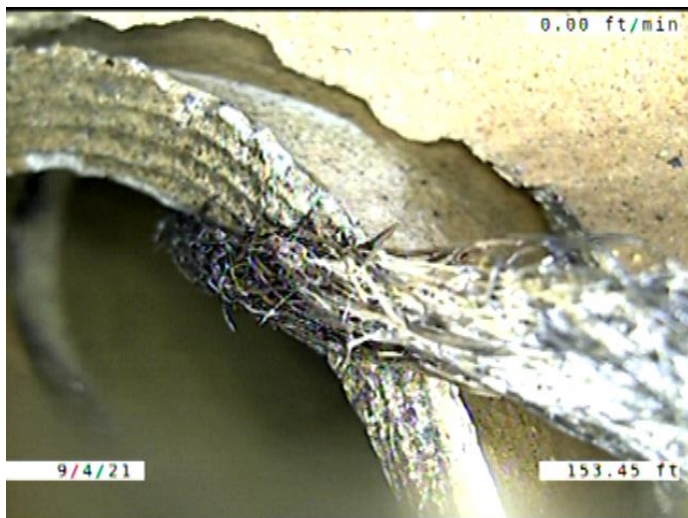
Code: **RFL**
 Description: **Roots Fine Lateral**

Distance (ft): **153.4**
 Structural Grade: **0**
 O&M Grade: **1**
 Clock Start/From: **1**
 Clock To: **3**
 1st Value:
 2nd Value:
 Value Percent:
 Continuous Index:
 Within 8" of Joint: **NO**
 Remarks:

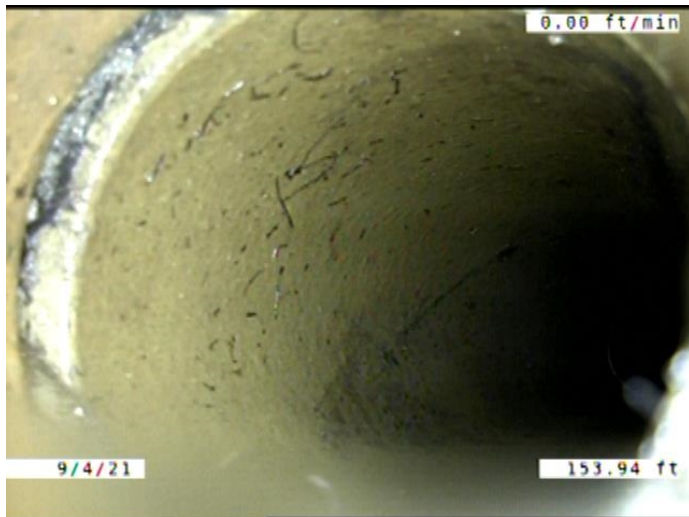
Code: **TBI**
 Description: **Tap Break-in Intruding**

Distance (ft): **153.9**
 Structural Grade: **0**
 O&M Grade: **2**
 Clock Start/From: **2**
 Clock To:
 1st Value: **6.000**
 2nd Value: **3.000**
 Value Percent:
 Continuous Index:
 Within 8" of Joint: **NO**
 Remarks:

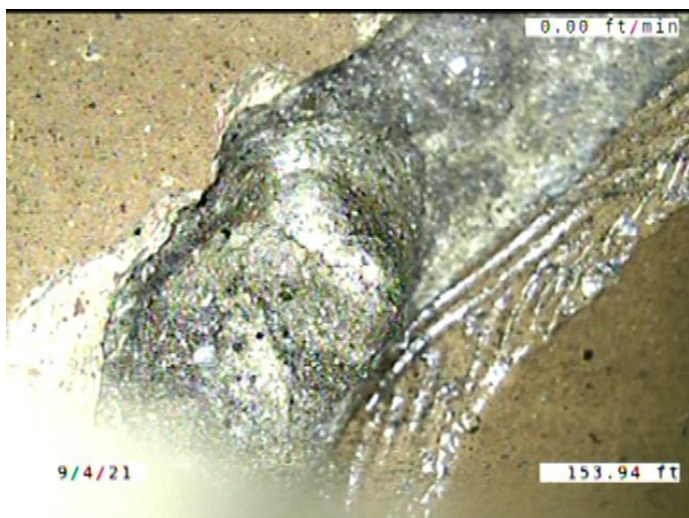
Code: **B**
 Description: **Broken**

Distance (ft): **153.9**
 Structural Grade: **4**
 O&M Grade: **0**
 Clock Start/From: **1**
 Clock To:
 1st Value:
 2nd Value:
 Value Percent:
 Continuous Index:
 Within 8" of Joint: **YES**
 Remarks:

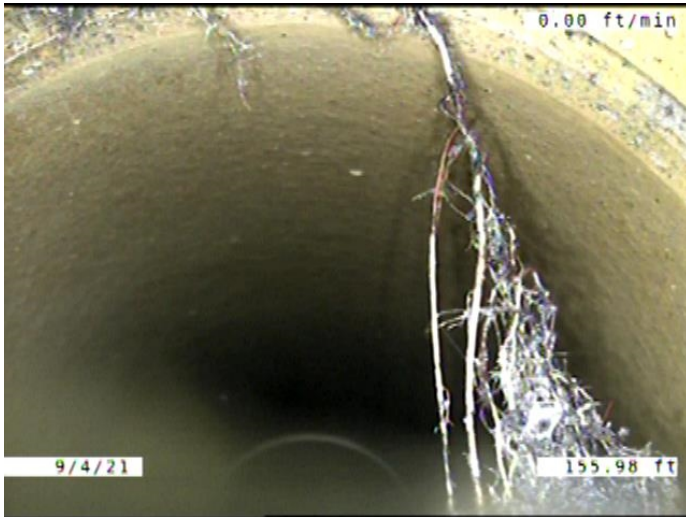
Code: **RMJ**
 Description: **Roots Medium Joint**

Distance (ft): **156.0**
 Structural Grade: **0**
 O&M Grade: **3**
 Clock Start/From: **9**
 Clock To: **1**
 1st Value:
 2nd Value:
 Value Percent: **5.000**
 Continuous Index:
 Within 8" of Joint: **YES**
 Remarks:

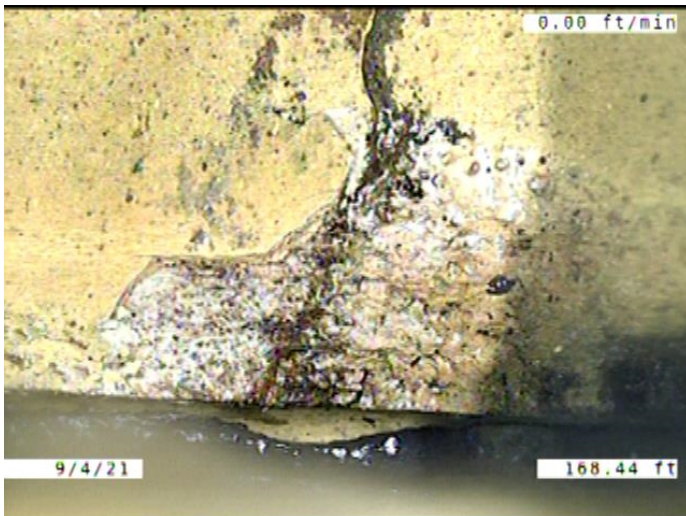
Code: **SSS**
 Description: **Surface Damage Surface Spalling**

Distance (ft): **168.4**
 Structural Grade: **2**
 O&M Grade: **0**
 Clock Start/From: **7**
 Clock To: **9**
 1st Value:
 2nd Value:
 Value Percent:
 Continuous Index:
 Within 8" of Joint: **YES**
 Remarks:

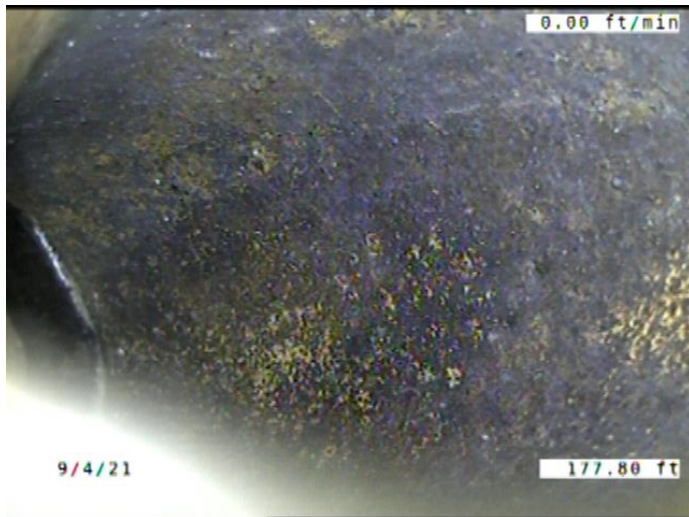
Code:	TBI
Description:	Tap Break-in Intruding
Distance (ft):	177.8
Structural Grade:	0
O&M Grade:	2
Clock Start/From:	11
Clock To:	
1st Value:	6.000
2nd Value:	1.000
Value Percent:	
Continuous Index:	
Within 8" of Joint:	YES
Remarks:	CONSTANTLY RUNNING WATER

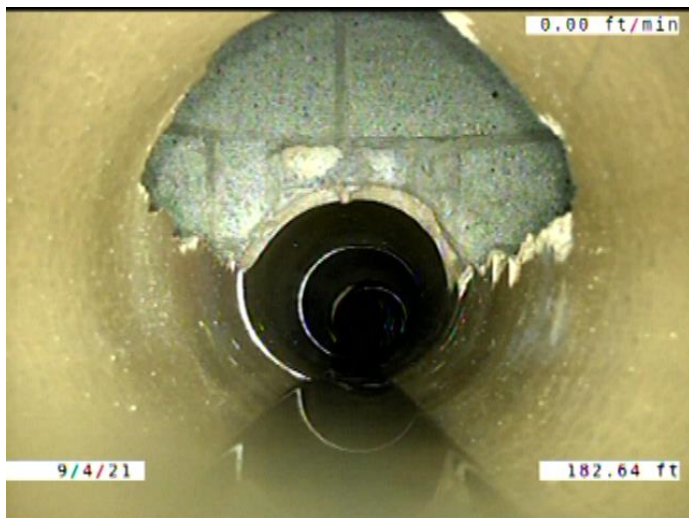
Code:	MWLS
Description:	Miscellaneous Water Level Sag
Distance (ft):	182.6
Structural Grade:	2
O&M Grade:	0
Clock Start/From:	
Clock To:	
1st Value:	
2nd Value:	
Value Percent:	10.000
Continuous Index:	F04
Within 8" of Joint:	NO
Remarks:

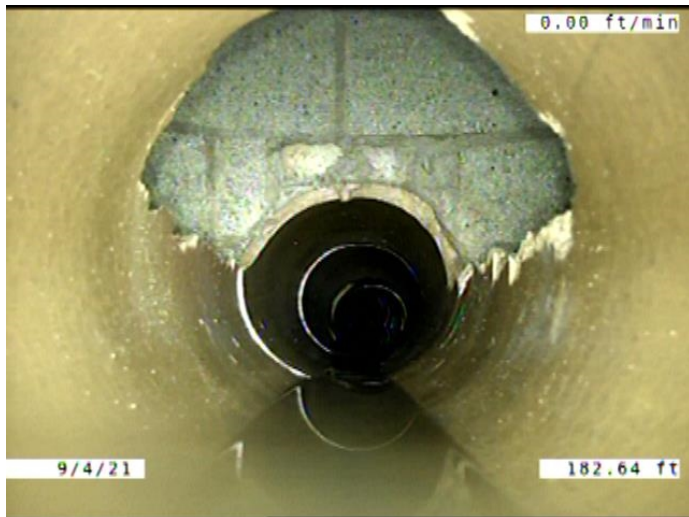
Code: **DSF**
 Description: **Deposits Settled Fine**

Distance (ft): **182.6**
 Structural Grade: **0**
 O&M Grade: **2**
 Clock Start/From: **5**
 Clock To: **7**
 1st Value:
 2nd Value:
 Value Percent: **5.000**
 Continuous Index: **F01**
 Within 8" of Joint: **YES**
 Remarks: **ALSO TP AND RAGS**

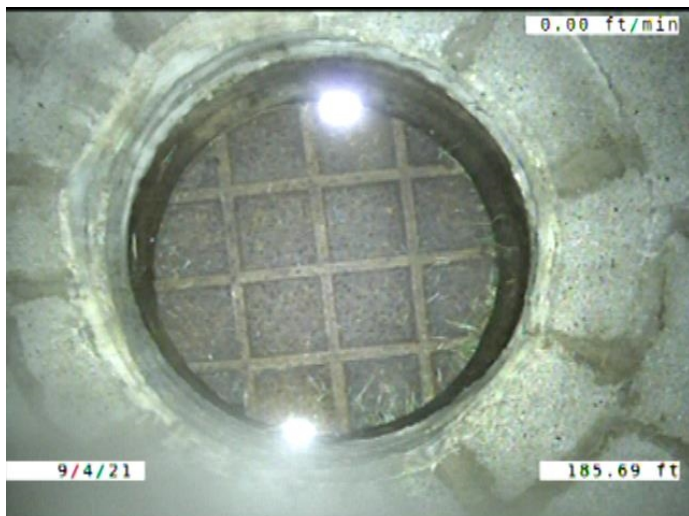
Code: **AMH**
 Description: **Manhole**

Distance (ft): **185.7**
 Structural Grade: **0**
 O&M Grade: **0**
 Clock Start/From:
 Clock To:
 1st Value:
 2nd Value:
 Value Percent:
 Continuous Index:
 Within 8" of Joint: **NO**
 Remarks: **M-404-021**
