Profile/Photo Observation Report

Date:	09/04/2021	Weather:		Coding:	PACP 7.0
Pipe Length (ft):	185.7	Owner:	City of Hobart	Pre Clean:	Heavy Cleaning
P.O.#:	YES502259	Surveyor:	S. Bucklin	PSR:	P-404-020-021
Customer:	City of Hobart	Clean Date:	09/04/2021	Shape:	C

Street:	North Wabash Street	Flow Control:	Not Controlled
City:	Hobart, IN	Year Renewed:	
Location:	Alley	Tape/Media #:	
Purpose:	Routine Assessment	Dia/Height:	10"
Use:	Sanitary Sewage Pipe	Material:	VCP
Drain Area:		Lining:	
Category:	NA		
Comment:

Location Details:		Direction of Survey:	Downstream
US MH:	M-404-020	DS MH:	M-404-021
		Total Length Surveyed (ft):	185.7

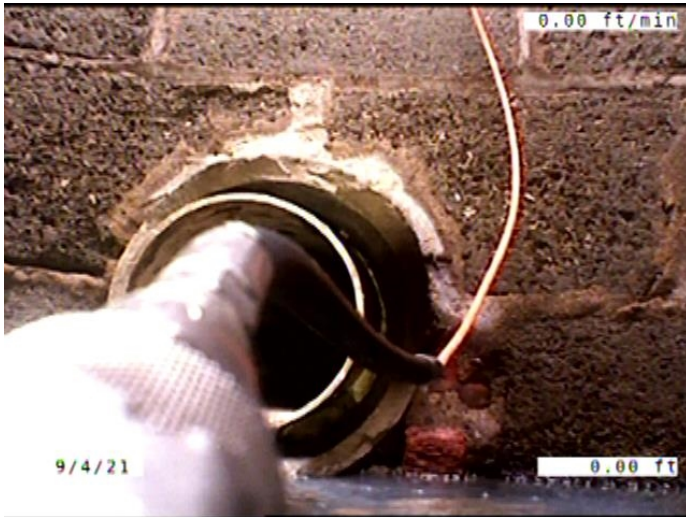
Code: **AMH**
 Description: **Manhole**

Distance (ft): **.0**
 Structural Grade: **0**
 O&M Grade: **0**
 Clock Start/From:
 Clock To:
 1st Value:
 2nd Value:
 Value Percent:
 Continuous Index:
 Within 8" of Joint: **NO**
 Remarks: **M-404-020**

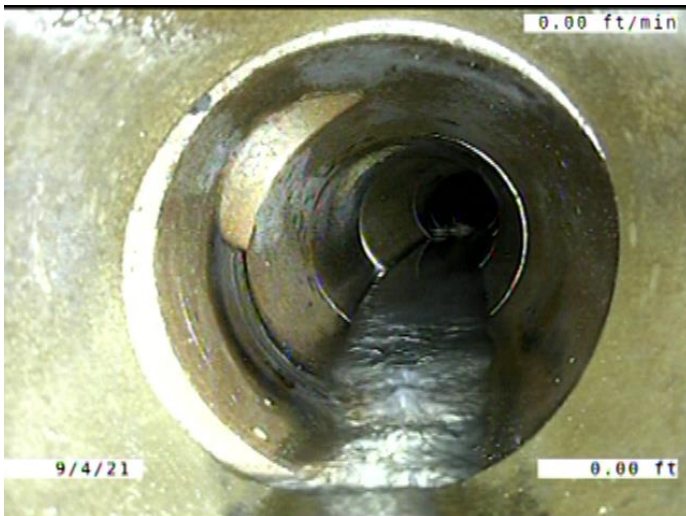
Code: **MWL**
 Description: **Miscellaneous Water Level**

Distance (ft): **.0**
 Structural Grade: **0**
 O&M Grade: **0**
 Clock Start/From:
 Clock To:
 1st Value:
 2nd Value:
 Value Percent: **5.000**
 Continuous Index:
 Within 8" of Joint: **NO**
 Remarks:

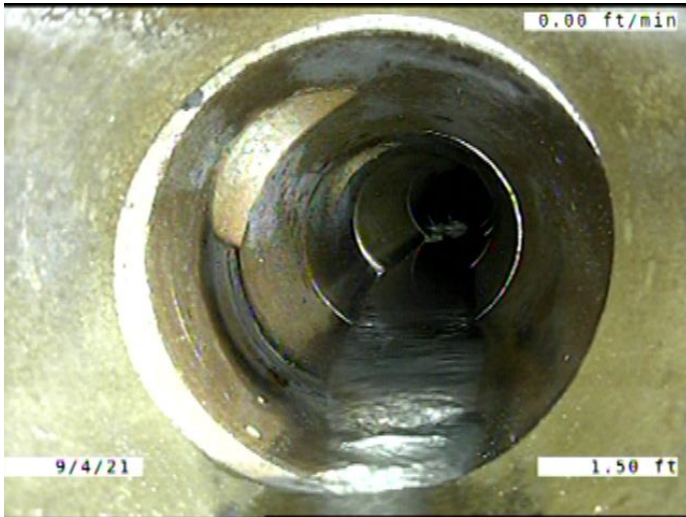
Code: **MGO**
 Description: **Miscellaneous General Observation**

Distance (ft): **1.5**
 Structural Grade: **0**
 O&M Grade: **0**
 Clock Start/From:
 Clock To:
 1st Value:
 2nd Value:
 Value Percent:
 Continuous Index:
 Within 8" of Joint: **NO**
 Remarks: **DROP INTO THE MANHOLE. HAD TO START IN THE PIPE.**

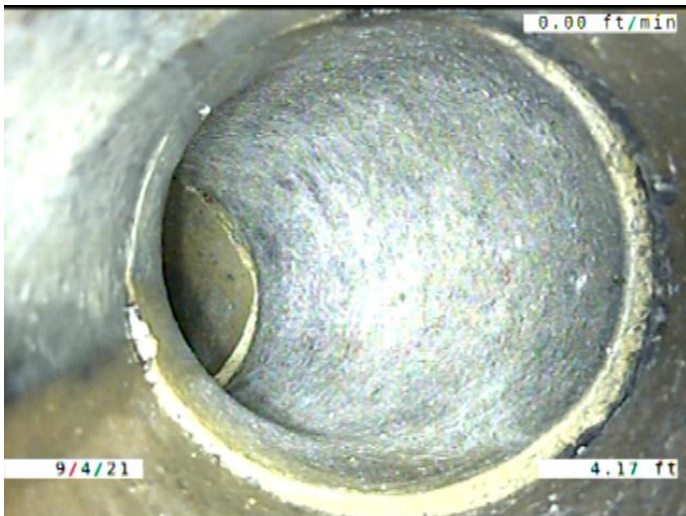
Code: **TF**
 Description: **Tap Factory**

Distance (ft): **4.2**
 Structural Grade: **0**
 O&M Grade: **0**
 Clock Start/From: **10**
 Clock To:
 1st Value: **6.000**
 2nd Value:
 Value Percent:
 Continuous Index:
 Within 8" of Joint: **YES**
 Remarks:

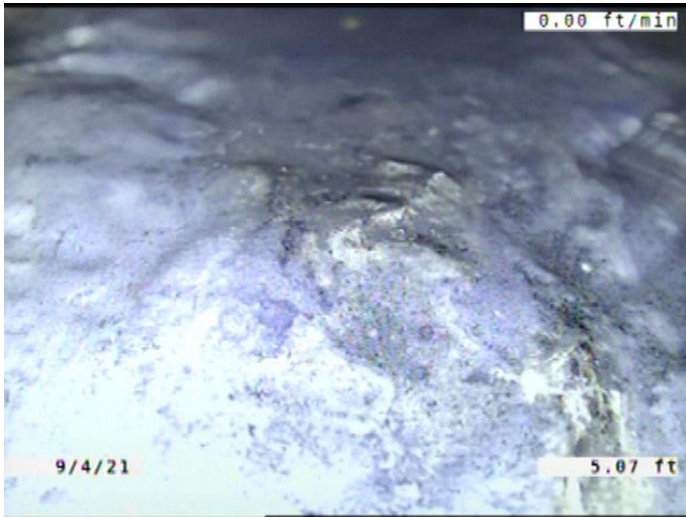
Code: **DSF**
 Description: **Deposits Settled Fine**

Distance (ft): **5.1**
 Structural Grade: **0**
 O&M Grade: **2**
 Clock Start/From: **5**
 Clock To: **7**
 1st Value:
 2nd Value:
 Value Percent: **5.000**
 Continuous Index: **S01**
 Within 8" of Joint: **YES**
 Remarks: **ALSO TP AND RAGS**

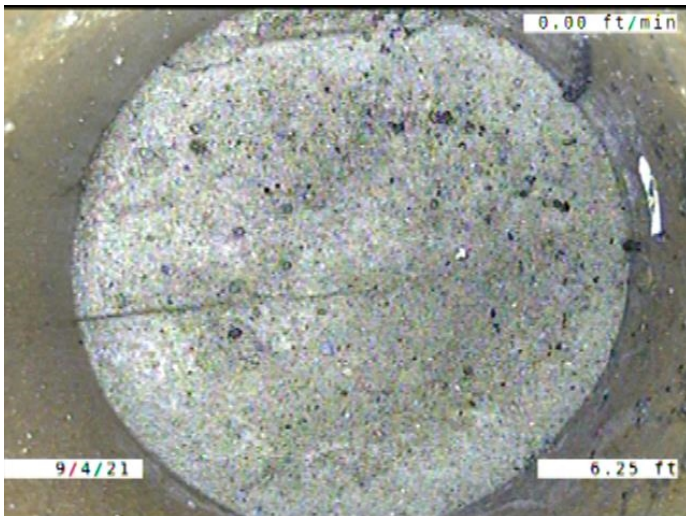
Code: **TFC**
 Description: **Tap Factory Capped**

Distance (ft): **6.2**
 Structural Grade: **0**
 O&M Grade: **0**
 Clock Start/From: **11**
 Clock To:
 1st Value: **6.000**
 2nd Value:
 Value Percent:
 Continuous Index:
 Within 8" of Joint: **YES**
 Remarks:

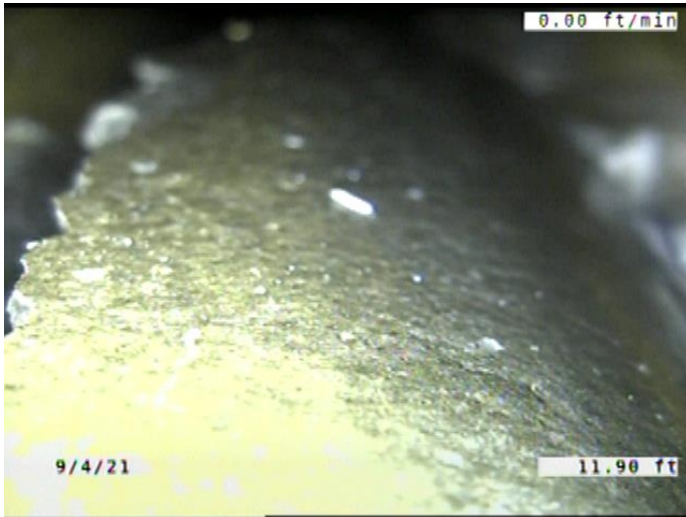
Code: **OBM**
 Description: **Obstruction Pipe Material in Invert**

Distance (ft): **11.9**
 Structural Grade: **0**
 O&M Grade: **2**
 Clock Start/From: **4**
 Clock To: **8**
 1st Value:
 2nd Value:
 Value Percent: **10.000**
 Continuous Index:
 Within 8" of Joint: **YES**
 Remarks:

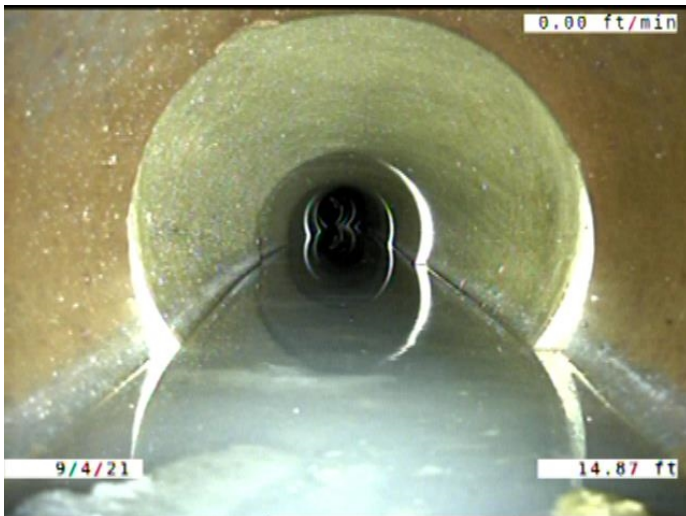
Code: **MWLS**
 Description: **Miscellaneous Water Level Sag**

Distance (ft): **14.9**
 Structural Grade: **2**
 O&M Grade: **0**
 Clock Start/From:
 Clock To:
 1st Value:
 2nd Value:
 Value Percent: **10.000**
 Continuous Index: **S02**
 Within 8" of Joint: **NO**
 Remarks:

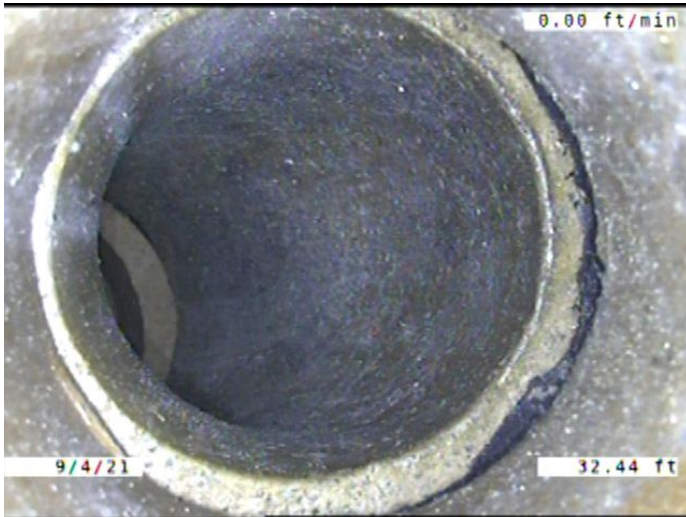
Code: **TF**
 Description: **Tap Factory**

Distance (ft): **32.4**
 Structural Grade: **0**
 O&M Grade: **0**
 Clock Start/From: **10**
 Clock To:
 1st Value: **6.000**
 2nd Value:
 Value Percent:
 Continuous Index:
 Within 8" of Joint: **YES**
 Remarks:

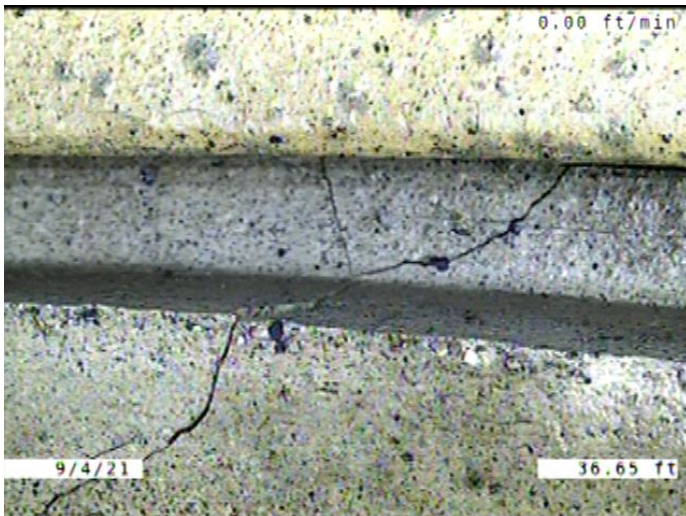
Code: **CM**
 Description: **Crack Multiple**

Distance (ft): **36.6**
 Structural Grade: **3**
 O&M Grade: **0**
 Clock Start/From: **12**
 Clock To: **3**
 1st Value:
 2nd Value:
 Value Percent:
 Continuous Index:
 Within 8" of Joint: **YES**
 Remarks:

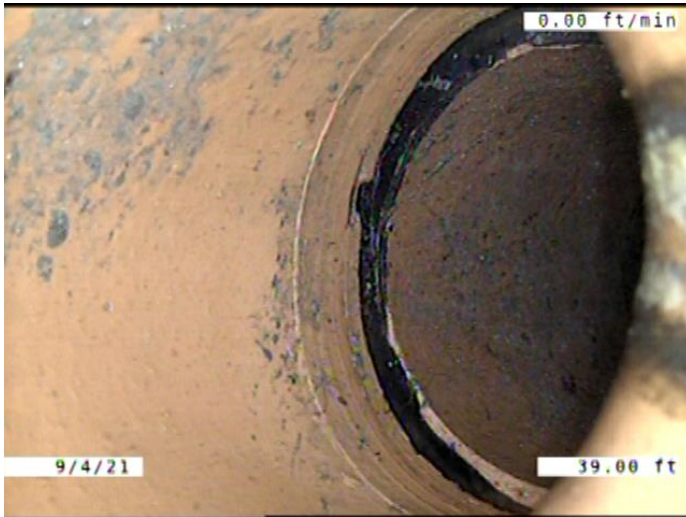
Code: **TB**
Description: **Tap Break-in/Hammer**

Distance (ft): **39.0**
Structural Grade: **0**
O&M Grade: **0**
Clock Start/From: **1**
Clock To:
1st Value: **6.000**
2nd Value:
Value Percent:
Continuous Index:
Within 8" of Joint: **YES**
Remarks:

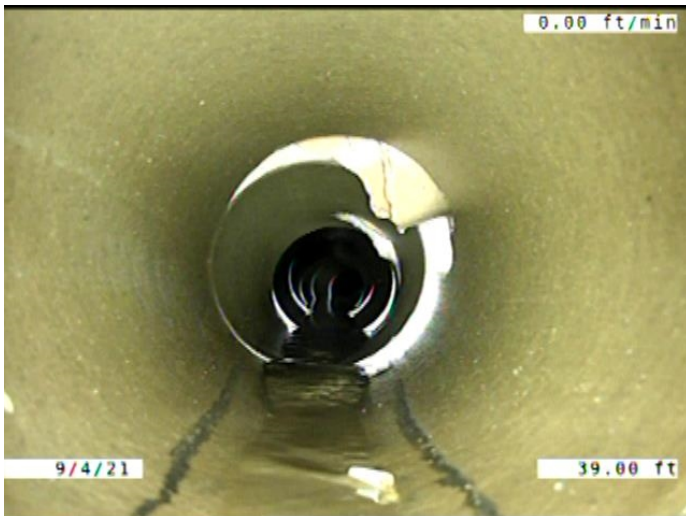
Code: **MWLS**
Description: **Miscellaneous Water Level Sag**

Distance (ft): **39.0**
Structural Grade: **2**
O&M Grade: **0**
Clock Start/From:
Clock To:
1st Value:
2nd Value:
Value Percent: **10.000**
Continuous Index: **F02**
Within 8" of Joint: **NO**
Remarks:

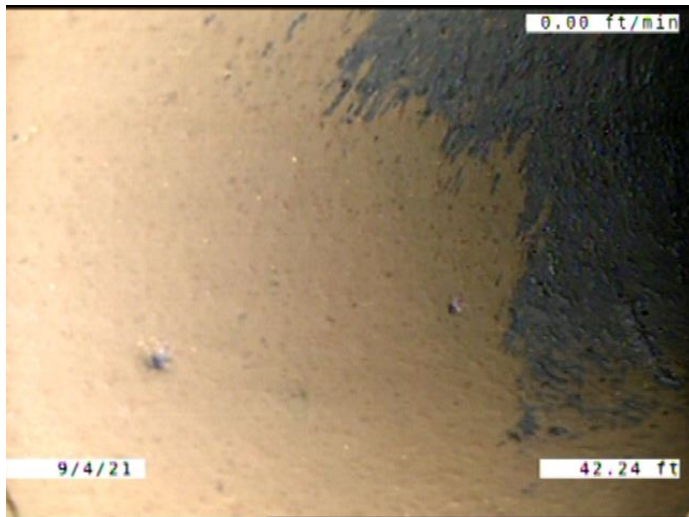
Code: **TBI**
 Description: **Tap Break-in Intruding**

Distance (ft): **42.2**
 Structural Grade: **0**
 O&M Grade: **2**
 Clock Start/From: **1**
 Clock To:
 1st Value: **6.000**
 2nd Value: **3.000**
 Value Percent:
 Continuous Index:
 Within 8" of Joint: **YES**
 Remarks:

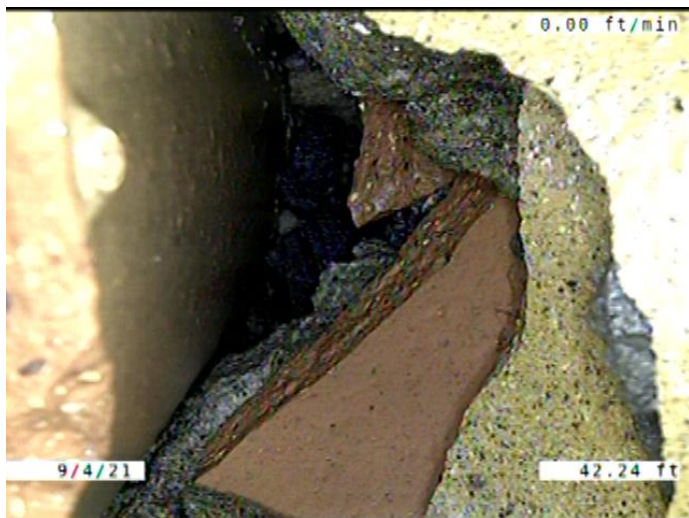
Code: **BSV**
 Description: **Broken Soil Visible**

Distance (ft): **42.2**
 Structural Grade: **5**
 O&M Grade: **0**
 Clock Start/From: **10**
 Clock To: **3**
 1st Value:
 2nd Value:
 Value Percent:
 Continuous Index:
 Within 8" of Joint: **YES**
 Remarks:

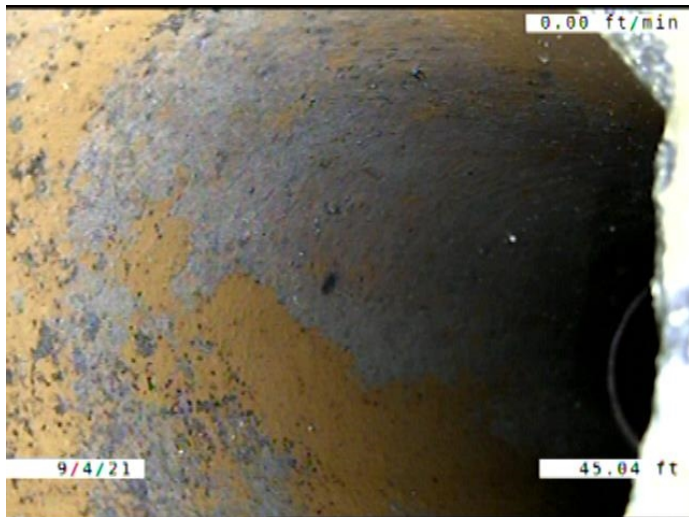
Code: **TBI**
 Description: **Tap Break-in Intruding**

Distance (ft): **45.0**
 Structural Grade: **0**
 O&M Grade: **2**
 Clock Start/From: **2**
 Clock To:
 1st Value: **6.000**
 2nd Value: **1.000**
 Value Percent:
 Continuous Index:
 Within 8" of Joint: **YES**
 Remarks:

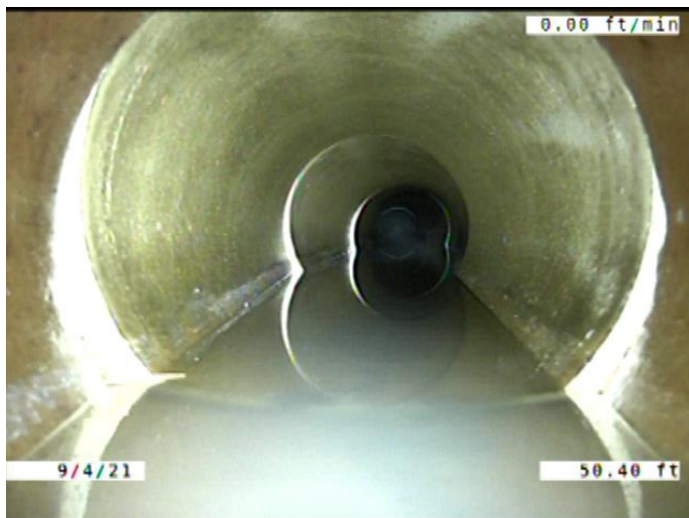
Code: **MWLS**
 Description: **Miscellaneous Water Level Sag**

Distance (ft): **50.4**
 Structural Grade: **2**
 O&M Grade: **0**
 Clock Start/From:
 Clock To:
 1st Value:
 2nd Value:
 Value Percent: **20.000**
 Continuous Index: **S03**
 Within 8" of Joint: **NO**
 Remarks:

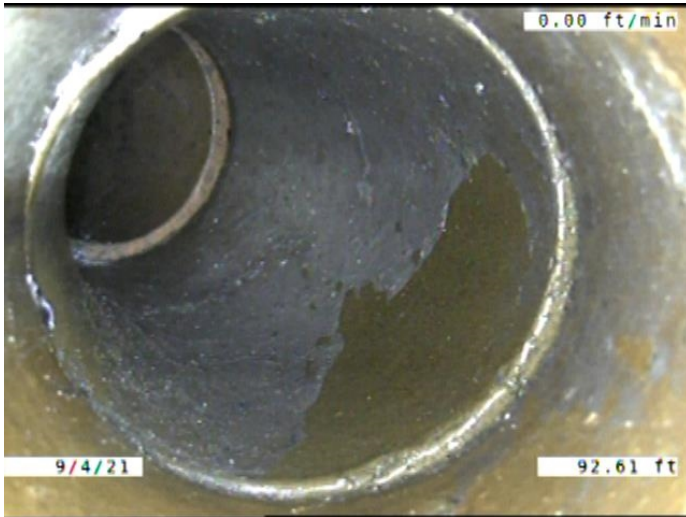
Code: **TF**
 Description: **Tap Factory**

Distance (ft): **92.6**
 Structural Grade: **0**
 O&M Grade: **0**
 Clock Start/From: **11**
 Clock To:
 1st Value: **6.000**
 2nd Value:
 Value Percent:
 Continuous Index:
 Within 8" of Joint: **YES**
 Remarks:

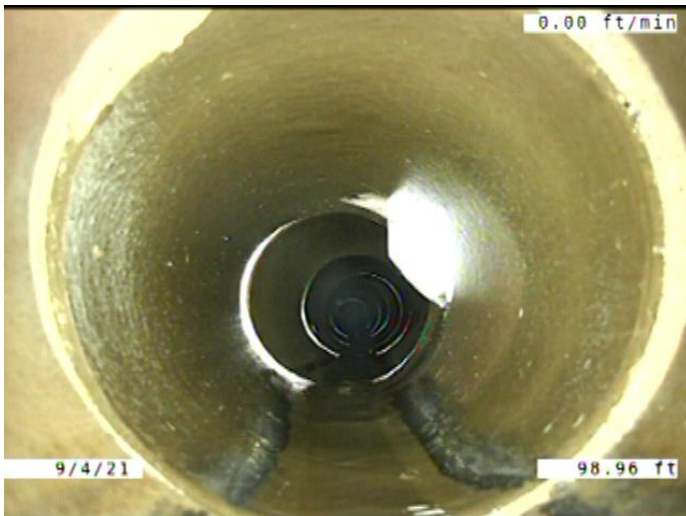
Code: **MWLS**
 Description: **Miscellaneous Water Level Sag**

Distance (ft): **99.0**
 Structural Grade: **2**
 O&M Grade: **0**
 Clock Start/From:
 Clock To:
 1st Value:
 2nd Value:
 Value Percent: **20.000**
 Continuous Index: **F03**
 Within 8" of Joint: **NO**
 Remarks:

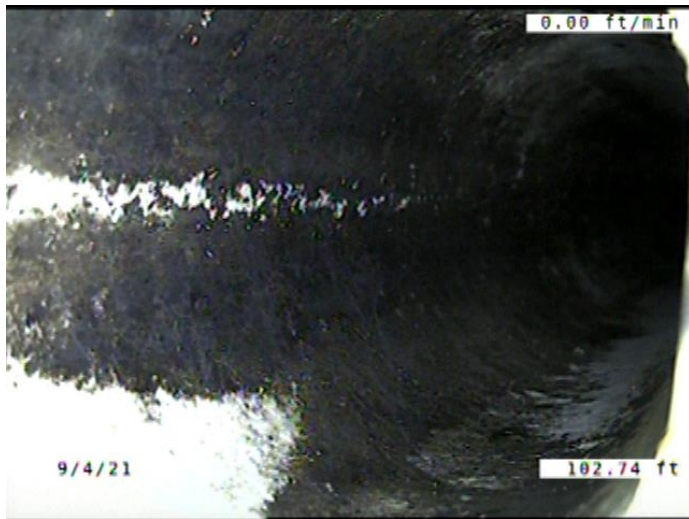
Code: **TFI**
 Description: **Tap Factory Intruding**

Distance (ft): **102.7**
 Structural Grade: **0**
 O&M Grade: **2**
 Clock Start/From: **2**
 Clock To:
 1st Value: **4.000**
 2nd Value: **1.000**
 Value Percent:
 Continuous Index:
 Within 8" of Joint: **NO**
 Remarks:

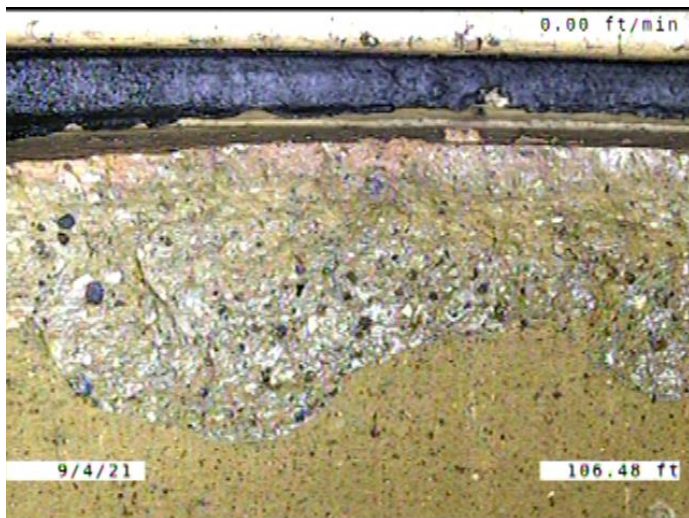
Code: **SZ**
 Description: **Surface Damage Other**

Distance (ft): **106.5**
 Structural Grade: **0**
 O&M Grade: **0**
 Clock Start/From: **10**
 Clock To: **11**
 1st Value:
 2nd Value:
 Value Percent:
 Continuous Index:
 Within 8" of Joint: **YES**
 Remarks: **PART OF THE JOINT CHIPPED AWAY**

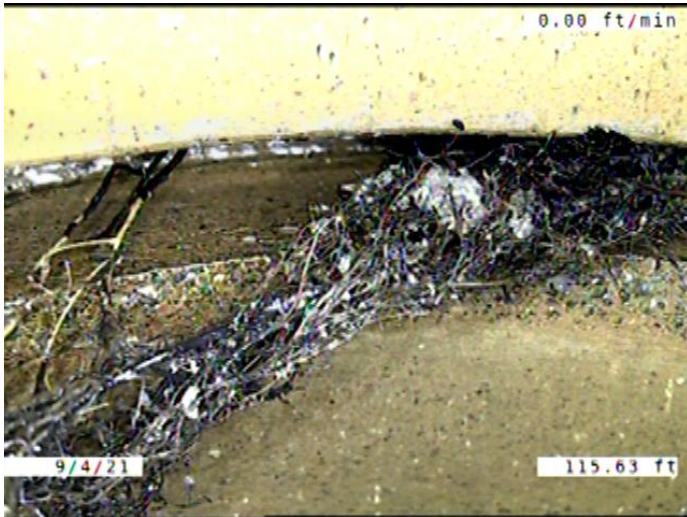
Code: **RFJ**
 Description: **Roots Fine Joint**

Distance (ft): **115.6**
 Structural Grade: **0**
 O&M Grade: **1**
 Clock Start/From: **9**
 Clock To: **12**
 1st Value:
 2nd Value:
 Value Percent:
 Continuous Index:
 Within 8" of Joint: **YES**
 Remarks:

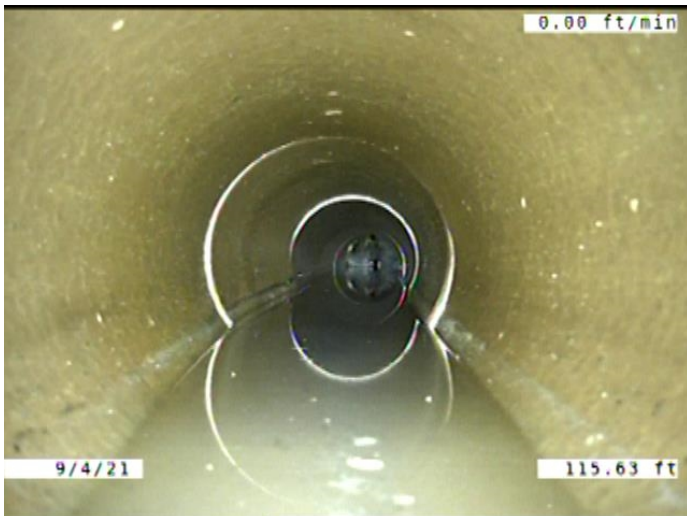
Code: **MWLS**
 Description: **Miscellaneous Water Level Sag**

Distance (ft): **115.6**
 Structural Grade: **2**
 O&M Grade: **0**
 Clock Start/From:
 Clock To:
 1st Value:
 2nd Value:
 Value Percent: **10.000**
 Continuous Index: **S04**
 Within 8" of Joint: **NO**
 Remarks:

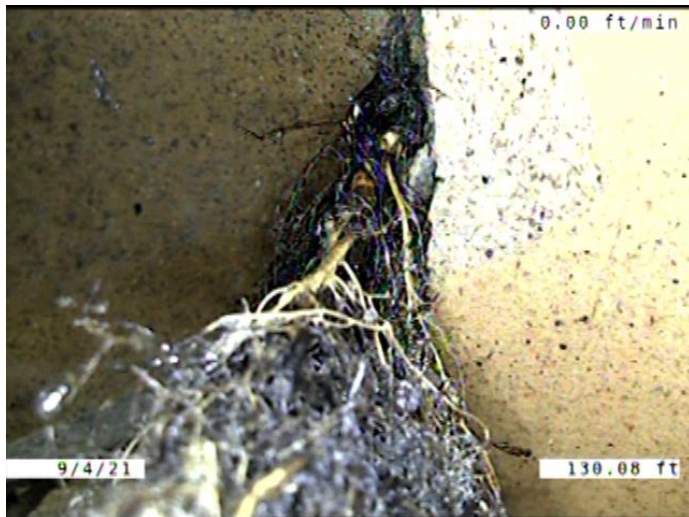
Code: **RMJ**
 Description: **Roots Medium Joint**

Distance (ft): **130.1**
 Structural Grade: **0**
 O&M Grade: **3**
 Clock Start/From: **9**
 Clock To: **12**
 1st Value:
 2nd Value:
 Value Percent: **10.000**
 Continuous Index:
 Within 8" of Joint: **YES**
 Remarks:

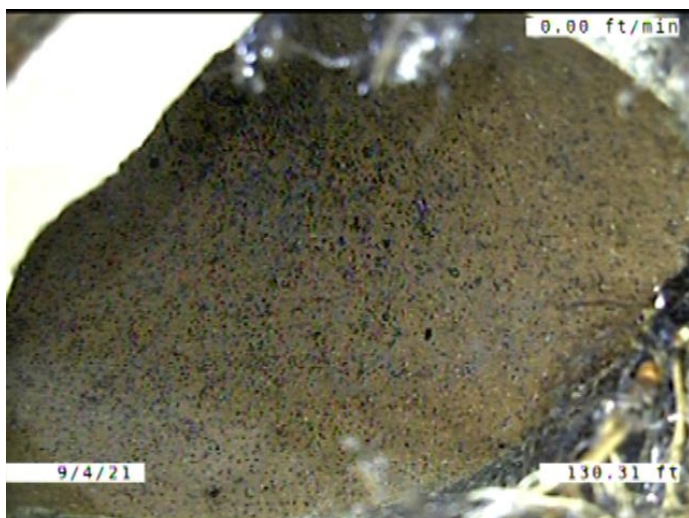
Code: **TBI**
 Description: **Tap Break-in Intruding**

Distance (ft): **130.3**
 Structural Grade: **0**
 O&M Grade: **2**
 Clock Start/From: **11**
 Clock To:
 1st Value: **6.000**
 2nd Value: **1.000**
 Value Percent:
 Continuous Index:
 Within 8" of Joint: **YES**
 Remarks:

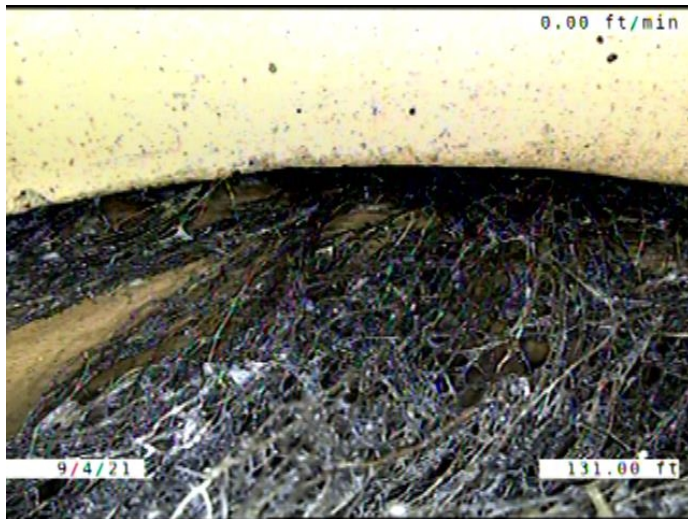
Code: **RMJ**
 Description: **Roots Medium Joint**

Distance (ft): **131.0**
 Structural Grade: **0**
 O&M Grade: **3**
 Clock Start/From: **9**
 Clock To: **3**
 1st Value:
 2nd Value:
 Value Percent: **35.000**
 Continuous Index:
 Within 8" of Joint: **YES**
 Remarks:

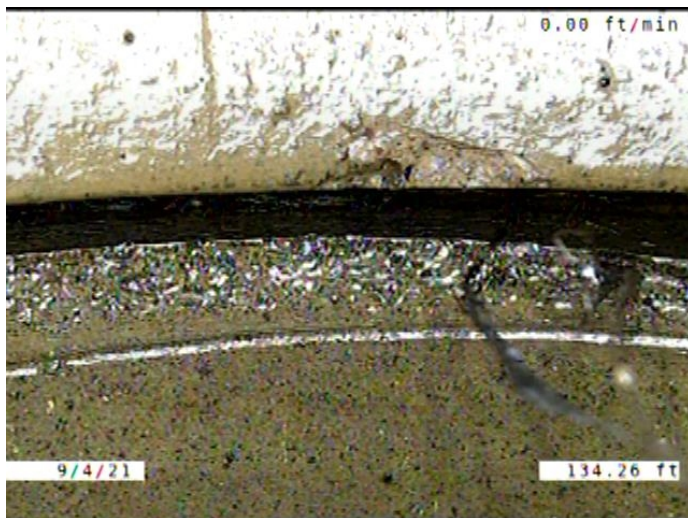
Code: **RFJ**
 Description: **Roots Fine Joint**

Distance (ft): **134.3**
 Structural Grade: **0**
 O&M Grade: **1**
 Clock Start/From: **11**
 Clock To: **1**
 1st Value:
 2nd Value:
 Value Percent:
 Continuous Index:
 Within 8" of Joint: **YES**
 Remarks:

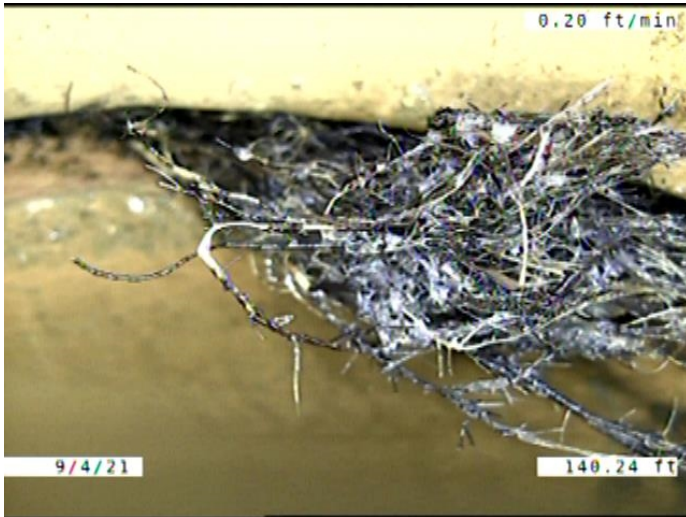
Code: **RFJ**
 Description: **Roots Fine Joint**

Distance (ft): **140.2**
 Structural Grade: **0**
 O&M Grade: **1**
 Clock Start/From: **2**
 Clock To: **3**
 1st Value:
 2nd Value:
 Value Percent:
 Continuous Index:
 Within 8" of Joint: **YES**
 Remarks:

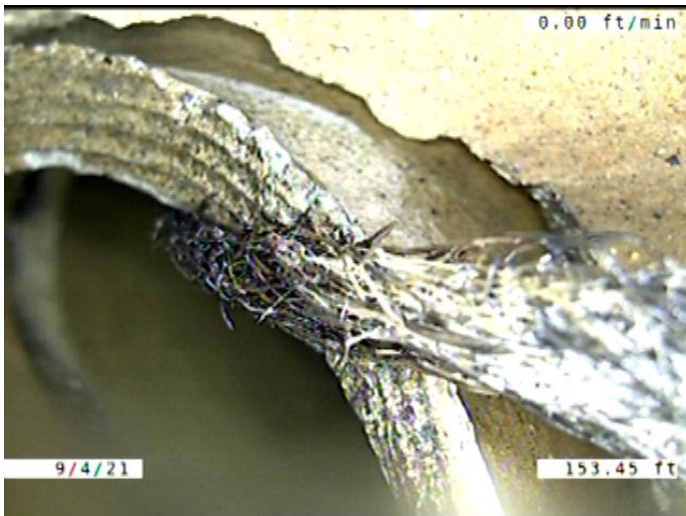
Code: **RFL**
 Description: **Roots Fine Lateral**

Distance (ft): **153.4**
 Structural Grade: **0**
 O&M Grade: **1**
 Clock Start/From: **1**
 Clock To: **3**
 1st Value:
 2nd Value:
 Value Percent:
 Continuous Index:
 Within 8" of Joint: **NO**
 Remarks:

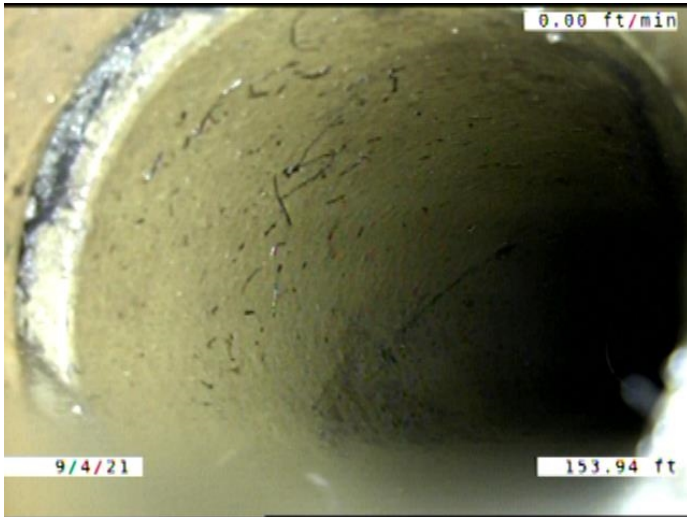
Code: **TBI**
 Description: **Tap Break-in Intruding**

Distance (ft): **153.9**
 Structural Grade: **0**
 O&M Grade: **2**
 Clock Start/From: **2**
 Clock To:
 1st Value: **6.000**
 2nd Value: **3.000**
 Value Percent:
 Continuous Index:
 Within 8" of Joint: **NO**
 Remarks:

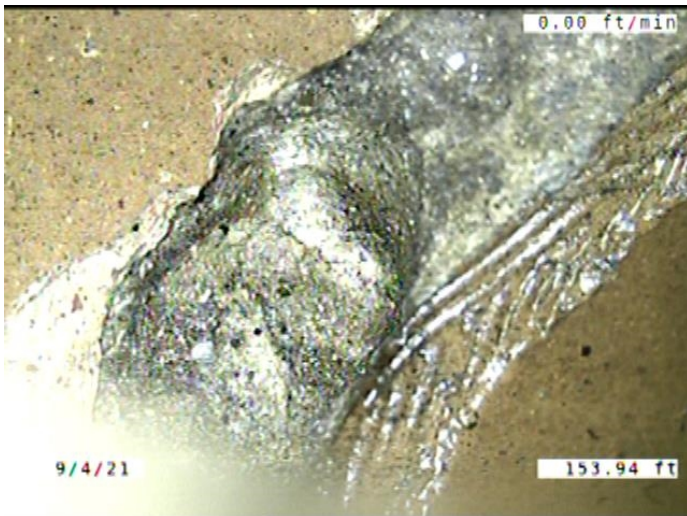
Code: **B**
 Description: **Broken**

Distance (ft): **153.9**
 Structural Grade: **4**
 O&M Grade: **0**
 Clock Start/From: **1**
 Clock To:
 1st Value:
 2nd Value:
 Value Percent:
 Continuous Index:
 Within 8" of Joint: **YES**
 Remarks:

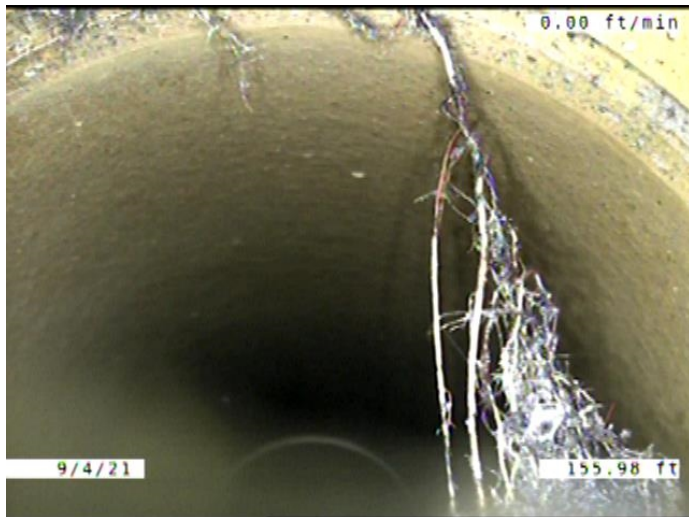
Code: **RMJ**
 Description: **Roots Medium Joint**

Distance (ft): **156.0**
 Structural Grade: **0**
 O&M Grade: **3**
 Clock Start/From: **9**
 Clock To: **1**
 1st Value:
 2nd Value:
 Value Percent: **5.000**
 Continuous Index:
 Within 8" of Joint: **YES**
 Remarks:

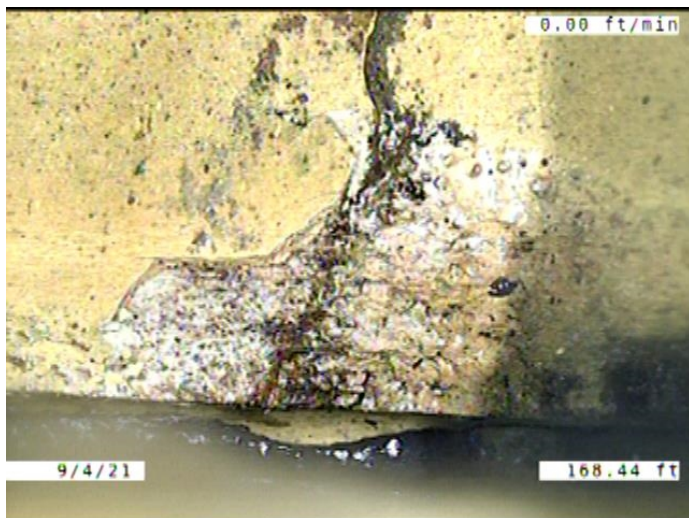
Code: **SSS**
 Description: **Surface Damage Surface Spalling**

Distance (ft): **168.4**
 Structural Grade: **2**
 O&M Grade: **0**
 Clock Start/From: **7**
 Clock To: **9**
 1st Value:
 2nd Value:
 Value Percent:
 Continuous Index:
 Within 8" of Joint: **YES**
 Remarks:

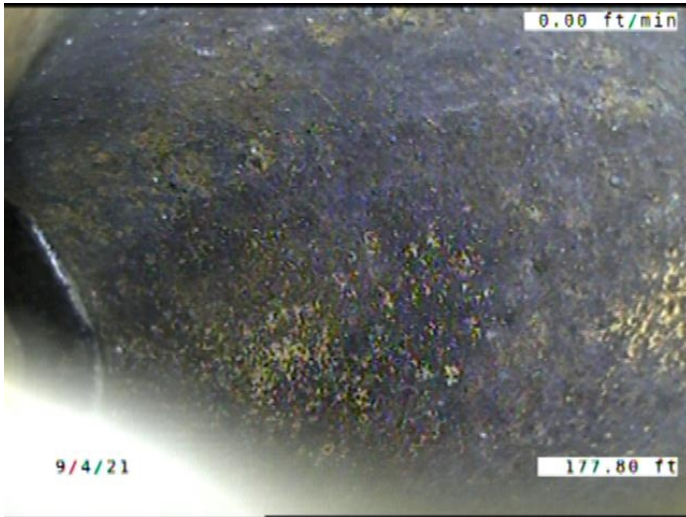
Code: **TBI**
Description: **Tap Break-in Intruding**

Distance (ft): **177.8**
Structural Grade: **0**
O&M Grade: **2**
Clock Start/From: **11**
Clock To:
1st Value: **6.000**
2nd Value: **1.000**
Value Percent:
Continuous Index:
Within 8" of Joint: **YES**
Remarks: **CONSTANTLY RUNNING WATER**

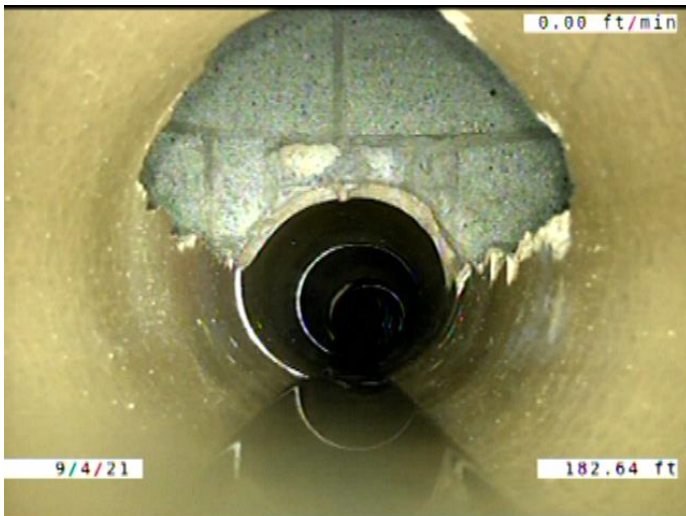
Code: **MWLS**
Description: **Miscellaneous Water Level Sag**

Distance (ft): **182.6**
Structural Grade: **2**
O&M Grade: **0**
Clock Start/From:
Clock To:
1st Value:
2nd Value:
Value Percent: **10.000**
Continuous Index: **F04**
Within 8" of Joint: **NO**
Remarks:

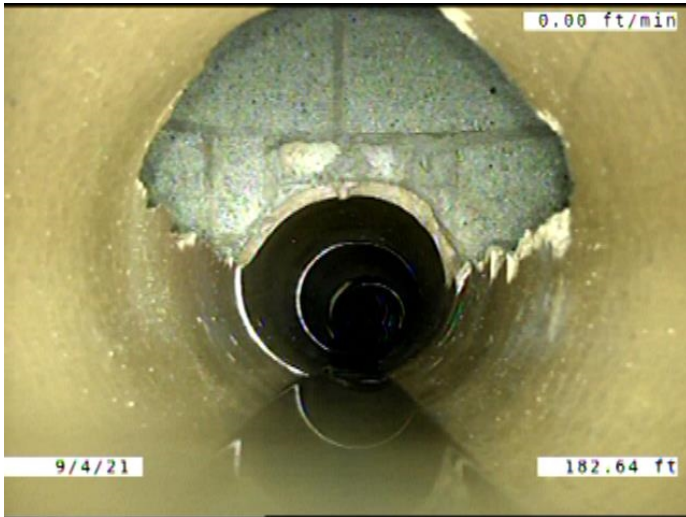
Code: **DSF**
 Description: **Deposits Settled Fine**

Distance (ft): **182.6**
 Structural Grade: **0**
 O&M Grade: **2**
 Clock Start/From: **5**
 Clock To: **7**
 1st Value:
 2nd Value:
 Value Percent: **5.000**
 Continuous Index: **F01**
 Within 8" of Joint: **YES**
 Remarks: **ALSO TP AND RAGS**

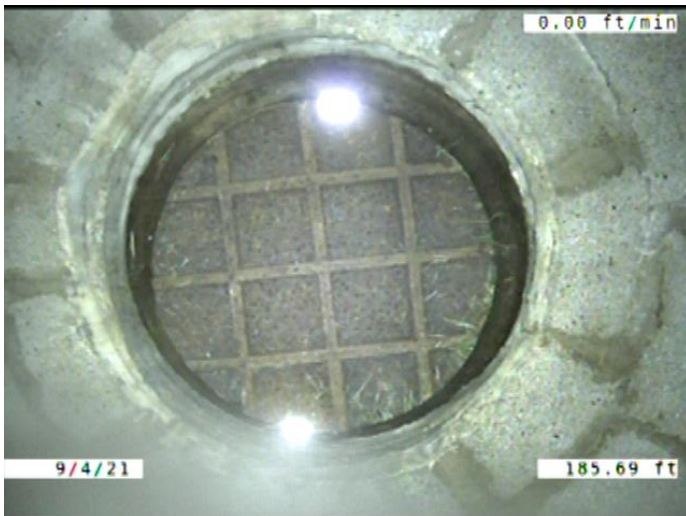
Code: **AMH**
 Description: **Manhole**

Distance (ft): **185.7**
 Structural Grade: **0**
 O&M Grade: **0**
 Clock Start/From:
 Clock To:
 1st Value:
 2nd Value:
 Value Percent:
 Continuous Index:
 Within 8" of Joint: **NO**
 Remarks: **M-404-021**
