Profile/Photo Observation Report

Street:	ALLEY BETWEEN N WABASH ST & N	Flow Control:	Not Controlled
City:	Hobart, IN	Year Renewed:	
Location:	Light Highway	Tape/Media #:	
Purpose:	Not Known	Dia/Height:	10"
Use:	Sanitary	Material:	VCP
Drain Area:	NA	Lining:	
Category:	NA		
Comment:

Location Details:		Direction of Survey:	Downstream
US MH:	M-404-022	DS MH:	M-404-023
		Total Length Surveyed (ft):	90.7

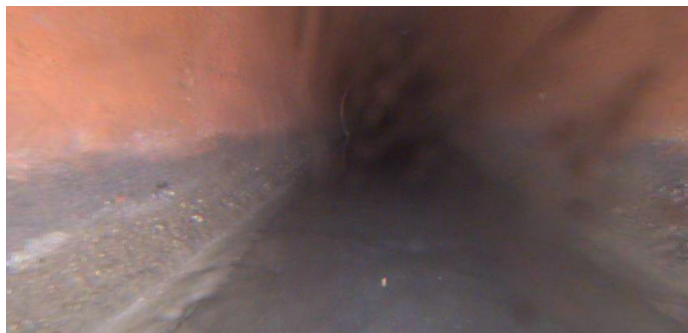
Code: **AMH**
 Description: **Manhole**
 Distance (ft): **.0**
 Structural Grade: **0**
 O&M Grade: **0**
 Clock Start/From:
 Clock To:
 1st Value:
 2nd Value:
 Value Percent:
 Continuous Index:
 Within 8" of Joint: **NO**
 Remarks: **M-404-022**

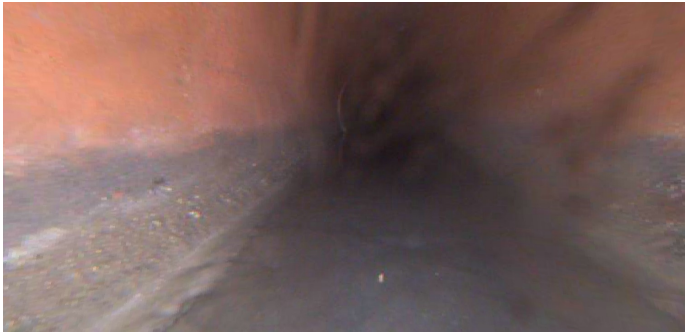
Code:	MWL
Description:	Water Level

Distance (ft):	.0
Structural Grade:	0
O&M Grade:	0
Clock Start/From:	
Clock To:	
1st Value:	
2nd Value:	
Value Percent:	5.000
Continuous Index:	
Within 8" of Joint:	NO
Remarks:

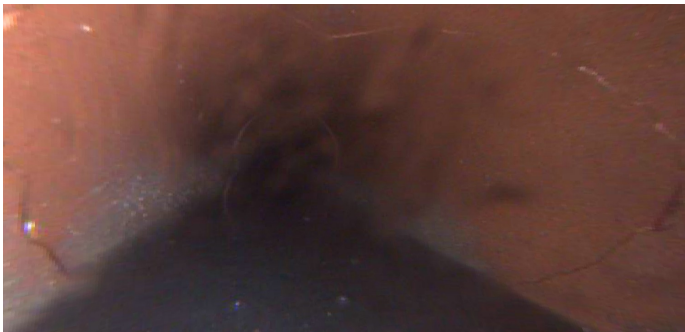
Code:	FC
Description:	Fracture Circumferential

Distance (ft):	14.5
Structural Grade:	2
O&M Grade:	0
Clock Start/From:	8
Clock To:	4
1st Value:	
2nd Value:	
Value Percent:	
Continuous Index:	
Within 8" of Joint:	
Remarks:

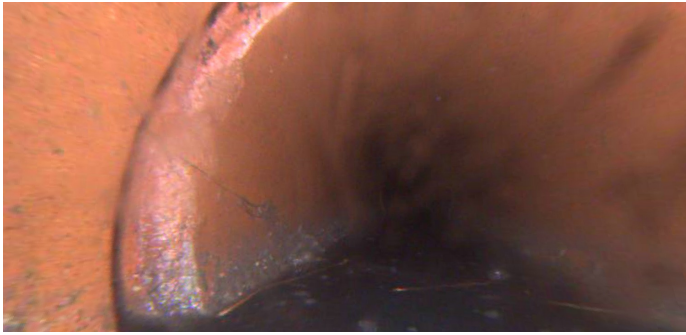
Code: **SSS**
Description: **Surface Spalling**

Distance (ft): **25.8**
Structural Grade: **2**
O&M Grade: **0**
Clock Start/From: **7**
Clock To: **11**
1st Value:
2nd Value:
Value Percent:
Continuous Index:
Within 8" of Joint: **YES**
Remarks:

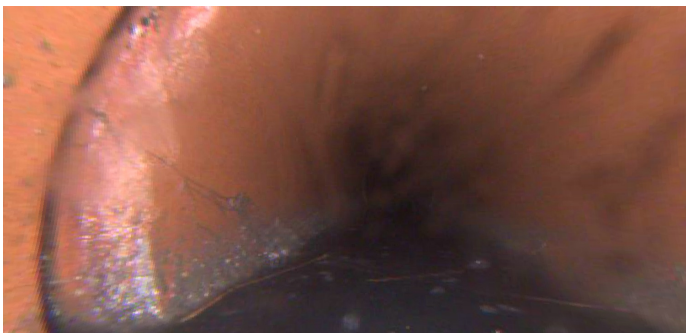
Code: **FL**
Description: **Fracture Longitudinal**

Distance (ft): **25.8**
Structural Grade: **3**
O&M Grade: **0**
Clock Start/From: **10**
Clock To:
1st Value:
2nd Value:
Value Percent:
Continuous Index:
Within 8" of Joint: **YES**
Remarks:

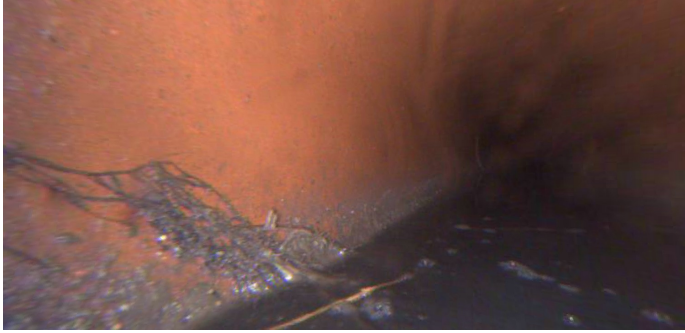
Code: **RFJ**
Description: **Roots Fine Joint**

Distance (ft): **26.3**
Structural Grade: **0**
O&M Grade: **1**
Clock Start/From: **8**
Clock To: **9**
1st Value:
2nd Value:
Value Percent:
Continuous Index:
Within 8" of Joint: **YES**
Remarks:

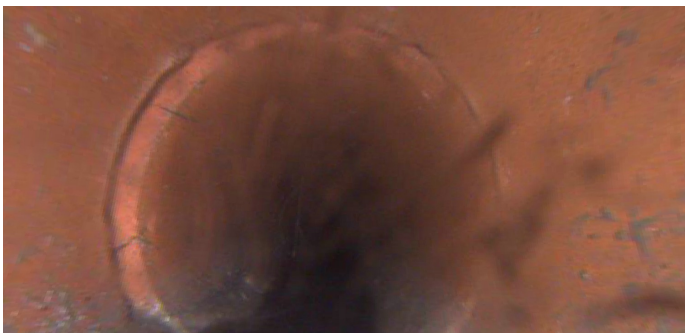
Code: **FM**
Description: **Fracture Multiple**

Distance (ft): **37.6**
Structural Grade: **4**
O&M Grade: **0**
Clock Start/From: **8**
Clock To: **10**
1st Value:
2nd Value:
Value Percent:
Continuous Index:
Within 8" of Joint: **YES**
Remarks:

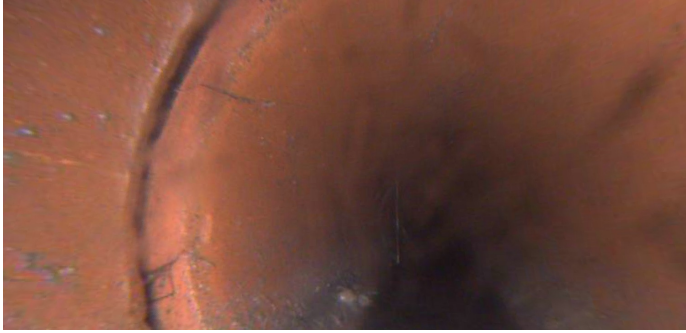
Code: **RFJ**
Description: **Roots Fine Joint**

Distance (ft): **37.9**
Structural Grade: **0**
O&M Grade: **1**
Clock Start/From: **8**
Clock To: **10**
1st Value:
2nd Value:
Value Percent:
Continuous Index:
Within 8" of Joint: **YES**
Remarks:

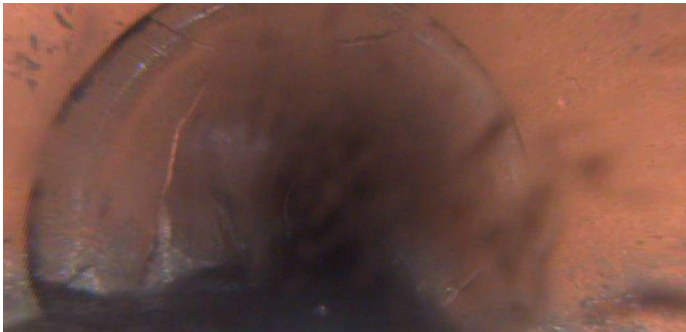
Code: **FM**
Description: **Fracture Multiple**

Distance (ft): **40.8**
Structural Grade: **4**
O&M Grade: **0**
Clock Start/From: **7**
Clock To: **5**
1st Value:
2nd Value:
Value Percent:
Continuous Index:
Within 8" of Joint: **YES**
Remarks:

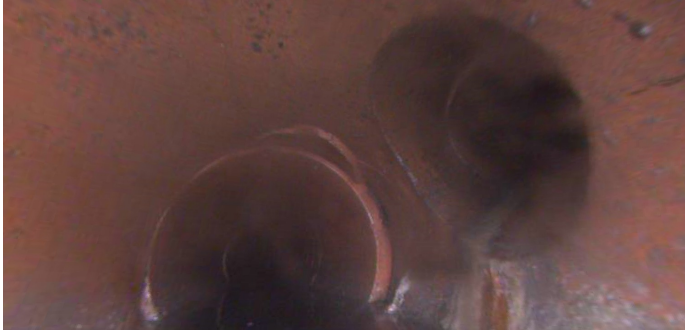
Code: **TF**
Description: **Tap Factory**

Distance (ft): **42.4**
Structural Grade: **0**
O&M Grade: **0**
Clock Start/From: **10**
Clock To:
1st Value: **4.000**
2nd Value:
Value Percent:
Continuous Index:
Within 8" of Joint:
Remarks:

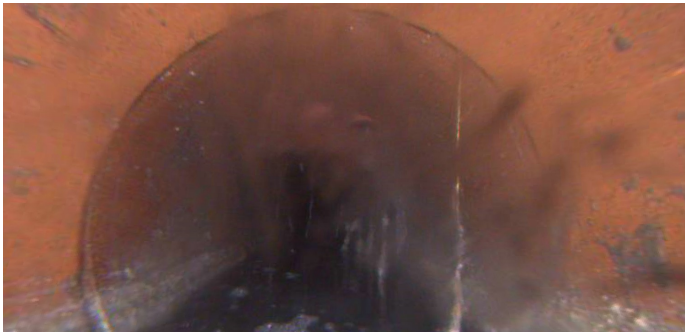
Code: **RFJ**
Description: **Roots Fine Joint**

Distance (ft): **48.9**
Structural Grade: **0**
O&M Grade: **1**
Clock Start/From: **1**
Clock To:
1st Value:
2nd Value:
Value Percent:
Continuous Index:
Within 8" of Joint: **YES**
Remarks:

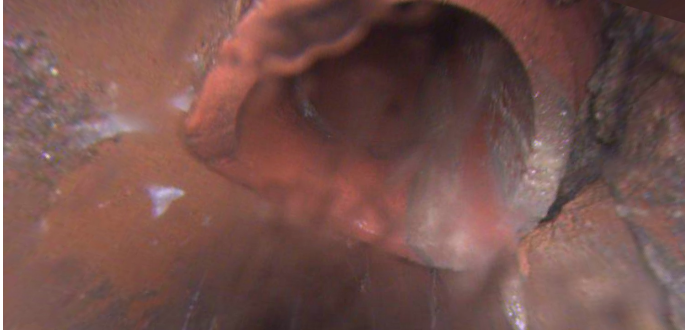
Code: **TBI**
Description: **Tap Break-in Intruding**

Distance (ft): **50.0**
Structural Grade: **0**
O&M Grade: **2**
Clock Start/From: **12**
Clock To:
1st Value: **4.000**
2nd Value: **1.000**
Value Percent:
Continuous Index:
Within 8" of Joint:
Remarks: **roots**

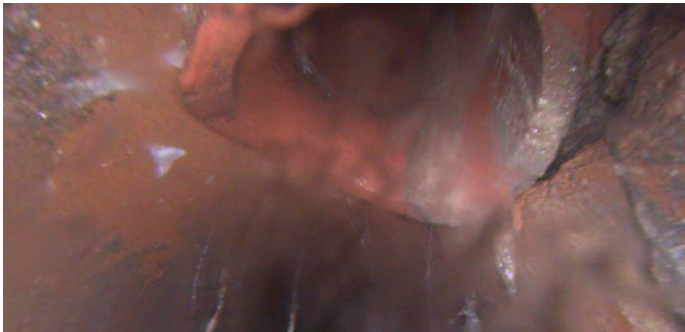
Code: **RFC**
Description: **Roots Fine Connection**

Distance (ft): **50.0**
Structural Grade: **0**
O&M Grade: **1**
Clock Start/From: **12**
Clock To: **3**
1st Value:
2nd Value:
Value Percent:
Continuous Index:
Within 8" of Joint: **NO**
Remarks:

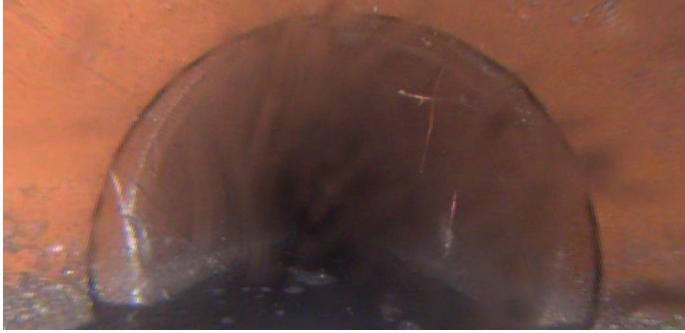
Code: **FL**
Description: **Fracture Longitudinal**

Distance (ft): **51.9**
Structural Grade: **3**
O&M Grade: **0**
Clock Start/From: **9**
Clock To:
1st Value:
2nd Value:
Value Percent:
Continuous Index:
Within 8" of Joint: **YES**
Remarks:

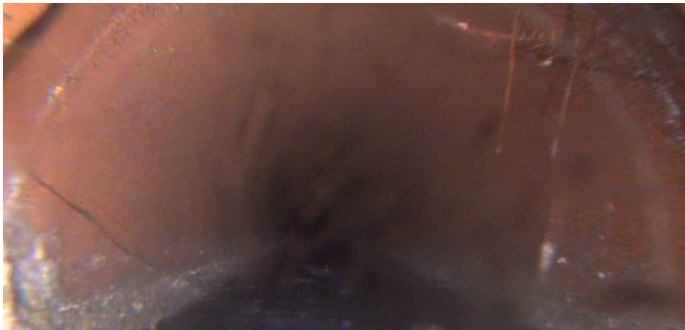
Code: **RFJ**
Description: **Roots Fine Joint**

Distance (ft): **52.2**
Structural Grade: **0**
O&M Grade: **1**
Clock Start/From: **8**
Clock To: **4**
1st Value:
2nd Value:
Value Percent:
Continuous Index:
Within 8" of Joint: **YES**
Remarks:

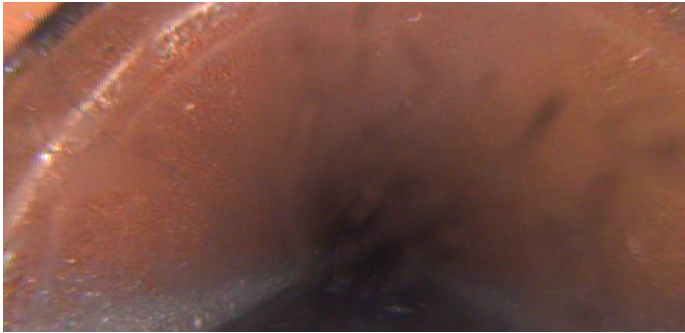
Code: **CL**
Description: **Crack Longitudinal**

Distance (ft): **64.4**
Structural Grade: **2**
O&M Grade: **0**
Clock Start/From: **10**
Clock To:
1st Value:
2nd Value:
Value Percent:
Continuous Index:
Within 8" of Joint: **YES**
Remarks:

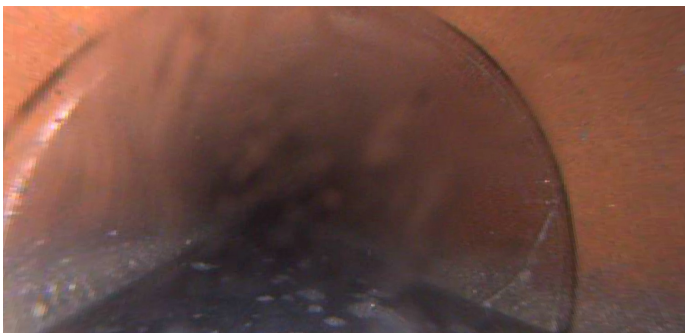
Code: **FS**
Description: **Fracture Spiral**

Distance (ft): **70.4**
Structural Grade: **3**
O&M Grade: **0**
Clock Start/From: **3**
Clock To: **4**
1st Value:
2nd Value:
Value Percent:
Continuous Index:
Within 8" of Joint: **YES**
Remarks:

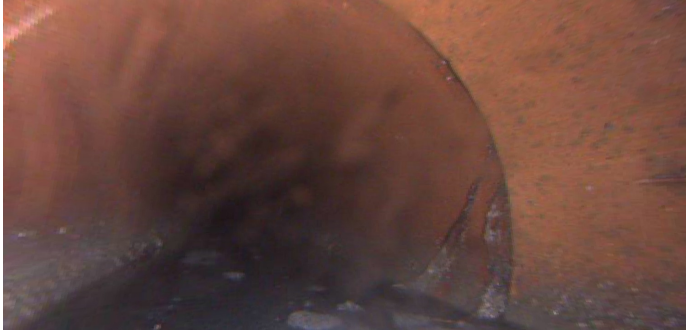
Code: **RFJ**
Description: **Roots Fine Joint**

Distance (ft): **76.4**
Structural Grade: **0**
O&M Grade: **1**
Clock Start/From: **2**
Clock To: **5**
1st Value:
2nd Value:
Value Percent:
Continuous Index:
Within 8" of Joint: **YES**
Remarks:

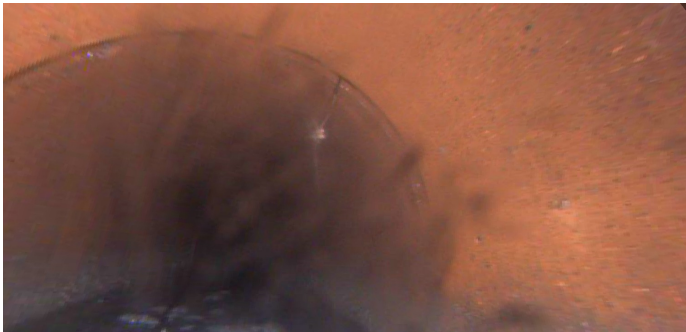
Code: **RFJ**
Description: **Roots Fine Joint**

Distance (ft): **82.3**
Structural Grade: **0**
O&M Grade: **1**
Clock Start/From: **7**
Clock To: **5**
1st Value:
2nd Value:
Value Percent:
Continuous Index: **S01**
Within 8" of Joint: **YES**
Remarks:

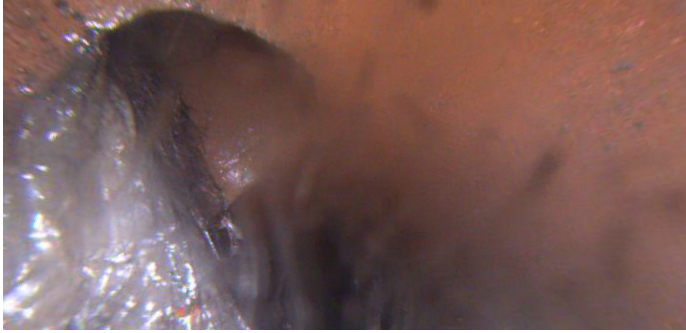
Code: **TFD**
Description: **Tap Factory Defective**

Distance (ft): **89.1**
Structural Grade: **0**
O&M Grade: **2**
Clock Start/From: **10**
Clock To:
1st Value: **4.000**
2nd Value:
Value Percent:
Continuous Index:
Within 8" of Joint:
Remarks: **rml**

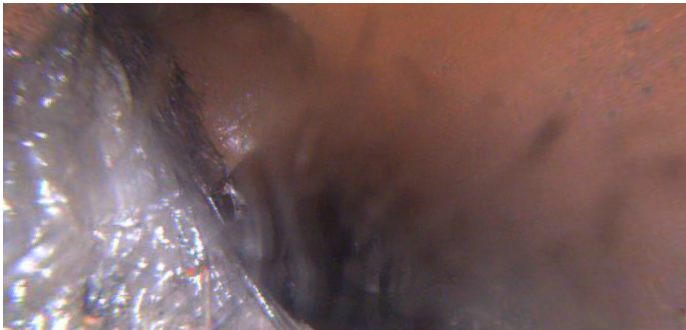
Code: **RML**
Description: **Roots Medium Lateral**

Distance (ft): **89.1**
Structural Grade: **0**
O&M Grade: **3**
Clock Start/From: **6**
Clock To: **11**
1st Value:
2nd Value:
Value Percent: **20.000**
Continuous Index:
Within 8" of Joint: **NO**
Remarks:

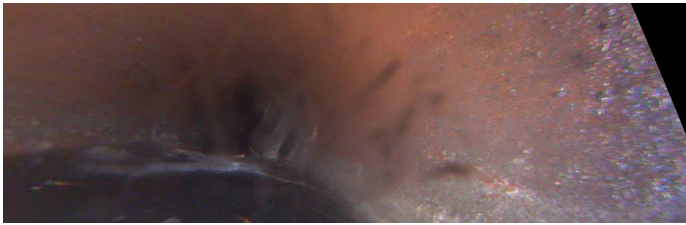
Code: **RFJ**
Description: **Roots Fine Joint**

Distance (ft): **90.7**
Structural Grade: **0**
O&M Grade: **1**
Clock Start/From: **7**
Clock To: **5**
1st Value:
2nd Value:
Value Percent:
Continuous Index: **F01**
Within 8" of Joint: **YES**
Remarks:

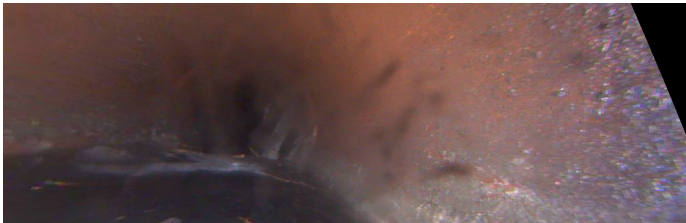
Code: **MSA**
Description: **Abandoned Survey**

Distance (ft): **90.7**
Structural Grade: **0**
O&M Grade: **0**
Clock Start/From:
Clock To:
1st Value:
2nd Value:
Value Percent:
Continuous Index:
Within 8" of Joint: **NO**
Remarks: **camera stopped**
