## Profile/Photo Observation Report

Date:	<b>04/16/2018</b>	Weather:		Coding:	<b>PACP 6.0</b>
Pipe Length (ft):	<b>191.0</b>	Owner:	<b>NA</b>	Pre Clean:	<b>Not Known</b>
P.O.#:		Surveyor:	<b>Selasie Honu</b>	PSR:	<b>P-404-022-023</b>
Customer:		Clean Date:	<b>01/01/1900</b>	Shape:	<b>C</b>

Street:	<b>Summerlin</b>	Flow Control:	<b>Not Controlled</b>
City:	<b>Hobart, IN</b>	Year Renewed:	
Location:	<b>Light Highway</b>	Tape/Media #:	
Purpose:	<b>Not Known</b>	Dia/Height:	<b>10"</b>
Use:	<b>Sanitary</b>	Material:	<b>VCP</b>
Drain Area:	<b>NA</b>	Lining:	
Category:	<b>NA</b>		
Comment:

Location Details:		Direction of Survey:	<b>Downstream</b>
US MH:	<b>M-404-022</b>	DS MH:	<b>M-404-023</b>
		Total Length Surveyed (ft):	<b>90.7</b>

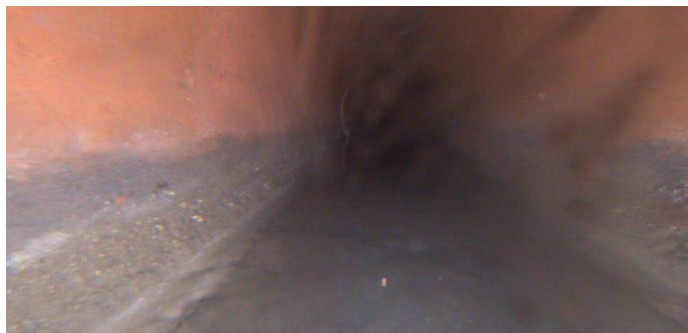
Code: **AMH**  
Description: **Manhole**

Distance (ft): **.0**  
Structural Grade: **0**  
O&M Grade: **0**  
Clock Start/From:  
Clock To:  
1st Value:  
2nd Value:  
Value Percent:  
Continuous Index:  
Within 8" of Joint: **NO**  
Remarks: **M-404-022**

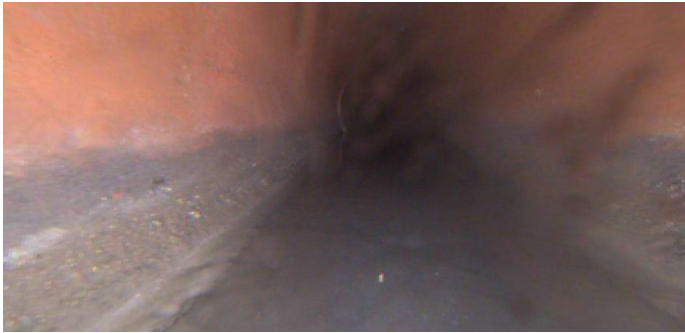
Code:	<b>MWL</b>
Description:	<b>Water Level</b>

Distance (ft):	<b>.0</b>
Structural Grade:	<b>0</b>
O&M Grade:	<b>0</b>
Clock Start/From:	
Clock To:	
1st Value:	
2nd Value:	
Value Percent:	<b>5.000</b>
Continuous Index:	
Within 8" of Joint:	<b>NO</b>
Remarks:

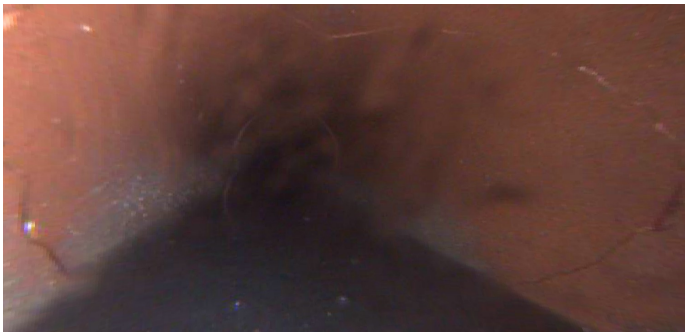
Code:	<b>FC</b>
Description:	<b>Fracture Circumferential</b>

Distance (ft):	<b>14.5</b>
Structural Grade:	<b>2</b>
O&M Grade:	<b>0</b>
Clock Start/From:	<b>8</b>
Clock To:	<b>4</b>
1st Value:	
2nd Value:	
Value Percent:	
Continuous Index:	
Within 8" of Joint:	
Remarks:

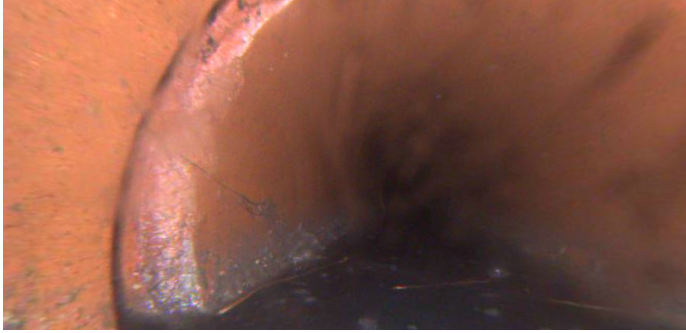
Code: **SSS**  
Description: **Surface Spalling**

Distance (ft): **25.8**  
Structural Grade: **2**  
O&M Grade: **0**  
Clock Start/From: **7**  
Clock To: **11**  
1st Value:  
2nd Value:  
Value Percent:  
Continuous Index:  
Within 8" of Joint: **YES**  
Remarks:

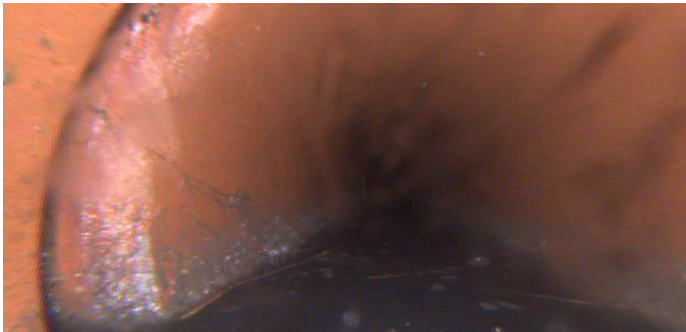
Code: **FL**  
Description: **Fracture Longitudinal**

Distance (ft): **25.8**  
Structural Grade: **3**  
O&M Grade: **0**  
Clock Start/From: **10**  
Clock To:  
1st Value:  
2nd Value:  
Value Percent:  
Continuous Index:  
Within 8" of Joint: **YES**  
Remarks:

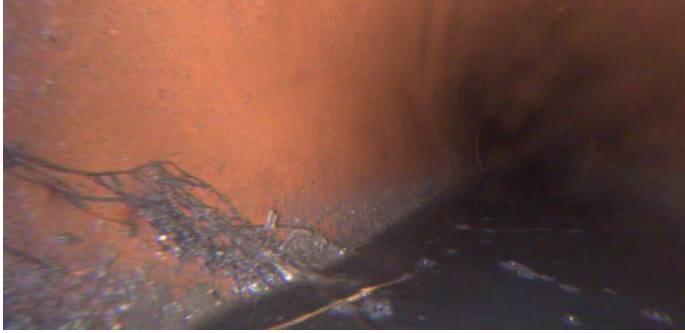
Code: **RFJ**  
Description: **Roots Fine Joint**

Distance (ft): **26.3**  
Structural Grade: **0**  
O&M Grade: **1**  
Clock Start/From: **8**  
Clock To: **9**  
1st Value:  
2nd Value:  
Value Percent:  
Continuous Index:  
Within 8" of Joint: **YES**  
Remarks:

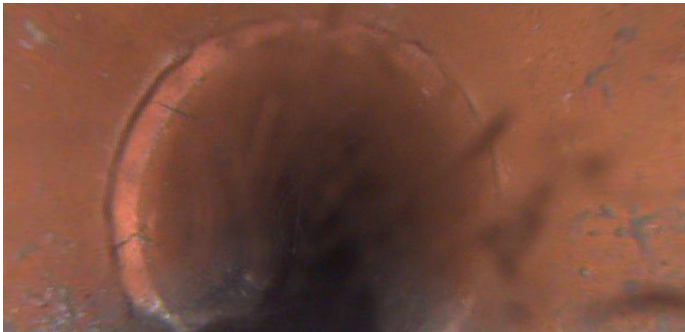
Code: **FM**  
Description: **Fracture Multiple**

Distance (ft): **37.6**  
Structural Grade: **4**  
O&M Grade: **0**  
Clock Start/From: **8**  
Clock To: **10**  
1st Value:  
2nd Value:  
Value Percent:  
Continuous Index:  
Within 8" of Joint: **YES**  
Remarks:

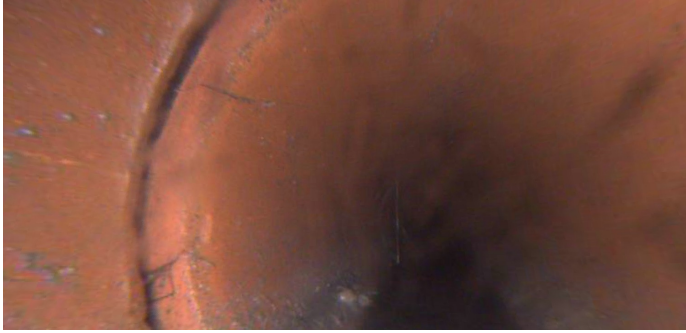
Code: **RFJ**  
Description: **Roots Fine Joint**

Distance (ft): **37.9**  
Structural Grade: **0**  
O&M Grade: **1**  
Clock Start/From: **8**  
Clock To: **10**  
1st Value:  
2nd Value:  
Value Percent:  
Continuous Index:  
Within 8" of Joint: **YES**  
Remarks:

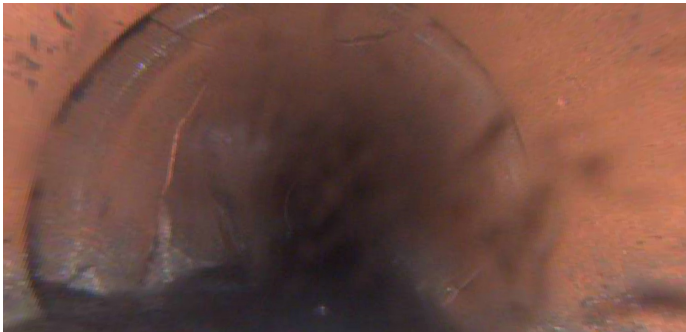
Code: **FM**  
Description: **Fracture Multiple**

Distance (ft): **40.8**  
Structural Grade: **4**  
O&M Grade: **0**  
Clock Start/From: **7**  
Clock To: **5**  
1st Value:  
2nd Value:  
Value Percent:  
Continuous Index:  
Within 8" of Joint: **YES**  
Remarks:

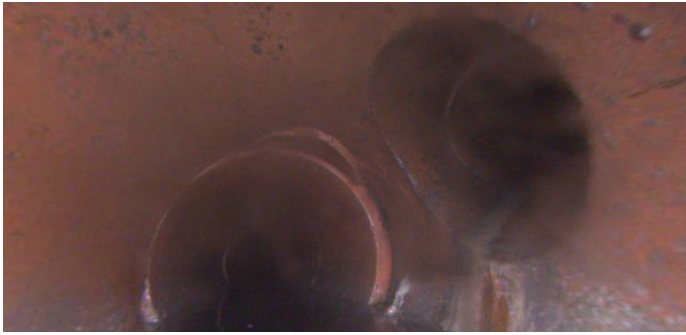
Code: **TF**  
Description: **Tap Factory**

Distance (ft): **42.4**  
Structural Grade: **0**  
O&M Grade: **0**  
Clock Start/From: **10**  
Clock To:  
1st Value: **4.000**  
2nd Value:  
Value Percent:  
Continuous Index:  
Within 8" of Joint:  
Remarks:

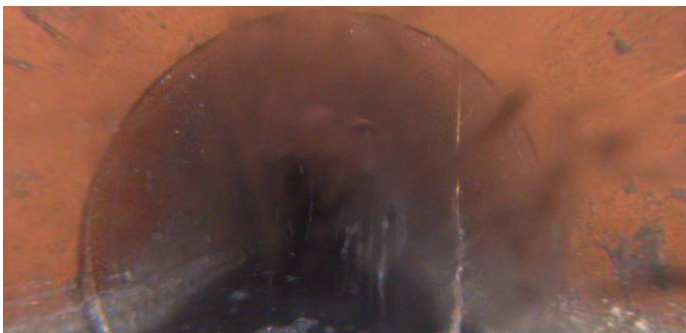
Code: **RFJ**  
Description: **Roots Fine Joint**

Distance (ft): **48.9**  
Structural Grade: **0**  
O&M Grade: **1**  
Clock Start/From: **1**  
Clock To:  
1st Value:  
2nd Value:  
Value Percent:  
Continuous Index:  
Within 8" of Joint: **YES**  
Remarks:

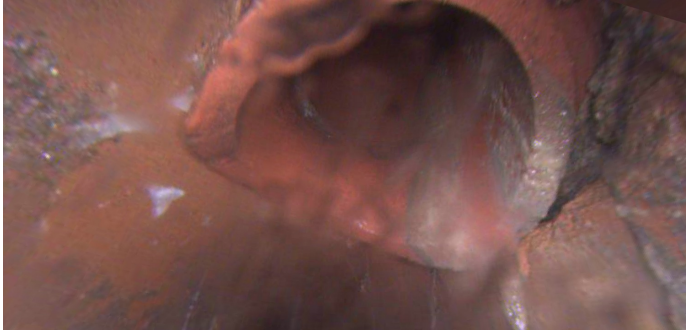
Code: **TBI**  
Description: **Tap Break-in Intruding**

Distance (ft): **50.0**  
Structural Grade: **0**  
O&M Grade: **2**  
Clock Start/From: **12**  
Clock To:  
1st Value: **4.000**  
2nd Value: **1.000**  
Value Percent:  
Continuous Index:  
Within 8" of Joint:  
Remarks: **roots**

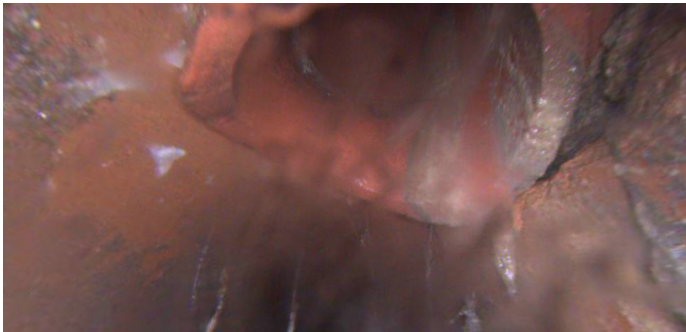
Code: **RFC**  
Description: **Roots Fine Connection**

Distance (ft): **50.0**  
Structural Grade: **0**  
O&M Grade: **1**  
Clock Start/From: **12**  
Clock To: **3**  
1st Value:  
2nd Value:  
Value Percent:  
Continuous Index:  
Within 8" of Joint: **NO**  
Remarks:

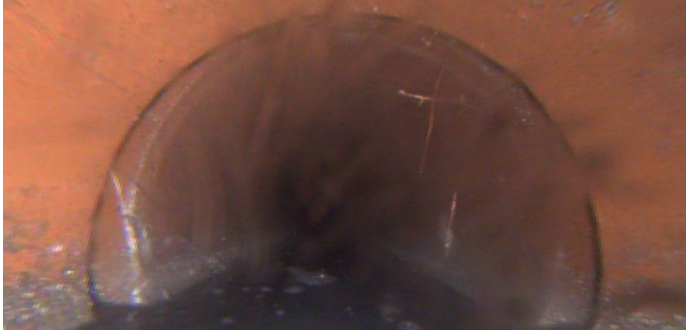
Code: **FL**  
Description: **Fracture Longitudinal**

Distance (ft): **51.9**  
Structural Grade: **3**  
O&M Grade: **0**  
Clock Start/From: **9**  
Clock To:  
1st Value:  
2nd Value:  
Value Percent:  
Continuous Index:  
Within 8" of Joint: **YES**  
Remarks:

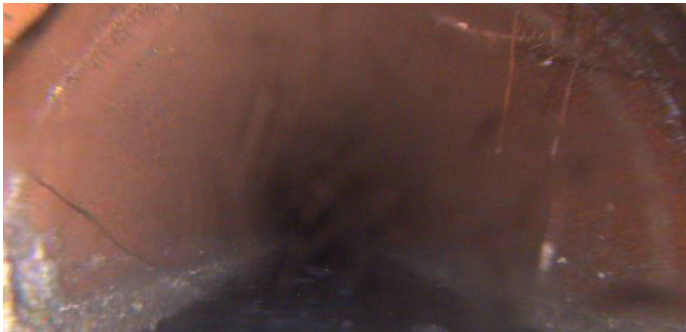
Code: **RFJ**  
Description: **Roots Fine Joint**

Distance (ft): **52.2**  
Structural Grade: **0**  
O&M Grade: **1**  
Clock Start/From: **8**  
Clock To: **4**  
1st Value:  
2nd Value:  
Value Percent:  
Continuous Index:  
Within 8" of Joint: **YES**  
Remarks:

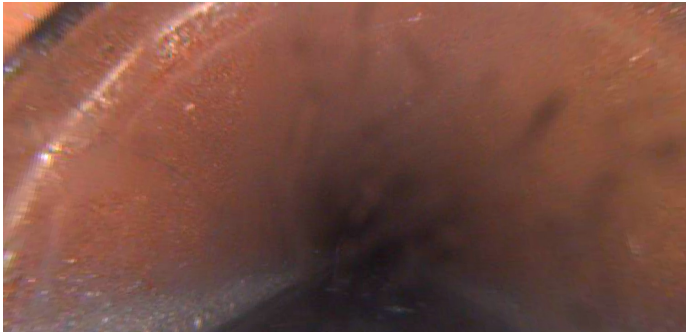
Code: **CL**  
Description: **Crack Longitudinal**

Distance (ft): **64.4**  
Structural Grade: **2**  
O&M Grade: **0**  
Clock Start/From: **10**  
Clock To:  
1st Value:  
2nd Value:  
Value Percent:  
Continuous Index:  
Within 8" of Joint: **YES**  
Remarks:

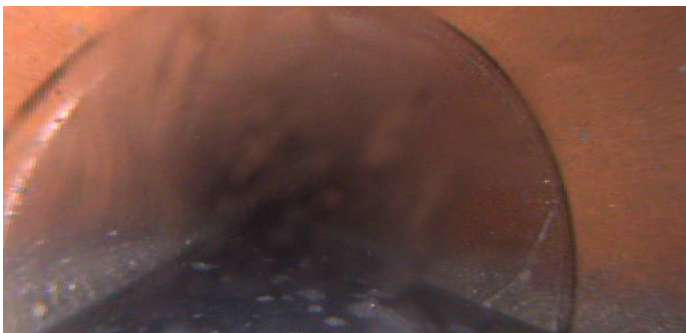
Code: **FS**  
Description: **Fracture Spiral**

Distance (ft): **70.4**  
Structural Grade: **3**  
O&M Grade: **0**  
Clock Start/From: **3**  
Clock To: **4**  
1st Value:  
2nd Value:  
Value Percent:  
Continuous Index:  
Within 8" of Joint: **YES**  
Remarks:

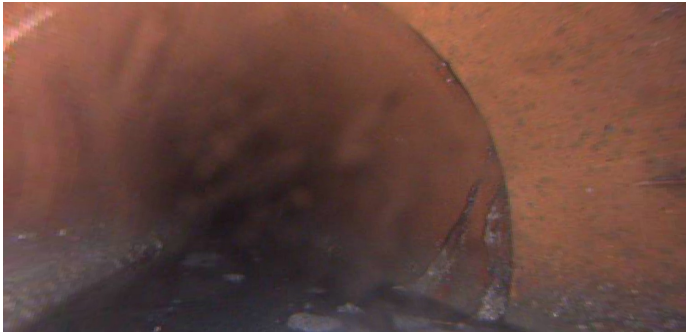
Code: **RFJ**  
Description: **Roots Fine Joint**

Distance (ft): **76.4**  
Structural Grade: **0**  
O&M Grade: **1**  
Clock Start/From: **2**  
Clock To: **5**  
1st Value:  
2nd Value:  
Value Percent:  
Continuous Index:  
Within 8" of Joint: **YES**  
Remarks:

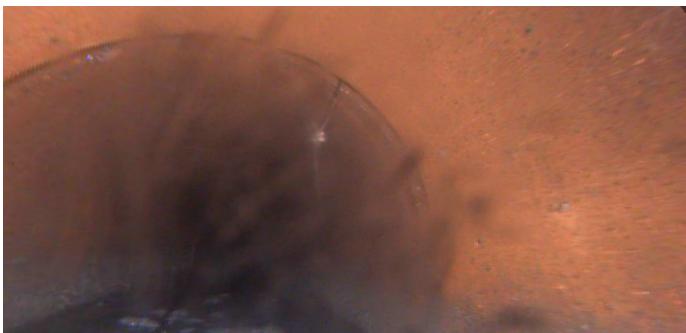
Code: **RFJ**  
Description: **Roots Fine Joint**

Distance (ft): **82.3**  
Structural Grade: **0**  
O&M Grade: **1**  
Clock Start/From: **7**  
Clock To: **5**  
1st Value:  
2nd Value:  
Value Percent:  
Continuous Index: **S01**  
Within 8" of Joint: **YES**  
Remarks:

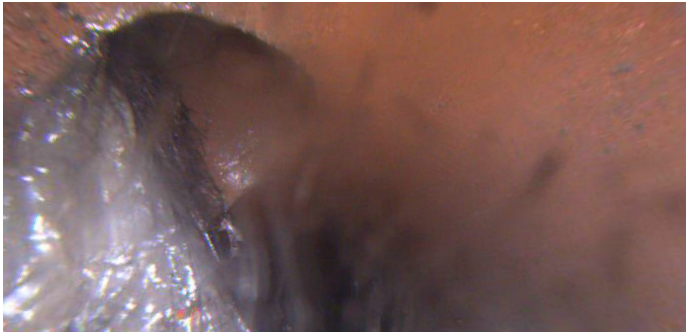
Code: **TFD**  
Description: **Tap Factory Defective**

Distance (ft): **89.1**  
Structural Grade: **0**  
O&M Grade: **2**  
Clock Start/From: **10**  
Clock To:  
1st Value: **4.000**  
2nd Value:  
Value Percent:  
Continuous Index:  
Within 8" of Joint:  
Remarks: **rml**

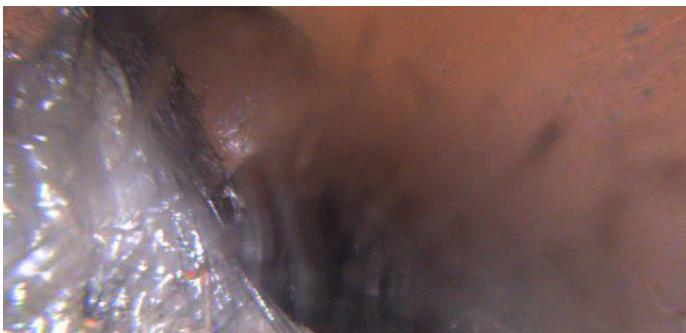
Code: **RML**  
Description: **Roots Medium Lateral**

Distance (ft): **89.1**  
Structural Grade: **0**  
O&M Grade: **3**  
Clock Start/From: **6**  
Clock To: **11**  
1st Value:  
2nd Value:  
Value Percent: **20.000**  
Continuous Index:  
Within 8" of Joint: **NO**  
Remarks:

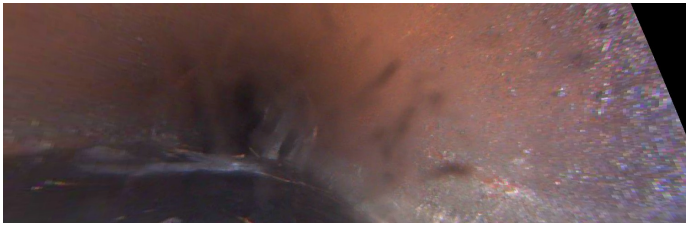
Code: **RFJ**  
Description: **Roots Fine Joint**

Distance (ft): **90.7**  
Structural Grade: **0**  
O&M Grade: **1**  
Clock Start/From: **7**  
Clock To: **5**  
1st Value:  
2nd Value:  
Value Percent:  
Continuous Index: **F01**  
Within 8" of Joint: **YES**  
Remarks:

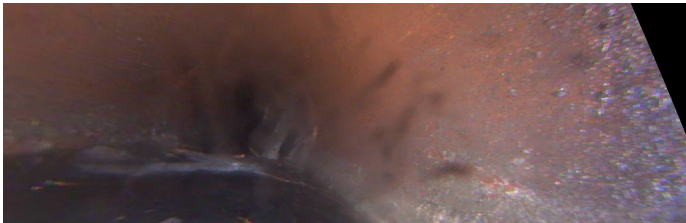
Code: **MSA**  
Description: **Abandoned Survey**

Distance (ft): **90.7**  
Structural Grade: **0**  
O&M Grade: **0**  
Clock Start/From:  
Clock To:  
1st Value:  
2nd Value:  
Value Percent:  
Continuous Index:  
Within 8" of Joint: **NO**  
Remarks: **camera stopped**
