# Profile/Photo Observation Report

Date:	<b>09/03/2021</b>	Weather:		Coding:	<b>PACP 7.0</b>
Pipe Length (ft):	<b>191.0</b>	Owner:	<b>City of Hobart</b>	Pre Clean:	<b>Light Cleaning</b>
P.O.#:	<b>YES502259</b>	Surveyor:	<b>S. Bucklin</b>	PSR:	<b>P-404-022-023</b>
Customer:	<b>City of Hobart</b>	Clean Date:	<b>08/30/2021</b>	Shape:	<b>C</b>

Street:	<b>41st Avenue</b>	Flow Control:	<b>Not Controlled</b>
City:	<b>Hobart, IN</b>	Year Renewed:	
Location:	<b>Alley</b>	Tape/Media #:	
Purpose:	<b>Routine Assessment</b>	Dia/Height:	<b>10"</b>
Use:	<b>Sanitary Sewage Pipe</b>	Material:	<b>VCP</b>
Drain Area:		Lining:	
Category:	<b>NA</b>		
Comment:			
Location Details:		Direction of Survey:	<b>Upstream</b>
US MH:	<b>M-404-022</b>	DS MH:	<b>M-404-023</b>
		Total Length Surveyed (ft):	<b>175.5</b>

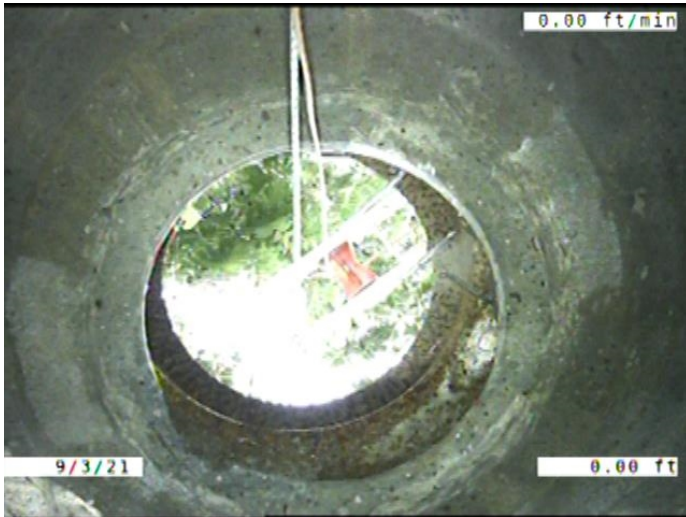
Code: **AMH**  
Description: **Manhole**

Distance (ft): **.0**  
Structural Grade: **0**  
O&M Grade: **0**  
Clock Start/From:  
Clock To:  
1st Value:  
2nd Value:  
Value Percent:  
Continuous Index:  
Within 8" of Joint: **NO**  
Remarks: **M-404-023**

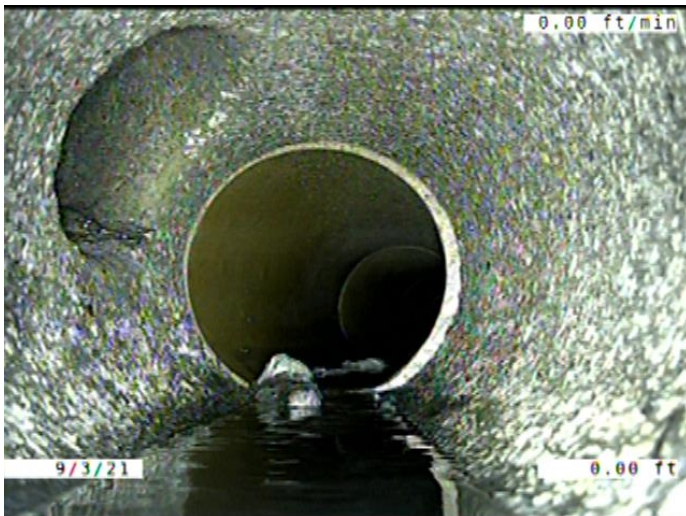
Code: **MWL**  
Description: **Miscellaneous Water Level**

Distance (ft): **.0**  
Structural Grade: **0**  
O&M Grade: **0**  
Clock Start/From:  
Clock To:  
1st Value:  
2nd Value:  
Value Percent: **5.000**  
Continuous Index:  
Within 8" of Joint: **NO**  
Remarks:

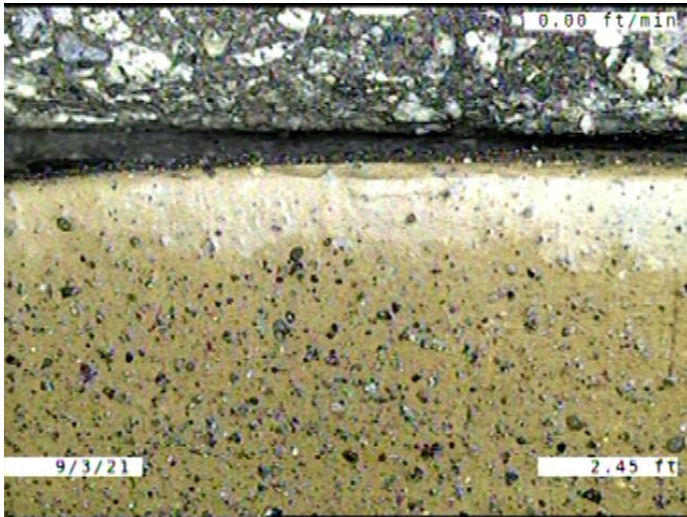
Code: **MMC**  
Description: **Miscellaneous Material Change**

Distance (ft): **2.4**  
Structural Grade: **0**  
O&M Grade: **0**  
Clock Start/From:  
Clock To:  
1st Value:  
2nd Value:  
Value Percent:  
Continuous Index:  
Within 8" of Joint: **NO**  
Remarks: **CONCRETE TO VCP**

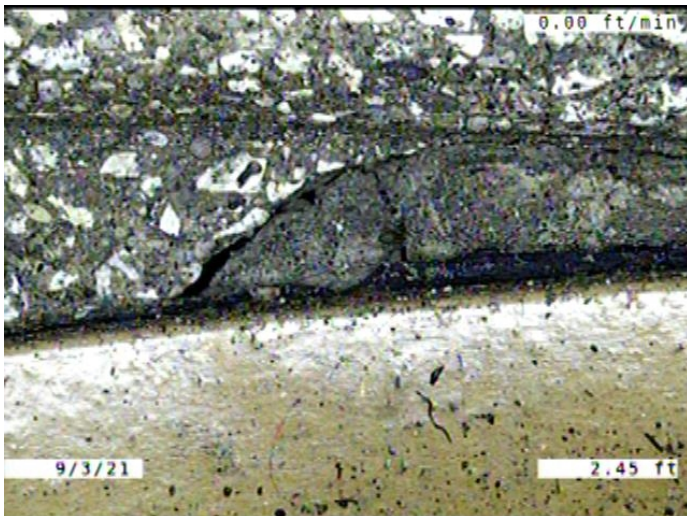
Code: **B**  
Description: **Broken**

Distance (ft): **2.4**  
Structural Grade: **4**  
O&M Grade: **0**  
Clock Start/From: **11**  
Clock To: **1**  
1st Value:  
2nd Value:  
Value Percent:  
Continuous Index:  
Within 8" of Joint: **YES**  
Remarks: **OUTSIDE OF THE JOINT**

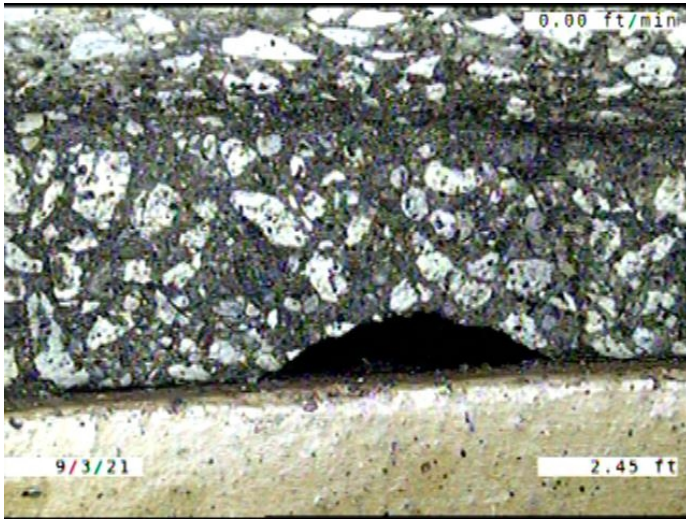
Code: **HVV**  
Description: **Hole Void Visible**

Distance (ft): **2.4**  
Structural Grade: **5**  
O&M Grade: **0**  
Clock Start/From: **10**  
Clock To:  
1st Value:  
2nd Value:  
Value Percent:  
Continuous Index:  
Within 8" of Joint: **YES**  
Remarks:

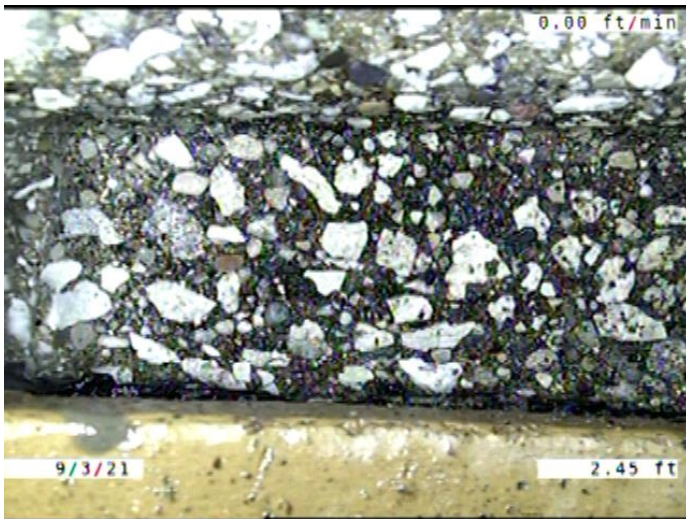
Code: **JAL**  
Description: **Joint Angular Large**

Distance (ft): **2.4**  
Structural Grade: **4**  
O&M Grade: **0**  
Clock Start/From:  
Clock To:  
1st Value:  
2nd Value:  
Value Percent:  
Continuous Index:  
Within 8" of Joint: **NO**  
Remarks:

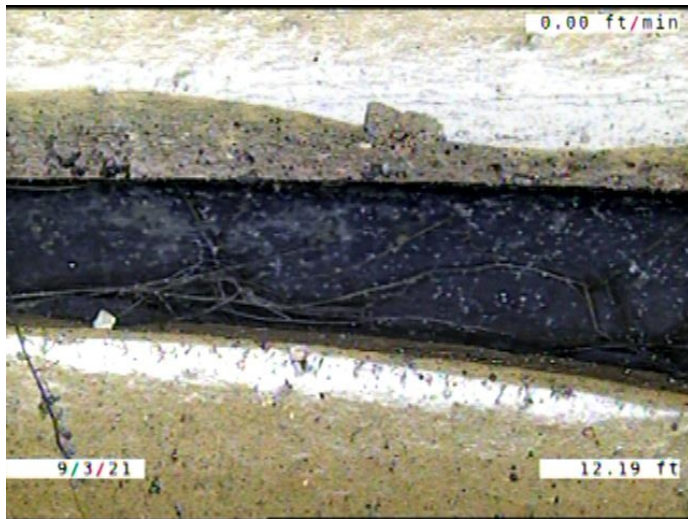
Code: **RFJ**  
 Description: **Roots Fine Joint**

Distance (ft): **12.2**  
 Structural Grade: **0**  
 O&M Grade: **1**  
 Clock Start/From: **8**  
 Clock To: **4**  
 1st Value:  
 2nd Value:  
 Value Percent:  
 Continuous Index:  
 Within 8" of Joint: **YES**  
 Remarks:

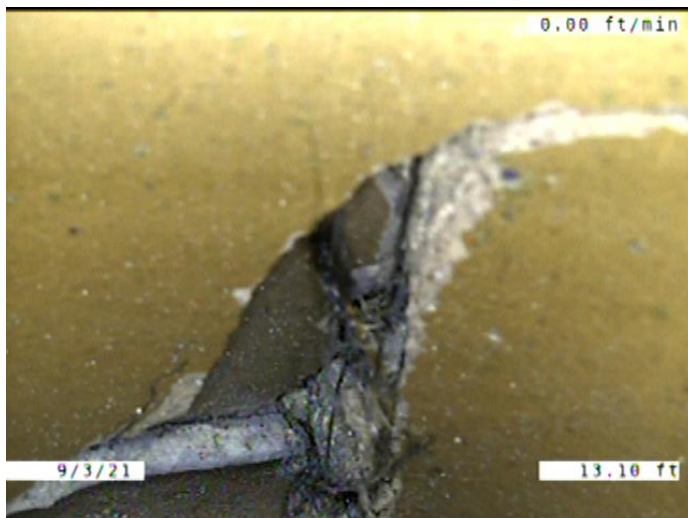
Code: **B**  
 Description: **Broken**

Distance (ft): **13.1**  
 Structural Grade: **4**  
 O&M Grade: **0**  
 Clock Start/From: **10**  
 Clock To: **5**  
 1st Value:  
 2nd Value:  
 Value Percent:  
 Continuous Index:  
 Within 8" of Joint: **YES**  
 Remarks:

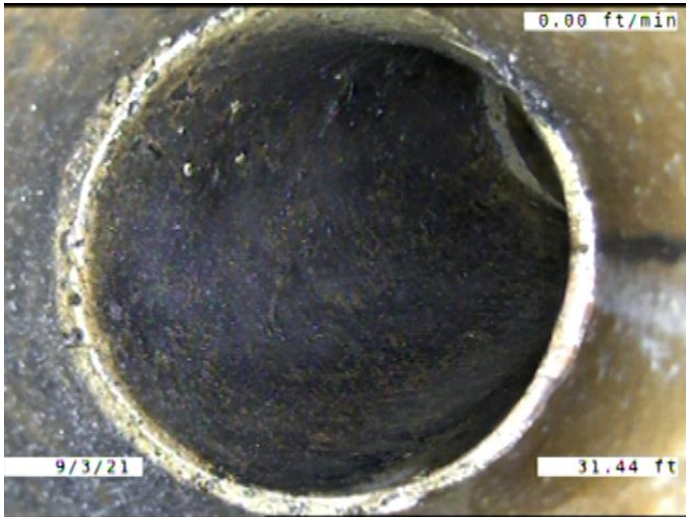
Code:	<b>TF</b>
Description:	<b>Tap Factory</b>
Distance (ft):	<b>31.4</b>
Structural Grade:	<b>0</b>
O&M Grade:	<b>0</b>
Clock Start/From:	<b>2</b>
Clock To:	
1st Value:	<b>6.000</b>
2nd Value:	
Value Percent:	
Continuous Index:	
Within 8" of Joint:	<b>YES</b>
Remarks:	<b>CONSTANTLY RUNNING WATER</b>

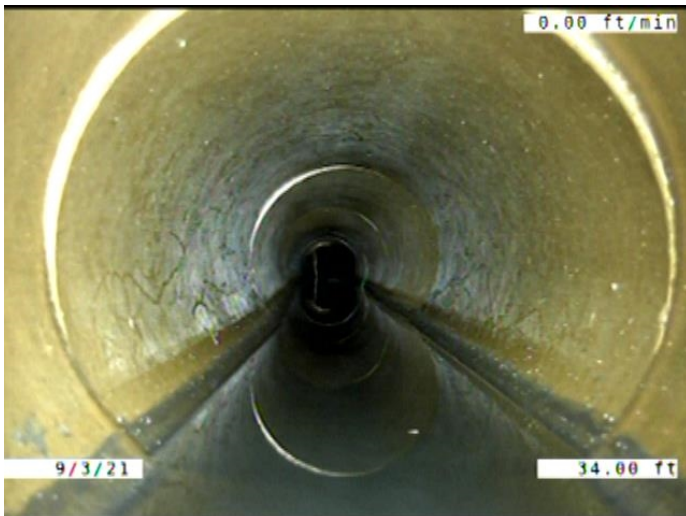
Code:	<b>MWLS</b>
Description:	<b>Miscellaneous Water Level Sag</b>
Distance (ft):	<b>34.0</b>
Structural Grade:	<b>2</b>
O&M Grade:	<b>0</b>
Clock Start/From:	
Clock To:	
1st Value:	
2nd Value:	
Value Percent:	<b>5.000</b>
Continuous Index:	<b>S02</b>
Within 8" of Joint:	<b>NO</b>
Remarks:

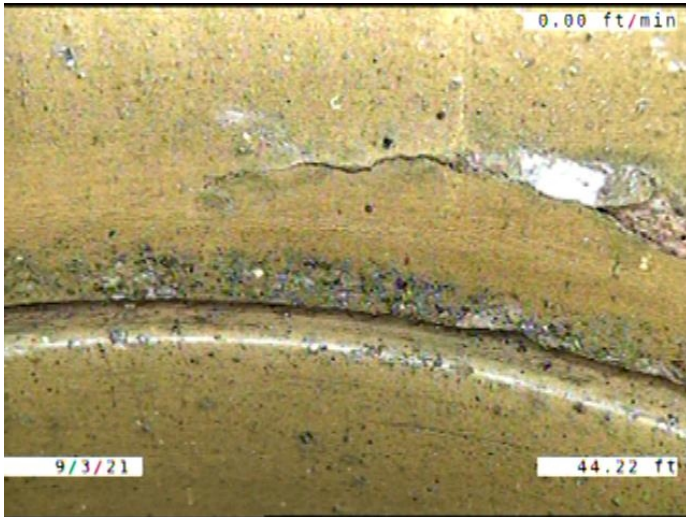
Code: **FM**  
 Description: **Fracture Multiple**

Distance (ft): **44.2**  
 Structural Grade: **4**  
 O&M Grade: **0**  
 Clock Start/From: **2**  
 Clock To: **4**  
 1st Value:  
 2nd Value:  
 Value Percent:  
 Continuous Index:  
 Within 8" of Joint: **YES**  
 Remarks:

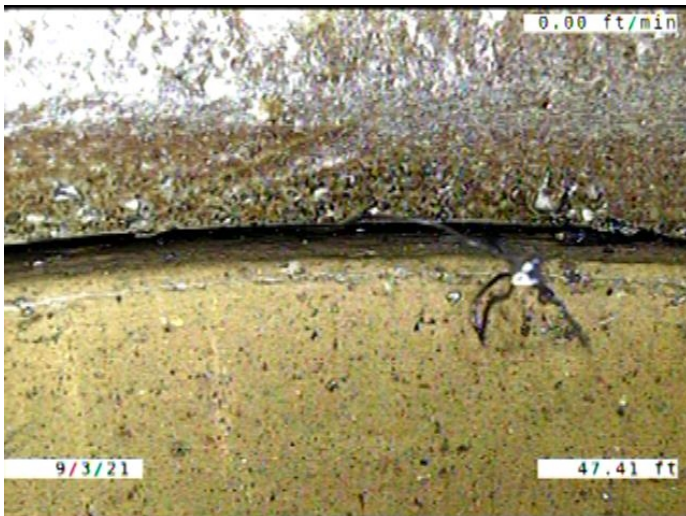
Code: **RFJ**  
 Description: **Roots Fine Joint**

Distance (ft): **47.4**  
 Structural Grade: **0**  
 O&M Grade: **1**  
 Clock Start/From: **9**  
 Clock To: **10**  
 1st Value:  
 2nd Value:  
 Value Percent:  
 Continuous Index:  
 Within 8" of Joint: **YES**  
 Remarks:

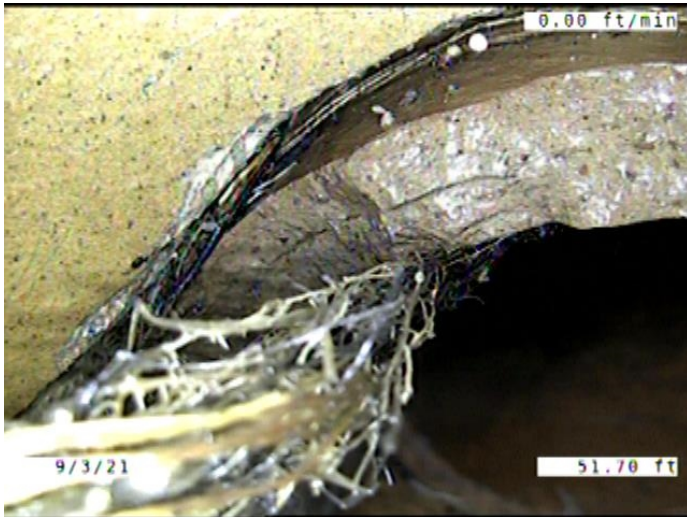
Code: **RML**  
 Description: **Roots Medium Lateral**

Distance (ft): **51.7**  
 Structural Grade: **0**  
 O&M Grade: **3**  
 Clock Start/From: **10**  
 Clock To: **1**  
 1st Value:  
 2nd Value:  
 Value Percent: **5.000**  
 Continuous Index:  
 Within 8" of Joint: **NO**  
 Remarks:

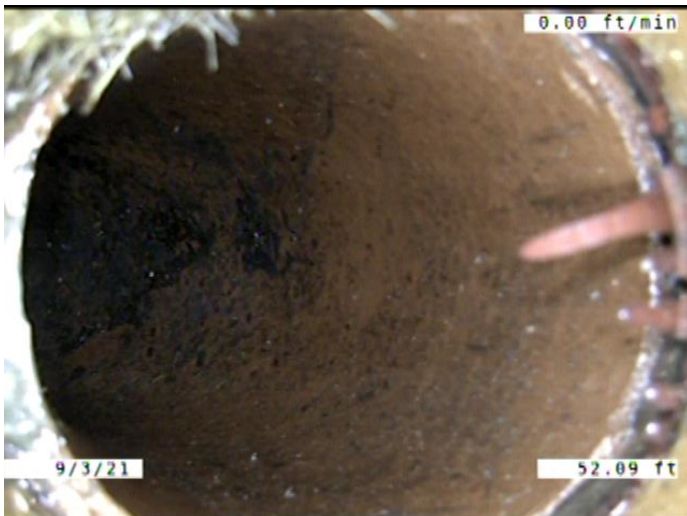
Code: **TBI**  
 Description: **Tap Break-in Intruding**

Distance (ft): **52.1**  
 Structural Grade: **0**  
 O&M Grade: **2**  
 Clock Start/From: **11**  
 Clock To:  
 1st Value: **6.000**  
 2nd Value: **1.000**  
 Value Percent:  
 Continuous Index:  
 Within 8" of Joint: **YES**  
 Remarks:

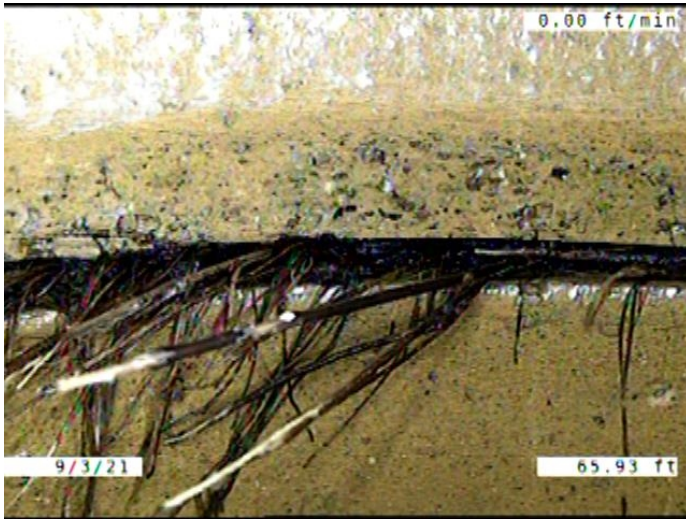
Code: **RFJ**  
 Description: **Roots Fine Joint**

Distance (ft): **65.9**  
 Structural Grade: **0**  
 O&M Grade: **1**  
 Clock Start/From: **8**  
 Clock To: **4**  
 1st Value:  
 2nd Value:  
 Value Percent:  
 Continuous Index:  
 Within 8" of Joint: **YES**  
 Remarks:

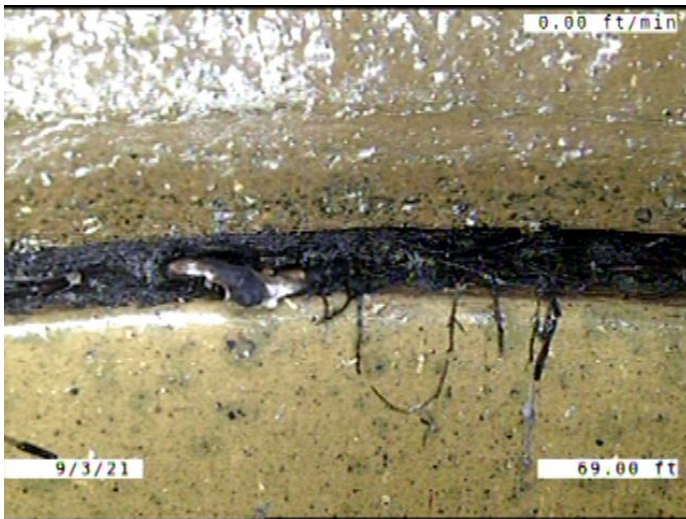
Code: **RFJ**  
 Description: **Roots Fine Joint**

Distance (ft): **69.0**  
 Structural Grade: **0**  
 O&M Grade: **1**  
 Clock Start/From: **7**  
 Clock To: **1**  
 1st Value:  
 2nd Value:  
 Value Percent:  
 Continuous Index:  
 Within 8" of Joint: **YES**  
 Remarks:

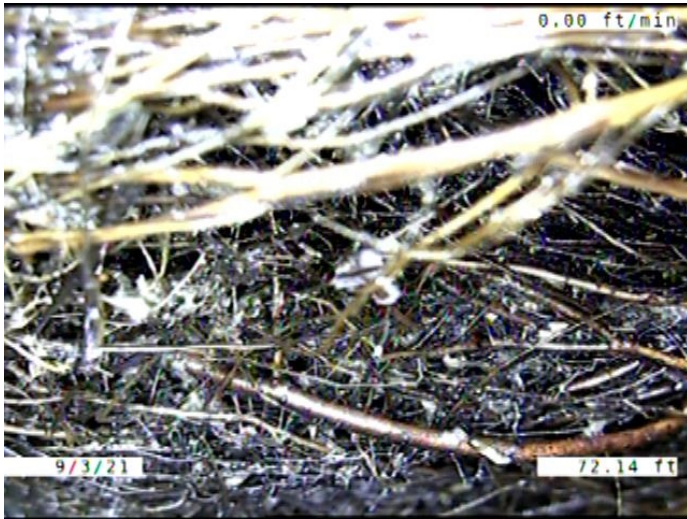
Code: **RMJ**  
 Description: **Roots Medium Joint**

Distance (ft): **72.1**  
 Structural Grade: **0**  
 O&M Grade: **3**  
 Clock Start/From: **7**  
 Clock To: **4**  
 1st Value:  
 2nd Value:  
 Value Percent: **5.000**  
 Continuous Index:  
 Within 8" of Joint: **YES**  
 Remarks:

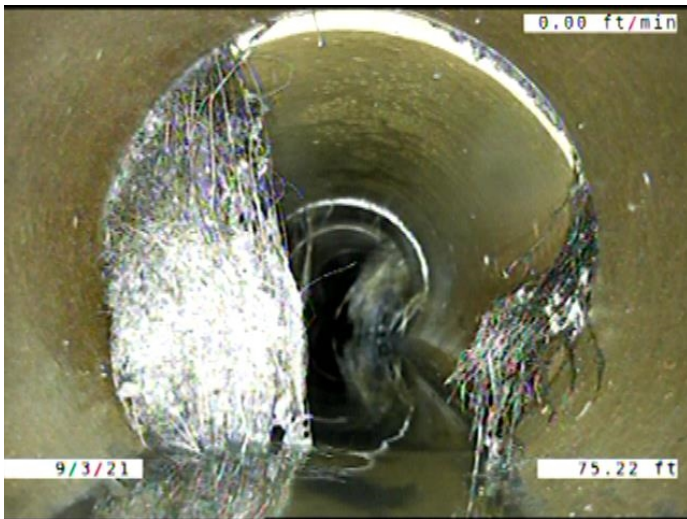
Code: **RMJ**  
 Description: **Roots Medium Joint**

Distance (ft): **75.2**  
 Structural Grade: **0**  
 O&M Grade: **3**  
 Clock Start/From: **7**  
 Clock To: **5**  
 1st Value:  
 2nd Value:  
 Value Percent: **30.000**  
 Continuous Index:  
 Within 8" of Joint: **YES**  
 Remarks:

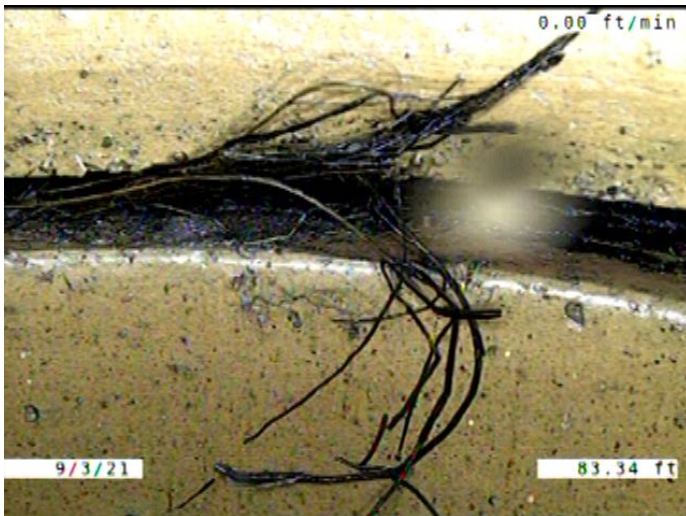
Code: **RFJ**  
 Description: **Roots Fine Joint**

Distance (ft): **83.3**  
 Structural Grade: **0**  
 O&M Grade: **1**  
 Clock Start/From: **8**  
 Clock To: **3**  
 1st Value:  
 2nd Value:  
 Value Percent:  
 Continuous Index:  
 Within 8" of Joint: **YES**  
 Remarks:

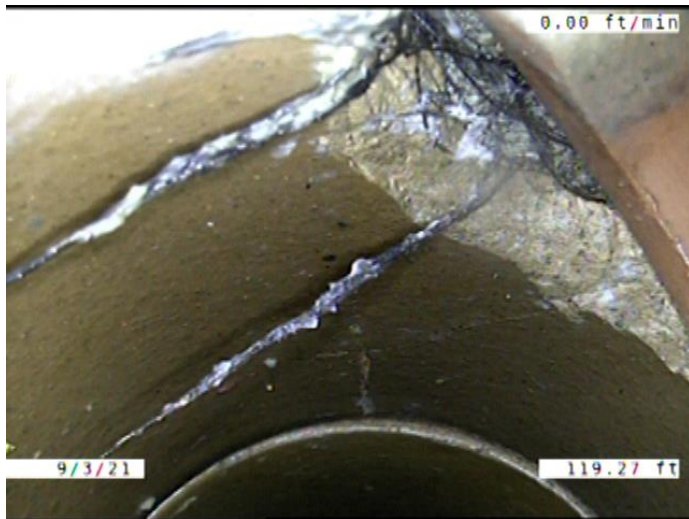
Code: **RML**  
Description: **Roots Medium Lateral**

Distance (ft): **119.3**  
Structural Grade: **0**  
O&M Grade: **3**  
Clock Start/From: **10**  
Clock To: **12**  
1st Value:  
2nd Value:  
Value Percent: **5.000**  
Continuous Index:  
Within 8" of Joint: **NO**  
Remarks:

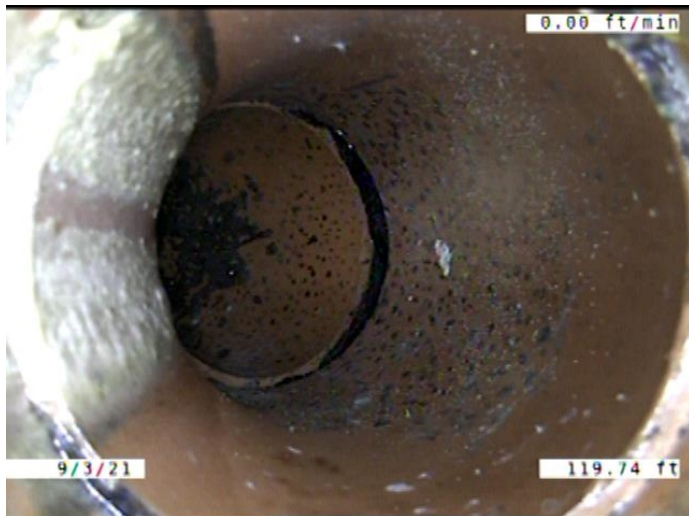
Code: **TBI**  
Description: **Tap Break-in Intruding**

Distance (ft): **119.7**  
Structural Grade: **0**  
O&M Grade: **2**  
Clock Start/From: **12**  
Clock To:  
1st Value: **6.000**  
2nd Value: **1.000**  
Value Percent:  
Continuous Index:  
Within 8" of Joint: **YES**  
Remarks:

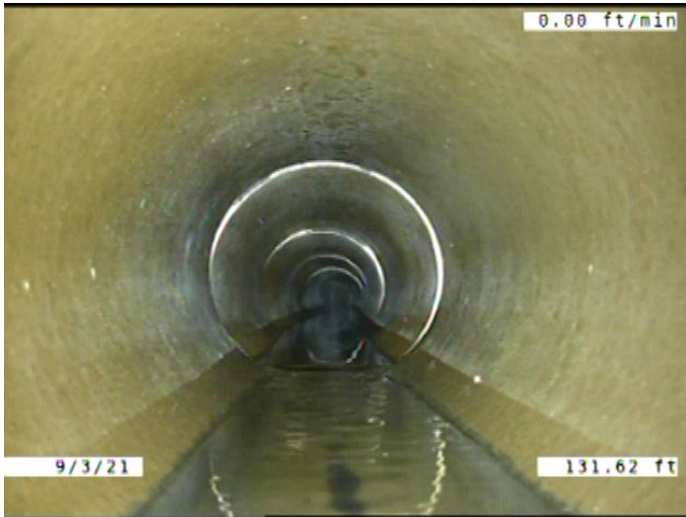
Code: **FM**  
Description: **Fracture Multiple**

Distance (ft): **131.6**  
Structural Grade: **4**  
O&M Grade: **0**  
Clock Start/From: **12**  
Clock To: **12**  
1st Value:  
2nd Value:  
Value Percent:  
Continuous Index: **F04**  
Within 8" of Joint: **YES**  
Remarks:

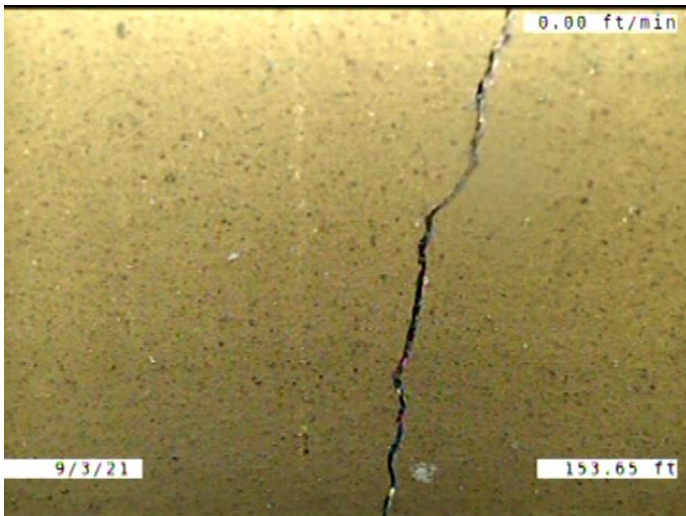
Code: **B**  
Description: **Broken**

Distance (ft): **153.6**  
Structural Grade: **4**  
O&M Grade: **0**  
Clock Start/From: **12**  
Clock To: **12**  
1st Value:  
2nd Value:  
Value Percent:  
Continuous Index:  
Within 8" of Joint: **YES**  
Remarks:

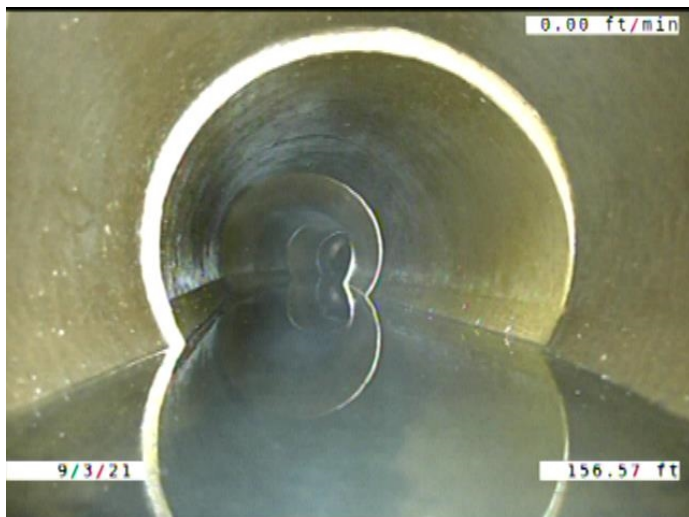
Code: **LL**  
Description: **Line Left**

Distance (ft): **156.6**  
Structural Grade: **0**  
O&M Grade: **1**  
Clock Start/From:  
Clock To:  
1st Value:  
2nd Value:  
Value Percent: **5.000**  
Continuous Index:  
Within 8" of Joint: **NO**  
Remarks:

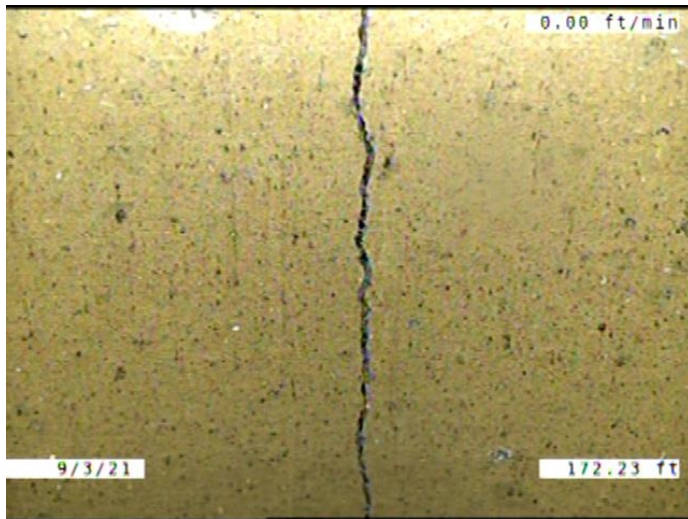
Code: **FM**  
 Description: **Fracture Multiple**

Distance (ft): **172.2**  
 Structural Grade: **4**  
 O&M Grade: **0**  
 Clock Start/From: **12**  
 Clock To: **8**  
 1st Value:  
 2nd Value:  
 Value Percent:  
 Continuous Index:  
 Within 8" of Joint: **YES**  
 Remarks:

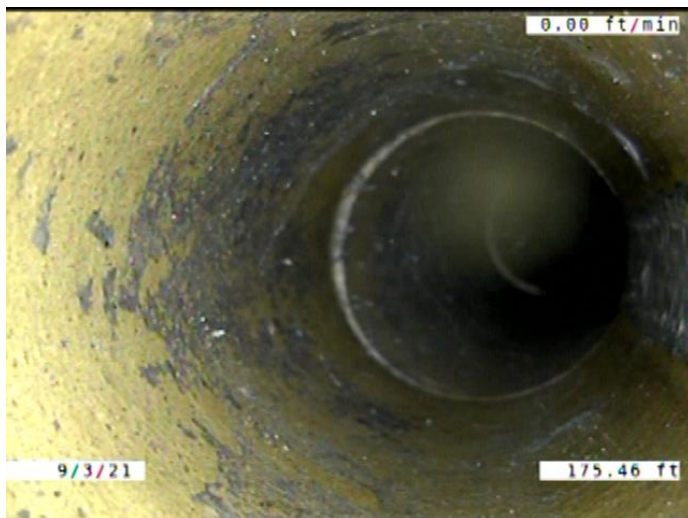
Code: **TBI**  
 Description: **Tap Break-in Intruding**

Distance (ft): **175.5**  
 Structural Grade: **0**  
 O&M Grade: **2**  
 Clock Start/From: **2**  
 Clock To:  
 1st Value: **6.000**  
 2nd Value: **4.000**  
 Value Percent:  
 Continuous Index:  
 Within 8" of Joint: **NO**  
 Remarks:
