# Profile/Photo Observation Report

Date:	<b>09/03/2021</b>	Weather:		Coding:	<b>PACP 7.0</b>
Pipe Length (ft):	<b>191.0</b>	Owner:	<b>City of Hobart</b>	Pre Clean:	<b>Light Cleaning</b>
P.O.#:	<b>YES502259</b>	Surveyor:	<b>S. Bucklin</b>	PSR:	<b>P-404-022-023</b>
Customer:	<b>City of Hobart</b>	Clean Date:	<b>08/30/2021</b>	Shape:	<b>C</b>

Street:	<b>41st Avenue</b>	Flow Control:	<b>Not Controlled</b>
City:	<b>Hobart, IN</b>	Year Renewed:	
Location:	<b>Alley</b>	Tape/Media #:	
Purpose:	<b>Routine Assessment</b>	Dia/Height:	<b>10"</b>
Use:	<b>Sanitary Sewage Pipe</b>	Material:	<b>VCP</b>
Drain Area:		Lining:	
Category:	<b>NA</b>		
Comment:			
Location Details:		Direction of Survey:	<b>Upstream</b>
US MH:	<b>M-404-022</b>	DS MH:	<b>M-404-023</b>
		Total Length Surveyed (ft):	<b>175.5</b>

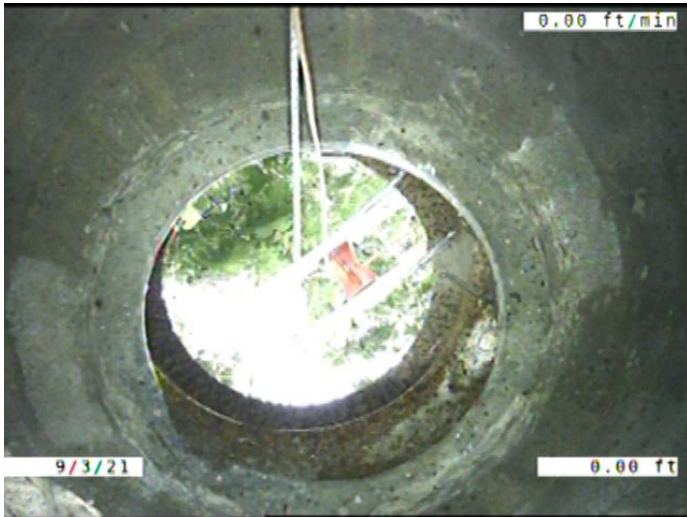
Code: **AMH**  
 Description: **Manhole**

Distance (ft): **.0**  
 Structural Grade: **0**  
 O&M Grade: **0**  
 Clock Start/From:  
 Clock To:  
 1st Value:  
 2nd Value:  
 Value Percent:  
 Continuous Index:  
 Within 8" of Joint: **NO**  
 Remarks: **M-404-023**

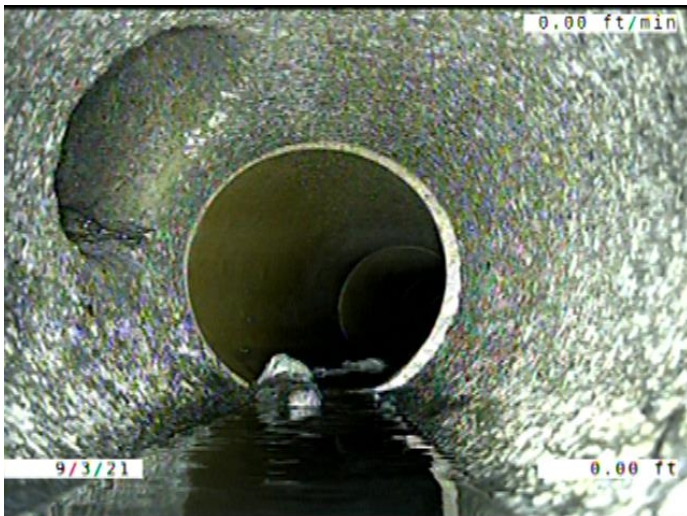
Code: **MWL**  
 Description: **Miscellaneous Water Level**

Distance (ft): **.0**  
 Structural Grade: **0**  
 O&M Grade: **0**  
 Clock Start/From:  
 Clock To:  
 1st Value:  
 2nd Value:  
 Value Percent: **5.000**  
 Continuous Index:  
 Within 8" of Joint: **NO**  
 Remarks:

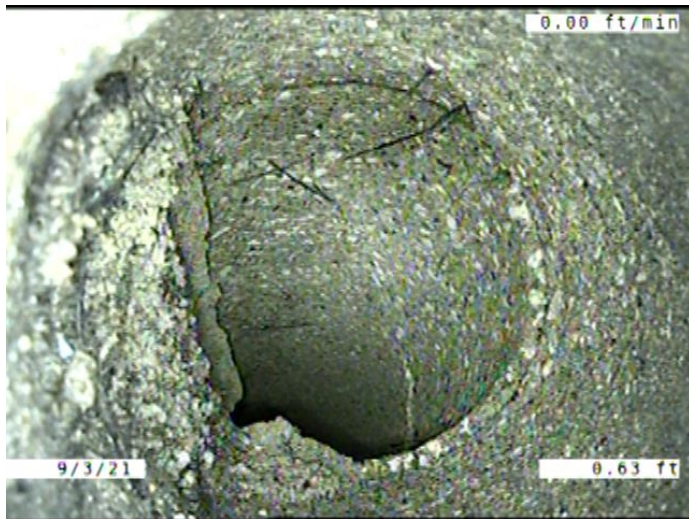
Code: **TF**  
 Description: **Tap Factory**

Distance (ft): **.6**  
 Structural Grade: **0**  
 O&M Grade: **0**  
 Clock Start/From: **10**  
 Clock To:  
 1st Value: **6.000**  
 2nd Value:  
 Value Percent:  
 Continuous Index:  
 Within 8" of Joint: **YES**  
 Remarks:

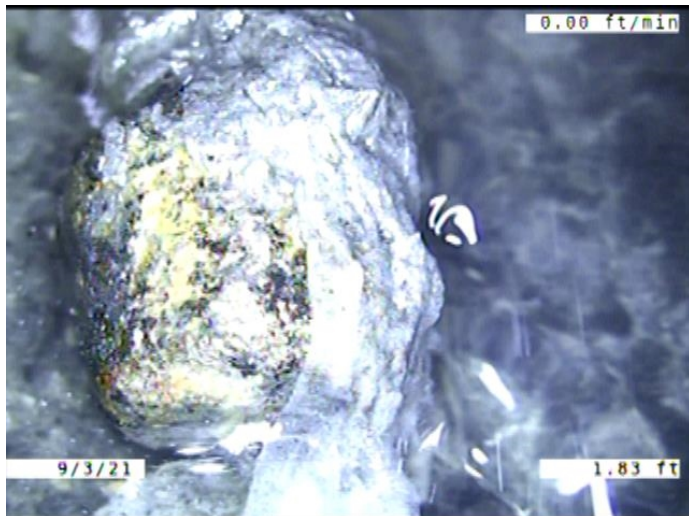
Code: **OBN**  
 Description: **Obstruction Construction Debris**

Distance (ft): **1.8**  
 Structural Grade: **0**  
 O&M Grade: **2**  
 Clock Start/From: **6**  
 Clock To:  
 1st Value:  
 2nd Value:  
 Value Percent: **5.000**  
 Continuous Index:  
 Within 8" of Joint: **YES**  
 Remarks: **METAL PIPE WITH TP**

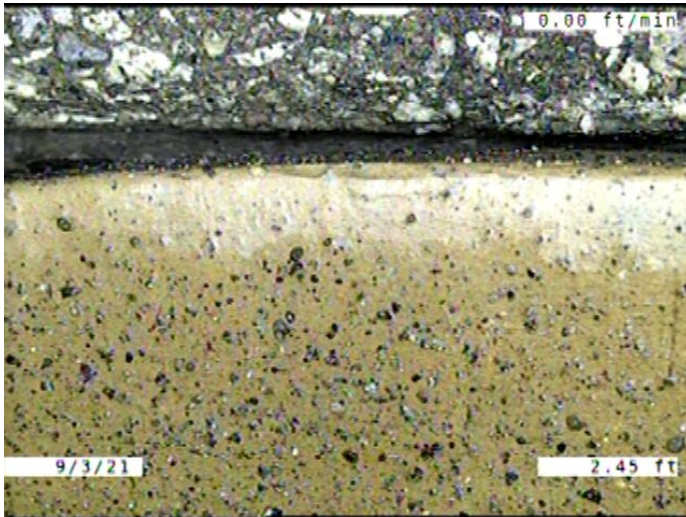
Code: **MMC**  
 Description: **Miscellaneous Material Change**

Distance (ft): **2.4**  
 Structural Grade: **0**  
 O&M Grade: **0**  
 Clock Start/From:  
 Clock To:  
 1st Value:  
 2nd Value:  
 Value Percent:  
 Continuous Index:  
 Within 8" of Joint: **NO**  
 Remarks: **CONCRETE TO VCP**

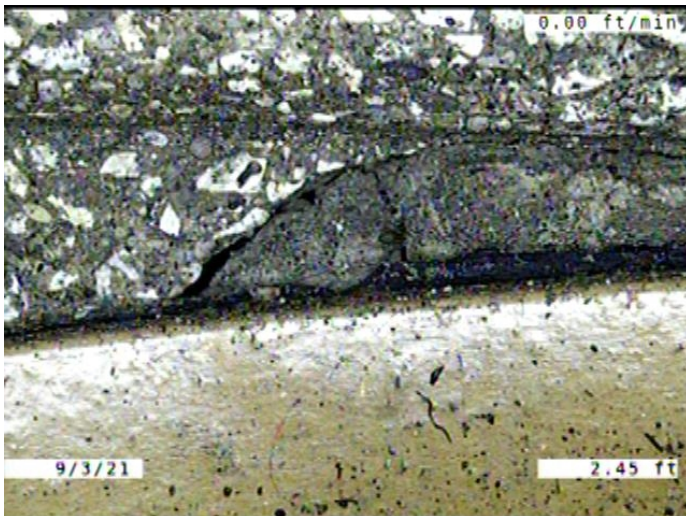
Code: **B**  
 Description: **Broken**

Distance (ft): **2.4**  
 Structural Grade: **4**  
 O&M Grade: **0**  
 Clock Start/From: **11**  
 Clock To: **1**  
 1st Value:  
 2nd Value:  
 Value Percent:  
 Continuous Index:  
 Within 8" of Joint: **YES**  
 Remarks: **OUTSIDE OF THE JOINT**

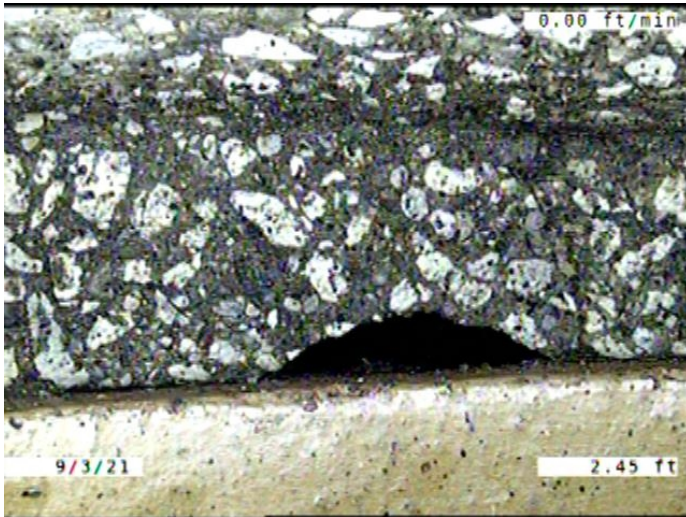
Code: **HVV**  
Description: **Hole Void Visible**

Distance (ft): **2.4**  
Structural Grade: **5**  
O&M Grade: **0**  
Clock Start/From: **10**  
Clock To:  
1st Value:  
2nd Value:  
Value Percent:  
Continuous Index:  
Within 8" of Joint: **YES**  
Remarks:

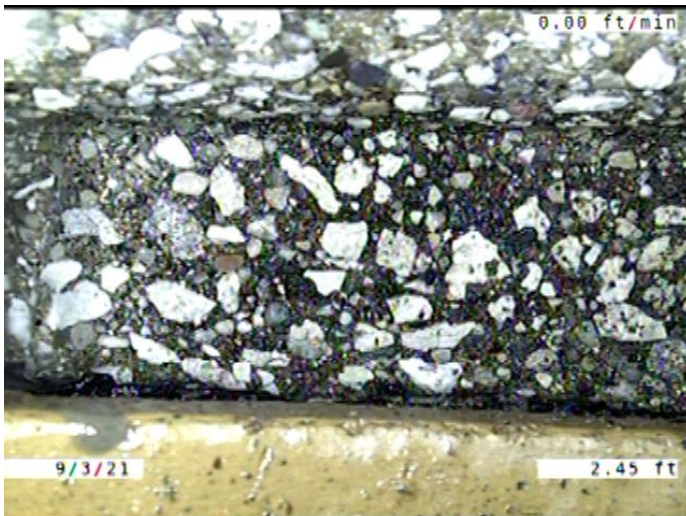
Code: **JAL**  
Description: **Joint Angular Large**

Distance (ft): **2.4**  
Structural Grade: **4**  
O&M Grade: **0**  
Clock Start/From:  
Clock To:  
1st Value:  
2nd Value:  
Value Percent:  
Continuous Index:  
Within 8" of Joint: **NO**  
Remarks:

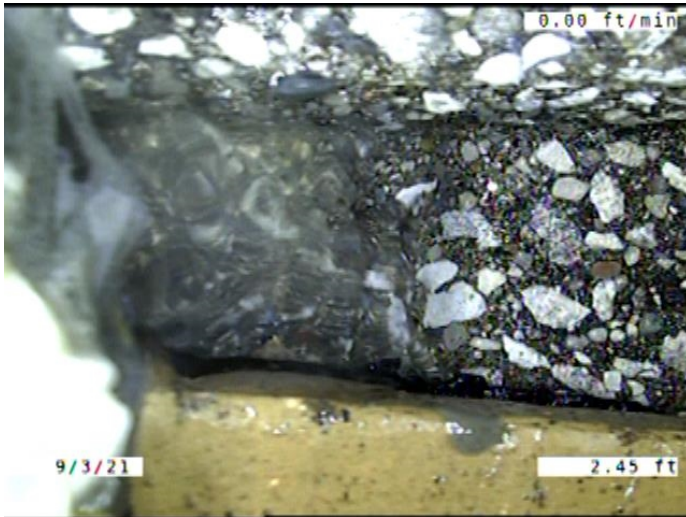
Code: **IRJ**  
 Description: **Infiltration Runner Joint**

Distance (ft): **2.4**  
 Structural Grade: **0**  
 O&M Grade: **4**  
 Clock Start/From: **8**  
 Clock To:  
 1st Value:  
 2nd Value:  
 Value Percent:  
 Continuous Index:  
 Within 8" of Joint: **YES**  
 Remarks:

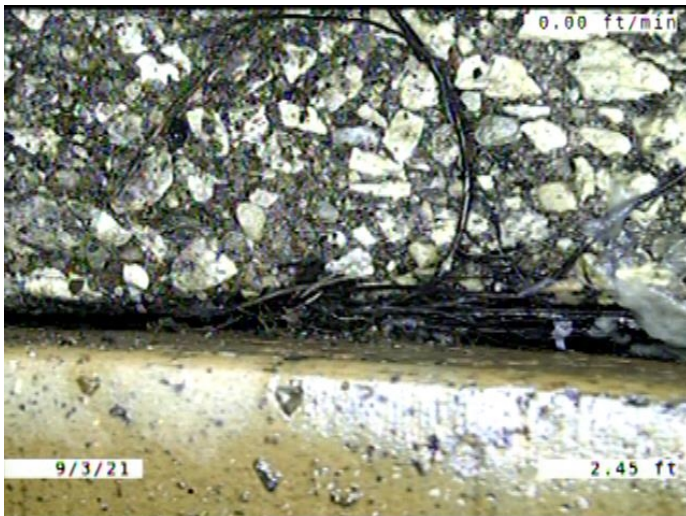
Code: **RFJ**  
 Description: **Roots Fine Joint**

Distance (ft): **2.4**  
 Structural Grade: **0**  
 O&M Grade: **1**  
 Clock Start/From: **3**  
 Clock To: **4**  
 1st Value:  
 2nd Value:  
 Value Percent:  
 Continuous Index:  
 Within 8" of Joint: **YES**  
 Remarks:

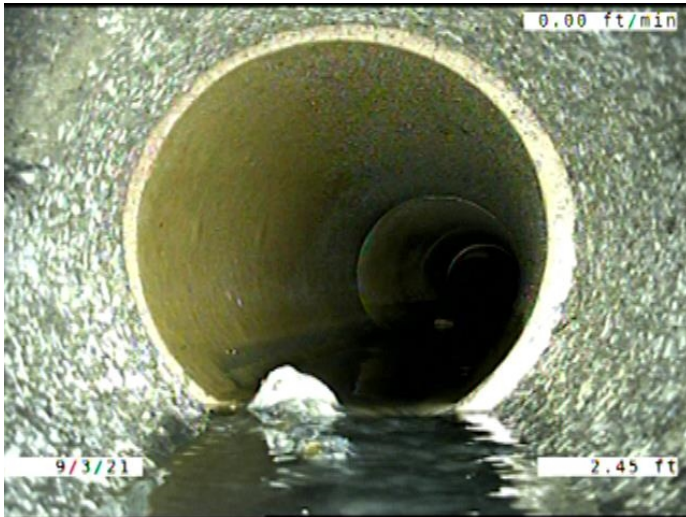
Code: **LR**  
 Description: **Line Right**

Distance (ft): **2.4**  
 Structural Grade: **0**  
 O&M Grade: **1**  
 Clock Start/From:  
 Clock To:  
 1st Value:  
 2nd Value:  
 Value Percent: **10.000**  
 Continuous Index:  
 Within 8" of Joint: **NO**  
 Remarks:

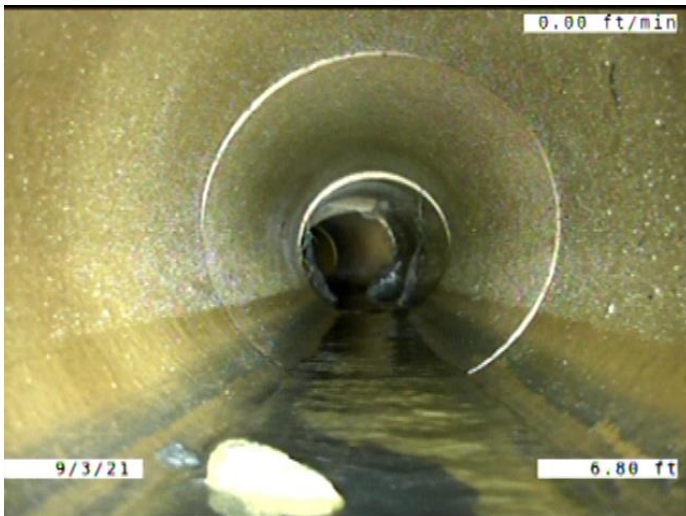
Code: **DSF**  
 Description: **Deposits Settled Fine**

Distance (ft): **6.8**  
 Structural Grade: **0**  
 O&M Grade: **2**  
 Clock Start/From: **5**  
 Clock To: **7**  
 1st Value:  
 2nd Value:  
 Value Percent: **5.000**  
 Continuous Index: **S01**  
 Within 8" of Joint: **YES**  
 Remarks:

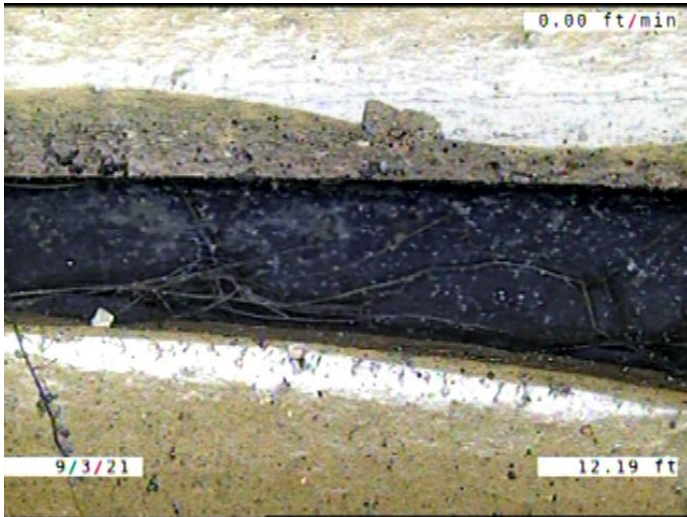
Code: **RFJ**  
 Description: **Roots Fine Joint**

Distance (ft): **12.2**  
 Structural Grade: **0**  
 O&M Grade: **1**  
 Clock Start/From: **8**  
 Clock To: **4**  
 1st Value:  
 2nd Value:  
 Value Percent:  
 Continuous Index:  
 Within 8" of Joint: **YES**  
 Remarks:

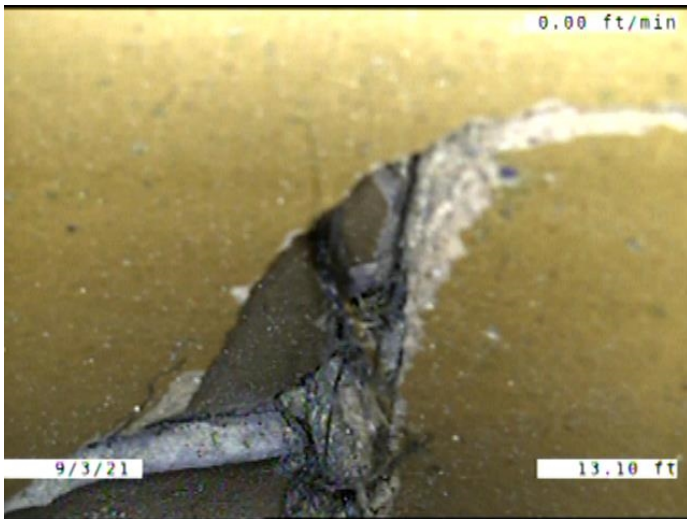
Code: **B**  
 Description: **Broken**

Distance (ft): **13.1**  
 Structural Grade: **4**  
 O&M Grade: **0**  
 Clock Start/From: **10**  
 Clock To: **5**  
 1st Value:  
 2nd Value:  
 Value Percent:  
 Continuous Index:  
 Within 8" of Joint: **YES**  
 Remarks:

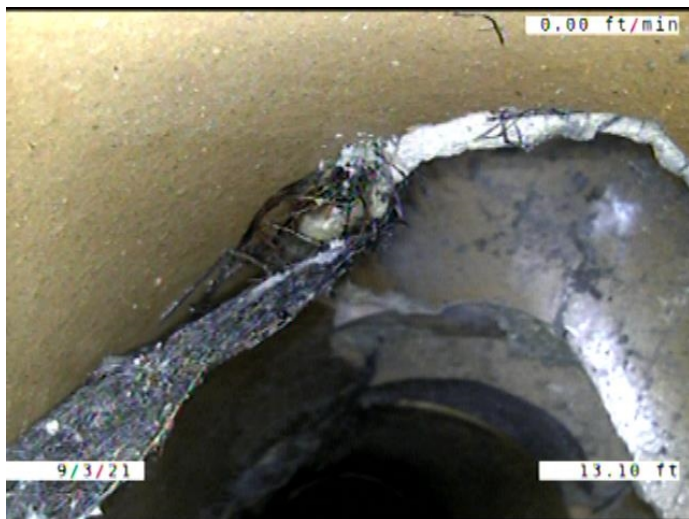
Code: **RMB**  
 Description: **Roots Medium Barrel**

Distance (ft): **13.1**  
 Structural Grade: **0**  
 O&M Grade: **4**  
 Clock Start/From: **9**  
 Clock To: **4**  
 1st Value:  
 2nd Value:  
 Value Percent: **5.000**  
 Continuous Index:  
 Within 8" of Joint: **NO**  
 Remarks:

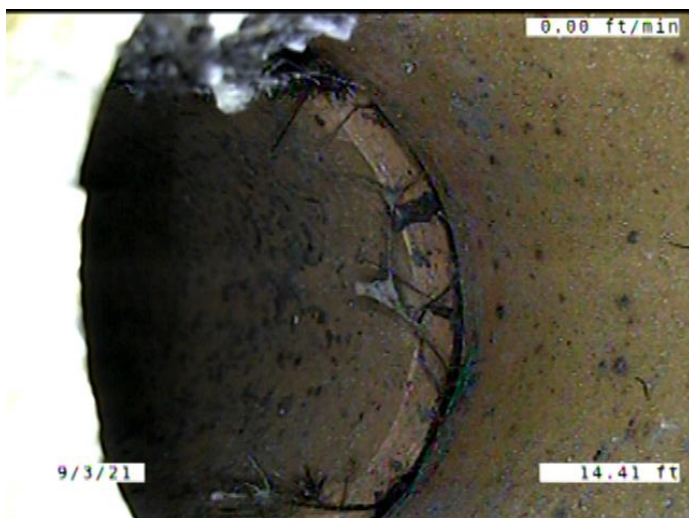
Code: **TBD**  
 Description: **Tap Break-in/Hammer Defective**

Distance (ft): **14.4**  
 Structural Grade: **0**  
 O&M Grade: **3**  
 Clock Start/From: **10**  
 Clock To:  
 1st Value: **6.000**  
 2nd Value:  
 Value Percent:  
 Continuous Index:  
 Within 8" of Joint: **YES**  
 Remarks: **Debris**

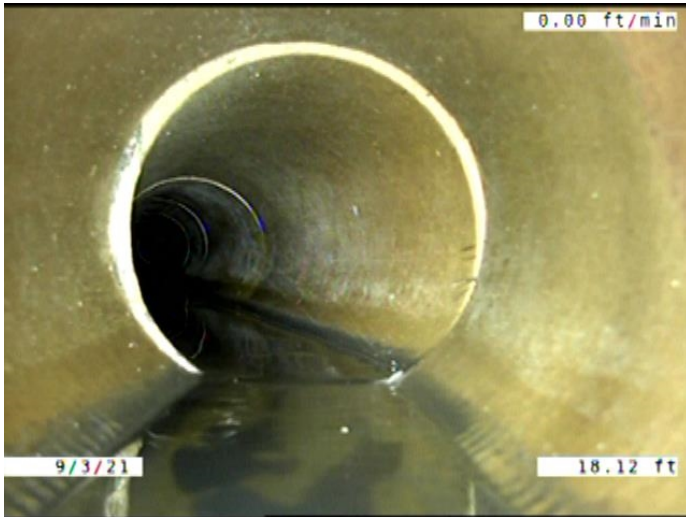
Code: **LL**  
 Description: **Line Left**

Distance (ft): **18.1**  
 Structural Grade: **0**  
 O&M Grade: **1**  
 Clock Start/From:  
 Clock To:  
 1st Value:  
 2nd Value:  
 Value Percent: **10.000**  
 Continuous Index:  
 Within 8" of Joint: **NO**  
 Remarks:

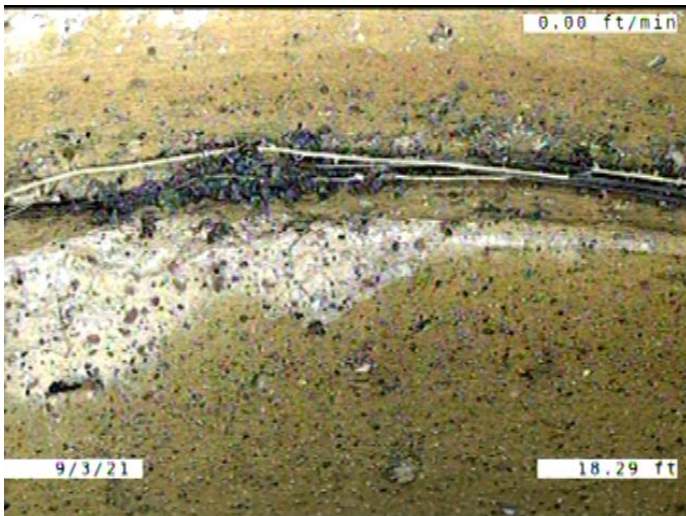
Code: **RFJ**  
 Description: **Roots Fine Joint**

Distance (ft): **18.3**  
 Structural Grade: **0**  
 O&M Grade: **1**  
 Clock Start/From: **8**  
 Clock To: **4**  
 1st Value:  
 2nd Value:  
 Value Percent:  
 Continuous Index:  
 Within 8" of Joint: **YES**  
 Remarks:

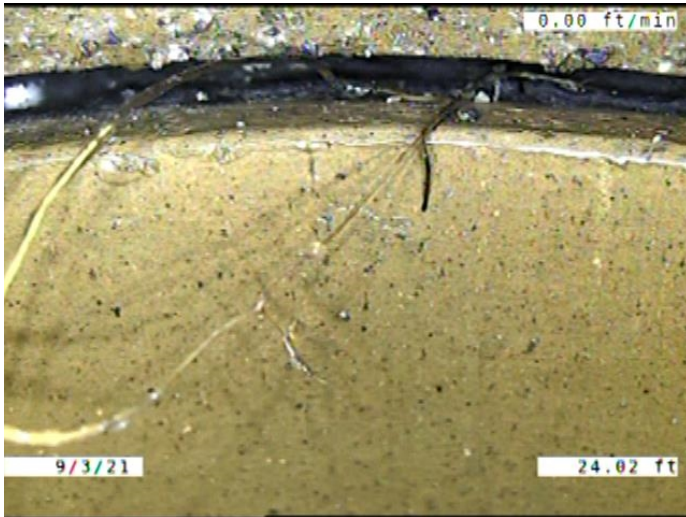
Code: **RFJ**  
 Description: **Roots Fine Joint**

Distance (ft): **24.0**  
 Structural Grade: **0**  
 O&M Grade: **1**  
 Clock Start/From: **10**  
 Clock To: **4**  
 1st Value:  
 2nd Value:  
 Value Percent:  
 Continuous Index:  
 Within 8" of Joint: **YES**  
 Remarks:

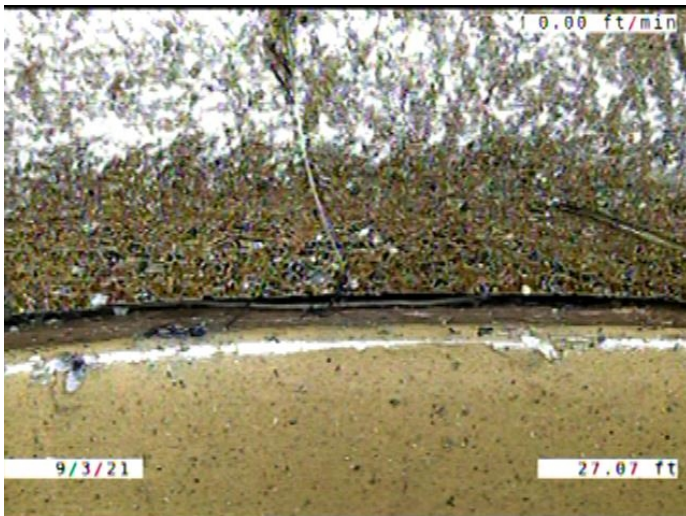
Code: **RFJ**  
 Description: **Roots Fine Joint**

Distance (ft): **27.1**  
 Structural Grade: **0**  
 O&M Grade: **1**  
 Clock Start/From: **10**  
 Clock To: **12**  
 1st Value:  
 2nd Value:  
 Value Percent:  
 Continuous Index:  
 Within 8" of Joint: **YES**  
 Remarks:

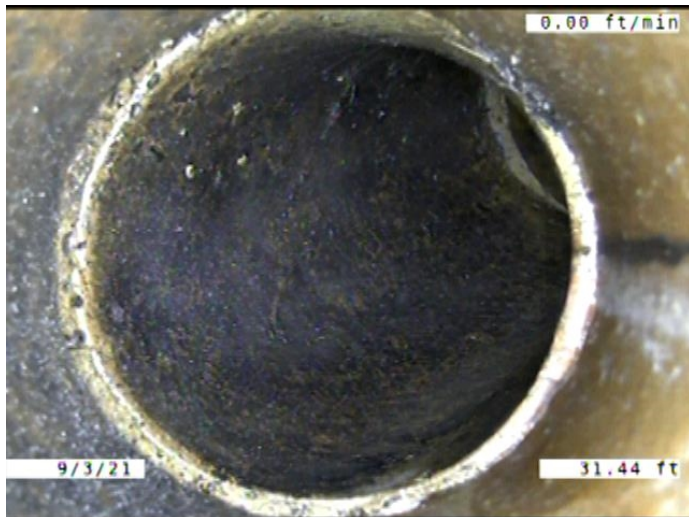
Code: **TF**  
 Description: **Tap Factory**

Distance (ft): **31.4**  
 Structural Grade: **0**  
 O&M Grade: **0**  
 Clock Start/From: **2**  
 Clock To:  
 1st Value: **6.000**  
 2nd Value:  
 Value Percent:  
 Continuous Index:  
 Within 8" of Joint: **YES**  
 Remarks: **CONSTANTLY RUNNING WATER**

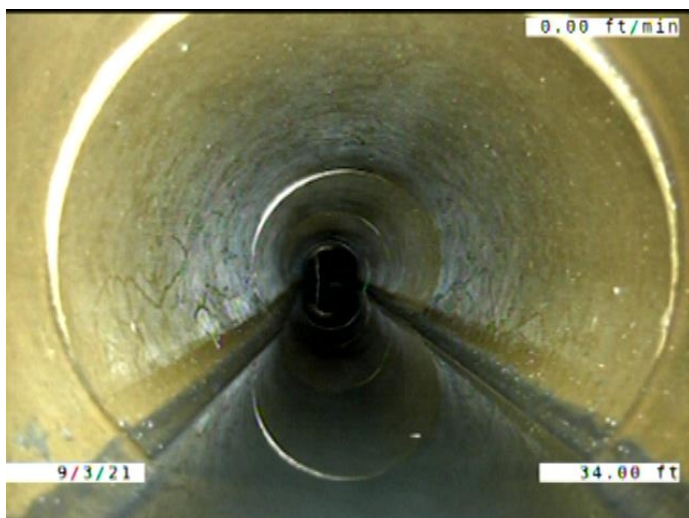
Code: **MWLS**  
 Description: **Miscellaneous Water Level Sag**

Distance (ft): **34.0**  
 Structural Grade: **2**  
 O&M Grade: **0**  
 Clock Start/From:  
 Clock To:  
 1st Value:  
 2nd Value:  
 Value Percent: **5.000**  
 Continuous Index: **S02**  
 Within 8" of Joint: **NO**  
 Remarks:

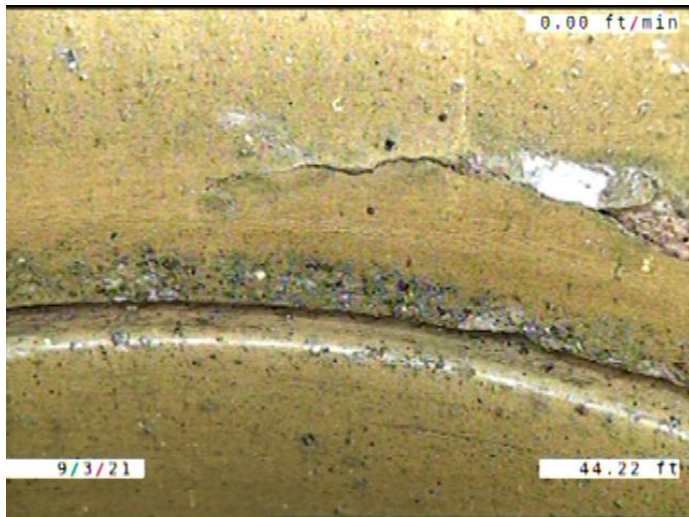
Code: **FM**  
 Description: **Fracture Multiple**

Distance (ft): **44.2**  
 Structural Grade: **4**  
 O&M Grade: **0**  
 Clock Start/From: **2**  
 Clock To: **4**  
 1st Value:  
 2nd Value:  
 Value Percent:  
 Continuous Index:  
 Within 8" of Joint: **YES**  
 Remarks:

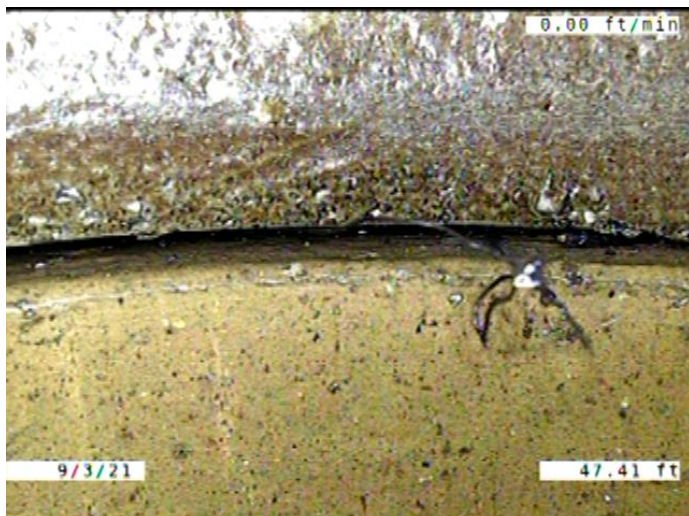
Code: **RFJ**  
 Description: **Roots Fine Joint**

Distance (ft): **47.4**  
 Structural Grade: **0**  
 O&M Grade: **1**  
 Clock Start/From: **9**  
 Clock To: **10**  
 1st Value:  
 2nd Value:  
 Value Percent:  
 Continuous Index:  
 Within 8" of Joint: **YES**  
 Remarks:

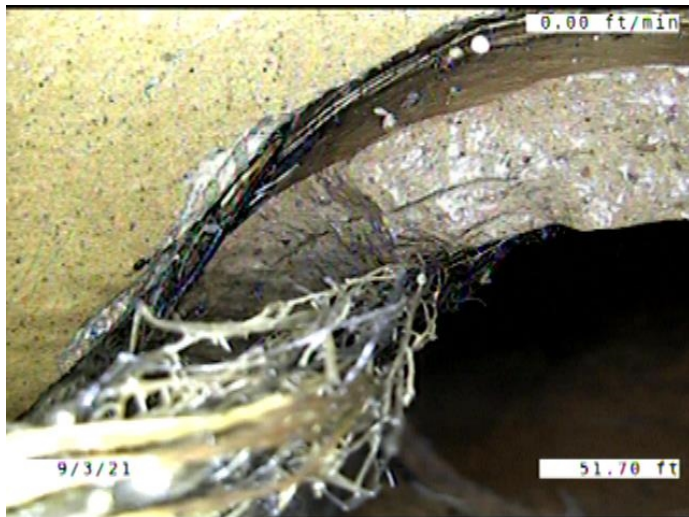
Code: **RML**  
 Description: **Roots Medium Lateral**

Distance (ft): **51.7**  
 Structural Grade: **0**  
 O&M Grade: **3**  
 Clock Start/From: **10**  
 Clock To: **1**  
 1st Value:  
 2nd Value:  
 Value Percent: **5.000**  
 Continuous Index:  
 Within 8" of Joint: **NO**  
 Remarks:

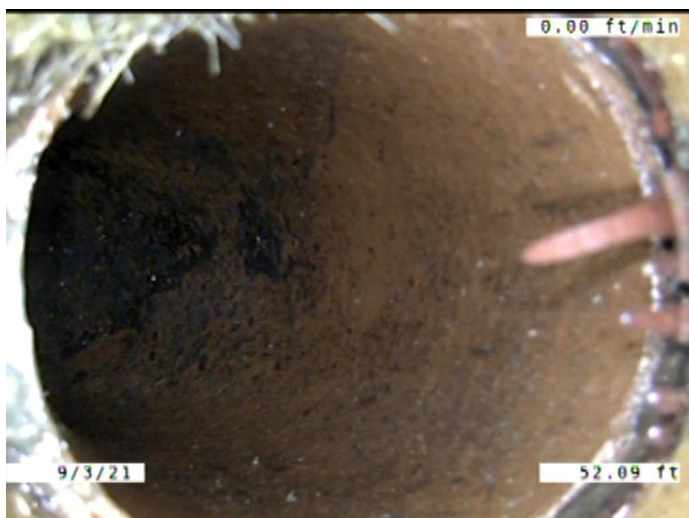
Code: **TBI**  
 Description: **Tap Break-in Intruding**

Distance (ft): **52.1**  
 Structural Grade: **0**  
 O&M Grade: **2**  
 Clock Start/From: **11**  
 Clock To:  
 1st Value: **6.000**  
 2nd Value: **1.000**  
 Value Percent:  
 Continuous Index:  
 Within 8" of Joint: **YES**  
 Remarks:

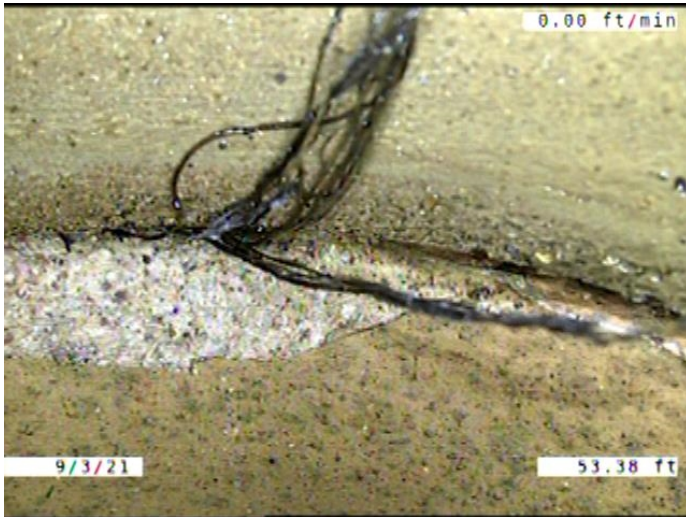
Code: **RFJ**  
 Description: **Roots Fine Joint**

Distance (ft): **53.4**  
 Structural Grade: **0**  
 O&M Grade: **1**  
 Clock Start/From: **10**  
 Clock To: **3**  
 1st Value:  
 2nd Value:  
 Value Percent:  
 Continuous Index:  
 Within 8" of Joint: **YES**  
 Remarks:

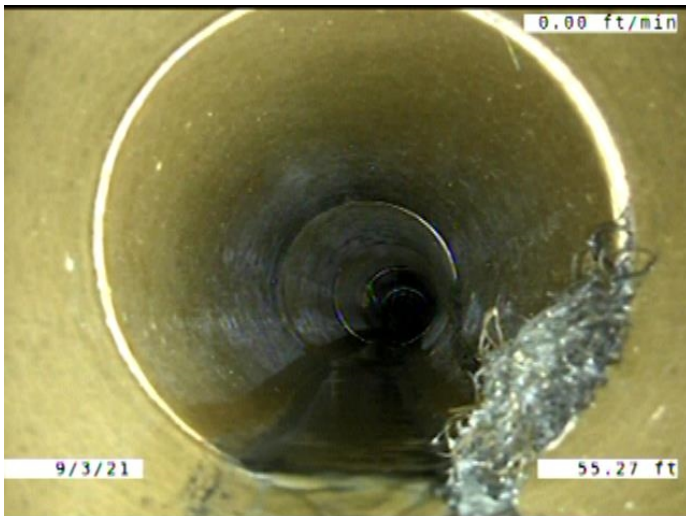
Code: **MWLS**  
 Description: **Miscellaneous Water Level Sag**

Distance (ft): **55.3**  
 Structural Grade: **2**  
 O&M Grade: **0**  
 Clock Start/From:  
 Clock To:  
 1st Value:  
 2nd Value:  
 Value Percent: **5.000**  
 Continuous Index: **F02**  
 Within 8" of Joint: **NO**  
 Remarks:

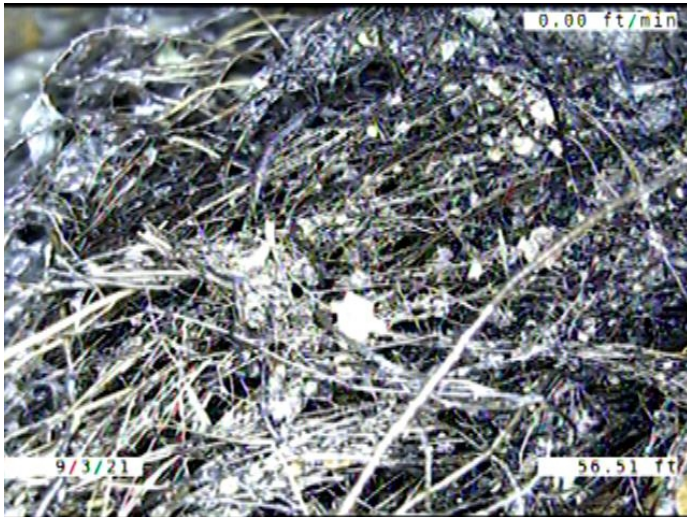
Code: **RMJ**  
Description: **Roots Medium Joint**

Distance (ft): **56.5**  
Structural Grade: **0**  
O&M Grade: **3**  
Clock Start/From: **2**  
Clock To: **5**  
1st Value:  
2nd Value:  
Value Percent: **10.000**  
Continuous Index:  
Within 8" of Joint: **YES**  
Remarks:

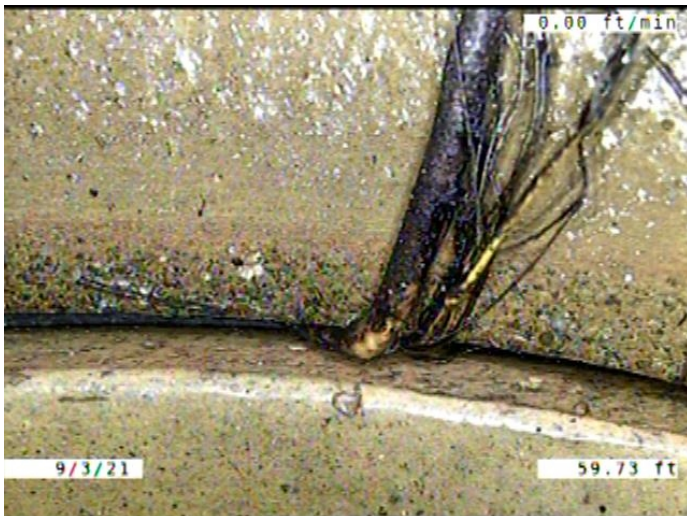
Code: **RMJ**  
Description: **Roots Medium Joint**

Distance (ft): **59.7**  
Structural Grade: **0**  
O&M Grade: **3**  
Clock Start/From: **3**  
Clock To:  
1st Value:  
2nd Value:  
Value Percent: **5.000**  
Continuous Index:  
Within 8" of Joint: **YES**  
Remarks:

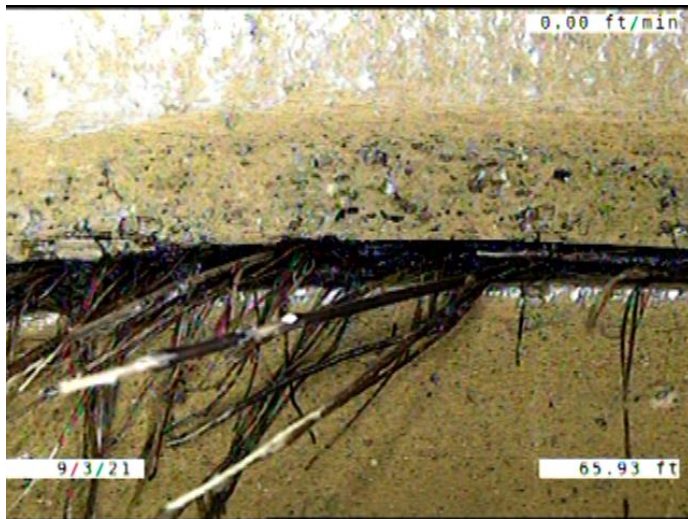
Code: **RFJ**  
 Description: **Roots Fine Joint**

Distance (ft): **65.9**  
 Structural Grade: **0**  
 O&M Grade: **1**  
 Clock Start/From: **8**  
 Clock To: **4**  
 1st Value:  
 2nd Value:  
 Value Percent:  
 Continuous Index:  
 Within 8" of Joint: **YES**  
 Remarks:

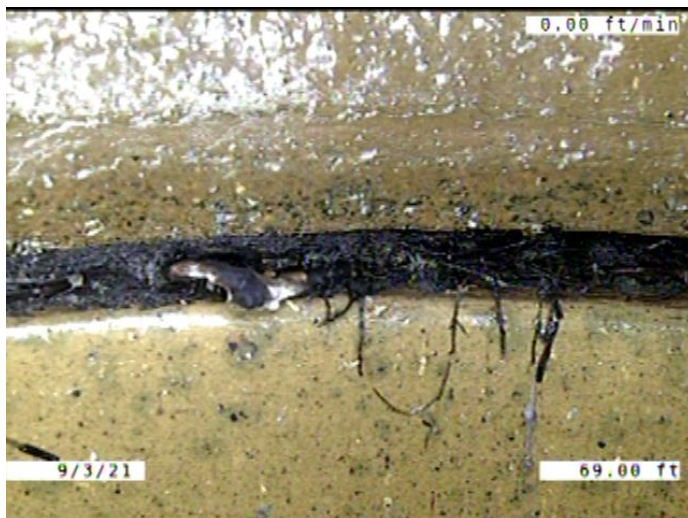
Code: **RFJ**  
 Description: **Roots Fine Joint**

Distance (ft): **69.0**  
 Structural Grade: **0**  
 O&M Grade: **1**  
 Clock Start/From: **7**  
 Clock To: **1**  
 1st Value:  
 2nd Value:  
 Value Percent:  
 Continuous Index:  
 Within 8" of Joint: **YES**  
 Remarks:

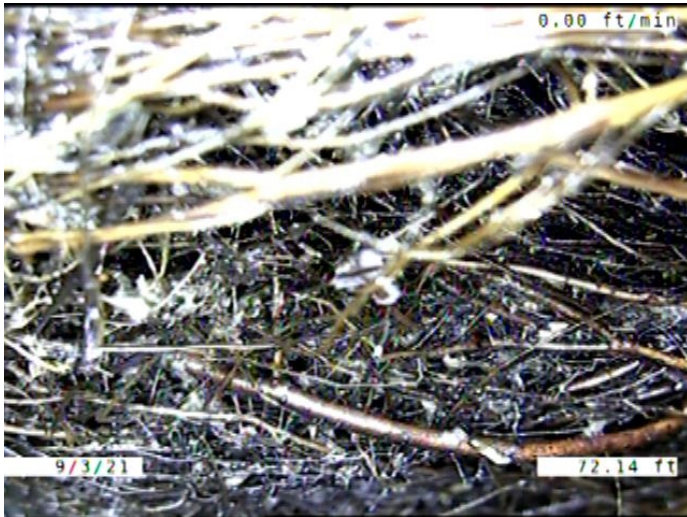
Code: **RMJ**  
 Description: **Roots Medium Joint**

Distance (ft): **72.1**  
 Structural Grade: **0**  
 O&M Grade: **3**  
 Clock Start/From: **7**  
 Clock To: **4**  
 1st Value:  
 2nd Value:  
 Value Percent: **5.000**  
 Continuous Index:  
 Within 8" of Joint: **YES**  
 Remarks:

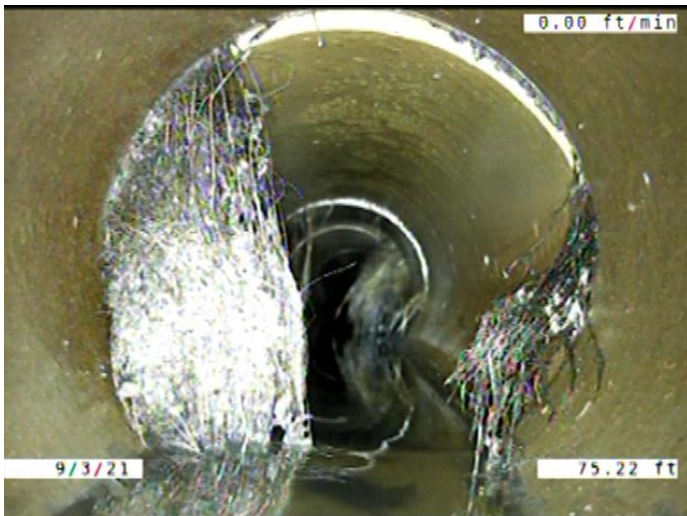
Code: **RMJ**  
 Description: **Roots Medium Joint**

Distance (ft): **75.2**  
 Structural Grade: **0**  
 O&M Grade: **3**  
 Clock Start/From: **7**  
 Clock To: **5**  
 1st Value:  
 2nd Value:  
 Value Percent: **30.000**  
 Continuous Index:  
 Within 8" of Joint: **YES**  
 Remarks:

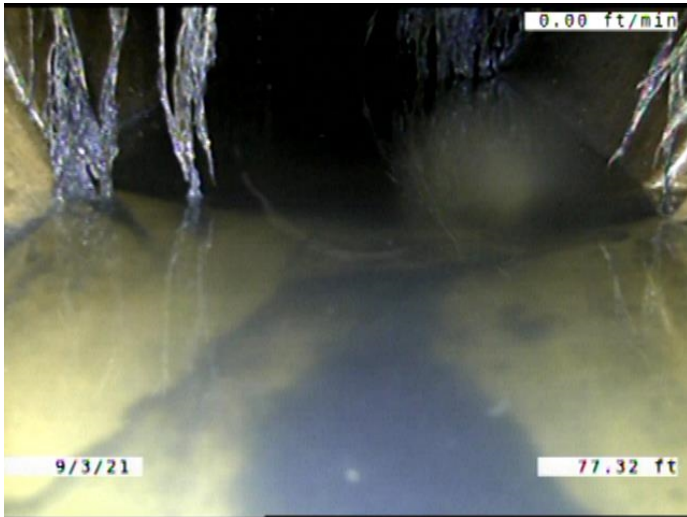
Code: **B**  
 Description: **Broken**

Distance (ft): **77.3**  
 Structural Grade: **4**  
 O&M Grade: **0**  
 Clock Start/From: **5**  
 Clock To: **12**  
 1st Value:  
 2nd Value:  
 Value Percent:  
 Continuous Index:  
 Within 8" of Joint: **NO**  
 Remarks:

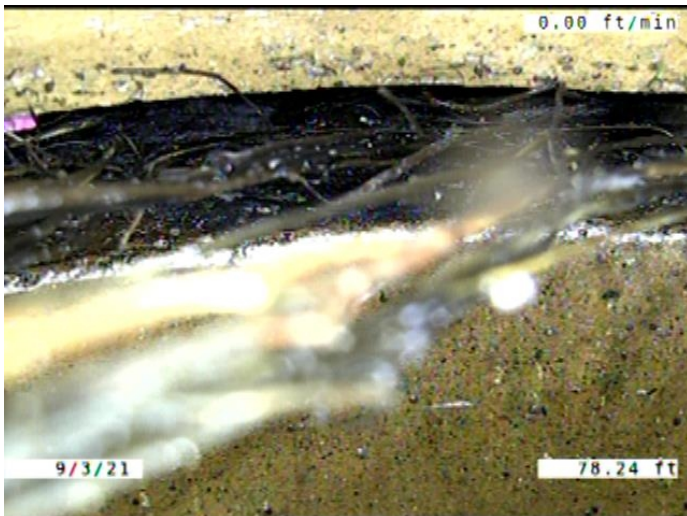
Code: **RFJ**  
 Description: **Roots Fine Joint**

Distance (ft): **78.2**  
 Structural Grade: **0**  
 O&M Grade: **1**  
 Clock Start/From: **7**  
 Clock To: **4**  
 1st Value:  
 2nd Value:  
 Value Percent:  
 Continuous Index:  
 Within 8" of Joint: **YES**  
 Remarks:

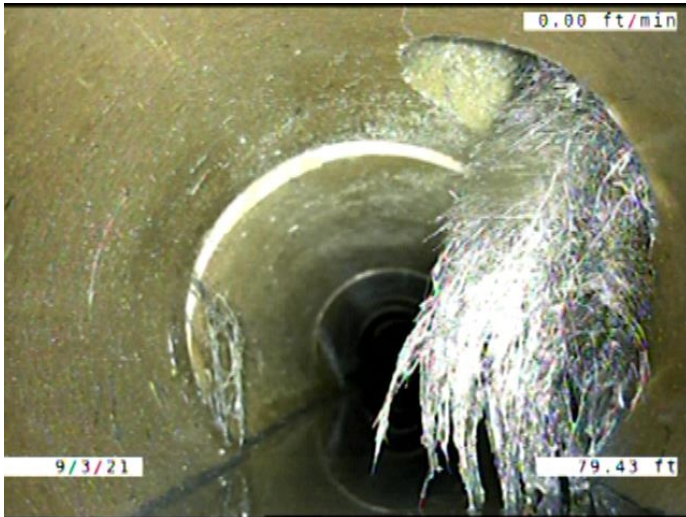
Code: **RML**  
 Description: **Roots Medium Lateral**

Distance (ft): **79.4**  
 Structural Grade: **0**  
 O&M Grade: **3**  
 Clock Start/From: **1**  
 Clock To:  
 1st Value:  
 2nd Value:  
 Value Percent: **20.000**  
 Continuous Index:  
 Within 8" of Joint: **NO**  
 Remarks:

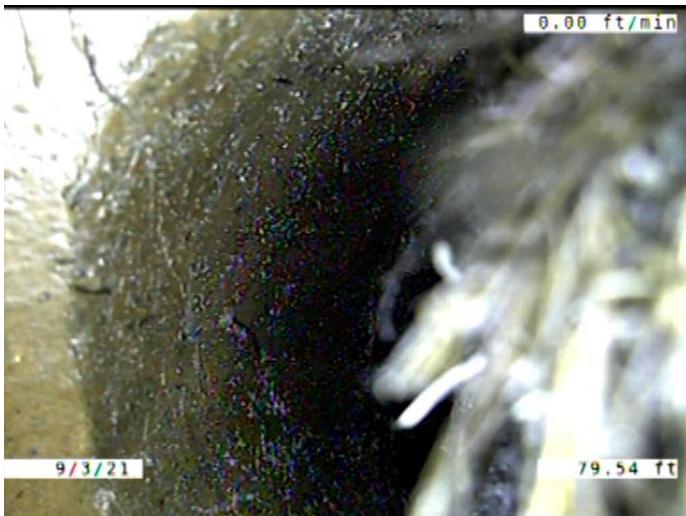
Code: **TFD**  
 Description: **Tap Factory Defective**

Distance (ft): **79.5**  
 Structural Grade: **0**  
 O&M Grade: **3**  
 Clock Start/From: **1**  
 Clock To:  
 1st Value: **6.000**  
 2nd Value:  
 Value Percent:  
 Continuous Index:  
 Within 8" of Joint: **YES**  
 Remarks: **Debris**

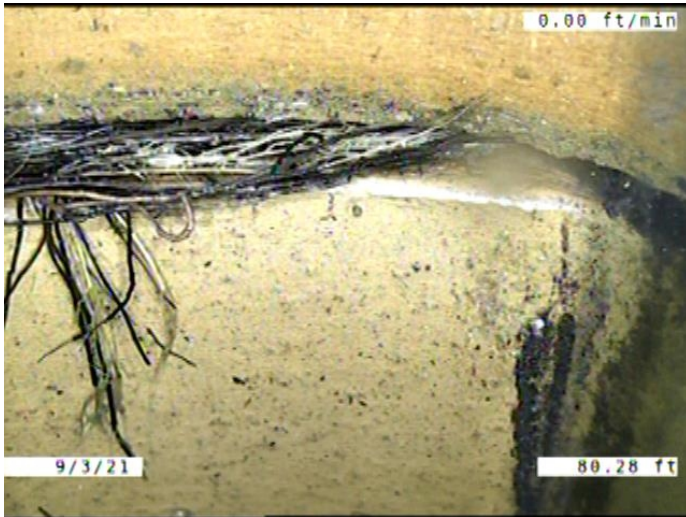
Code: **RFJ**  
 Description: **Roots Fine Joint**

Distance (ft): **80.3**  
 Structural Grade: **0**  
 O&M Grade: **1**  
 Clock Start/From: **9**  
 Clock To: **4**  
 1st Value:  
 2nd Value:  
 Value Percent:  
 Continuous Index:  
 Within 8" of Joint: **YES**  
 Remarks:

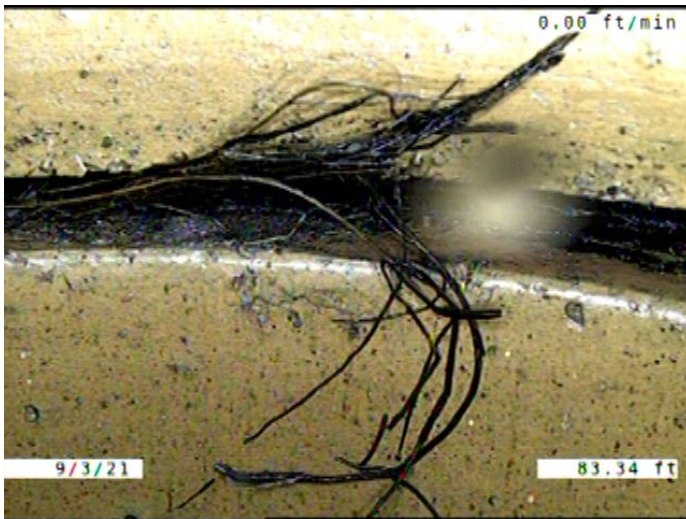
Code: **RFJ**  
 Description: **Roots Fine Joint**

Distance (ft): **83.3**  
 Structural Grade: **0**  
 O&M Grade: **1**  
 Clock Start/From: **8**  
 Clock To: **3**  
 1st Value:  
 2nd Value:  
 Value Percent:  
 Continuous Index:  
 Within 8" of Joint: **YES**  
 Remarks:

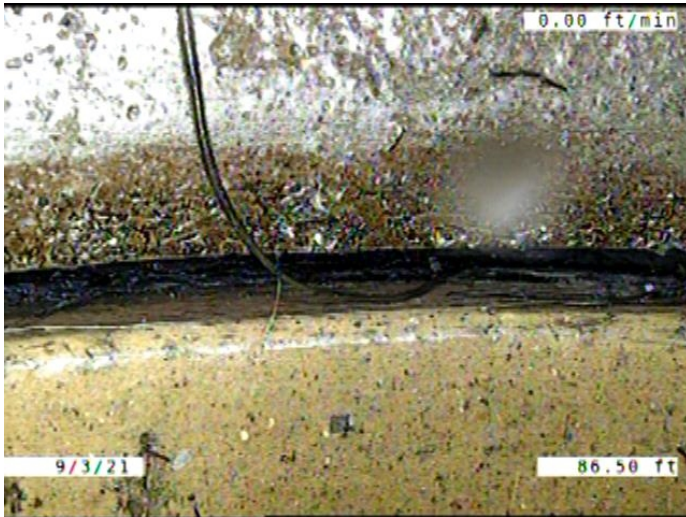
Code: **RFJ**  
 Description: **Roots Fine Joint**

Distance (ft): **86.5**  
 Structural Grade: **0**  
 O&M Grade: **1**  
 Clock Start/From: **9**  
 Clock To: **10**  
 1st Value:  
 2nd Value:  
 Value Percent:  
 Continuous Index:  
 Within 8" of Joint: **YES**  
 Remarks:

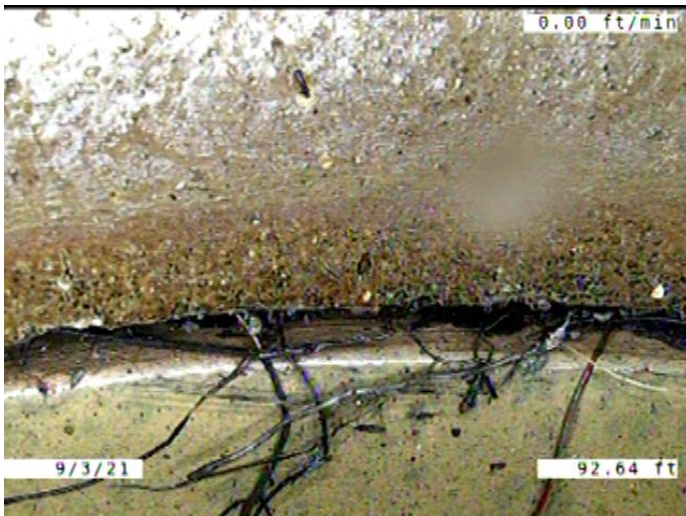
Code: **RFJ**  
 Description: **Roots Fine Joint**

Distance (ft): **92.6**  
 Structural Grade: **0**  
 O&M Grade: **1**  
 Clock Start/From: **8**  
 Clock To: **11**  
 1st Value:  
 2nd Value:  
 Value Percent:  
 Continuous Index:  
 Within 8" of Joint: **YES**  
 Remarks:

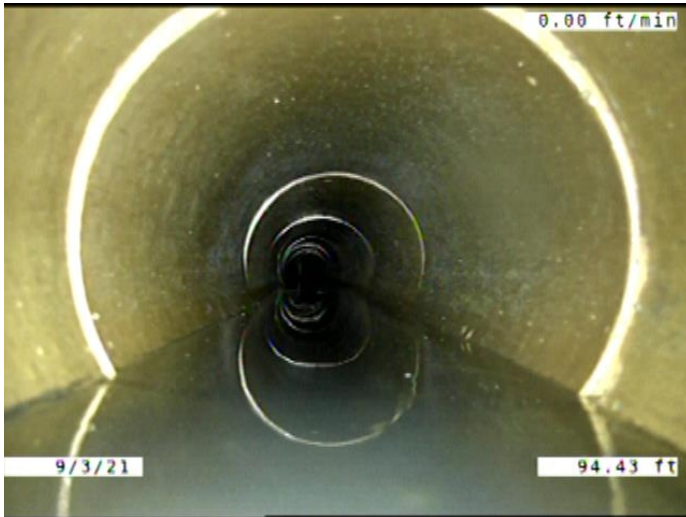
Code: **MWLS**  
 Description: **Miscellaneous Water Level Sag**

Distance (ft): **94.4**  
 Structural Grade: **2**  
 O&M Grade: **0**  
 Clock Start/From:  
 Clock To:  
 1st Value:  
 2nd Value:  
 Value Percent: **5.000**  
 Continuous Index: **S03**  
 Within 8" of Joint: **NO**  
 Remarks:

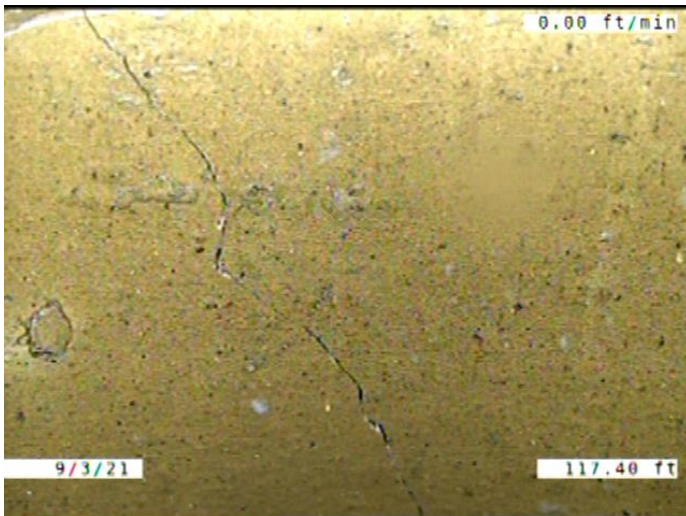
Code: **CS**  
 Description: **Crack Spiral**

Distance (ft): **117.4**  
 Structural Grade: **2**  
 O&M Grade: **0**  
 Clock Start/From: **11**  
 Clock To: **12**  
 1st Value:  
 2nd Value:  
 Value Percent:  
 Continuous Index:  
 Within 8" of Joint: **YES**  
 Remarks:

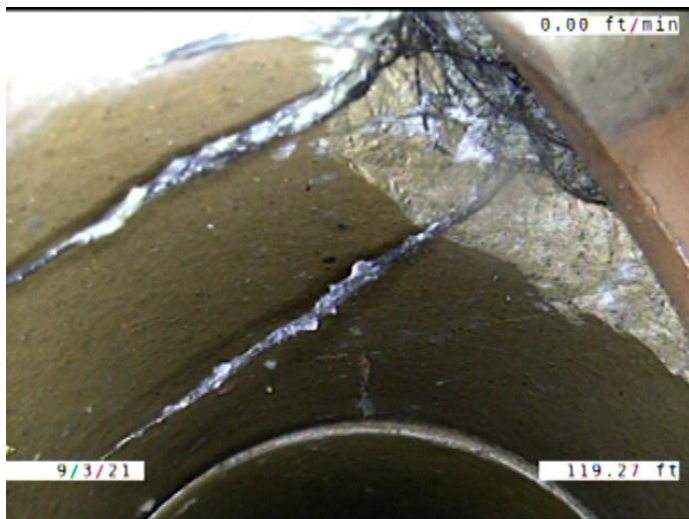
Code: **RML**  
 Description: **Roots Medium Lateral**

Distance (ft): **119.3**  
 Structural Grade: **0**  
 O&M Grade: **3**  
 Clock Start/From: **10**  
 Clock To: **12**  
 1st Value:  
 2nd Value:  
 Value Percent: **5.000**  
 Continuous Index:  
 Within 8" of Joint: **NO**  
 Remarks:

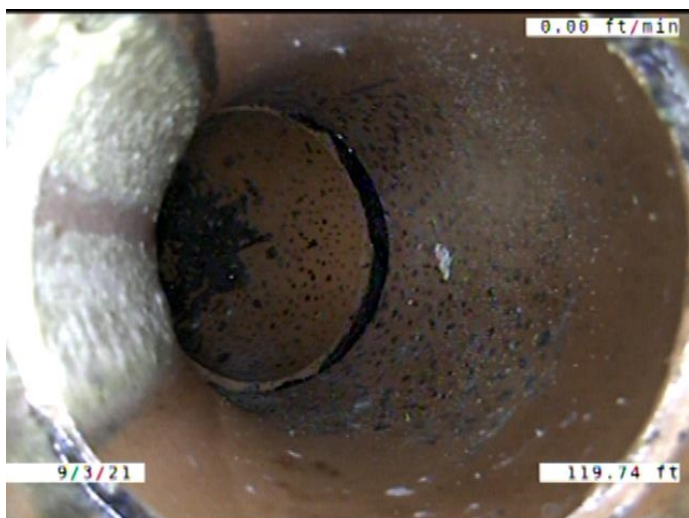
Code: **TBI**  
 Description: **Tap Break-in Intruding**

Distance (ft): **119.7**  
 Structural Grade: **0**  
 O&M Grade: **2**  
 Clock Start/From: **12**  
 Clock To:  
 1st Value: **6.000**  
 2nd Value: **1.000**  
 Value Percent:  
 Continuous Index:  
 Within 8" of Joint: **YES**  
 Remarks:

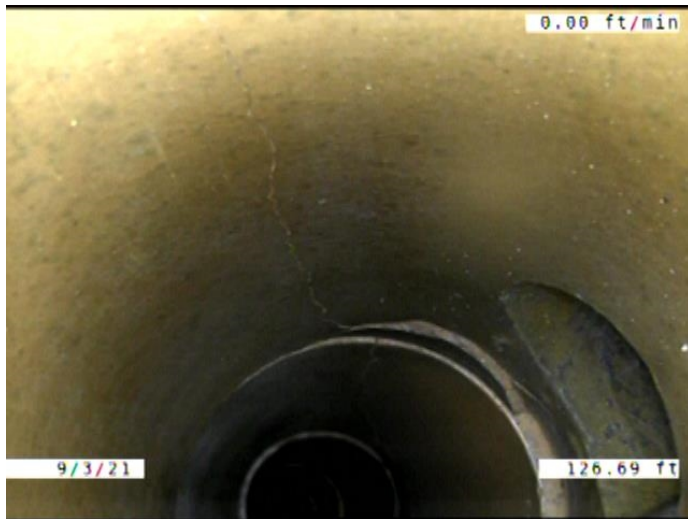
Code: **FM**  
 Description: **Fracture Multiple**

Distance (ft): **126.7**  
 Structural Grade: **4**  
 O&M Grade: **0**  
 Clock Start/From: **12**  
 Clock To: **12**  
 1st Value:  
 2nd Value:  
 Value Percent:  
 Continuous Index: **S04**  
 Within 8" of Joint: **YES**  
 Remarks:

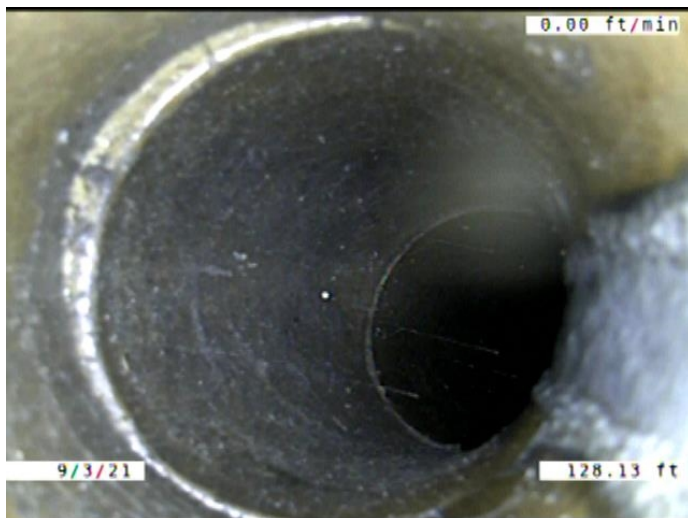
Code: **TF**  
 Description: **Tap Factory**

Distance (ft): **128.1**  
 Structural Grade: **0**  
 O&M Grade: **0**  
 Clock Start/From: **2**  
 Clock To:  
 1st Value: **6.000**  
 2nd Value:  
 Value Percent:  
 Continuous Index:  
 Within 8" of Joint: **YES**  
 Remarks:

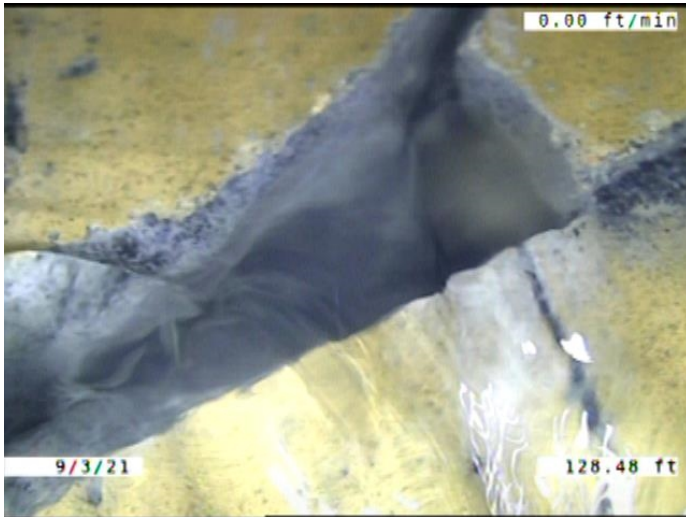
Code: **BVV**  
 Description: **Broken Void Visible**

Distance (ft): **128.5**  
 Structural Grade: **5**  
 O&M Grade: **0**  
 Clock Start/From: **2**  
 Clock To: **7**  
 1st Value:  
 2nd Value:  
 Value Percent:  
 Continuous Index:  
 Within 8" of Joint: **YES**  
 Remarks:

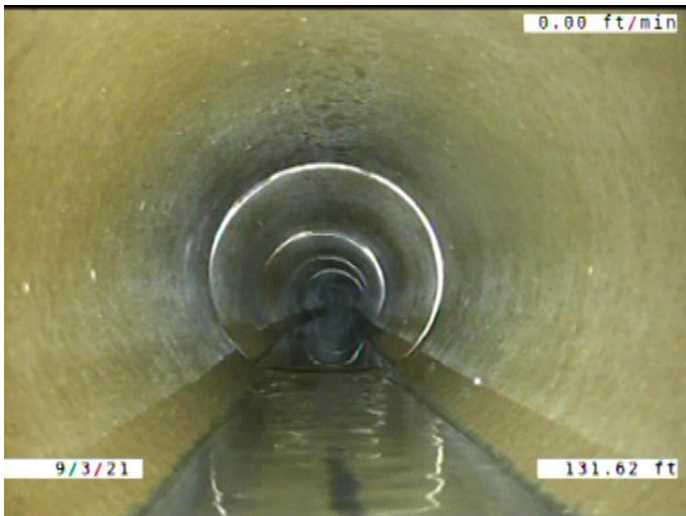
Code: **MWLS**  
 Description: **Miscellaneous Water Level Sag**

Distance (ft): **131.6**  
 Structural Grade: **2**  
 O&M Grade: **0**  
 Clock Start/From:  
 Clock To:  
 1st Value:  
 2nd Value:  
 Value Percent: **5.000**  
 Continuous Index: **F03**  
 Within 8" of Joint: **NO**  
 Remarks:

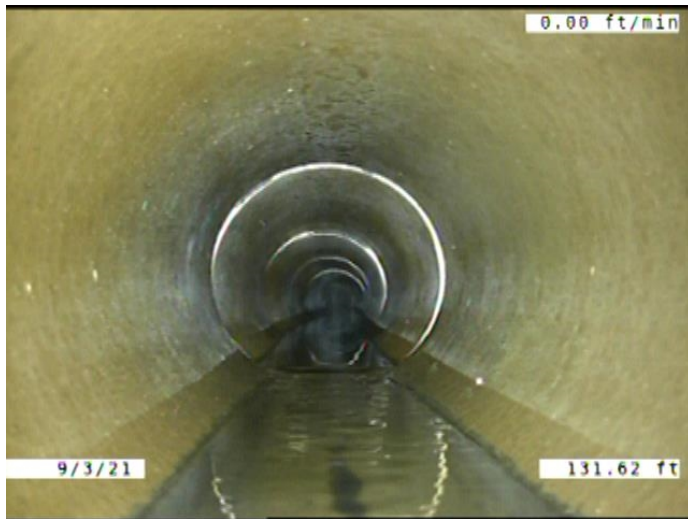
Code: **FM**  
 Description: **Fracture Multiple**

Distance (ft): **131.6**  
 Structural Grade: **4**  
 O&M Grade: **0**  
 Clock Start/From: **12**  
 Clock To: **12**  
 1st Value:  
 2nd Value:  
 Value Percent:  
 Continuous Index: **F04**  
 Within 8" of Joint: **YES**  
 Remarks:

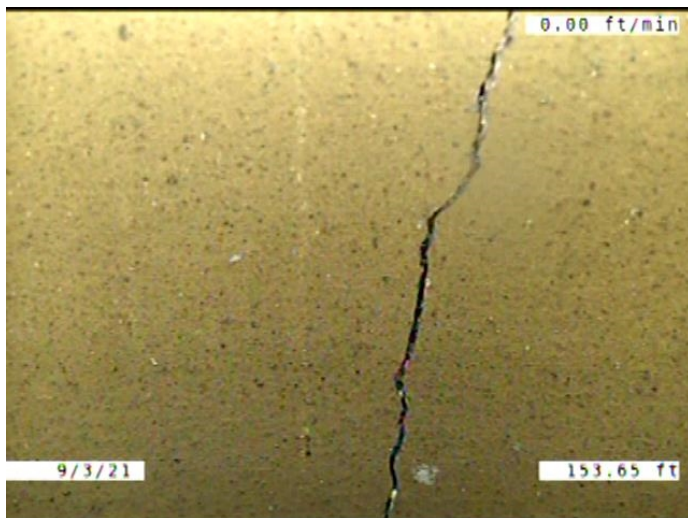
Code: **B**  
 Description: **Broken**

Distance (ft): **153.6**  
 Structural Grade: **4**  
 O&M Grade: **0**  
 Clock Start/From: **12**  
 Clock To: **12**  
 1st Value:  
 2nd Value:  
 Value Percent:  
 Continuous Index:  
 Within 8" of Joint: **YES**  
 Remarks:
