# Profile/Photo Observation Report

Date:	<b>09/03/2021</b>	Weather:		Coding:	<b>PACP 7.0</b>
Pipe Length (ft):	<b>191.0</b>	Owner:	<b>City of Hobart</b>	Pre Clean:	<b>Light Cleaning</b>
P.O.#:	<b>YES502259</b>	Surveyor:	<b>S. Bucklin</b>	PSR:	<b>P-404-022-023</b>
Customer:	<b>City of Hobart</b>	Clean Date:	<b>08/30/2021</b>	Shape:	<b>C</b>

Street:	<b>41st Avenue</b>	Flow Control:	<b>Not Controlled</b>
City:	<b>Hobart, IN</b>	Year Renewed:	
Location:	<b>Alley</b>	Tape/Media #:	
Purpose:	<b>Routine Assessment</b>	Dia/Height:	<b>10"</b>
Use:	<b>Sanitary Sewage Pipe</b>	Material:	<b>VCP</b>
Drain Area:		Lining:	
Category:	<b>NA</b>		
Comment:			
Location Details:		Direction of Survey:	<b>Upstream</b>
US MH:	<b>M-404-022</b>	DS MH:	<b>M-404-023</b>
		Total Length Surveyed (ft):	<b>175.5</b>

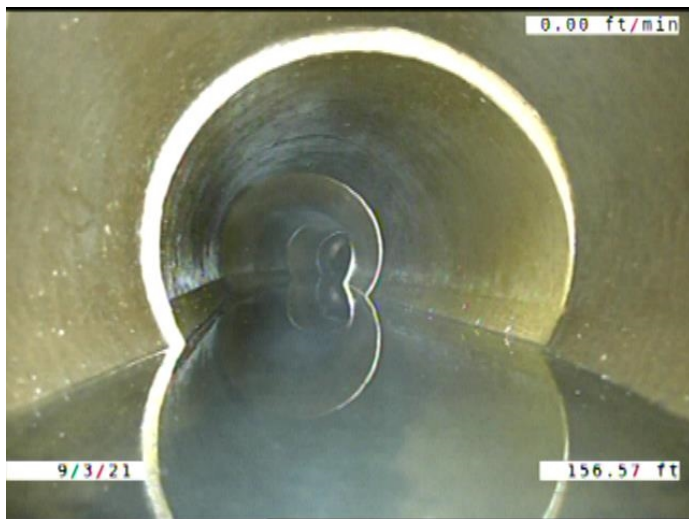
Code: **LL**  
 Description: **Line Left**

Distance (ft): **156.6**  
 Structural Grade: **0**  
 O&M Grade: **1**  
 Clock Start/From:  
 Clock To:  
 1st Value:  
 2nd Value:  
 Value Percent: **5.000**  
 Continuous Index:  
 Within 8" of Joint: **NO**  
 Remarks:

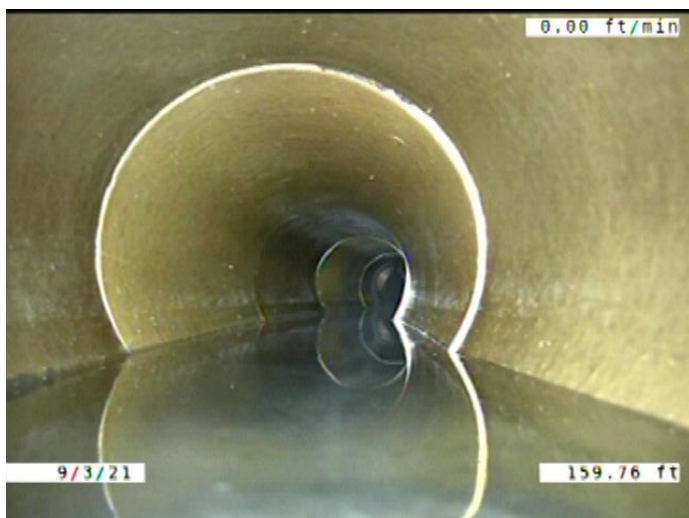
Code: **LR**  
 Description: **Line Right**

Distance (ft): **159.8**  
 Structural Grade: **0**  
 O&M Grade: **1**  
 Clock Start/From:  
 Clock To:  
 1st Value:  
 2nd Value:  
 Value Percent: **5.000**  
 Continuous Index:  
 Within 8" of Joint: **NO**  
 Remarks:

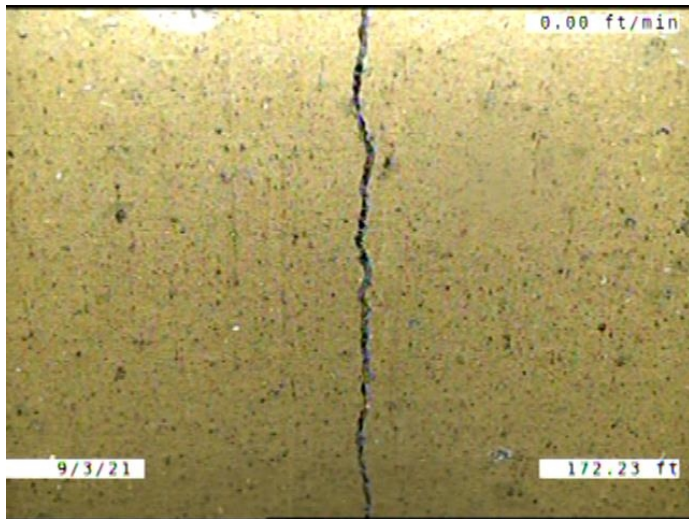
Code: **FM**  
 Description: **Fracture Multiple**

Distance (ft): **172.2**  
 Structural Grade: **4**  
 O&M Grade: **0**  
 Clock Start/From: **12**  
 Clock To: **8**  
 1st Value:  
 2nd Value:  
 Value Percent:  
 Continuous Index:  
 Within 8" of Joint: **YES**  
 Remarks:

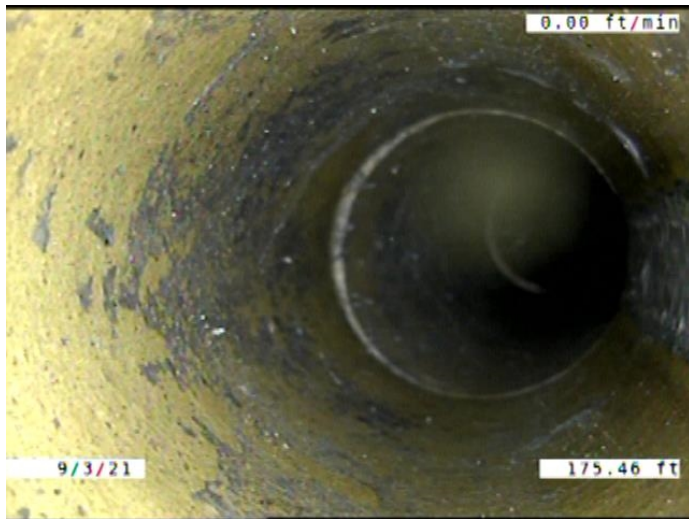
Code: **TBI**  
 Description: **Tap Break-in Intruding**

Distance (ft): **175.5**  
 Structural Grade: **0**  
 O&M Grade: **2**  
 Clock Start/From: **2**  
 Clock To:  
 1st Value: **6.000**  
 2nd Value: **4.000**  
 Value Percent:  
 Continuous Index:  
 Within 8" of Joint: **NO**  
 Remarks:

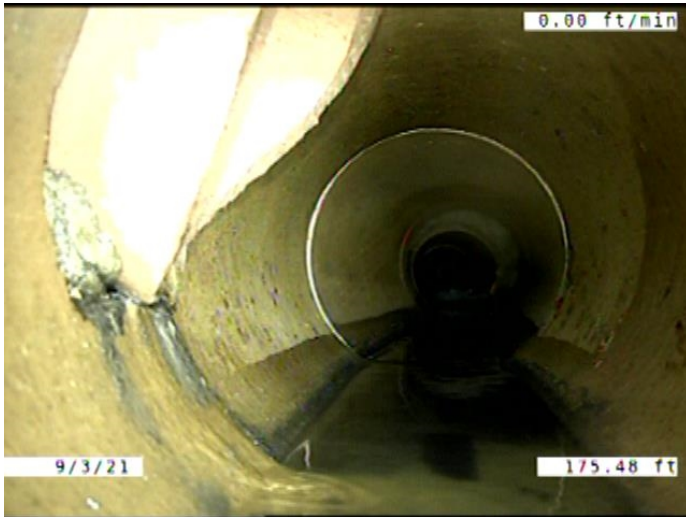
Code: **DSF**  
 Description: **Deposits Settled Fine**

Distance (ft): **175.5**  
 Structural Grade: **0**  
 O&M Grade: **2**  
 Clock Start/From: **5**  
 Clock To: **7**  
 1st Value:  
 2nd Value:  
 Value Percent: **5.000**  
 Continuous Index: **F01**  
 Within 8" of Joint: **YES**  
 Remarks:

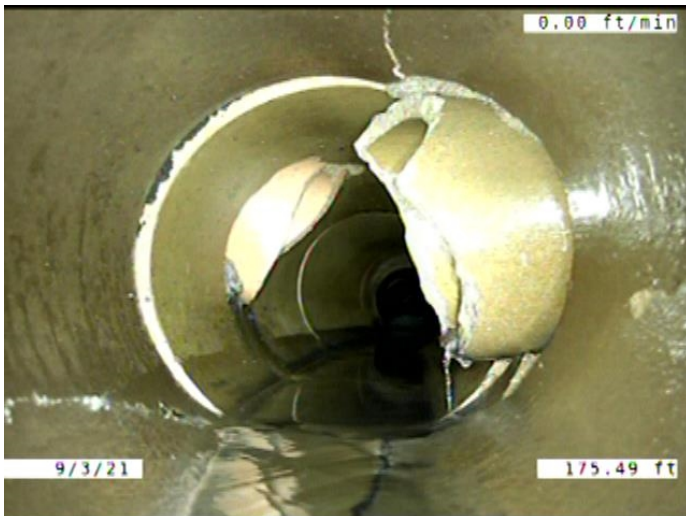
Code: **MSA**  
 Description: **Miscellaneous Survey Abandoned**

Distance (ft): **175.5**  
 Structural Grade: **0**  
 O&M Grade: **0**  
 Clock Start/From:  
 Clock To:  
 1st Value:  
 2nd Value:  
 Value Percent:  
 Continuous Index:  
 Within 8" of Joint: **NO**  
 Remarks: **CAMERA CANT MAKE IT PAST PROTRUDING TAP**
