## Profile/Photo Observation Report

| Pipe Length (ft): | <b>191.0</b> | Owner: | <b>City of Hobart</b> | Pre Clean: | <b>Light Cleaning</b> |

| Street: | <b>41st Avenue</b> | Flow Control: | <b>Not Controlled</b> |
| US MH: | <b>M-404-022</b> | DS MH: | <b>M-404-023</b> |

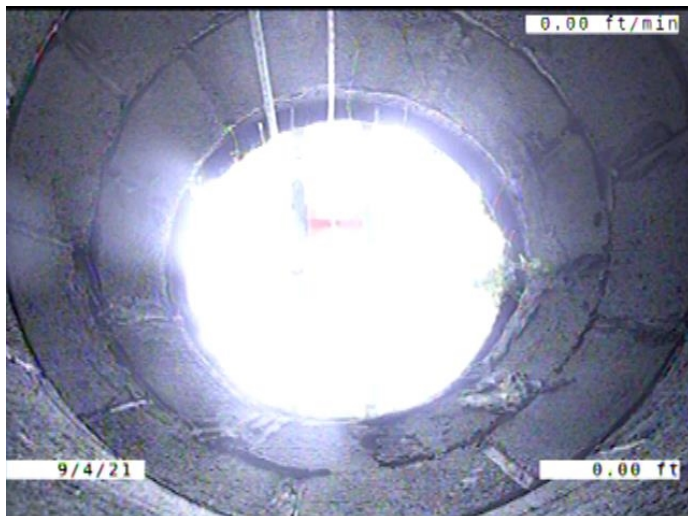
Code: **AMH**  
Description: **Manhole**

Distance (ft): **.0**  
Structural Grade: **0**  
O&M Grade: **0**  
Clock Start/From:  
Clock To:  
1st Value:  
2nd Value:  
Value Percent:  
Continuous Index:  
Within 8" of Joint: **NO**  
Remarks: **M-404-022**

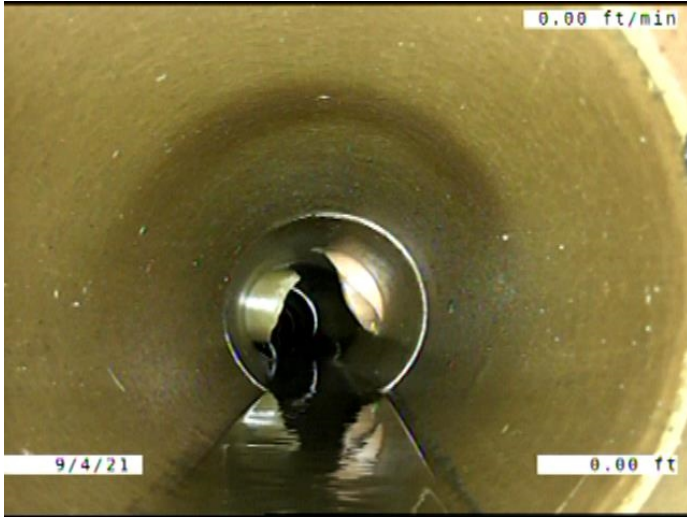
| Code: | <b>MWL</b> |
| Description: | <b>Miscellaneous Water Level</b> |
| Value Percent: | <b>5.000</b> |

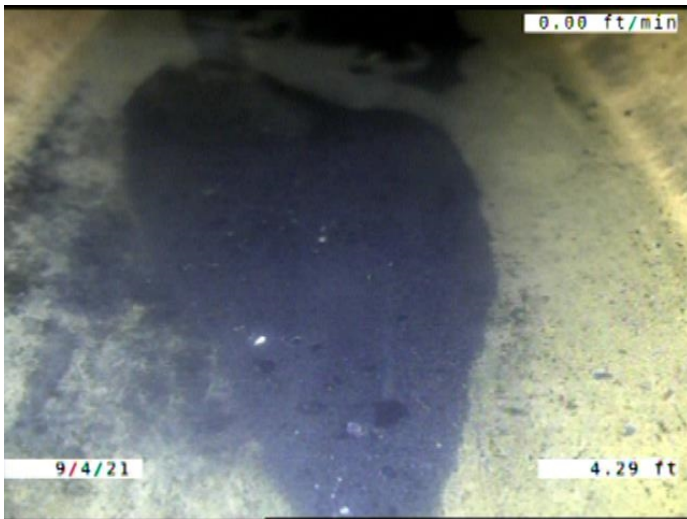
| Code: | <b>DSF</b> |
| Description: | <b>Deposits Settled Fine</b> |
| Distance (ft): | <b>4.3</b> |
| O&M Grade: | <b>2</b> |
| Value Percent: | <b>5.000</b> |

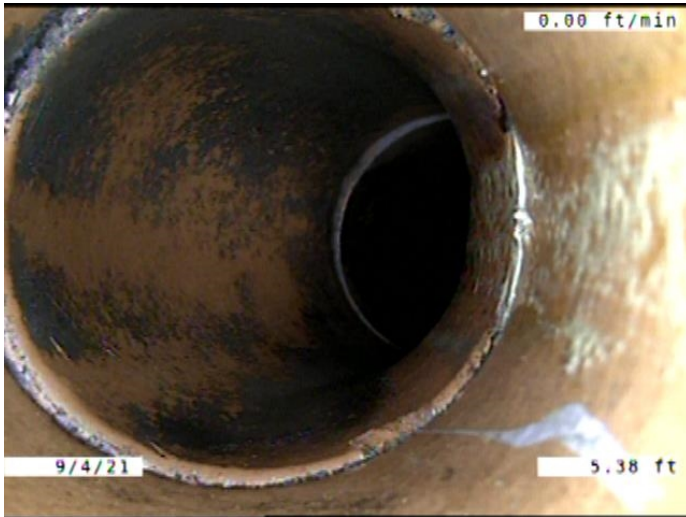
| Code: | <b>TBI</b> |
| Description: | <b>Tap Break-in Intruding</b> |
| Distance (ft): | <b>5.4</b> |
| O&M Grade: | <b>2</b> |
| Remarks: | <b>CONSTANTLY RUNNING WATER</b> |

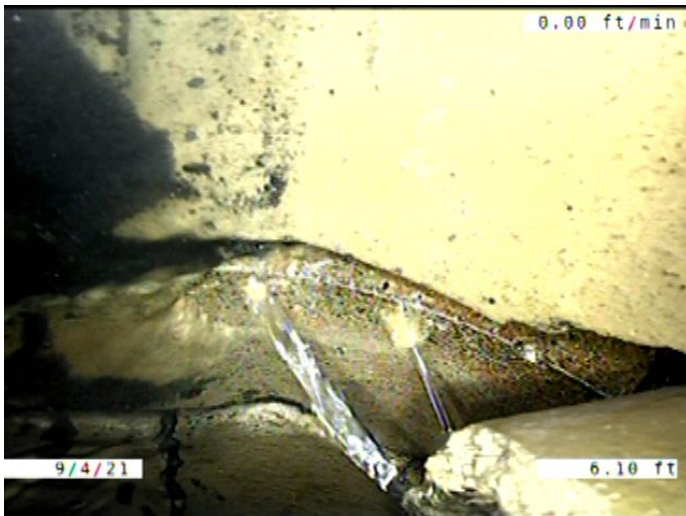
| Code: | <b>FM</b> |
| Description: | <b>Fracture Multiple</b> |
| Distance (ft): | <b>6.1</b> |
| Structural Grade: | <b>4</b> |
| Clock Start/From: | <b>4</b> |
| Clock To: | <b>12</b> |

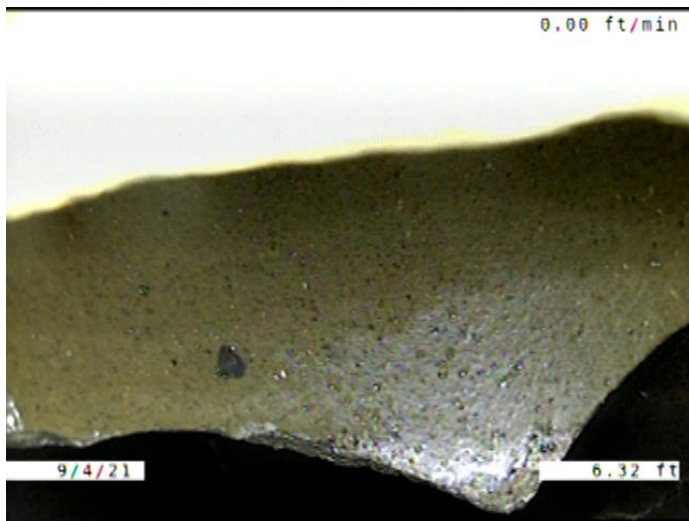
Code: **TBI**  
 Description: **Tap Break-in Intruding**

Distance (ft): **6.3**  
 Structural Grade: **0**  
 O&M Grade: **2**  
 Clock Start/From: **10**  
 Clock To:  
 1st Value: **6.000**  
 2nd Value: **4.000**  
 Value Percent:  
 Continuous Index:  
 Within 8" of Joint: **YES**  
 Remarks:

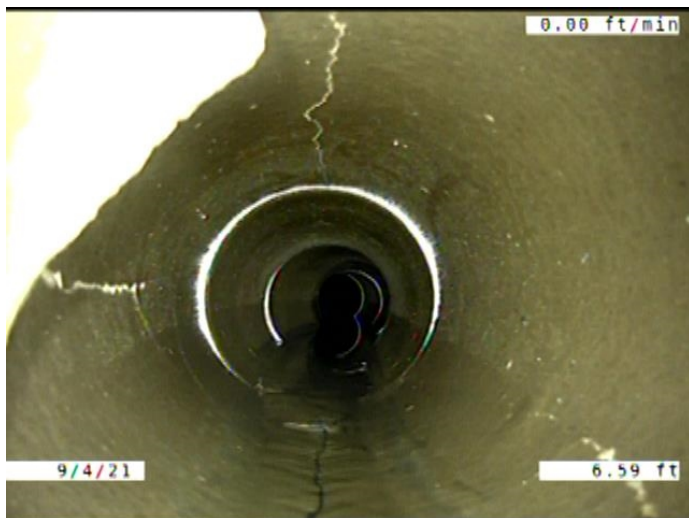
Code: **MSA**  
 Description: **Miscellaneous Survey Abandoned**

Distance (ft): **6.6**  
 Structural Grade: **0**  
 O&M Grade: **0**  
 Clock Start/From:  
 Clock To:  
 1st Value:  
 2nd Value:  
 Value Percent:  
 Continuous Index:  
 Within 8" of Joint: **NO**  
 Remarks: **CAMERA CANT MAKE IT PAST PROTRUDING TAP. MADE IT TO THE**
