Profile/Photo Observation Report

Date:	09/04/2021	Weather:		Coding:	PACP 7.0
Pipe Length (ft):	191.0	Owner:	City of Hobart	Pre Clean:	Light Cleaning
P.O.#:	YES502259	Surveyor:	S. Bucklin	PSR:	P-404-022-023
Customer:	City of Hobart	Clean Date:	08/30/2021	Shape:	C

Street:	41st Avenue	Flow Control:	Not Controlled
City:	Hobart, IN	Year Renewed:	
Location:	Alley	Tape/Media #:	
Purpose:	Routine Assessment	Dia/Height:	10"
Use:	Sanitary Sewage Pipe	Material:	VCP
Drain Area:		Lining:	
Category:	NA		
Comment:			
Location Details:		Direction of Survey:	Downstream
US MH:	M-404-022	DS MH:	M-404-023
		Total Length Surveyed (ft):	6.6

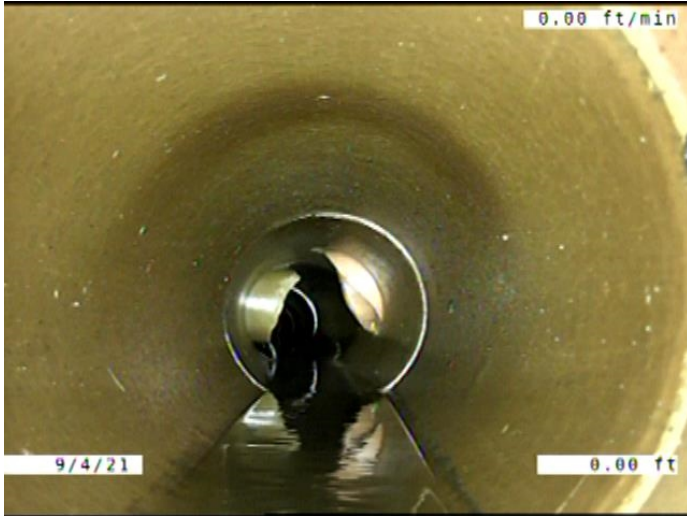
Code: **MWL**
 Description: **Miscellaneous Water Level**

Distance (ft): **.0**
 Structural Grade: **0**
 O&M Grade: **0**
 Clock Start/From:
 Clock To:
 1st Value:
 2nd Value:
 Value Percent: **5.000**
 Continuous Index:
 Within 8" of Joint: **NO**
 Remarks:

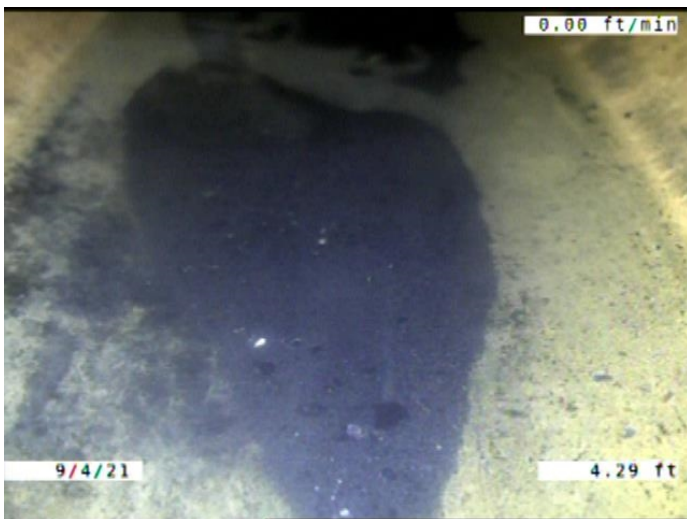
Code: **DSF**
 Description: **Deposits Settled Fine**

Distance (ft): **4.3**
 Structural Grade: **0**
 O&M Grade: **2**
 Clock Start/From: **6**
 Clock To:
 1st Value:
 2nd Value:
 Value Percent: **5.000**
 Continuous Index:
 Within 8" of Joint: **YES**
 Remarks:

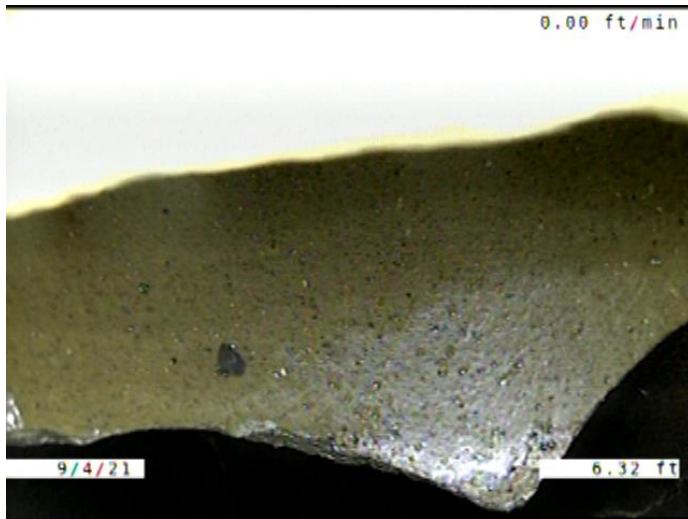
Code: **TBI**
 Description: **Tap Break-in Intruding**

Distance (ft): **6.3**
 Structural Grade: **0**
 O&M Grade: **2**
 Clock Start/From: **10**
 Clock To:
 1st Value: **6.000**
 2nd Value: **4.000**
 Value Percent:
 Continuous Index:
 Within 8" of Joint: **YES**
 Remarks:

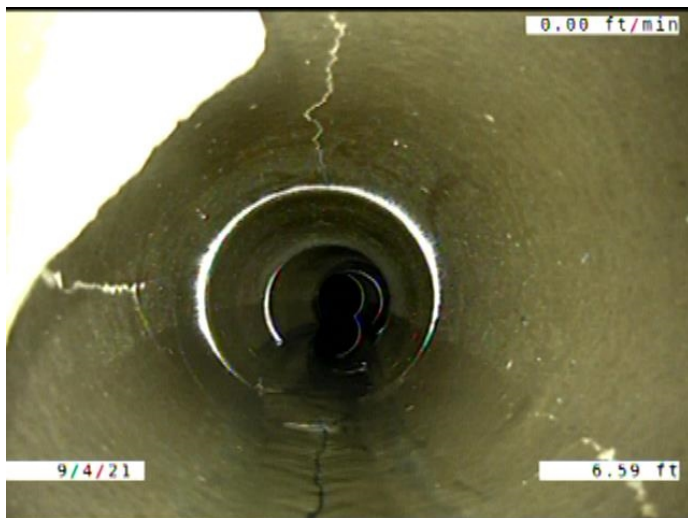
Code: **MSA**
 Description: **Miscellaneous Survey Abandoned**

Distance (ft): **6.6**
 Structural Grade: **0**
 O&M Grade: **0**
 Clock Start/From:
 Clock To:
 1st Value:
 2nd Value:
 Value Percent:
 Continuous Index:
 Within 8" of Joint: **NO**
 Remarks: **CAMERA CANT MAKE IT PAST PROTRUDING TAP. MADE IT TO THE**
