Profile/Photo Observation Report

Date:	04/09/2018	Weather:		Coding:	PACP 6.0
Pipe Length (ft):	118.8	Owner:	NA	Pre Clean:	Not Known
P.O.#:		Surveyor:	Jen Costello	PSR:	P-404-023-024
Customer:		Clean Date:	01/01/1900	Shape:	C

Street:	W 41ST AVE	Flow Control:	Not Controlled
City:	Hobart, IN	Year Renewed:	
Location:	Other	Tape/Media #:	
Purpose:	Not Known	Dia/Height:	10"
Use:	Sanitary	Material:	CP
Drain Area:	NA	Lining:	
Category:	NA		
Comment:

Location Details:		Direction of Survey:	Upstream
US MH:	M-404-023	DS MH:	M-404-024
		Total Length Surveyed (ft):	19.3

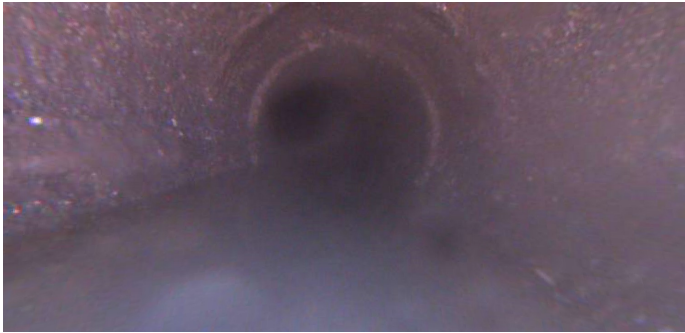
Code:	MWL
Description:	Water Level

Distance (ft):	.0
Structural Grade:	0
O&M Grade:	0
Clock Start/From:	
Clock To:	
1st Value:	
2nd Value:	
Value Percent:	20.000
Continuous Index:	
Within 8" of Joint:	NO
Remarks:

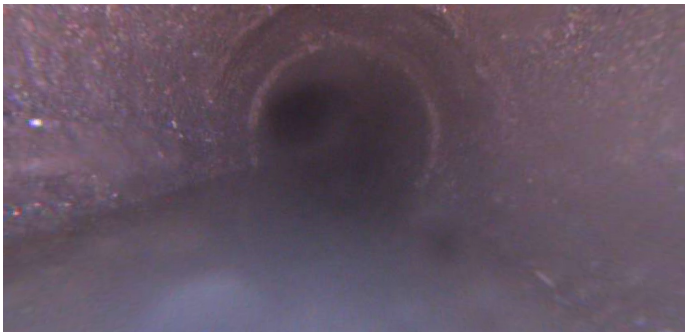
Code:	SAP
Description:	Surface Aggregate Projecting

Distance (ft):	.0
Structural Grade:	3
O&M Grade:	0
Clock Start/From:	8
Clock To:	4
1st Value:	
2nd Value:	
Value Percent:	
Continuous Index:	S01
Within 8" of Joint:	
Remarks:

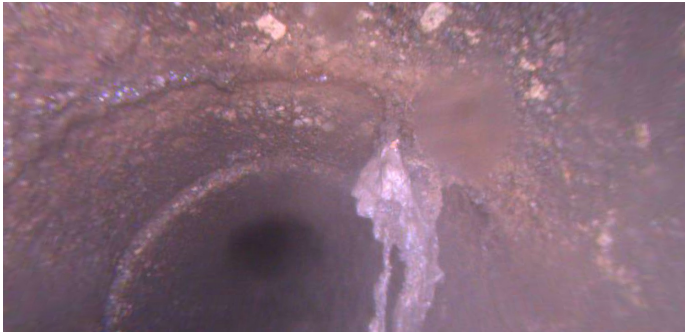
Code: **FC**
Description: **Fracture Circumferential**

Distance (ft): **7.6**
Structural Grade: **2**
O&M Grade: **0**
Clock Start/From: **8**
Clock To: **4**
1st Value:
2nd Value:
Value Percent:
Continuous Index:
Within 8" of Joint:
Remarks:

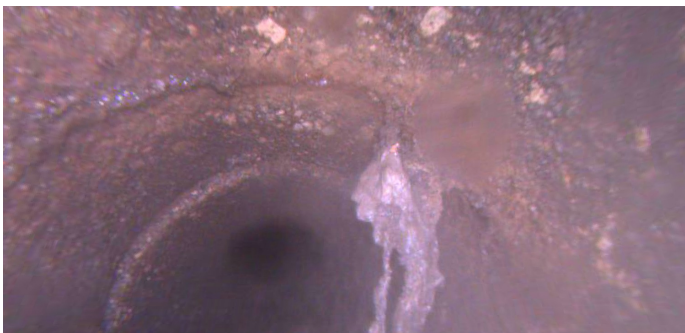
Code: **DAR**
Description: **Deposits Attached Ragging**

Distance (ft): **7.6**
Structural Grade: **0**
O&M Grade: **2**
Clock Start/From: **1**
Clock To:
1st Value:
2nd Value:
Value Percent: **10.000**
Continuous Index:
Within 8" of Joint: **NO**
Remarks:

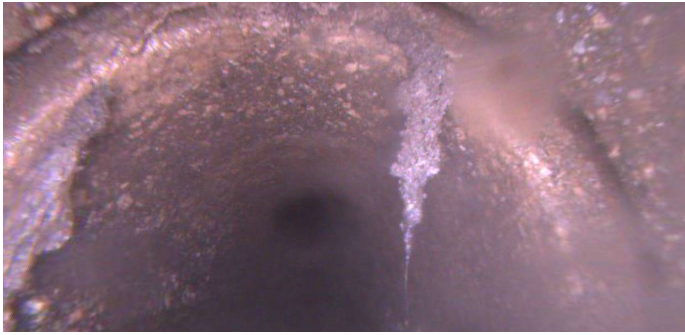
Code: **RMJ**
Description: **Roots Medium Joint**

Distance (ft): **11.1**
Structural Grade: **0**
O&M Grade: **3**
Clock Start/From: **10**
Clock To: **1**
1st Value:
2nd Value:
Value Percent: **5.000**
Continuous Index:
Within 8" of Joint: **YES**
Remarks:

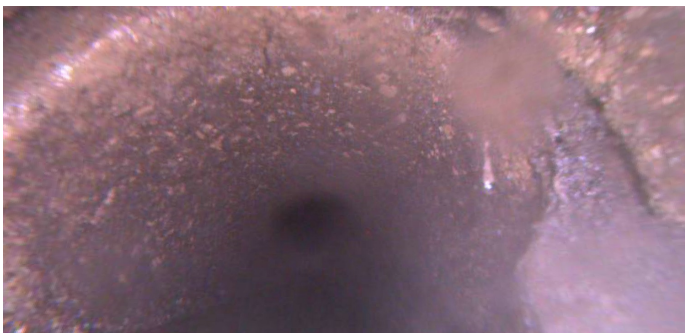
Code: **RMJ**
Description: **Roots Medium Joint**

Distance (ft): **17.1**
Structural Grade: **0**
O&M Grade: **3**
Clock Start/From: **1**
Clock To: **4**
1st Value:
2nd Value:
Value Percent: **5.000**
Continuous Index:
Within 8" of Joint: **YES**
Remarks:

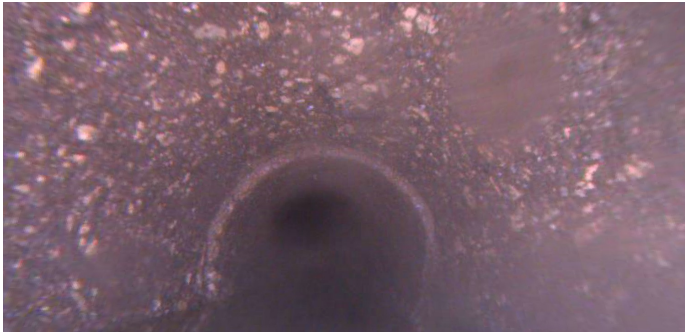
Code: **SAP**
Description: **Surface Aggregate Projecting**

Distance (ft): **19.3**
Structural Grade: **3**
O&M Grade: **0**
Clock Start/From: **8**
Clock To: **4**
1st Value:
2nd Value:
Value Percent:
Continuous Index: **F01**
Within 8" of Joint:
Remarks:

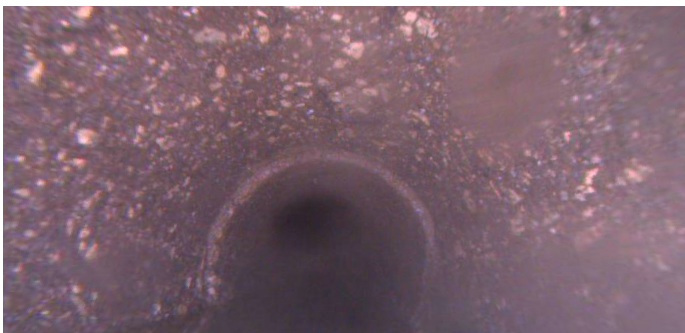
Code: **MSA**
Description: **Abandoned Survey**

Distance (ft): **19.3**
Structural Grade: **0**
O&M Grade: **0**
Clock Start/From:
Clock To:
1st Value:
2nd Value:
Value Percent:
Continuous Index:
Within 8" of Joint: **NO**
Remarks: **debris under water**
