## Profile/Photo Observation Report

| Street: | <b>W 40th ave</b> | Flow Control: | <b>Not Controlled</b> |
| Use: | <b>Sanitary</b> | Material: | <b>CP</b> |

| US MH: | <b>M-404-023</b> | DS MH: | <b>M-404-024</b> |

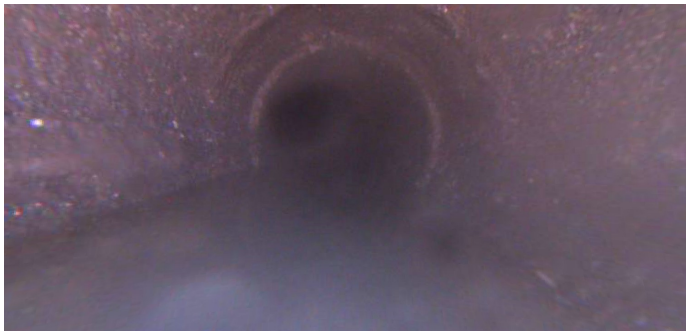
Code: **AMH**  
Description: **Manhole**

Distance (ft): **.0**  
Structural Grade: **0**  
O&M Grade: **0**  
Clock Start/From:  
Clock To:  
1st Value:  
2nd Value:  
Value Percent:  
Continuous Index:  
Within 8" of Joint: **NO**  
Remarks: **M-404-024**

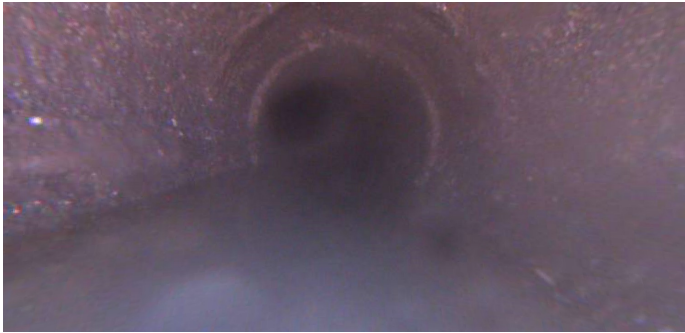
| Code: | <b>MWL</b> |
| Description: | <b>Water Level</b> |

| Value Percent: | <b>20.000</b> |

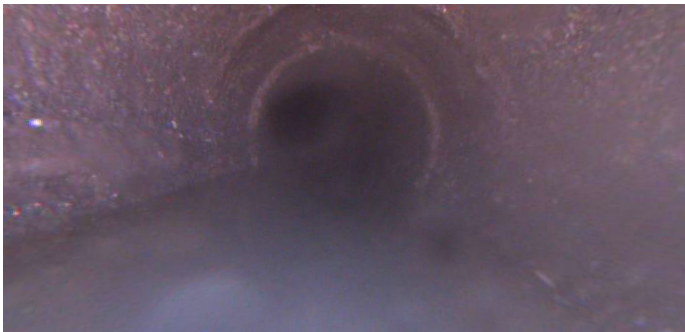
| Code: | <b>SAP</b> |
| Description: | <b>Surface Aggregate Projecting</b> |

| Structural Grade: | <b>3</b> |
| Clock Start/From: | <b>8</b> |
| Clock To: | <b>4</b> |

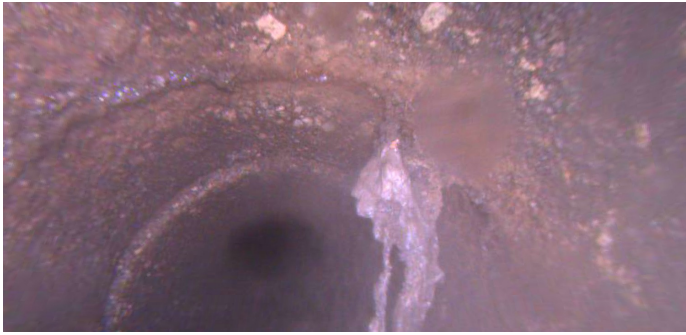
| | Position | Code | Observation | Video (sec) | Grade |
|--|---|---|---|---|---|
| | 7.6 | FC | Fracture Circumferential | 59 | S 2 |

Code: **FC**  
Description: **Fracture Circumferential**

Distance (ft): **7.6**  
Structural Grade: **2**  
O&M Grade: **0**  
Clock Start/From: **8**  
Clock To: **4**  
1st Value:  
2nd Value:  
Value Percent:  
Continuous Index:  
Within 8" of Joint:  
Remarks:

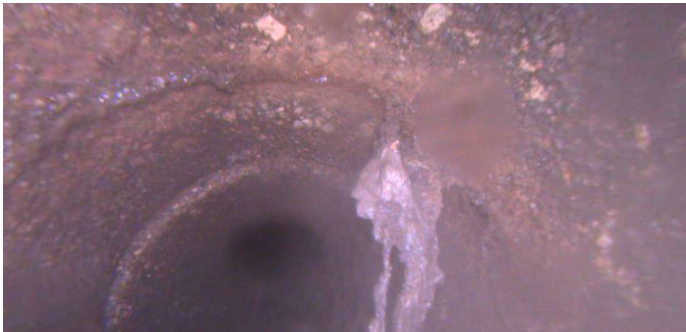
| | Position | Code | Observation | Video (sec) | Grade |
|--|---|---|---|---|---|
| | 7.6 | DAR | Deposits Attached Ragging | 70 | M 2 |

Code: **DAR**  
Description: **Deposits Attached Ragging**

Distance (ft): **7.6**  
Structural Grade: **0**  
O&M Grade: **2**  
Clock Start/From: **1**  
Clock To:  
1st Value:  
2nd Value:  
Value Percent: **10.000**  
Continuous Index:  
Within 8" of Joint: **NO**  
Remarks:

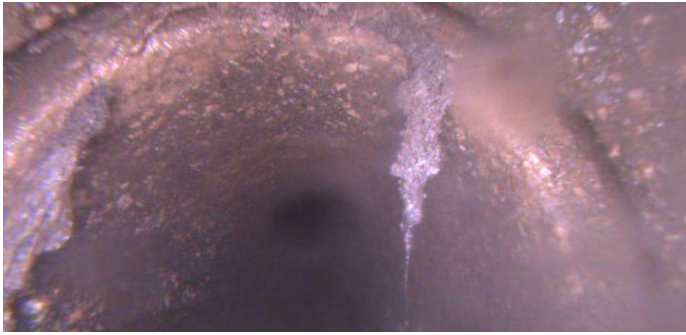
| | Position | Code | Observation | Video (sec) | Grade |
|--|---|---|---|---|---|
| | 11.1 | RMJ | Roots Medium Joint | 89 | M 3 |

Code: **RMJ**  
Description: **Roots Medium Joint**

Distance (ft): **11.1**  
Structural Grade: **0**  
O&M Grade: **3**  
Clock Start/From: **10**  
Clock To: **1**  
1st Value:  
2nd Value:  
Value Percent: **5.000**  
Continuous Index:  
Within 8" of Joint: **YES**  
Remarks:

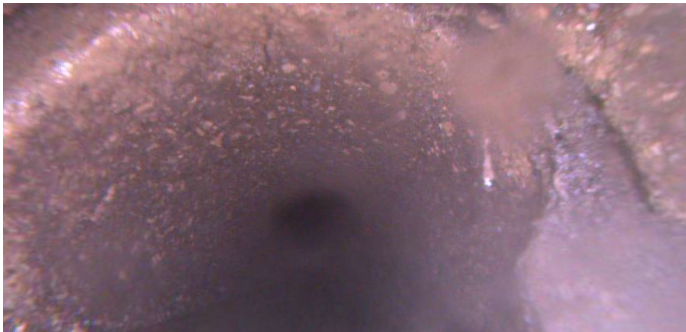
| | Position | Code | Observation | Video (sec) | Grade |
|--|---|---|---|---|---|
| | 17.1 | RMJ | Roots Medium Joint | 113 | M 3 |

Code: **RMJ**  
Description: **Roots Medium Joint**

Distance (ft): **17.1**  
Structural Grade: **0**  
O&M Grade: **3**  
Clock Start/From: **1**  
Clock To: **4**  
1st Value:  
2nd Value:  
Value Percent: **5.000**  
Continuous Index:  
Within 8" of Joint: **YES**  
Remarks:

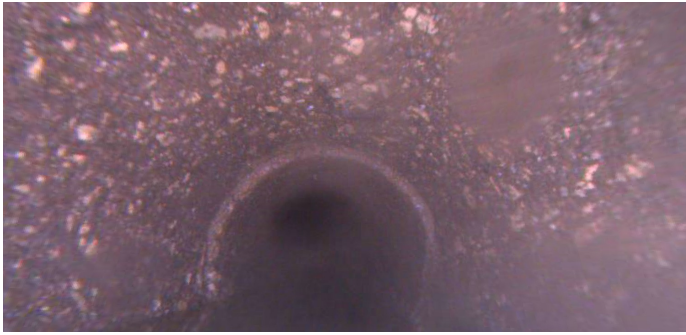
| | Position | Code | Observation | Video (sec) | Grade |
|--|---|---|---|---|---|
| | 19.3 | SAP(F01) | Surface Aggregate Projecting | 129 | S 3 |

Code: **SAP**  
Description: **Surface Aggregate Projecting**

Distance (ft): **19.3**  
Structural Grade: **3**  
O&M Grade: **0**  
Clock Start/From: **8**  
Clock To: **4**  
1st Value:  
2nd Value:  
Value Percent:  
Continuous Index: **F01**  
Within 8" of Joint:  
Remarks:

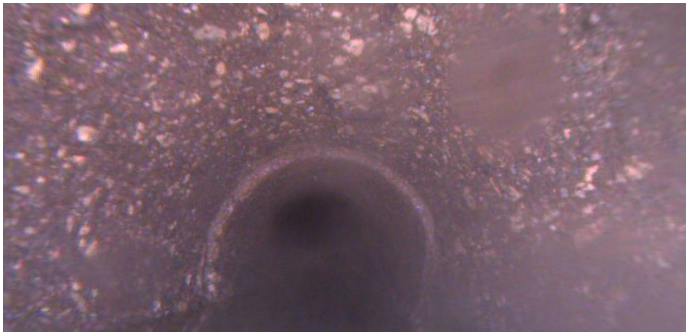
Code: **MSA**  
Description: **Abandoned Survey**

Distance (ft): **19.3**  
Structural Grade: **0**  
O&M Grade: **0**  
Clock Start/From:  
Clock To:  
1st Value:  
2nd Value:  
Value Percent:  
Continuous Index:  
Within 8" of Joint: **NO**  
Remarks: **debris under water**
