Profile/Photo Observation Report

Street:	W 41ST AVE	Flow Control:	Not Controlled
City:	Hobart, IN	Year Renewed:	
Location:	Other	Tape/Media #:	
Purpose:	Not Known	Dia/Height:	10"
Use:	Sanitary	Material:	CP
Drain Area:	NA	Lining:	
Category:	NA		
Comment:

Location Details:		Direction of Survey:	Downstream
US MH:	M-404-023	DS MH:	M-404-024
		Total Length Surveyed (ft):	27.0

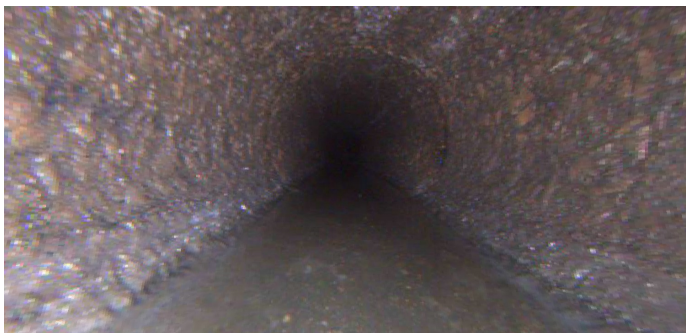
Code: **AMH**
Description: **Manhole**

Distance (ft): **.0**
Structural Grade: **0**
O&M Grade: **0**
Clock Start/From:
Clock To:
1st Value:
2nd Value:
Value Percent:
Continuous Index:
Within 8" of Joint: **NO**
Remarks: **M-404-023**

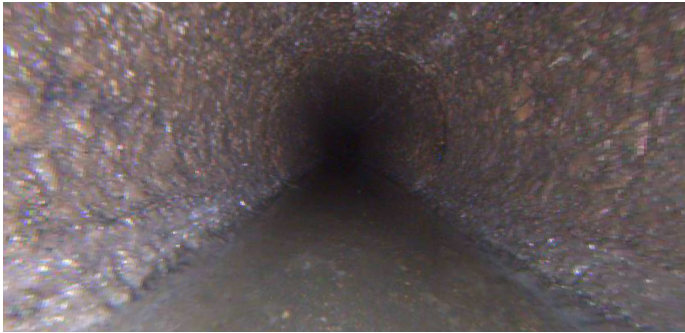
Code:	MWL
Description:	Water Level

Distance (ft):	.0
Structural Grade:	0
O&M Grade:	0
Clock Start/From:	
Clock To:	
1st Value:	
2nd Value:	
Value Percent:	5.000
Continuous Index:	
Within 8" of Joint:	NO
Remarks:

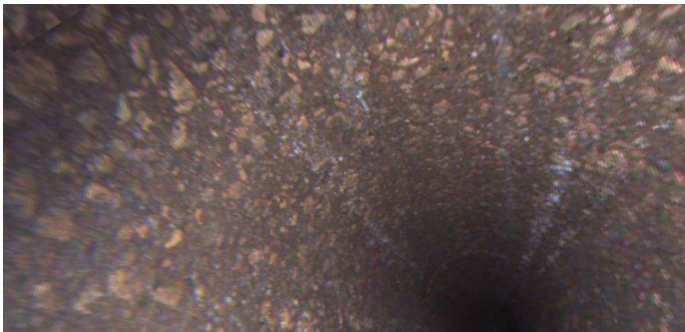
Code:	SAV
Description:	Surface Aggregate Visible

Distance (ft):	3.1
Structural Grade:	3
O&M Grade:	0
Clock Start/From:	7
Clock To:	5
1st Value:	
2nd Value:	
Value Percent:	
Continuous Index:	S01
Within 8" of Joint:	
Remarks:

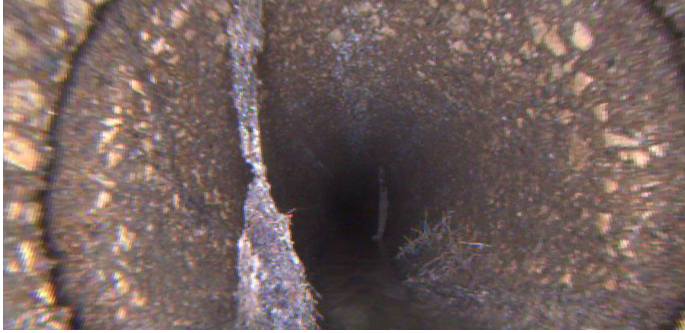
Code: **RFJ**
Description: **Roots Fine Joint**

Distance (ft): **11.1**
Structural Grade: **0**
O&M Grade: **1**
Clock Start/From: **11**
Clock To: **5**
1st Value:
2nd Value:
Value Percent:
Continuous Index: **S02**
Within 8" of Joint: **YES**
Remarks: **wandering**

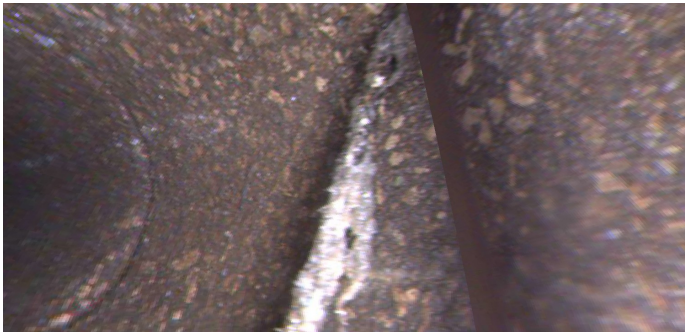
Code: **RFB**
Description: **Roots Fine Barrel**

Distance (ft): **13.5**
Structural Grade: **0**
O&M Grade: **2**
Clock Start/From: **1**
Clock To:
1st Value:
2nd Value:
Value Percent:
Continuous Index:
Within 8" of Joint: **NO**
Remarks:

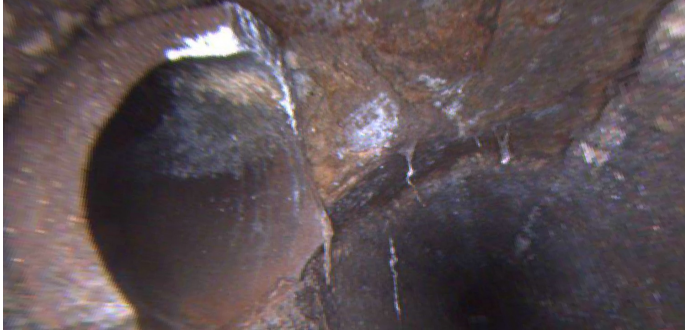
Code: **TB**
Description: **Tap Break-in**

Distance (ft): **23.2**
Structural Grade: **0**
O&M Grade: **0**
Clock Start/From: **9**
Clock To:
1st Value: **4.000**
2nd Value:
Value Percent:
Continuous Index:
Within 8" of Joint:
Remarks:

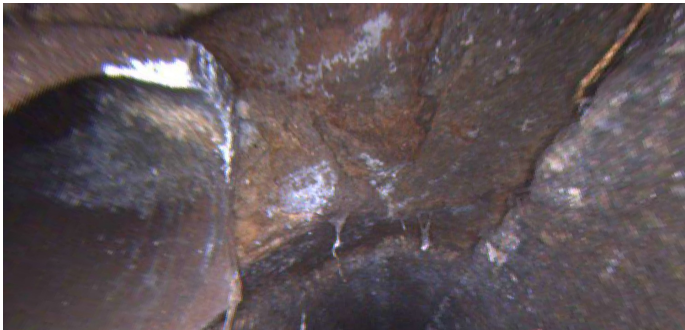
Code: **RPP**
Description: **Repair Patch**

Distance (ft): **23.2**
Structural Grade: **0**
O&M Grade: **0**
Clock Start/From: **10**
Clock To: **1**
1st Value:
2nd Value:
Value Percent:
Continuous Index:
Within 8" of Joint: **NO**
Remarks: **access point patched**
