Profile/Photo Observation Report

Street:	W 40th ave	Flow Control:	Not Controlled
City:	Hobart, IN	Year Renewed:	
Location:	Other	Tape/Media #:	
Purpose:	Not Known	Dia/Height:	10"
Use:	Sanitary	Material:	CP
Drain Area:	NA	Lining:	
Category:	NA		
Comment:

Location Details:		Direction of Survey:	Downstream
US MH:	M-404-023	DS MH:	M-404-024
		Total Length Surveyed (ft):	27.0

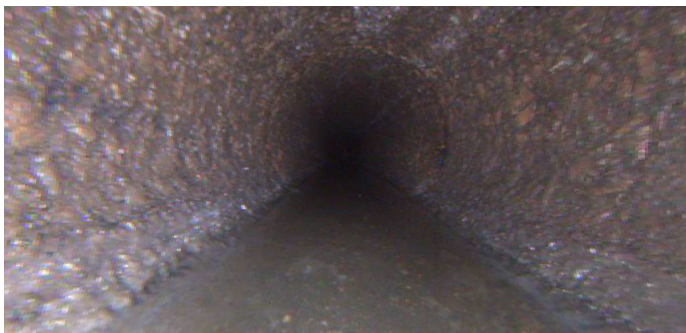
Code: **AMH**
Description: **Manhole**

Distance (ft): **.0**
Structural Grade: **0**
O&M Grade: **0**
Clock Start/From:
Clock To:
1st Value:
2nd Value:
Value Percent:
Continuous Index:
Within 8" of Joint: **NO**
Remarks: **M-404-023**

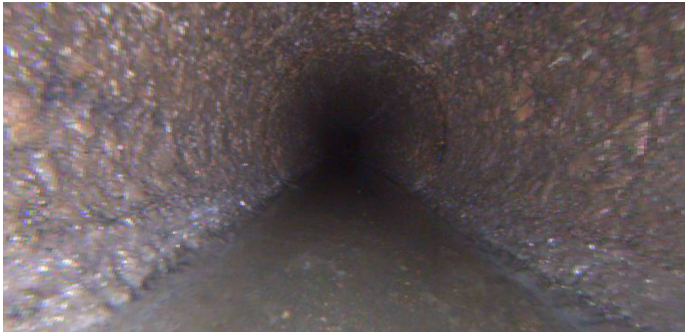
Code:	MWL
Description:	Water Level

Distance (ft):	.0
Structural Grade:	0
O&M Grade:	0
Clock Start/From:	
Clock To:	
1st Value:	
2nd Value:	
Value Percent:	5.000
Continuous Index:	
Within 8" of Joint:	NO
Remarks:

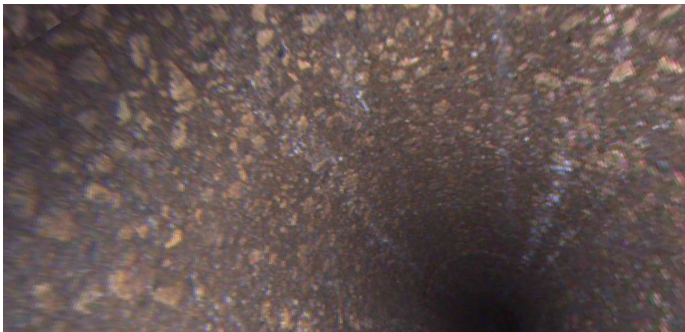
Code:	SAV
Description:	Surface Aggregate Visible

Distance (ft):	3.1
Structural Grade:	3
O&M Grade:	0
Clock Start/From:	7
Clock To:	5
1st Value:	
2nd Value:	
Value Percent:	
Continuous Index:	S01
Within 8" of Joint:	
Remarks:

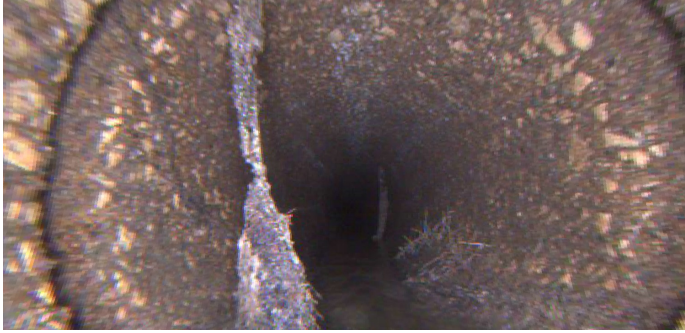
Code: **RFJ**
Description: **Roots Fine Joint**

Distance (ft): **11.1**
Structural Grade: **0**
O&M Grade: **1**
Clock Start/From: **11**
Clock To: **5**
1st Value:
2nd Value:
Value Percent:
Continuous Index: **S02**
Within 8" of Joint: **YES**
Remarks: **wandering**

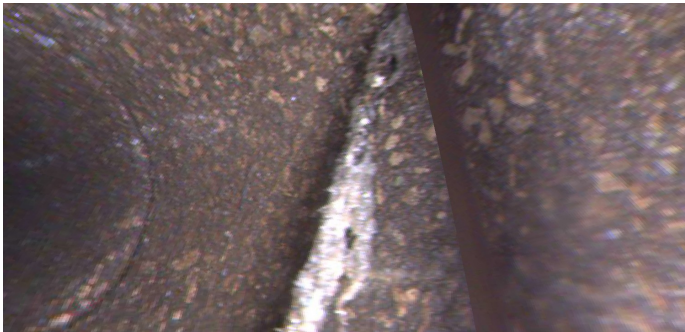
Code: **RFB**
Description: **Roots Fine Barrel**

Distance (ft): **13.5**
Structural Grade: **0**
O&M Grade: **2**
Clock Start/From: **1**
Clock To:
1st Value:
2nd Value:
Value Percent:
Continuous Index:
Within 8" of Joint: **NO**
Remarks:

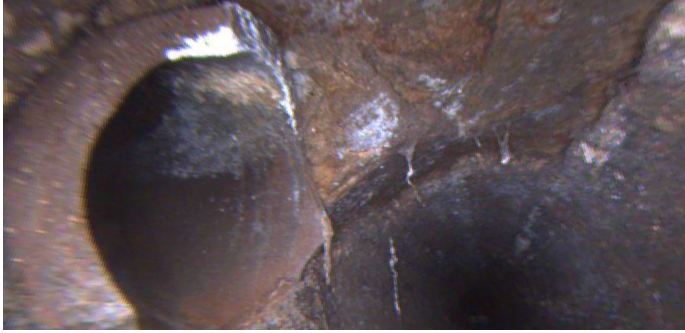
Code: **TB**
Description: **Tap Break-in**

Distance (ft): **23.2**
Structural Grade: **0**
O&M Grade: **0**
Clock Start/From: **9**
Clock To:
1st Value: **4.000**
2nd Value:
Value Percent:
Continuous Index:
Within 8" of Joint:
Remarks:

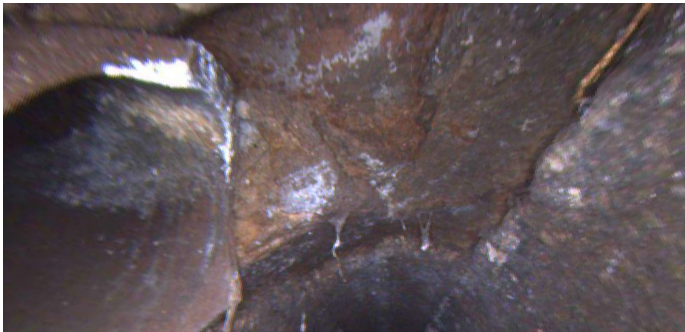
Code: **RPP**
Description: **Repair Patch**

Distance (ft): **23.2**
Structural Grade: **0**
O&M Grade: **0**
Clock Start/From: **10**
Clock To: **1**
1st Value:
2nd Value:
Value Percent:
Continuous Index:
Within 8" of Joint: **NO**
Remarks: **access point patched**
