Profile/Photo Observation Report

Street:	W 41ST AVE & N WILSON ST	Flow Control:	Not Controlled
City:	Hobart, IN	Year Renewed:	
Location:	Other	Tape/Media #:	
Purpose:	Not Known	Dia/Height:	12"
Use:	Sanitary	Material:	VCP
Drain Area:	NA	Lining:	
Category:	NA		
Comment:

Location Details:		Direction of Survey:	Downstream
US MH:	M-404-024	DS MH:	M-504-128
		Total Length Surveyed (ft):	14.6

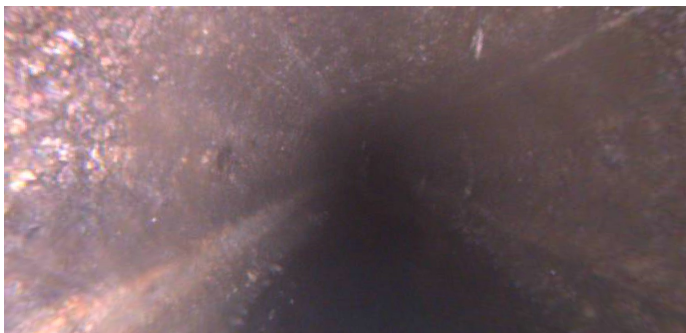
Code: **AMH**
Description: **Manhole**

Distance (ft): **.0**
Structural Grade: **0**
O&M Grade: **0**
Clock Start/From:
Clock To:
1st Value:
2nd Value:
Value Percent:
Continuous Index:
Within 8" of Joint: **NO**
Remarks: **M-404-024**

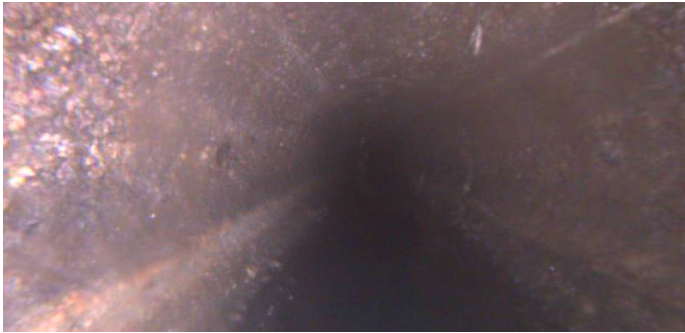
Code:	MWL
Description:	Water Level

Distance (ft):	.0
Structural Grade:	0
O&M Grade:	0
Clock Start/From:	
Clock To:	
1st Value:	
2nd Value:	
Value Percent:	10.000
Continuous Index:	
Within 8" of Joint:	NO
Remarks:

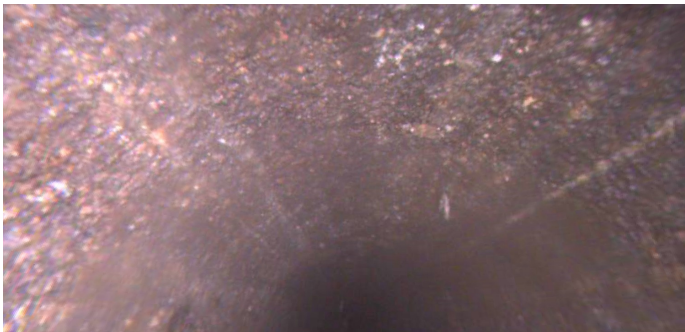
Code:	DAGS
Description:	Deposits Attached Grease

Distance (ft):	.0
Structural Grade:	0
O&M Grade:	2
Clock Start/From:	8
Clock To:	4
1st Value:	
2nd Value:	
Value Percent:	5.000
Continuous Index:	S01
Within 8" of Joint:	NO
Remarks:

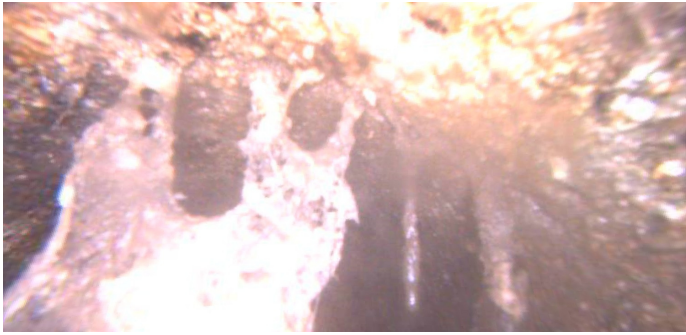
Code: **RMJ**
Description: **Roots Medium Joint**

Distance (ft): **7.3**
Structural Grade: **0**
O&M Grade: **3**
Clock Start/From: **11**
Clock To: **1**
1st Value:
2nd Value:
Value Percent: **20.000**
Continuous Index:
Within 8" of Joint: **YES**
Remarks:

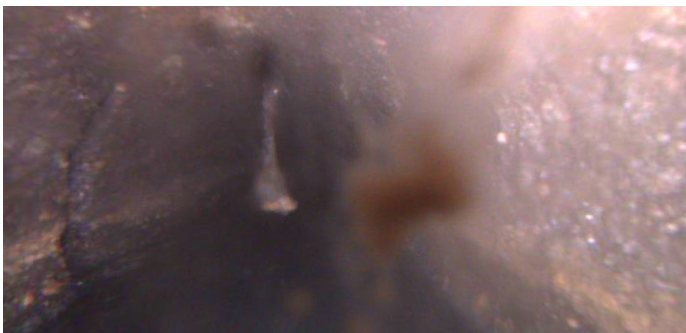
Code: **MSA**
Description: **Abandoned Survey**

Distance (ft): **14.6**
Structural Grade: **0**
O&M Grade: **0**
Clock Start/From:
Clock To:
1st Value:
2nd Value:
Value Percent:
Continuous Index:
Within 8" of Joint: **NO**
Remarks: **debris under water**

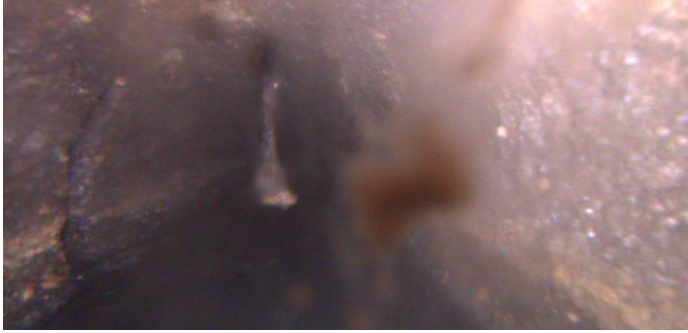
Code:	DAGS
Description:	Deposits Attached Grease
Distance (ft):	14.6
Structural Grade:	0
O&M Grade:	2
Clock Start/From:	8
Clock To:	4
1st Value:	
2nd Value:	
Value Percent:	5.000
Continuous Index:	F01
Within 8" of Joint:	NO
Remarks:
