Profile/Photo Observation Report

Street:	W 40th ave	Flow Control:	Not Controlled
City:	Hobart, IN	Year Renewed:	
Location:	Other	Tape/Media #:	
Purpose:	Not Known	Dia/Height:	12"
Use:	Sanitary	Material:	VCP
Drain Area:	NA	Lining:	
Category:	NA		
Comment:

Location Details:		Direction of Survey:	Downstream
US MH:	M-404-024	DS MH:	M-504-128
		Total Length Surveyed (ft):	14.6

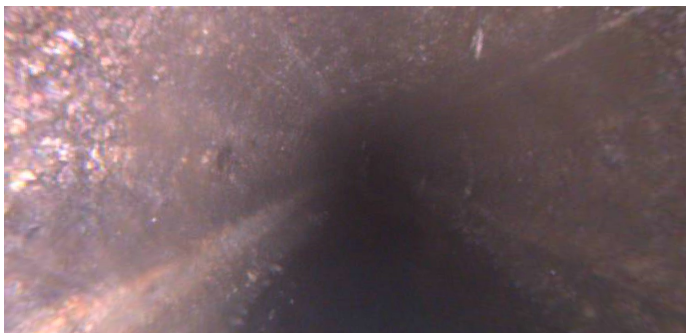
Code: **AMH**
Description: **Manhole**

Distance (ft): **.0**
Structural Grade: **0**
O&M Grade: **0**
Clock Start/From:
Clock To:
1st Value:
2nd Value:
Value Percent:
Continuous Index:
Within 8" of Joint: **NO**
Remarks: **M-404-024**

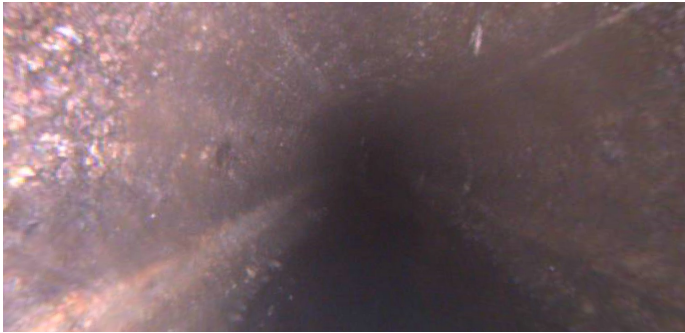
Code:	MWL
Description:	Water Level

Distance (ft):	.0
Structural Grade:	0
O&M Grade:	0
Clock Start/From:	
Clock To:	
1st Value:	
2nd Value:	
Value Percent:	10.000
Continuous Index:	
Within 8" of Joint:	NO
Remarks:

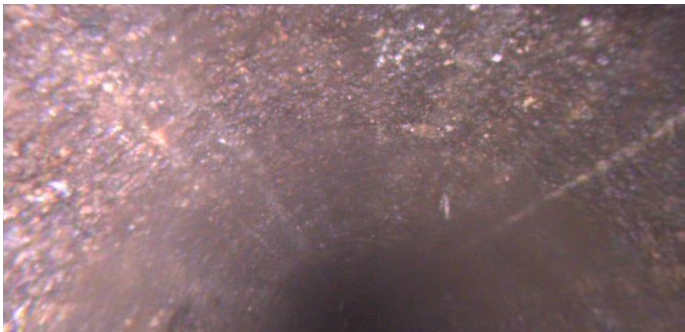
Code:	DAGS
Description:	Deposits Attached Grease

Distance (ft):	.0
Structural Grade:	0
O&M Grade:	2
Clock Start/From:	8
Clock To:	4
1st Value:	
2nd Value:	
Value Percent:	5.000
Continuous Index:	S01
Within 8" of Joint:	NO
Remarks:

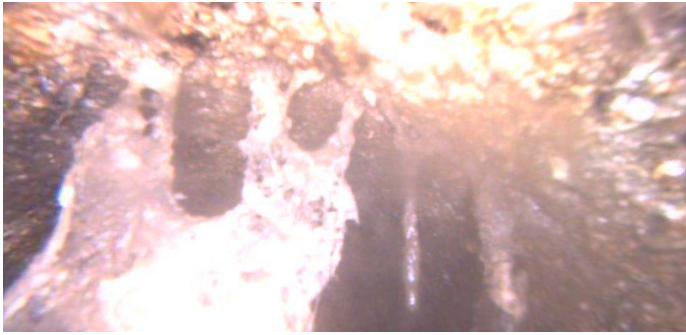
Code: **RMJ**
Description: **Roots Medium Joint**

Distance (ft): **7.3**
Structural Grade: **0**
O&M Grade: **3**
Clock Start/From: **11**
Clock To: **1**
1st Value:
2nd Value:
Value Percent: **20.000**
Continuous Index:
Within 8" of Joint: **YES**
Remarks:

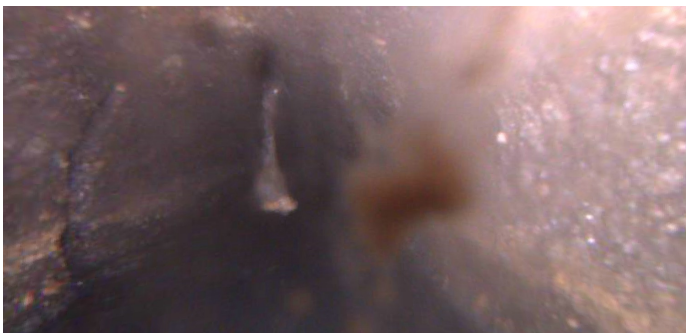
Code: **MSA**
Description: **Abandoned Survey**

Distance (ft): **14.6**
Structural Grade: **0**
O&M Grade: **0**
Clock Start/From:
Clock To:
1st Value:
2nd Value:
Value Percent:
Continuous Index:
Within 8" of Joint: **NO**
Remarks: **debris under water**

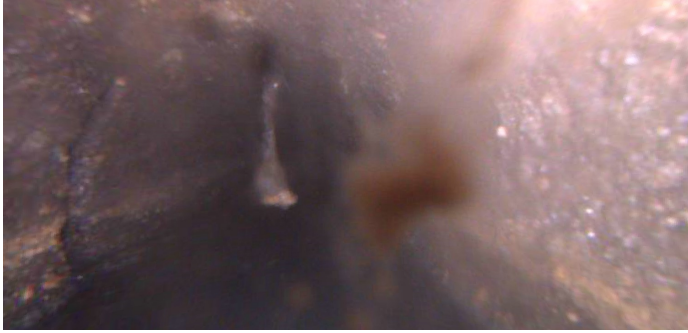
Code:	DAGS
Description:	Deposits Attached Grease
Distance (ft):	14.6
Structural Grade:	0
O&M Grade:	2
Clock Start/From:	8
Clock To:	4
1st Value:	
2nd Value:	
Value Percent:	5.000
Continuous Index:	F01
Within 8" of Joint:	NO
Remarks:
