Profile/Photo Observation Report

Street:	W 41ST AVE & N WILSON ST	Flow Control:	Not Controlled
City:	Hobart, IN	Year Renewed:	
Location:	Other	Tape/Media #:	
Purpose:	Not Known	Dia/Height:	10"
Use:	Sanitary	Material:	VCP
Drain Area:	NA	Lining:	
Category:	NA		
Comment:

Location Details:		Direction of Survey:	Upstream
US MH:	M-404-024	DS MH:	M-504-128
		Total Length Surveyed (ft):	61.2

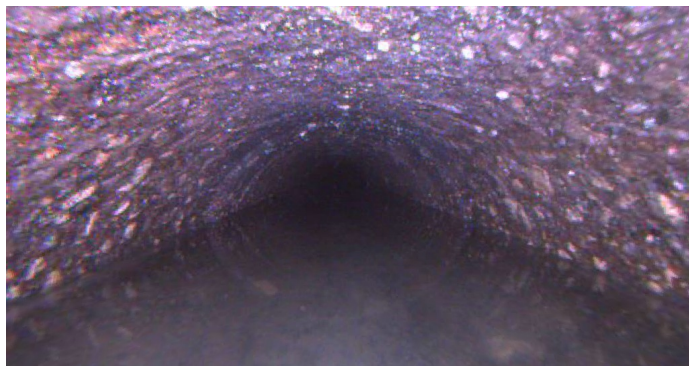
Code: **AMH**
 Description: **Manhole**

Distance (ft): **.0**
 Structural Grade: **0**
 O&M Grade: **0**
 Clock Start/From:
 Clock To:
 1st Value:
 2nd Value:
 Value Percent:
 Continuous Index:
 Within 8" of Joint: **NO**
 Remarks: **M-404-024**

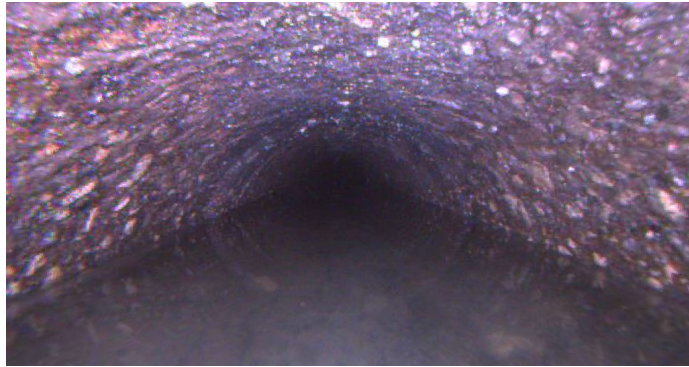
Code: **MWL**
Description: **Water Level**

Distance (ft): **.0**
Structural Grade: **0**
O&M Grade: **0**
Clock Start/From:
Clock To:
1st Value:
2nd Value:
Value Percent: **30.000**
Continuous Index:
Within 8" of Joint: **NO**
Remarks:

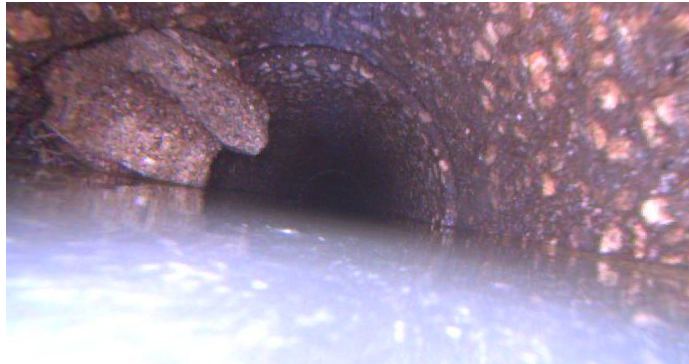
Code: **DAZ**
Description: **Deposits Attached Other**

Distance (ft): **25.3**
Structural Grade: **0**
O&M Grade: **2**
Clock Start/From: **10**
Clock To:
1st Value:
2nd Value:
Value Percent: **10.000**
Continuous Index:
Within 8" of Joint: **YES**
Remarks:

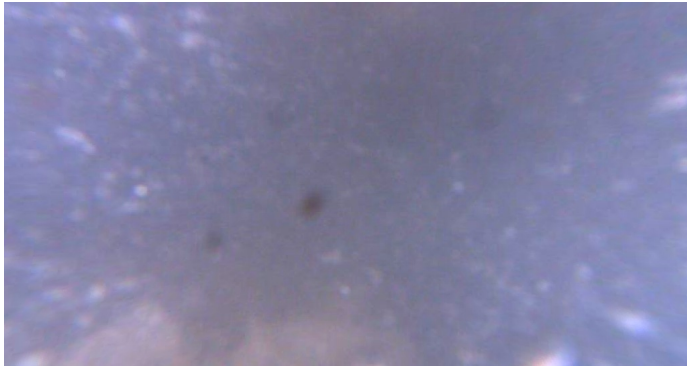
Code:	MCU
Description:	Camera Underwater
Distance (ft):	26.5
Structural Grade:	0
O&M Grade:	4
Clock Start/From:	
Clock To:	
1st Value:	
2nd Value:	
Value Percent:	
Continuous Index:	
Within 8" of Joint:	NO
Remarks:

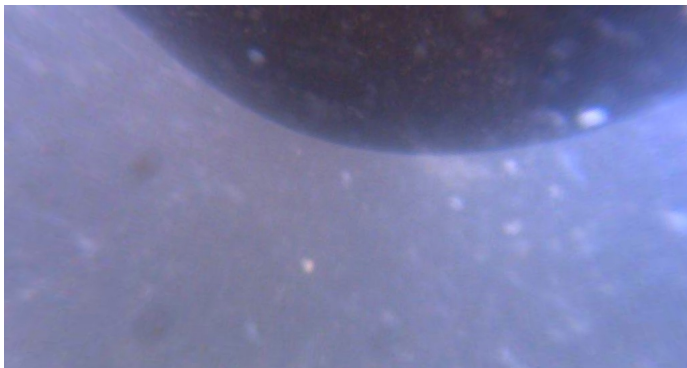
Code:	TF
Description:	Tap Factory
Distance (ft):	49.1
Structural Grade:	0
O&M Grade:	0
Clock Start/From:	2
Clock To:	
1st Value:	4.000
2nd Value:	
Value Percent:	
Continuous Index:	
Within 8" of Joint:	
Remarks:

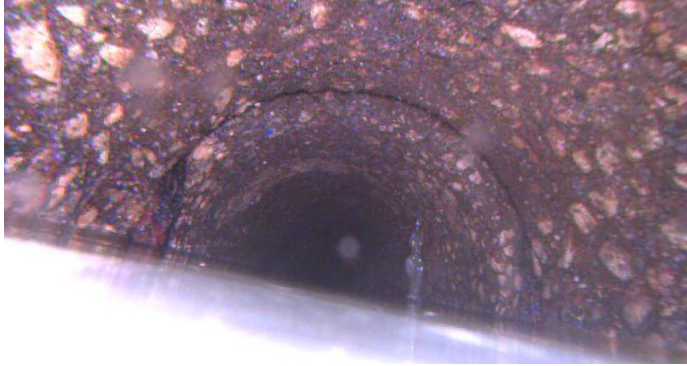
Code:	MSA
Description:	Abandoned Survey
Distance (ft):	61.2
Structural Grade:	0
O&M Grade:	0
Clock Start/From:	
Clock To:	
1st Value:	
2nd Value:	
Value Percent:	
Continuous Index:	
Within 8" of Joint:	NO
Remarks:	Debris under water
