## Profile/Photo Observation Report

Street:	<b>W 40th ave</b>	Flow Control:	<b>Not Controlled</b>
City:	<b>Hobart, IN</b>	Year Renewed:	
Location:	<b>Other</b>	Tape/Media #:	
Purpose:	<b>Not Known</b>	Dia/Height:	<b>10"</b>
Use:	<b>Sanitary</b>	Material:	<b>VCP</b>
Drain Area:	<b>NA</b>	Lining:	
Category:	<b>NA</b>		
Comment:

Location Details:		Direction of Survey:	<b>Upstream</b>
US MH:	<b>M-404-024</b>	DS MH:	<b>M-504-128</b>
		Total Length Surveyed (ft):	<b>61.2</b>

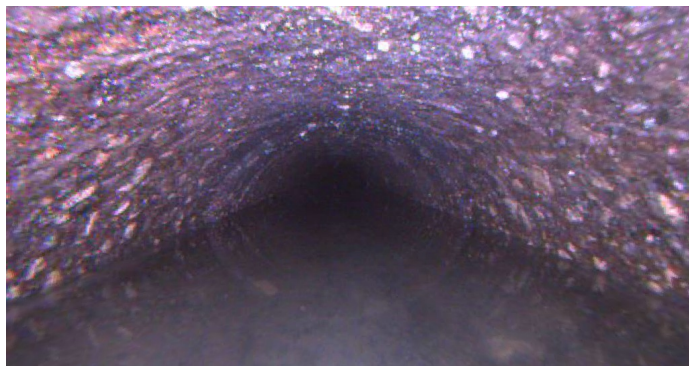
Code: **AMH**  
 Description: **Manhole**

Distance (ft): **.0**  
 Structural Grade: **0**  
 O&M Grade: **0**  
 Clock Start/From:  
 Clock To:  
 1st Value:  
 2nd Value:  
 Value Percent:  
 Continuous Index:  
 Within 8" of Joint: **NO**  
 Remarks: **M-404-024**

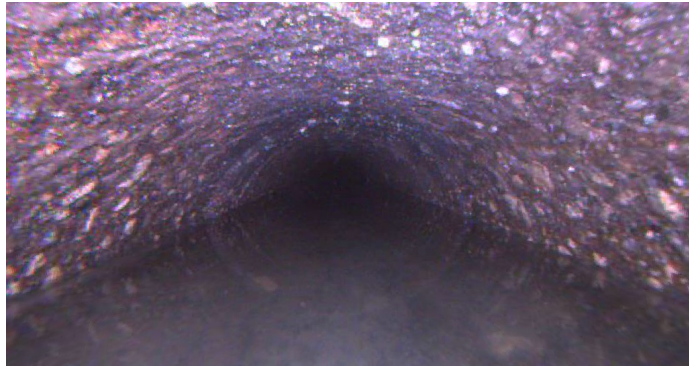
Code: **MWL**  
Description: **Water Level**

Distance (ft): **.0**  
Structural Grade: **0**  
O&M Grade: **0**  
Clock Start/From:  
Clock To:  
1st Value:  
2nd Value:  
Value Percent: **30.000**  
Continuous Index:  
Within 8" of Joint: **NO**  
Remarks:

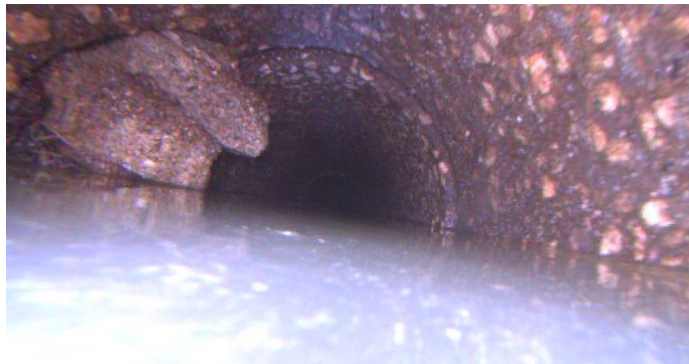
Code: **DAZ**  
Description: **Deposits Attached Other**

Distance (ft): **25.3**  
Structural Grade: **0**  
O&M Grade: **2**  
Clock Start/From: **10**  
Clock To:  
1st Value:  
2nd Value:  
Value Percent: **10.000**  
Continuous Index:  
Within 8" of Joint: **YES**  
Remarks:

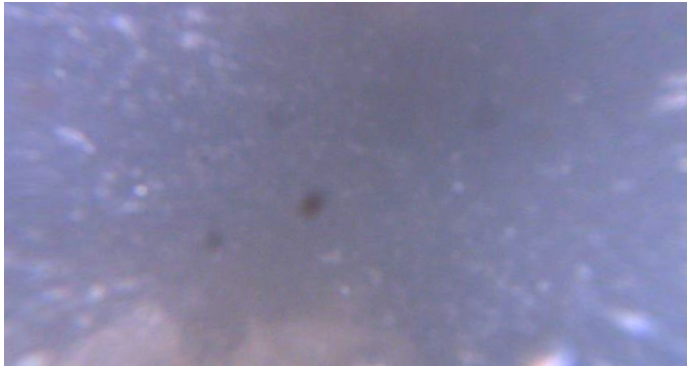
Code: **MCU**  
Description: **Camera Underwater**

Distance (ft): **26.5**  
Structural Grade: **0**  
O&M Grade: **4**  
Clock Start/From:  
Clock To:  
1st Value:  
2nd Value:  
Value Percent:  
Continuous Index:  
Within 8" of Joint: **NO**  
Remarks:

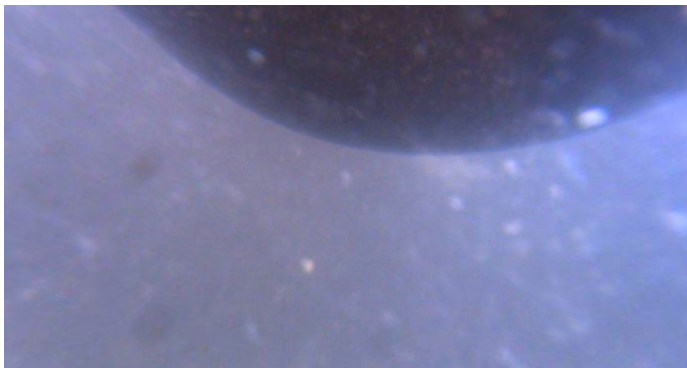
Code: **TF**  
Description: **Tap Factory**

Distance (ft): **49.1**  
Structural Grade: **0**  
O&M Grade: **0**  
Clock Start/From: **2**  
Clock To:  
1st Value: **4.000**  
2nd Value:  
Value Percent:  
Continuous Index:  
Within 8" of Joint:  
Remarks:

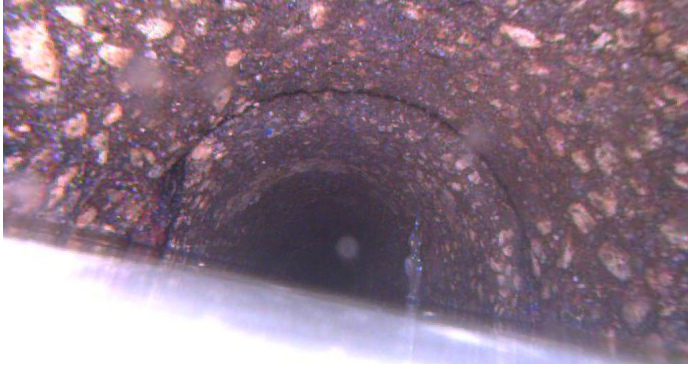
Code:	<b>MSA</b>
Description:	<b>Abandoned Survey</b>
Distance (ft):	<b>61.2</b>
Structural Grade:	<b>0</b>
O&M Grade:	<b>0</b>
Clock Start/From:	
Clock To:	
1st Value:	
2nd Value:	
Value Percent:	
Continuous Index:	
Within 8" of Joint:	<b>NO</b>
Remarks:	<b>Debris under water</b>
