Profile/Photo Observation Report

Date:	04/16/2018	Weather:		Coding:	PACP 6.0
Pipe Length (ft):	339.3	Owner:	NA	Pre Clean:	Not Known
P.O.#:		Surveyor:	Selasie Honu	PSR:	P-404-027-026
Customer:		Clean Date:	01/01/1900	Shape:	C

Street:	DEARBORN ST	Flow Control:	Not Controlled
City:	Hobart, IN	Year Renewed:	
Location:	Light Highway	Tape/Media #:	
Purpose:	Not Known	Dia/Height:	10"
Use:	Sanitary	Material:	VCP
Drain Area:	NA	Lining:	
Category:	NA		
Comment:

Location Details:		Direction of Survey:	Downstream
US MH:	M-404-026	DS MH:	M-404-027
		Total Length Surveyed (ft):	223.0

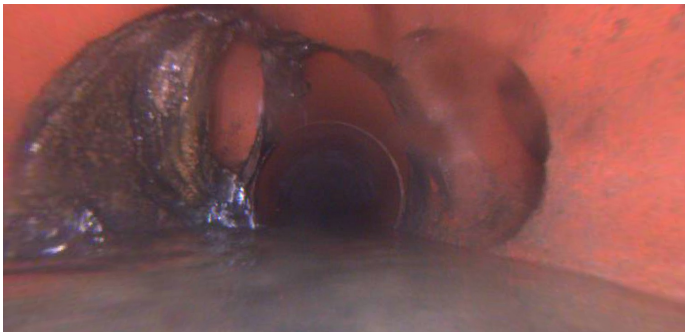
Code:	FS
Description:	Fracture Spiral

Distance (ft):	25.9
Structural Grade:	3
O&M Grade:	0
Clock Start/From:	7
Clock To:	12
1st Value:	
2nd Value:	
Value Percent:	
Continuous Index:	
Within 8" of Joint:	
Remarks:

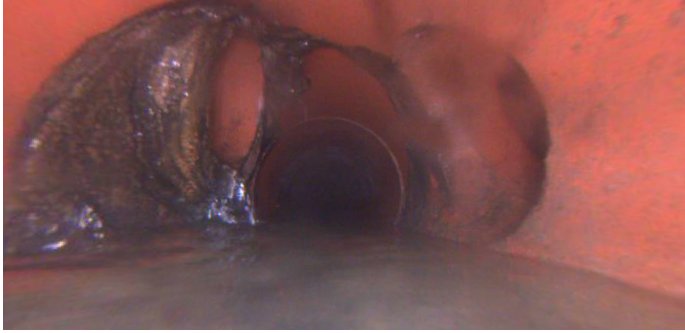
Code: **IW**
Description: **Infil Weeper**

Distance (ft): **25.9**
Structural Grade: **0**
O&M Grade: **2**
Clock Start/From: **7**
Clock To: **12**
1st Value:
2nd Value:
Value Percent:
Continuous Index:
Within 8" of Joint:
Remarks:

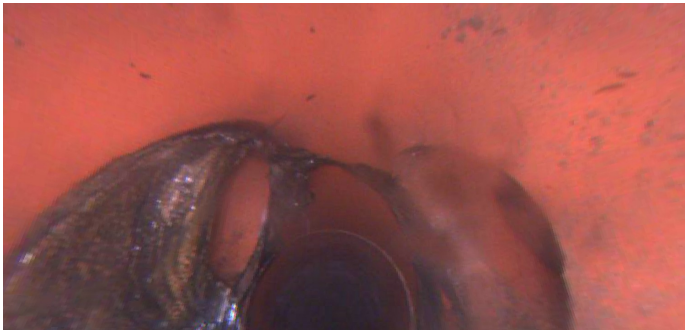
Code: **TBI**
Description: **Tap Break-in Intruding**

Distance (ft): **25.9**
Structural Grade: **0**
O&M Grade: **2**
Clock Start/From: **9**
Clock To:
1st Value: **6.000**
2nd Value: **2.000**
Value Percent:
Continuous Index:
Within 8" of Joint:
Remarks:

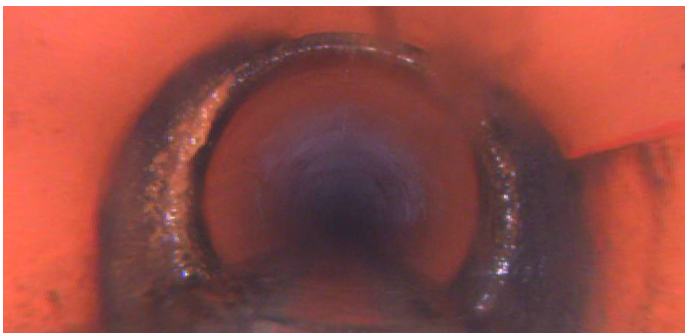
Code: **DAE**
Description: **Deposits Attached Encrustation**

Distance (ft): **32.2**
Structural Grade: **0**
O&M Grade: **3**
Clock Start/From: **7**
Clock To: **5**
1st Value:
2nd Value:
Value Percent: **20.000**
Continuous Index:
Within 8" of Joint: **YES**
Remarks:

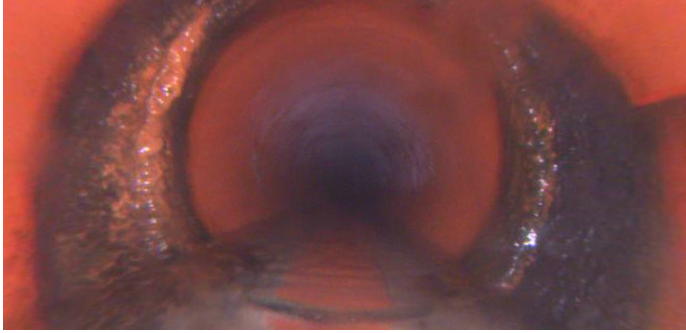
Code: **IW**
Description: **Infil Weeper**

Distance (ft): **32.3**
Structural Grade: **0**
O&M Grade: **2**
Clock Start/From: **8**
Clock To: **4**
1st Value:
2nd Value:
Value Percent:
Continuous Index:
Within 8" of Joint: **YES**
Remarks:

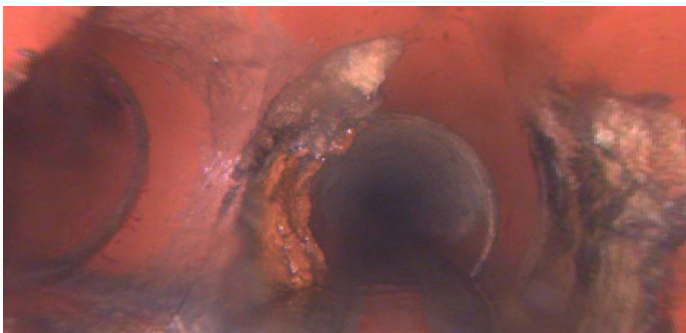
Code: **DAE**
Description: **Deposits Attached Encrustation**

Distance (ft): **83.7**
Structural Grade: **0**
O&M Grade: **3**
Clock Start/From: **7**
Clock To: **5**
1st Value:
2nd Value:
Value Percent: **20.000**
Continuous Index:
Within 8" of Joint:
Remarks:

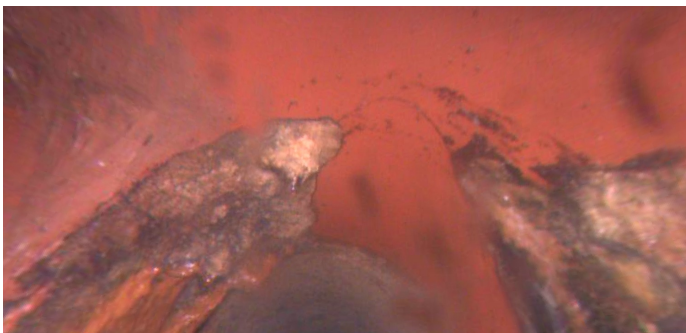
Code: **CM**
Description: **Crack Multiple**

Distance (ft): **84.0**
Structural Grade: **3**
O&M Grade: **0**
Clock Start/From: **11**
Clock To: **1**
1st Value:
2nd Value:
Value Percent:
Continuous Index:
Within 8" of Joint:
Remarks:

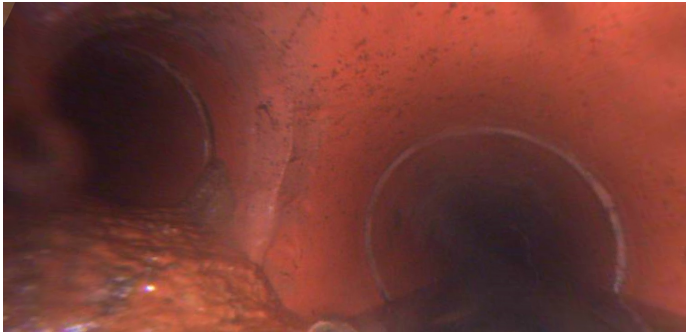
Code: **TFD**
Description: **Tap Factory Defective**

Distance (ft): **215.2**
Structural Grade: **0**
O&M Grade: **2**
Clock Start/From: **9**
Clock To:
1st Value: **4.000**
2nd Value:
Value Percent:
Continuous Index:
Within 8" of Joint:
Remarks: **dae**

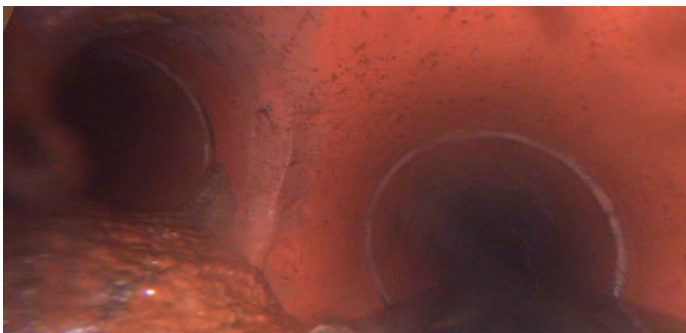
Code: **DAE**
Description: **Deposits Attached Encrustation**

Distance (ft): **215.2**
Structural Grade: **0**
O&M Grade: **2**
Clock Start/From: **7**
Clock To: **9**
1st Value:
2nd Value:
Value Percent: **10.000**
Continuous Index:
Within 8" of Joint: **NO**
Remarks:

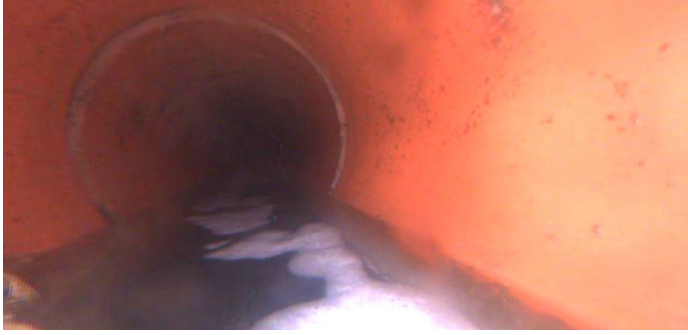
Code:	MSA
Description:	Abandoned Survey
Distance (ft):	223.0
Structural Grade:	0
O&M Grade:	0
Clock Start/From:	
Clock To:	
1st Value:	
2nd Value:	
Value Percent:	
Continuous Index:	
Within 8" of Joint:	NO
Remarks:	camera stoppeds
