## Profile/Photo Observation Report

Street:	<b>Summerlin</b>	Flow Control:	<b>Not Controlled</b>
City:	<b>Hobart, IN</b>	Year Renewed:	
Location:	<b>Light Highway</b>	Tape/Media #:	
Purpose:	<b>Not Known</b>	Dia/Height:	<b>10"</b>
Use:	<b>Sanitary</b>	Material:	<b>VCP</b>
Drain Area:	<b>NA</b>	Lining:	
Category:	<b>NA</b>		
Comment:

Location Details:		Direction of Survey:	<b>Downstream</b>
US MH:	<b>M-404-026</b>	DS MH:	<b>M-404-027</b>
		Total Length Surveyed (ft):	<b>223.0</b>

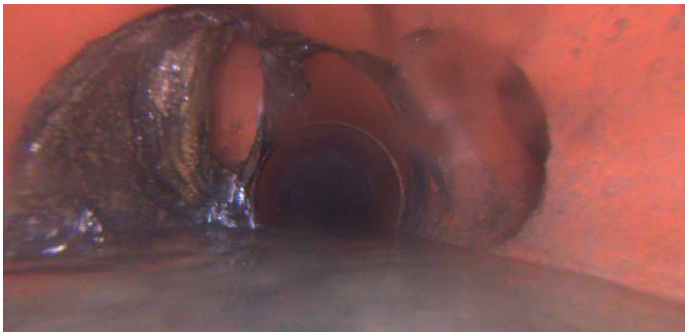
Code:	<b>FS</b>
Description:	<b>Fracture Spiral</b>

Distance (ft):	<b>25.9</b>
Structural Grade:	<b>3</b>
O&M Grade:	<b>0</b>
Clock Start/From:	<b>7</b>
Clock To:	<b>12</b>
1st Value:	
2nd Value:	
Value Percent:	
Continuous Index:	
Within 8" of Joint:	
Remarks:

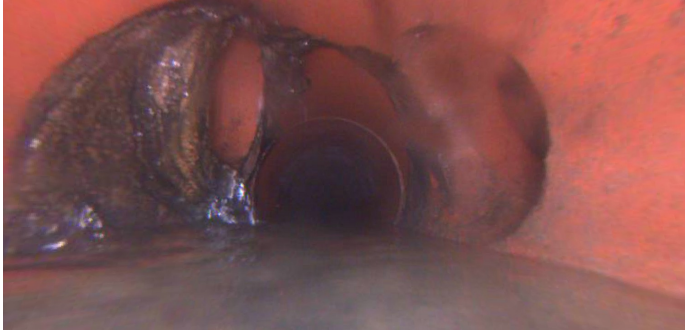
Code: **IW**  
Description: **Infil Weeper**

Distance (ft): **25.9**  
Structural Grade: **0**  
O&M Grade: **2**  
Clock Start/From: **7**  
Clock To: **12**  
1st Value:  
2nd Value:  
Value Percent:  
Continuous Index:  
Within 8" of Joint:  
Remarks:

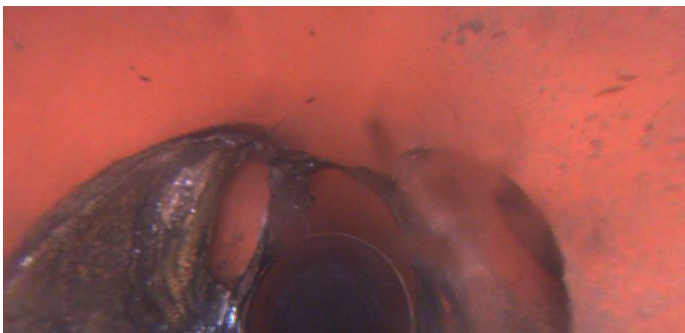
Code: **TBI**  
Description: **Tap Break-in Intruding**

Distance (ft): **25.9**  
Structural Grade: **0**  
O&M Grade: **2**  
Clock Start/From: **9**  
Clock To:  
1st Value: **6.000**  
2nd Value: **2.000**  
Value Percent:  
Continuous Index:  
Within 8" of Joint:  
Remarks:

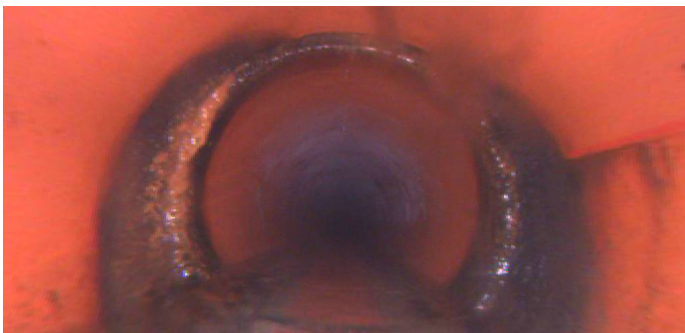
Code: **DAE**  
Description: **Deposits Attached Encrustation**

Distance (ft): **32.2**  
Structural Grade: **0**  
O&M Grade: **3**  
Clock Start/From: **7**  
Clock To: **5**  
1st Value:  
2nd Value:  
Value Percent: **20.000**  
Continuous Index:  
Within 8" of Joint: **YES**  
Remarks:

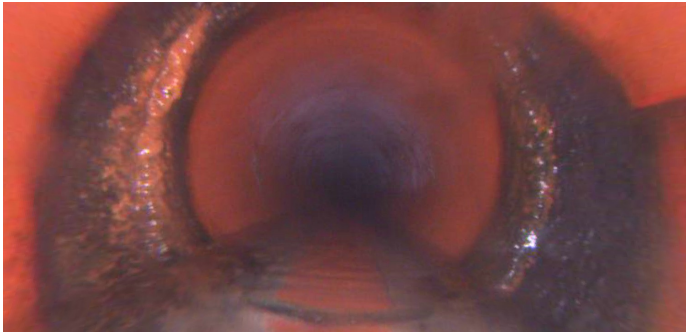
Code: **IW**  
Description: **Infil Weeper**

Distance (ft): **32.3**  
Structural Grade: **0**  
O&M Grade: **2**  
Clock Start/From: **8**  
Clock To: **4**  
1st Value:  
2nd Value:  
Value Percent:  
Continuous Index:  
Within 8" of Joint: **YES**  
Remarks:

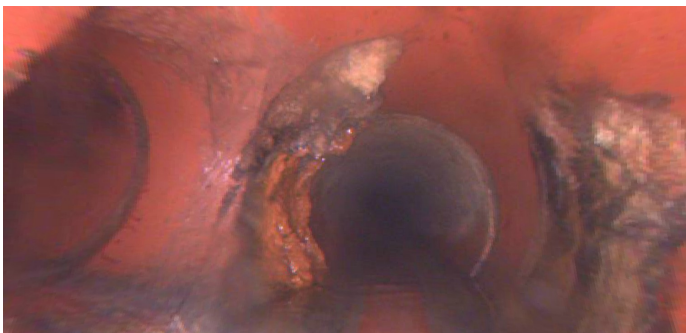
Code: **DAE**  
Description: **Deposits Attached Encrustation**

Distance (ft): **83.7**  
Structural Grade: **0**  
O&M Grade: **3**  
Clock Start/From: **7**  
Clock To: **5**  
1st Value:  
2nd Value:  
Value Percent: **20.000**  
Continuous Index:  
Within 8" of Joint:  
Remarks:

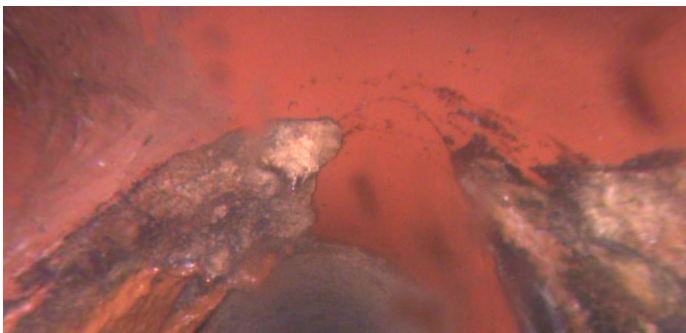
Code: **CM**  
Description: **Crack Multiple**

Distance (ft): **84.0**  
Structural Grade: **3**  
O&M Grade: **0**  
Clock Start/From: **11**  
Clock To: **1**  
1st Value:  
2nd Value:  
Value Percent:  
Continuous Index:  
Within 8" of Joint:  
Remarks:

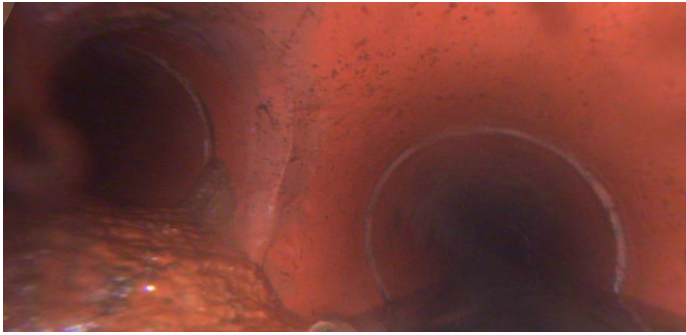
Code: **TFD**  
Description: **Tap Factory Defective**

Distance (ft): **215.2**  
Structural Grade: **0**  
O&M Grade: **2**  
Clock Start/From: **9**  
Clock To:  
1st Value: **4.000**  
2nd Value:  
Value Percent:  
Continuous Index:  
Within 8" of Joint:  
Remarks: **dae**

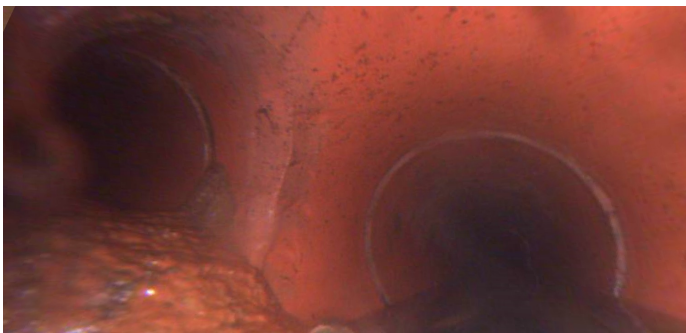
Code: **DAE**  
Description: **Deposits Attached Encrustation**

Distance (ft): **215.2**  
Structural Grade: **0**  
O&M Grade: **2**  
Clock Start/From: **7**  
Clock To: **9**  
1st Value:  
2nd Value:  
Value Percent: **10.000**  
Continuous Index:  
Within 8" of Joint: **NO**  
Remarks:

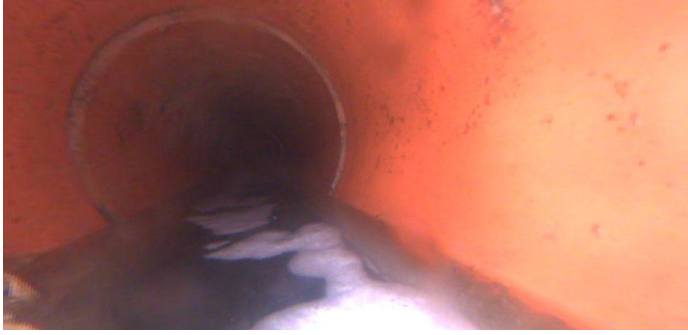
Code:	<b>MSA</b>
Description:	<b>Abandoned Survey</b>
Distance (ft):	<b>223.0</b>
Structural Grade:	<b>0</b>
O&M Grade:	<b>0</b>
Clock Start/From:	
Clock To:	
1st Value:	
2nd Value:	
Value Percent:	
Continuous Index:	
Within 8" of Joint:	<b>NO</b>
Remarks:	<b>camera stoppeds</b>
