Profile/Photo Observation Report

Date:	04/16/2018	Weather:		Coding:	PACP 6.0
Pipe Length (ft):	339.3	Owner:	NA	Pre Clean:	Not Known
P.O.#:		Surveyor:	Selasie Honu	PSR:	P-404-027-026
Customer:		Clean Date:	01/01/1900	Shape:	C

Street:	DEARBORN ST	Flow Control:	Not Controlled
City:	Hobart, IN	Year Renewed:	
Location:	Light Highway	Tape/Media #:	
Purpose:	Not Known	Dia/Height:	10"
Use:	Sanitary	Material:	VCP
Drain Area:	NA	Lining:	
Category:	NA		
Comment:

Location Details:		Direction of Survey:	Downstream
US MH:	M-404-026	DS MH:	M-404-027
		Total Length Surveyed (ft):	349.9

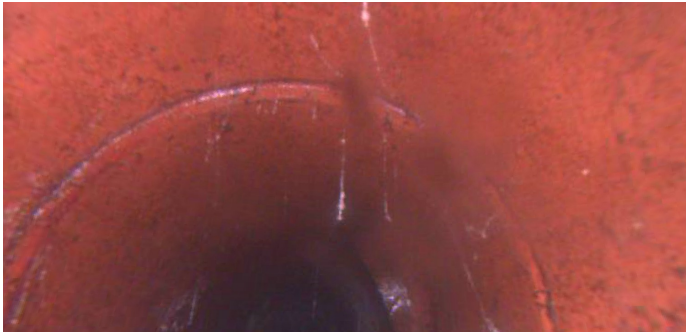
Code: **RFJ**
Description: **Roots Fine Joint**

Distance (ft): **41.5**
Structural Grade: **0**
O&M Grade: **1**
Clock Start/From: **10**
Clock To: **2**
1st Value:
2nd Value:
Value Percent:
Continuous Index:
Within 8" of Joint: **YES**
Remarks:

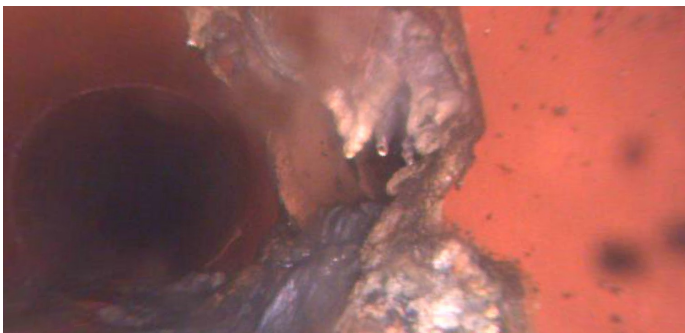
Code: **DAE**
Description: **Deposits Attached Encrustation**

Distance (ft): **50.0**
Structural Grade: **0**
O&M Grade: **2**
Clock Start/From: **1**
Clock To: **4**
1st Value:
2nd Value:
Value Percent: **10.000**
Continuous Index:
Within 8" of Joint: **NO**
Remarks:

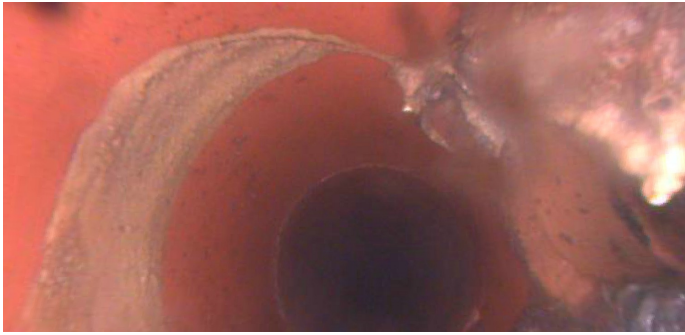
Code: **FC**
Description: **Fracture Circumferential**

Distance (ft): **50.1**
Structural Grade: **2**
O&M Grade: **0**
Clock Start/From: **8**
Clock To: **12**
1st Value:
2nd Value:
Value Percent:
Continuous Index:
Within 8" of Joint:
Remarks:

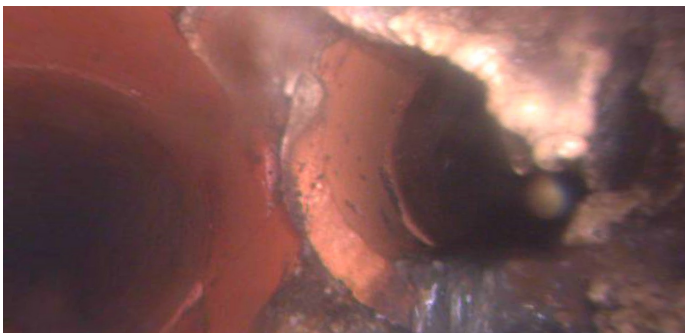
Code: **TBI**
Description: **Tap Break-in Intruding**

Distance (ft): **50.5**
Structural Grade: **0**
O&M Grade: **2**
Clock Start/From: **3**
Clock To:
1st Value: **4.000**
2nd Value: **1.000**
Value Percent:
Continuous Index:
Within 8" of Joint:
Remarks:

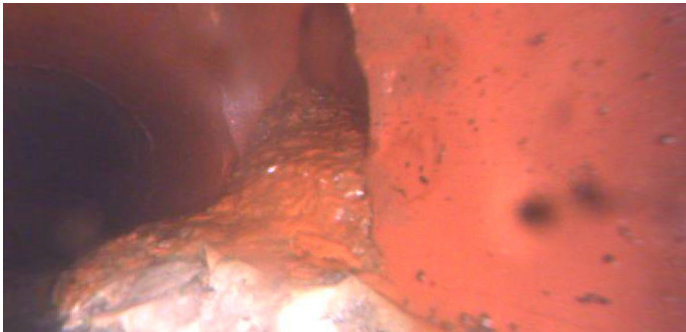
Code: **TFD**
Description: **Tap Factory Defective**

Distance (ft): **131.9**
Structural Grade: **0**
O&M Grade: **2**
Clock Start/From: **3**
Clock To:
1st Value: **4.000**
2nd Value:
Value Percent:
Continuous Index:
Within 8" of Joint:
Remarks: **dae**

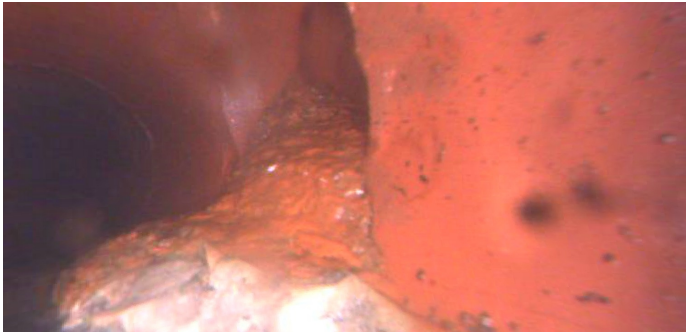
Code: **DAE**
Description: **Deposits Attached Encrustation**

Distance (ft): **131.9**
Structural Grade: **0**
O&M Grade: **2**
Clock Start/From: **3**
Clock To: **5**
1st Value:
2nd Value:
Value Percent: **10.000**
Continuous Index:
Within 8" of Joint: **NO**
Remarks:

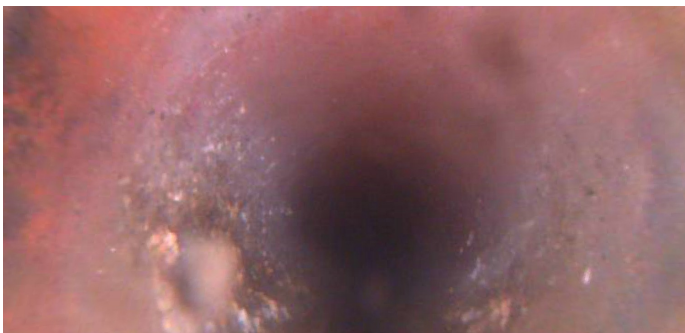
Code: **DAGS**
Description: **Deposits Attached Grease**

Distance (ft): **173.7**
Structural Grade: **0**
O&M Grade: **2**
Clock Start/From: **8**
Clock To: **4**
1st Value:
2nd Value:
Value Percent: **5.000**
Continuous Index:
Within 8" of Joint: **NO**
Remarks:

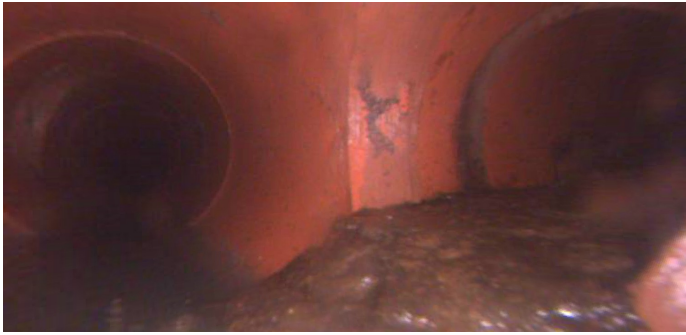
Code: **TFD**
Description: **Tap Factory Defective**

Distance (ft): **189.6**
Structural Grade: **0**
O&M Grade: **2**
Clock Start/From: **3**
Clock To:
1st Value: **4.000**
2nd Value:
Value Percent:
Continuous Index:
Within 8" of Joint:
Remarks: **dae**

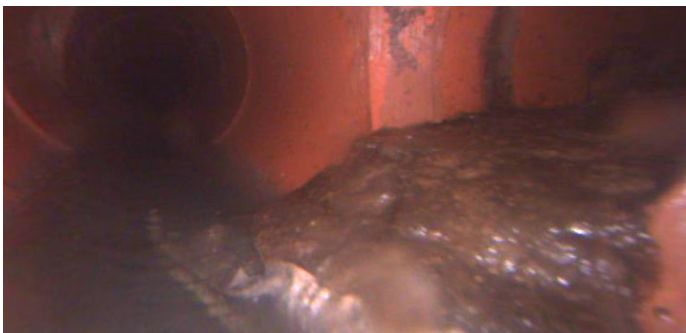
Code: **DAE**
Description: **Deposits Attached Encrustation**

Distance (ft): **189.6**
Structural Grade: **0**
O&M Grade: **2**
Clock Start/From: **3**
Clock To: **4**
1st Value:
2nd Value:
Value Percent: **10.000**
Continuous Index:
Within 8" of Joint: **NO**
Remarks:

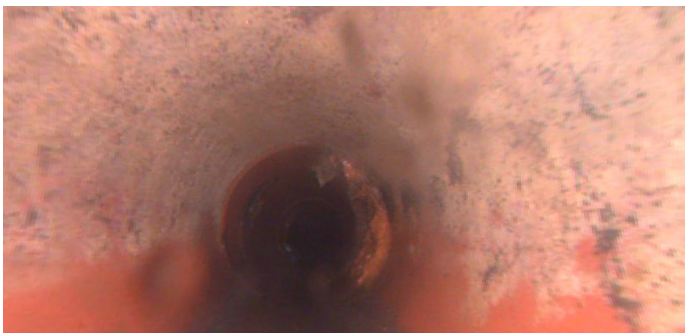
Code: **DAE**
Description: **Deposits Attached Encrustation**

Distance (ft): **261.4**
Structural Grade: **0**
O&M Grade: **2**
Clock Start/From: **12**
Clock To: **5**
1st Value:
2nd Value:
Value Percent: **10.000**
Continuous Index:
Within 8" of Joint: **YES**
Remarks:

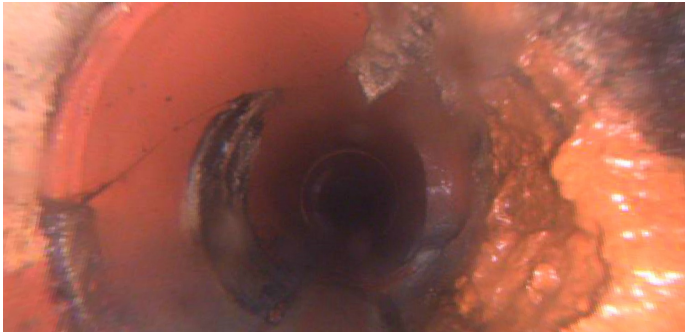
Code: **CC**
Description: **Crack Circumferential**

Distance (ft): **262.6**
Structural Grade: **1**
O&M Grade: **0**
Clock Start/From: **9**
Clock To: **12**
1st Value:
2nd Value:
Value Percent:
Continuous Index:
Within 8" of Joint: **YES**
Remarks:

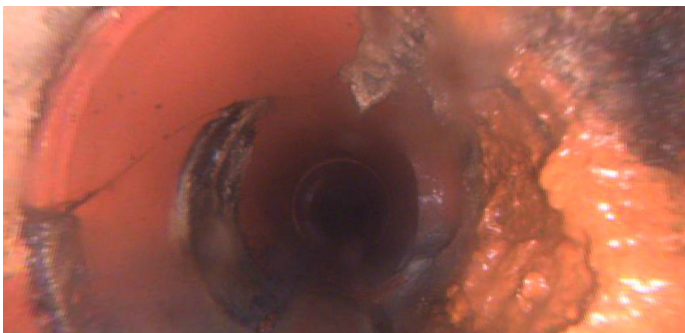
Code: **IS**
Description: **Infil Stain**

Distance (ft): **262.6**
Structural Grade: **0**
O&M Grade: **0**
Clock Start/From: **7**
Clock To: **12**
1st Value:
2nd Value:
Value Percent:
Continuous Index:
Within 8" of Joint: **YES**
Remarks:

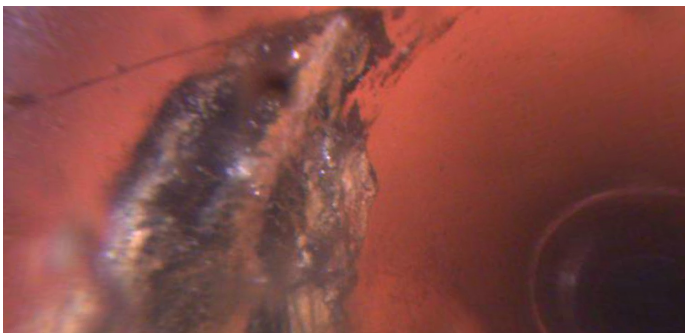
Code: **FC**
Description: **Fracture Circumferential**

Distance (ft): **263.1**
Structural Grade: **2**
O&M Grade: **0**
Clock Start/From: **10**
Clock To: **11**
1st Value:
2nd Value:
Value Percent:
Continuous Index:
Within 8" of Joint:
Remarks:

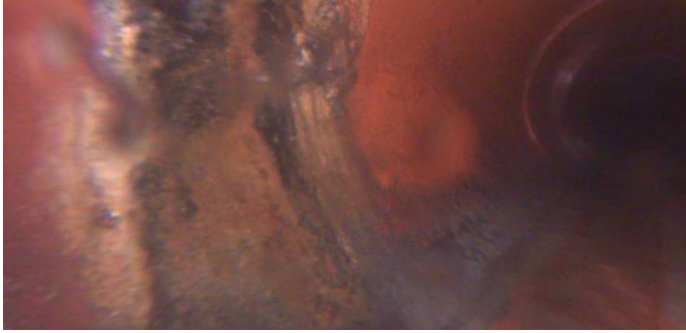
Code: **DAE**
Description: **Deposits Attached Encrustation**

Distance (ft): **263.1**
Structural Grade: **0**
O&M Grade: **2**
Clock Start/From: **7**
Clock To: **11**
1st Value:
2nd Value:
Value Percent: **5.000**
Continuous Index:
Within 8" of Joint: **NO**
Remarks:

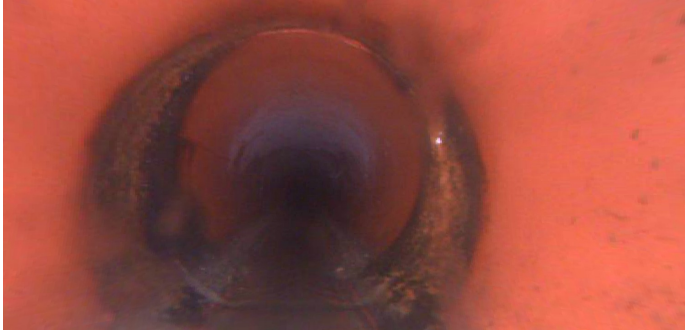
Code: **IW**
Description: **Infil Weeper**

Distance (ft): **314.2**
Structural Grade: **0**
O&M Grade: **2**
Clock Start/From: **12**
Clock To: **12**
1st Value:
2nd Value:
Value Percent:
Continuous Index:
Within 8" of Joint: **YES**
Remarks:

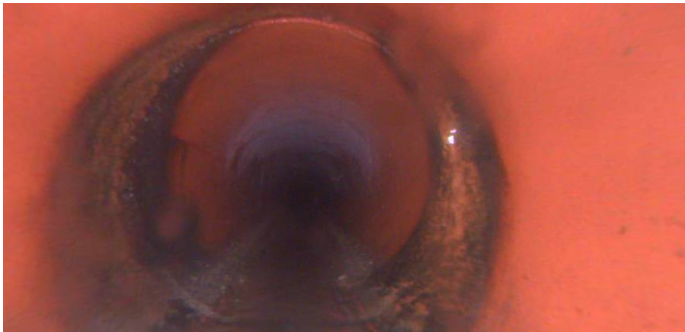
Code: **DAE**
Description: **Deposits Attached Encrustation**

Distance (ft): **314.2**
Structural Grade: **0**
O&M Grade: **2**
Clock Start/From: **8**
Clock To: **4**
1st Value:
2nd Value:
Value Percent: **5.000**
Continuous Index:
Within 8" of Joint: **YES**
Remarks:

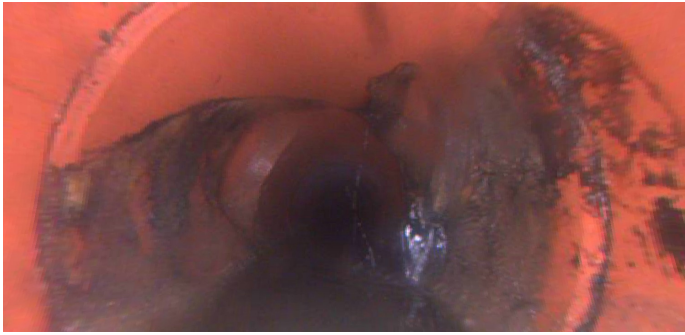
Code: **FM**
Description: **Fracture Multiple**

Distance (ft): **319.8**
Structural Grade: **4**
O&M Grade: **0**
Clock Start/From: **7**
Clock To: **5**
1st Value:
2nd Value:
Value Percent:
Continuous Index:
Within 8" of Joint: **YES**
Remarks:

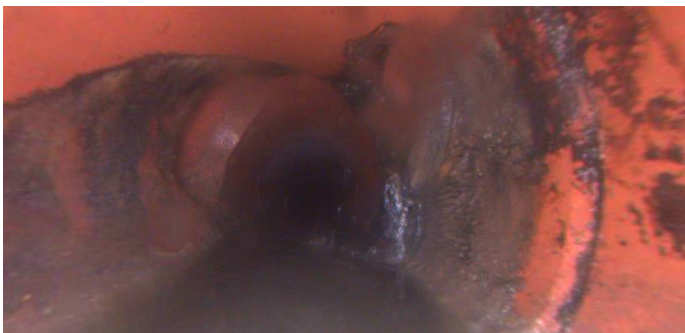
Code: **DAE**
Description: **Deposits Attached Encrustation**

Distance (ft): **319.9**
Structural Grade: **0**
O&M Grade: **2**
Clock Start/From: **8**
Clock To: **4**
1st Value:
2nd Value:
Value Percent: **10.000**
Continuous Index:
Within 8" of Joint: **NO**
Remarks:

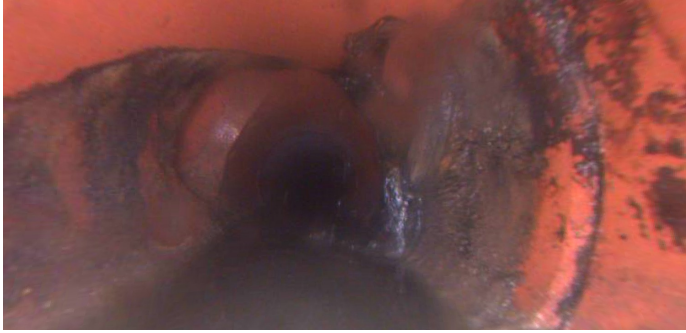
Code: **IW**
Description: **Infil Weeper**

Distance (ft): **319.9**
Structural Grade: **0**
O&M Grade: **2**
Clock Start/From: **8**
Clock To:
1st Value:
2nd Value:
Value Percent:
Continuous Index:
Within 8" of Joint:
Remarks:

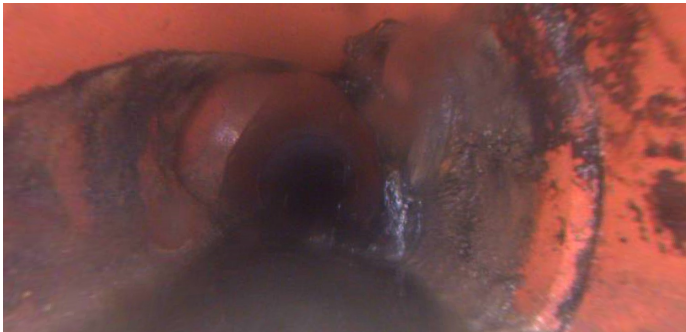
Code: **FS**
Description: **Fracture Spiral**

Distance (ft): **319.9**
Structural Grade: **3**
O&M Grade: **0**
Clock Start/From: **9**
Clock To: **1**
1st Value:
2nd Value:
Value Percent:
Continuous Index:
Within 8" of Joint:
Remarks:

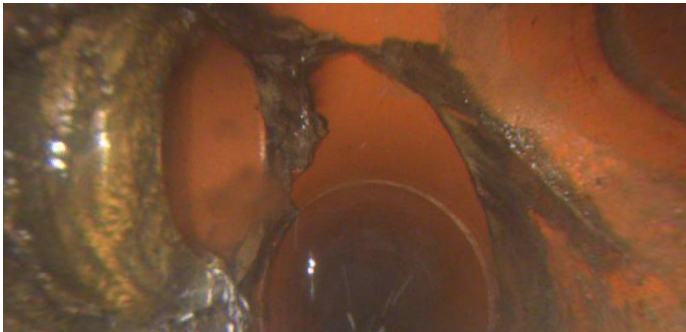
Code: **TBI**
Description: **Tap Break-in Intruding**

Distance (ft): **321.6**
Structural Grade: **0**
O&M Grade: **2**
Clock Start/From: **3**
Clock To:
1st Value: **4.000**
2nd Value: **2.000**
Value Percent:
Continuous Index:
Within 8" of Joint:
Remarks: **ative**
