## Profile/Photo Observation Report

Street:	<b>Summerlin</b>	Flow Control:	<b>Not Controlled</b>
City:	<b>Hobart, IN</b>	Year Renewed:	
Location:	<b>Light Highway</b>	Tape/Media #:	
Purpose:	<b>Not Known</b>	Dia/Height:	<b>10"</b>
Use:	<b>Sanitary</b>	Material:	<b>VCP</b>
Drain Area:	<b>NA</b>	Lining:	
Category:	<b>NA</b>		
Comment:

Location Details:		Direction of Survey:	<b>Downstream</b>
US MH:	<b>M-404-026</b>	DS MH:	<b>M-404-027</b>
		Total Length Surveyed (ft):	<b>349.9</b>

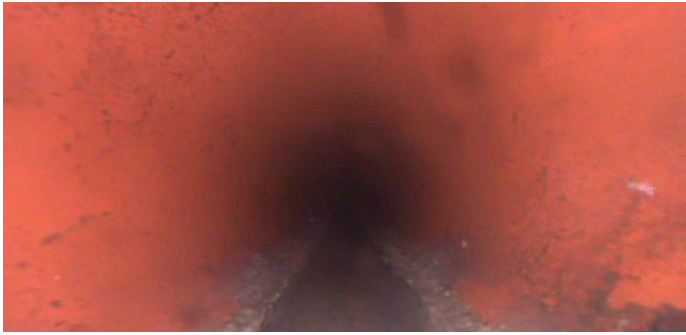
Code: **AMH**  
Description: **Manhole**

Distance (ft): **.0**  
Structural Grade: **0**  
O&M Grade: **0**  
Clock Start/From:  
Clock To:  
1st Value:  
2nd Value:  
Value Percent:  
Continuous Index:  
Within 8" of Joint: **NO**  
Remarks: **M-404-026**

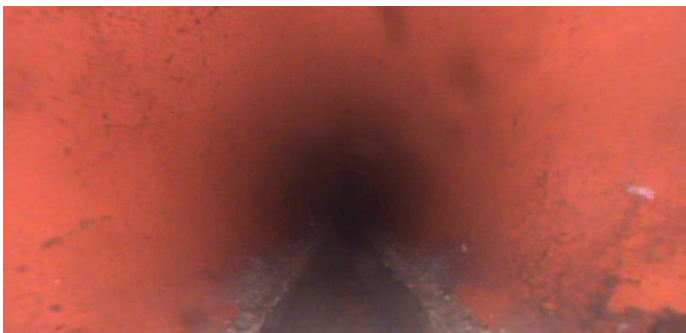
Code: **MWL**  
Description: **Water Level**

Distance (ft): **.0**  
Structural Grade: **0**  
O&M Grade: **0**  
Clock Start/From:  
Clock To:  
1st Value:  
2nd Value:  
Value Percent: **5.000**  
Continuous Index:  
Within 8" of Joint: **NO**  
Remarks:

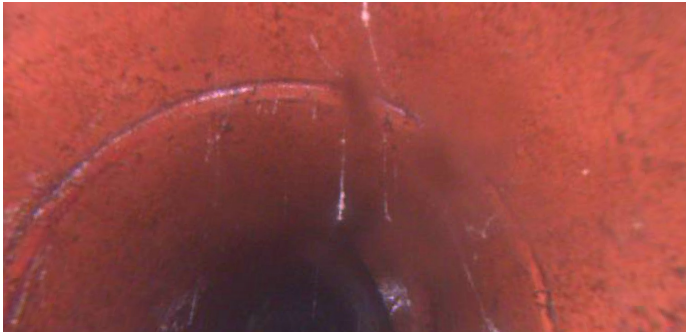
Code: **RFJ**  
Description: **Roots Fine Joint**

Distance (ft): **41.5**  
Structural Grade: **0**  
O&M Grade: **1**  
Clock Start/From: **10**  
Clock To: **2**  
1st Value:  
2nd Value:  
Value Percent:  
Continuous Index:  
Within 8" of Joint: **YES**  
Remarks:

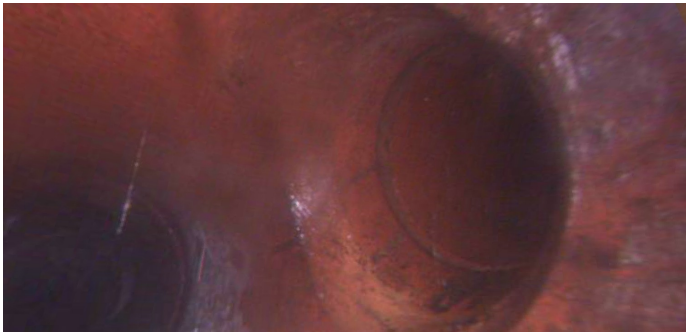
Code: **TF**  
Description: **Tap Factory**

Distance (ft): **42.5**  
Structural Grade: **0**  
O&M Grade: **0**  
Clock Start/From: **3**  
Clock To:  
1st Value: **4.000**  
2nd Value:  
Value Percent:  
Continuous Index:  
Within 8" of Joint:  
Remarks:

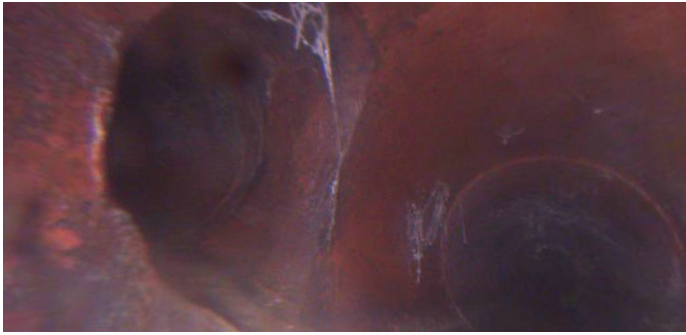
Code: **TFA**  
Description: **Tap Factory Active**

Distance (ft): **44.6**  
Structural Grade: **0**  
O&M Grade: **0**  
Clock Start/From: **9**  
Clock To:  
1st Value: **4.000**  
2nd Value:  
Value Percent:  
Continuous Index:  
Within 8" of Joint:  
Remarks:

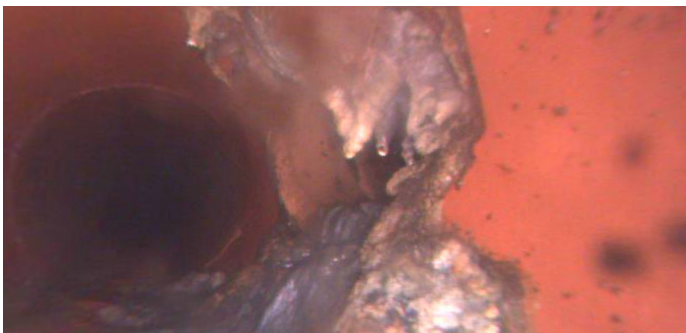
Code: **DAE**  
Description: **Deposits Attached Encrustation**

Distance (ft): **50.0**  
Structural Grade: **0**  
O&M Grade: **2**  
Clock Start/From: **1**  
Clock To: **4**  
1st Value:  
2nd Value:  
Value Percent: **10.000**  
Continuous Index:  
Within 8" of Joint: **NO**  
Remarks:

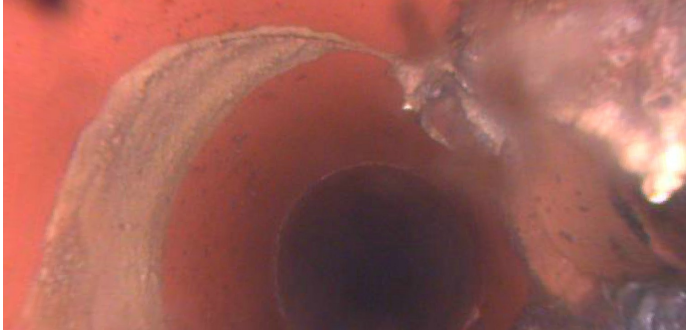
Code: **FC**  
Description: **Fracture Circumferential**

Distance (ft): **50.1**  
Structural Grade: **2**  
O&M Grade: **0**  
Clock Start/From: **8**  
Clock To: **12**  
1st Value:  
2nd Value:  
Value Percent:  
Continuous Index:  
Within 8" of Joint:  
Remarks:

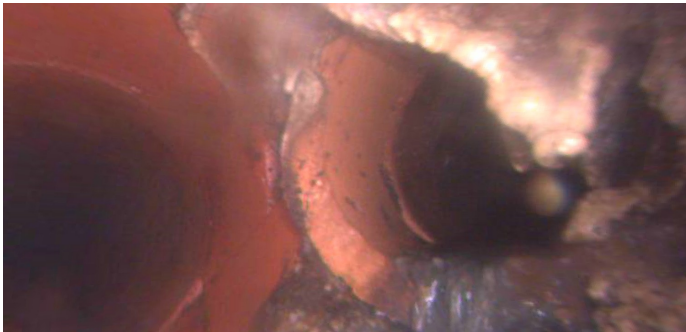
Code: **TBI**  
Description: **Tap Break-in Intruding**

Distance (ft): **50.5**  
Structural Grade: **0**  
O&M Grade: **2**  
Clock Start/From: **3**  
Clock To:  
1st Value: **4.000**  
2nd Value: **1.000**  
Value Percent:  
Continuous Index:  
Within 8" of Joint:  
Remarks:

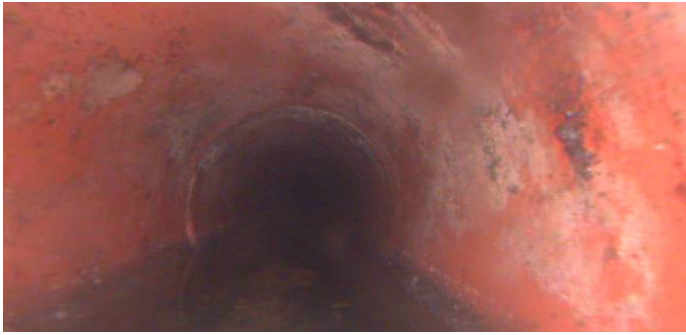
Code: **MWL**  
Description: **Water Level**

Distance (ft): **92.9**  
Structural Grade: **0**  
O&M Grade: **0**  
Clock Start/From:  
Clock To:  
1st Value:  
2nd Value:  
Value Percent: **30.000**  
Continuous Index:  
Within 8" of Joint: **NO**  
Remarks:

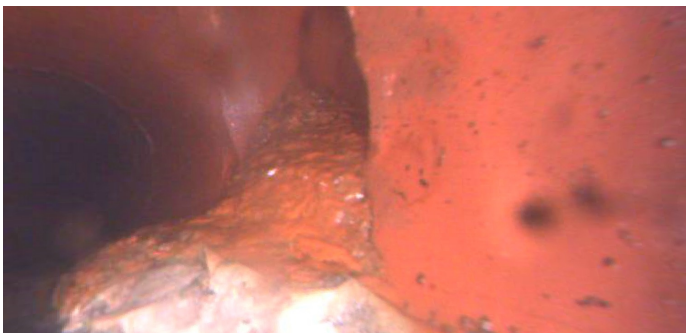
Code: **TFD**  
Description: **Tap Factory Defective**

Distance (ft): **131.9**  
Structural Grade: **0**  
O&M Grade: **2**  
Clock Start/From: **3**  
Clock To:  
1st Value: **4.000**  
2nd Value:  
Value Percent:  
Continuous Index:  
Within 8" of Joint:  
Remarks: **dae**

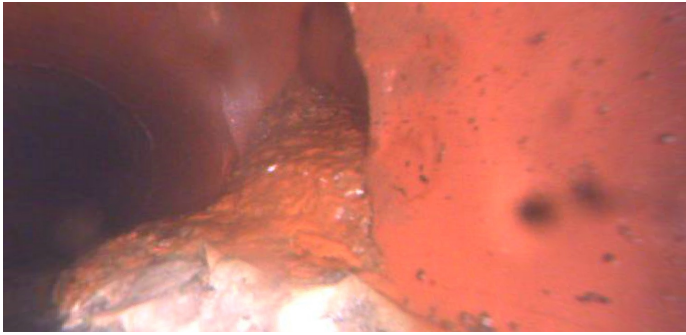
Code: **DAE**  
Description: **Deposits Attached Encrustation**

Distance (ft): **131.9**  
Structural Grade: **0**  
O&M Grade: **2**  
Clock Start/From: **3**  
Clock To: **5**  
1st Value:  
2nd Value:  
Value Percent: **10.000**  
Continuous Index:  
Within 8" of Joint: **NO**  
Remarks:

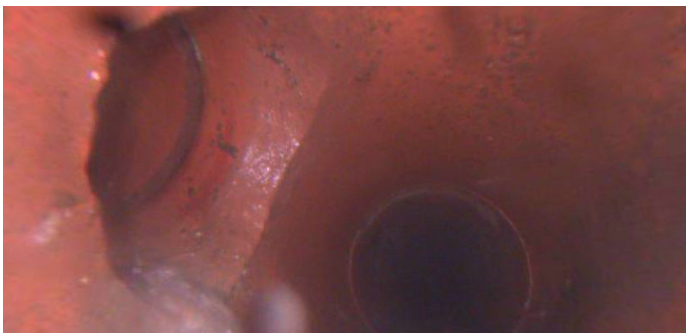
Code: **TFA**  
Description: **Tap Factory Active**

Distance (ft): **144.7**  
Structural Grade: **0**  
O&M Grade: **0**  
Clock Start/From: **9**  
Clock To:  
1st Value: **4.000**  
2nd Value:  
Value Percent:  
Continuous Index:  
Within 8" of Joint:  
Remarks:

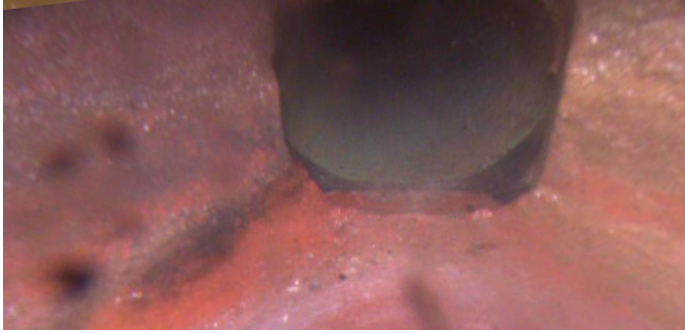
Code: **TB**  
Description: **Tap Break-in**

Distance (ft): **173.7**  
Structural Grade: **0**  
O&M Grade: **0**  
Clock Start/From: **12**  
Clock To:  
1st Value: **4.000**  
2nd Value:  
Value Percent:  
Continuous Index:  
Within 8" of Joint:  
Remarks:

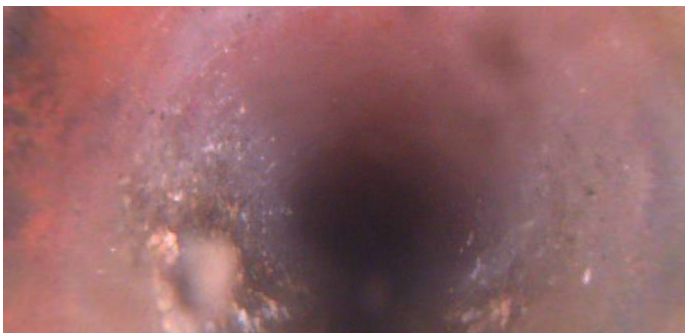
Code: **DAGS**  
Description: **Deposits Attached Grease**

Distance (ft): **173.7**  
Structural Grade: **0**  
O&M Grade: **2**  
Clock Start/From: **8**  
Clock To: **4**  
1st Value:  
2nd Value:  
Value Percent: **5.000**  
Continuous Index:  
Within 8" of Joint: **NO**  
Remarks:

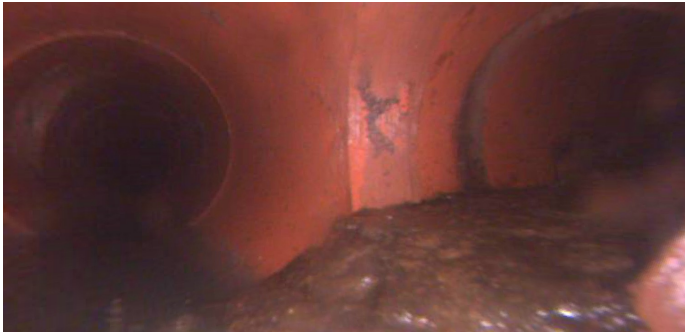
Code: **TFD**  
Description: **Tap Factory Defective**

Distance (ft): **189.6**  
Structural Grade: **0**  
O&M Grade: **2**  
Clock Start/From: **3**  
Clock To:  
1st Value: **4.000**  
2nd Value:  
Value Percent:  
Continuous Index:  
Within 8" of Joint:  
Remarks: **dae**

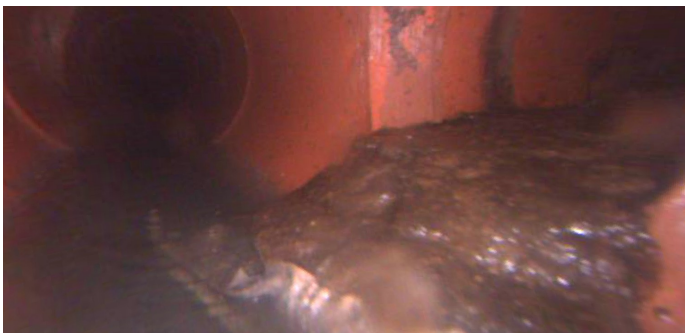
Code: **DAE**  
Description: **Deposits Attached Encrustation**

Distance (ft): **189.6**  
Structural Grade: **0**  
O&M Grade: **2**  
Clock Start/From: **3**  
Clock To: **4**  
1st Value:  
2nd Value:  
Value Percent: **10.000**  
Continuous Index:  
Within 8" of Joint: **NO**  
Remarks:

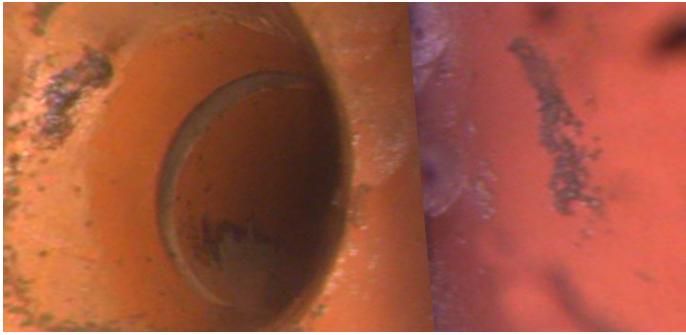
Code: **TF**  
Description: **Tap Factory**

Distance (ft): **192.5**  
Structural Grade: **0**  
O&M Grade: **0**  
Clock Start/From: **9**  
Clock To:  
1st Value: **4.000**  
2nd Value:  
Value Percent:  
Continuous Index:  
Within 8" of Joint:  
Remarks:

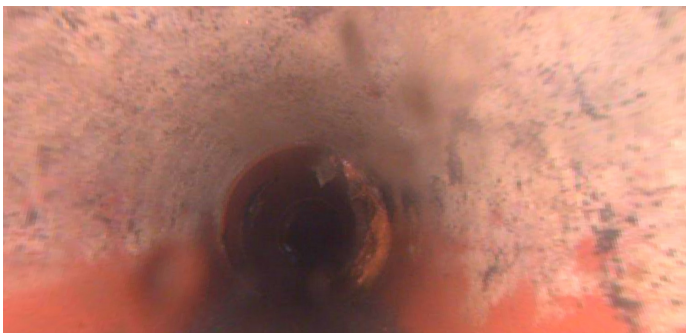
Code: **DAE**  
Description: **Deposits Attached Encrustation**

Distance (ft): **261.4**  
Structural Grade: **0**  
O&M Grade: **2**  
Clock Start/From: **12**  
Clock To: **5**  
1st Value:  
2nd Value:  
Value Percent: **10.000**  
Continuous Index:  
Within 8" of Joint: **YES**  
Remarks:

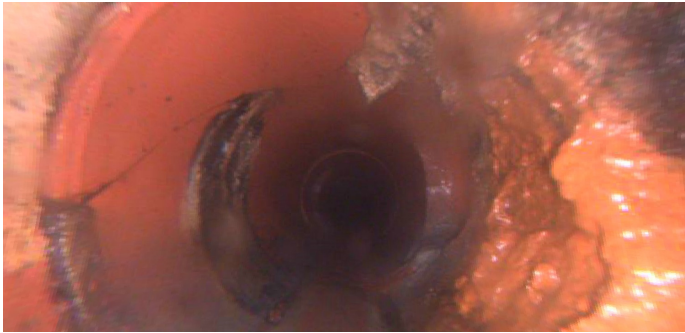
Code: **CC**  
Description: **Crack Circumferential**

Distance (ft): **262.6**  
Structural Grade: **1**  
O&M Grade: **0**  
Clock Start/From: **9**  
Clock To: **12**  
1st Value:  
2nd Value:  
Value Percent:  
Continuous Index:  
Within 8" of Joint: **YES**  
Remarks:

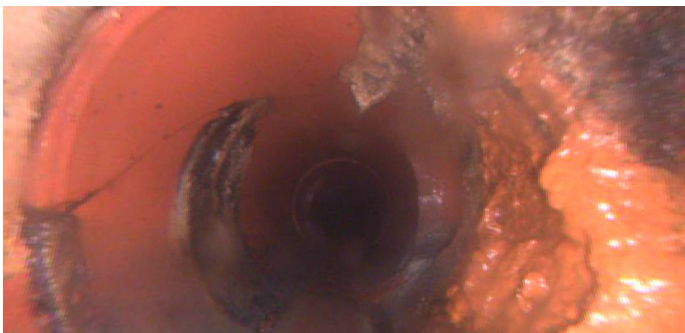
Code: **IS**  
Description: **Infil Stain**

Distance (ft): **262.6**  
Structural Grade: **0**  
O&M Grade: **0**  
Clock Start/From: **7**  
Clock To: **12**  
1st Value:  
2nd Value:  
Value Percent:  
Continuous Index:  
Within 8" of Joint: **YES**  
Remarks:

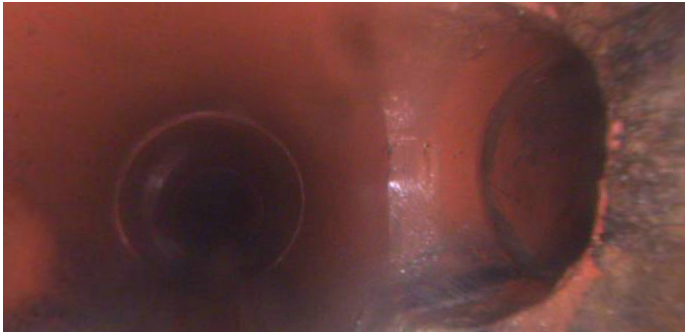
Code: **TFA**  
Description: **Tap Factory Active**

Distance (ft): **263.1**  
Structural Grade: **0**  
O&M Grade: **0**  
Clock Start/From: **3**  
Clock To:  
1st Value: **4.000**  
2nd Value:  
Value Percent:  
Continuous Index:  
Within 8" of Joint:  
Remarks:

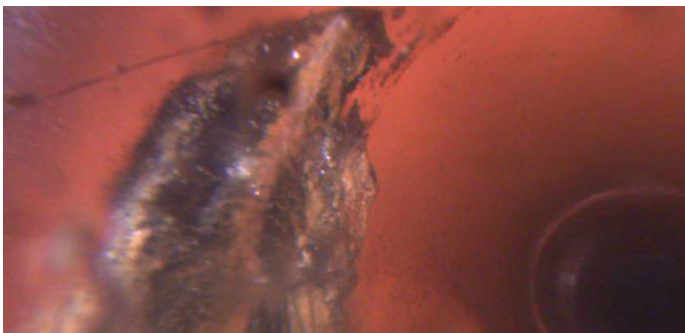
Code: **FC**  
Description: **Fracture Circumferential**

Distance (ft): **263.1**  
Structural Grade: **2**  
O&M Grade: **0**  
Clock Start/From: **10**  
Clock To: **11**  
1st Value:  
2nd Value:  
Value Percent:  
Continuous Index:  
Within 8" of Joint:  
Remarks:

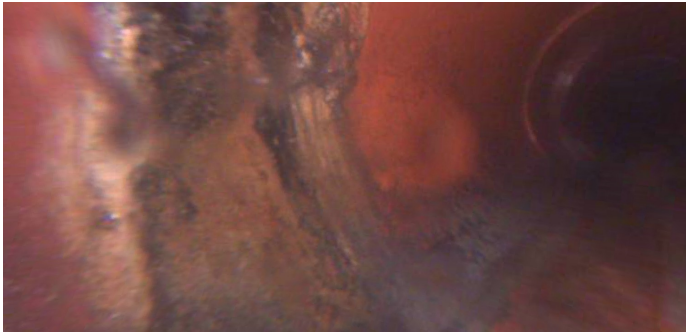
Code: **DAE**  
Description: **Deposits Attached Encrustation**

Distance (ft): **263.1**  
Structural Grade: **0**  
O&M Grade: **2**  
Clock Start/From: **7**  
Clock To: **11**  
1st Value:  
2nd Value:  
Value Percent: **5.000**  
Continuous Index:  
Within 8" of Joint: **NO**  
Remarks:

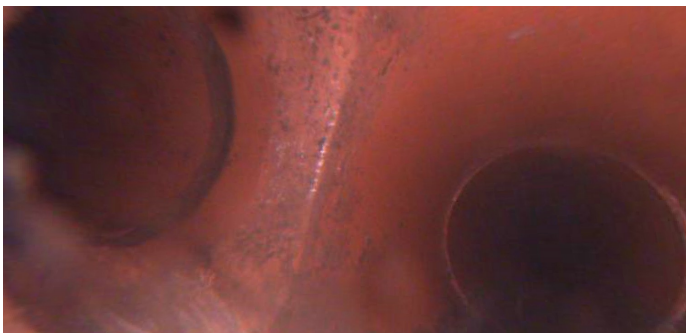
Code: **TFA**  
Description: **Tap Factory Active**

Distance (ft): **265.5**  
Structural Grade: **0**  
O&M Grade: **0**  
Clock Start/From: **9**  
Clock To:  
1st Value: **4.000**  
2nd Value:  
Value Percent:  
Continuous Index:  
Within 8" of Joint:  
Remarks:

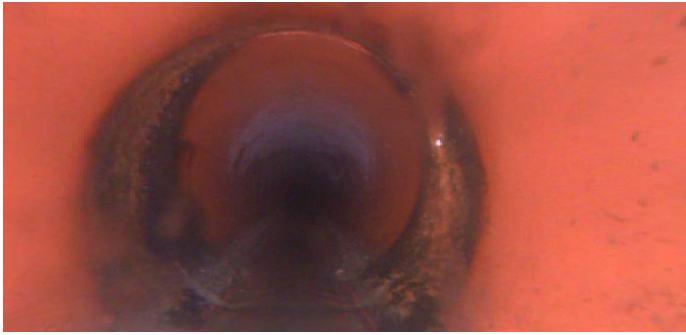
Code: **IW**  
Description: **Infil Weeper**

Distance (ft): **314.2**  
Structural Grade: **0**  
O&M Grade: **2**  
Clock Start/From: **12**  
Clock To: **12**  
1st Value:  
2nd Value:  
Value Percent:  
Continuous Index:  
Within 8" of Joint: **YES**  
Remarks:

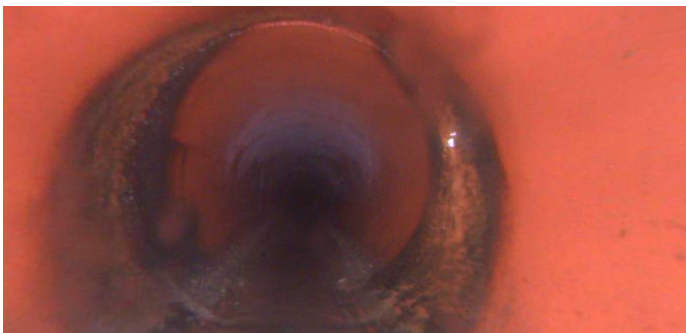
Code: **DAE**  
Description: **Deposits Attached Encrustation**

Distance (ft): **314.2**  
Structural Grade: **0**  
O&M Grade: **2**  
Clock Start/From: **8**  
Clock To: **4**  
1st Value:  
2nd Value:  
Value Percent: **5.000**  
Continuous Index:  
Within 8" of Joint: **YES**  
Remarks:

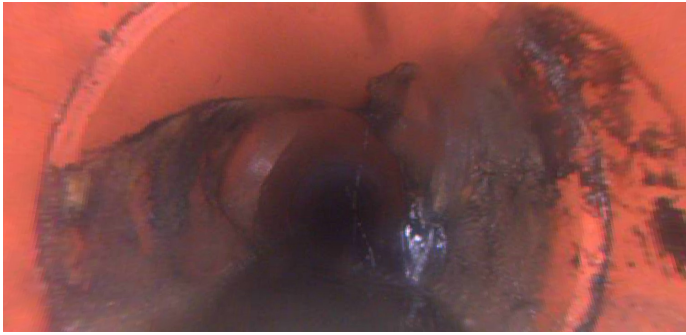
Code: **FM**  
Description: **Fracture Multiple**

Distance (ft): **319.8**  
Structural Grade: **4**  
O&M Grade: **0**  
Clock Start/From: **7**  
Clock To: **5**  
1st Value:  
2nd Value:  
Value Percent:  
Continuous Index:  
Within 8" of Joint: **YES**  
Remarks:

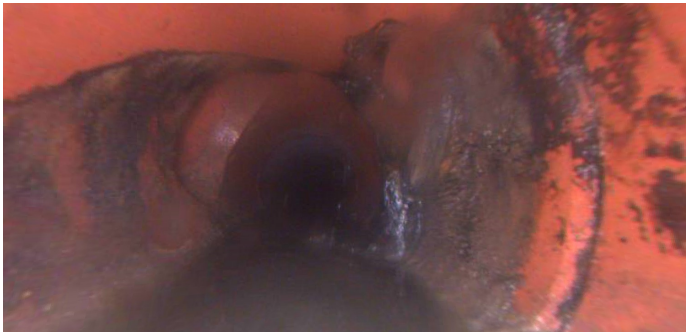
Code: **DAE**  
Description: **Deposits Attached Encrustation**

Distance (ft): **319.9**  
Structural Grade: **0**  
O&M Grade: **2**  
Clock Start/From: **8**  
Clock To: **4**  
1st Value:  
2nd Value:  
Value Percent: **10.000**  
Continuous Index:  
Within 8" of Joint: **NO**  
Remarks:

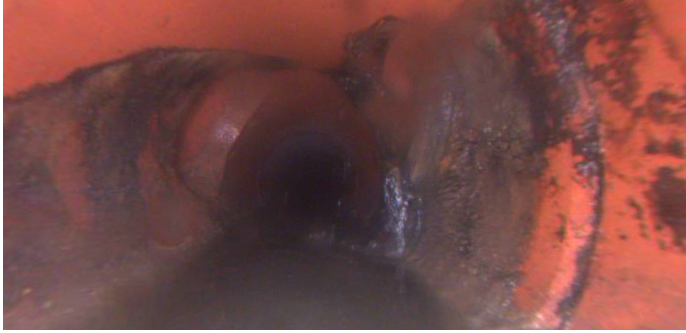
Code: **IW**  
Description: **Infil Weeper**

Distance (ft): **319.9**  
Structural Grade: **0**  
O&M Grade: **2**  
Clock Start/From: **8**  
Clock To:  
1st Value:  
2nd Value:  
Value Percent:  
Continuous Index:  
Within 8" of Joint:  
Remarks:

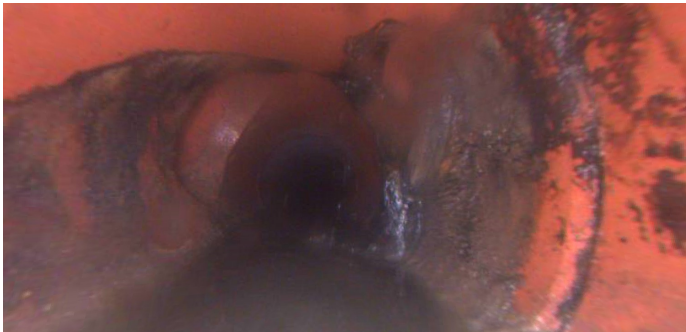
Code: **FS**  
Description: **Fracture Spiral**

Distance (ft): **319.9**  
Structural Grade: **3**  
O&M Grade: **0**  
Clock Start/From: **9**  
Clock To: **1**  
1st Value:  
2nd Value:  
Value Percent:  
Continuous Index:  
Within 8" of Joint:  
Remarks:

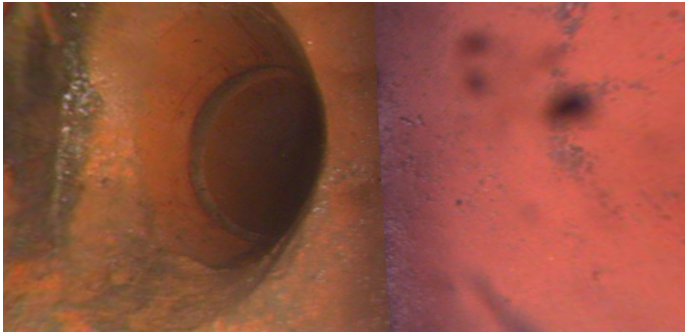
Code: **TF**  
Description: **Tap Factory**

Distance (ft): **321.6**  
Structural Grade: **0**  
O&M Grade: **0**  
Clock Start/From: **9**  
Clock To:  
1st Value: **4.000**  
2nd Value:  
Value Percent:  
Continuous Index:  
Within 8" of Joint:  
Remarks:

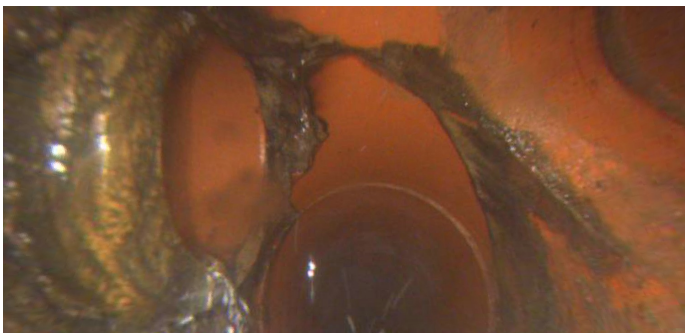
Code: **TBI**  
Description: **Tap Break-in Intruding**

Distance (ft): **321.6**  
Structural Grade: **0**  
O&M Grade: **2**  
Clock Start/From: **3**  
Clock To:  
1st Value: **4.000**  
2nd Value: **2.000**  
Value Percent:  
Continuous Index:  
Within 8" of Joint:  
Remarks: **ative**

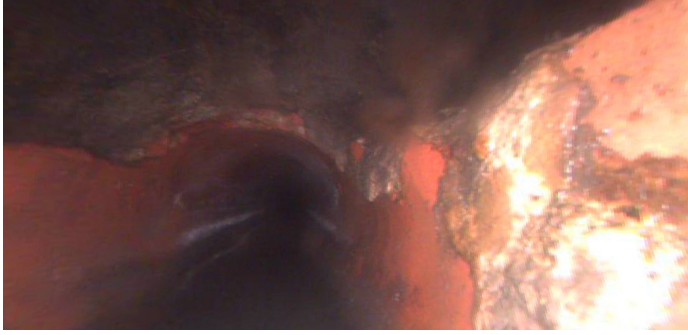
Code:	AMH
Description:	Manhole
Distance (ft):	349.9
Structural Grade:	0
O&M Grade:	0
Clock Start/From:	
Clock To:	
1st Value:	
2nd Value:	
Value Percent:	
Continuous Index:	
Within 8" of Joint:	NO
Remarks:	M-404-027
