## Profile/Photo Observation Report

Street:	<b>DEARBORN ST</b>	Flow Control:	<b>Not Controlled</b>
City:	<b>Hobart, IN</b>	Year Renewed:	
Location:	<b>Light Highway</b>	Tape/Media #:	
Purpose:	<b>Not Known</b>	Dia/Height:	<b>10"</b>
Use:	<b>Sanitary</b>	Material:	<b>PVC</b>
Drain Area:	<b>NA</b>	Lining:	
Category:	<b>NA</b>		
Comment:

Location Details:		Direction of Survey:	<b>Downstream</b>
US MH:	<b>M-404-027</b>	DS MH:	<b>M-404-036</b>
		Total Length Surveyed (ft):	<b>39.2</b>

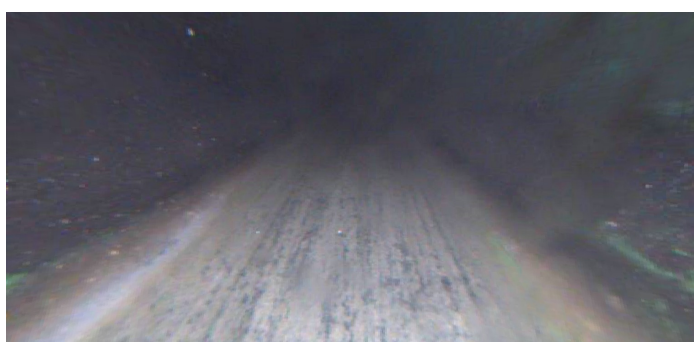
Code: **AMH**  
Description: **Manhole**

Distance (ft): **.0**  
Structural Grade: **0**  
O&M Grade: **0**  
Clock Start/From:  
Clock To:  
1st Value:  
2nd Value:  
Value Percent:  
Continuous Index:  
Within 8" of Joint: **NO**  
Remarks: **M-404-027**

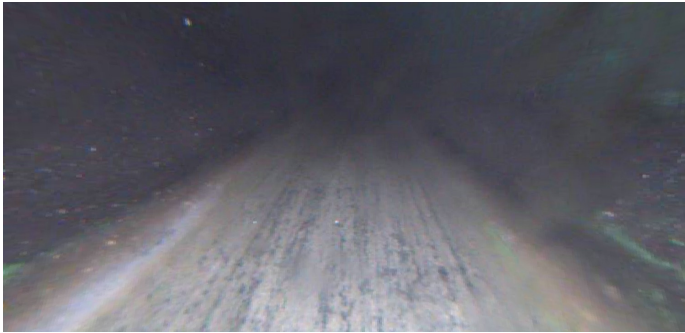
Code:	<b>MWL</b>
Description:	<b>Water Level</b>

Distance (ft):	<b>.0</b>
Structural Grade:	<b>0</b>
O&M Grade:	<b>0</b>
Clock Start/From:	
Clock To:	
1st Value:	
2nd Value:	
Value Percent:	<b>5.000</b>
Continuous Index:	
Within 8" of Joint:	<b>NO</b>
Remarks:

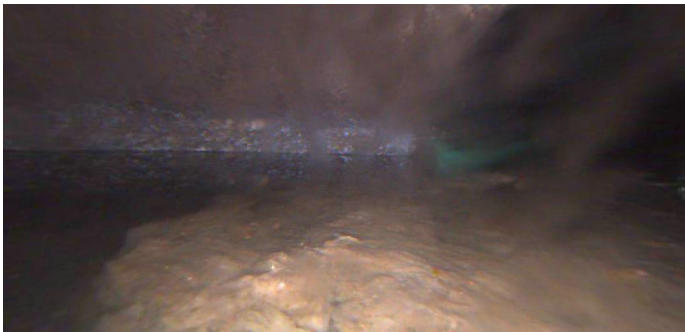
Code:	<b>AMH</b>
Description:	<b>Manhole</b>

Distance (ft):	<b>39.2</b>
Structural Grade:	<b>0</b>
O&M Grade:	<b>0</b>
Clock Start/From:	
Clock To:	
1st Value:	
2nd Value:	
Value Percent:	
Continuous Index:	
Within 8" of Joint:	<b>NO</b>
Remarks:	<b>M-404-036</b>
