Profile/Photo Observation Report

Date:	04/07/2018	Weather:		Coding:	PACP 6.0
Pipe Length (ft):		Owner:	City of Hobart	Pre Clean:	No Pre-Cleaning
P.O.#:	17-3	Surveyor:	M. Pielacha	PSR:	M-404-028-M-404-025
Customer:	City of Hobart	Clean Date:		Shape:	C

Street:	Old Ridge Road	Flow Control:	Not Controlled
City:	Hobart, IN	Year Renewed:	
Location:	Light Highway	Tape/Media #:	DEP 17
Purpose:	Routine Assessment	Dia/Height:	18"
Use:	Sanitary	Material:	VCP
Drain Area:		Lining:	
Category:	NA		
Comment:			
Location Details:		Direction of Survey:	Downstream
US MH:	M-404-028	DS MH:	M-404-025
		Total Length Surveyed (ft):	87.0

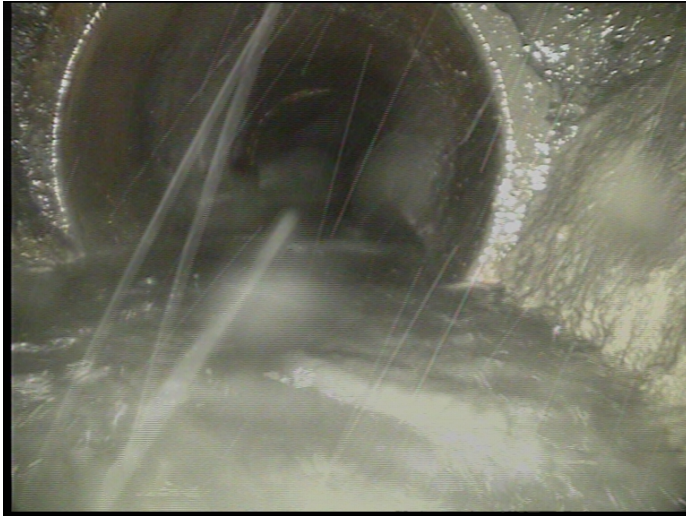
Code: **MWL**
Description: **Water Level**

Distance (ft): **.0**
Structural Grade: **0**
O&M Grade: **0**
Clock Start/From:
Clock To:
1st Value:
2nd Value:
Value Percent: **10.000**
Continuous Index:
Within 8" of Joint: **NO**
Remarks:

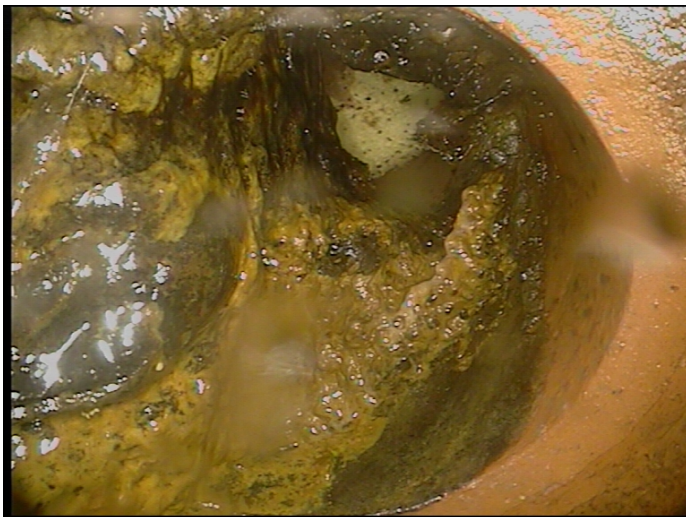
Code: **TFD**
Description: **Tap Factory Defective**

Distance (ft): **23.4**
Structural Grade: **0**
O&M Grade: **2**
Clock Start/From: **10**
Clock To:
1st Value: **4.000**
2nd Value:
Value Percent:
Continuous Index:
Within 8" of Joint: **NO**
Remarks: **Defective**

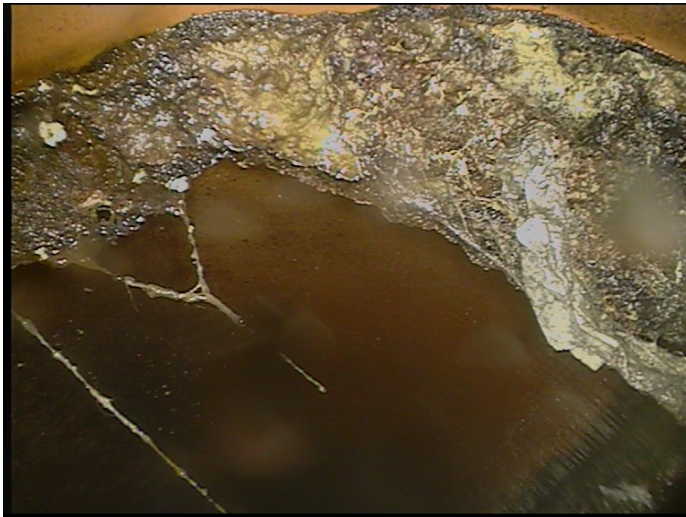
Code:	DAE
Description:	Deposits Attached Encrustation
Distance (ft):	35.1
Structural Grade:	0
O&M Grade:	2
Clock Start/From:	11
Clock To:	5
1st Value:	
2nd Value:	
Value Percent:	5.000
Continuous Index:	
Within 8" of Joint:	YES
Remarks:

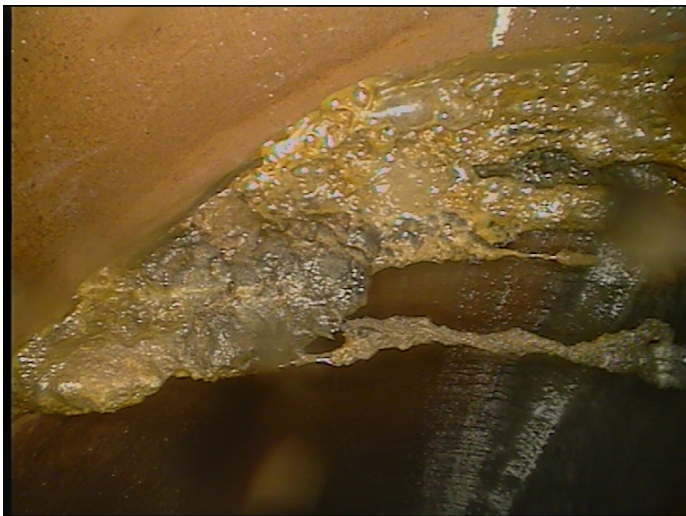
Code:	DAE
Description:	Deposits Attached Encrustation
Distance (ft):	60.4
Structural Grade:	0
O&M Grade:	2
Clock Start/From:	1
Clock To:	5
1st Value:	
2nd Value:	
Value Percent:	5.000
Continuous Index:	
Within 8" of Joint:	YES
Remarks:

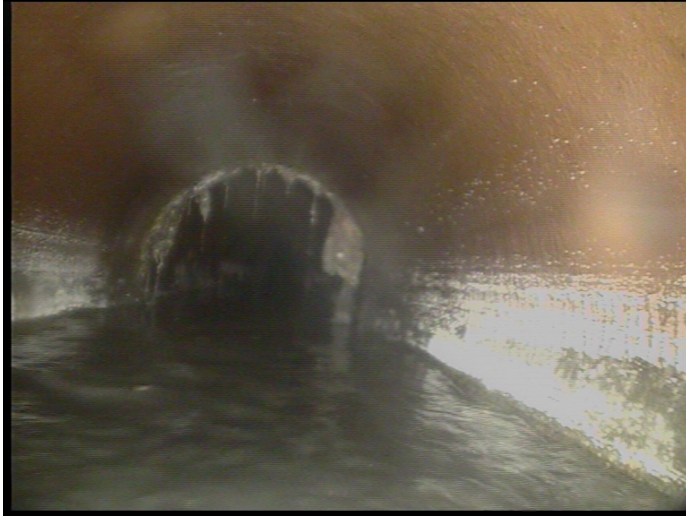
Code:	MSA
Description:	Abandoned Survey
Distance (ft):	87.0
Structural Grade:	0
O&M Grade:	0
Clock Start/From:	
Clock To:	
1st Value:	
2nd Value:	
Value Percent:	
Continuous Index:	
Within 8" of Joint:	NO
Remarks:	under water debris
