Profile/Photo Observation Report

Street:	Old Ridge Road	Flow Control:	Not Controlled
City:	Hobart, IN	Year Renewed:	
Location:	Light Highway	Tape/Media #:	DEP 17
Purpose:	Routine Assessment	Dia/Height:	18"
Use:	Sanitary	Material:	VCP
Drain Area:		Lining:	
Category:	NA		
Comment:			
Location Details:		Direction of Survey:	Downstream
US MH:	M-404-028	DS MH:	M-404-025
		Total Length Surveyed (ft):	87.0

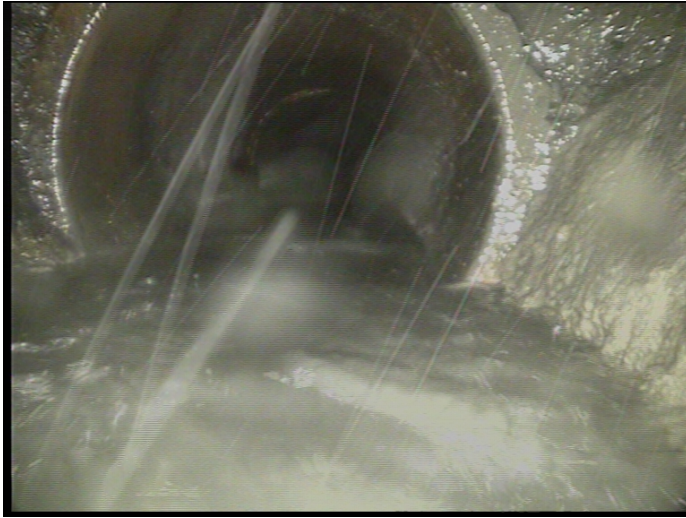
Code: **MWL**
Description: **Water Level**

Distance (ft): **.0**
Structural Grade: **0**
O&M Grade: **0**
Clock Start/From:
Clock To:
1st Value:
2nd Value:
Value Percent: **10.000**
Continuous Index:
Within 8" of Joint: **NO**
Remarks:

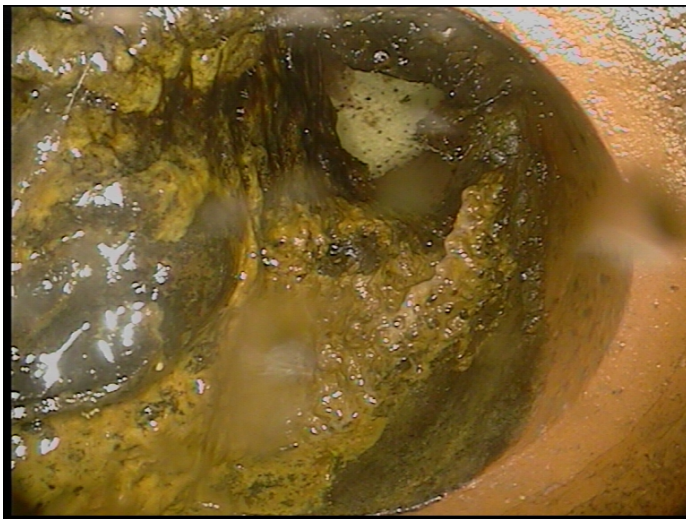
Code: **TFD**
Description: **Tap Factory Defective**

Distance (ft): **23.4**
Structural Grade: **0**
O&M Grade: **2**
Clock Start/From: **10**
Clock To:
1st Value: **4.000**
2nd Value:
Value Percent:
Continuous Index:
Within 8" of Joint: **NO**
Remarks: **Defective**

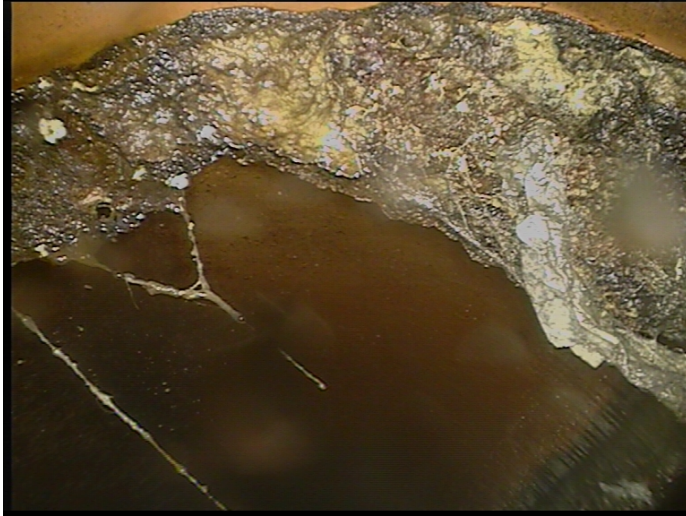
Code:	DAE
Description:	Deposits Attached Encrustation
Distance (ft):	35.1
Structural Grade:	0
O&M Grade:	2
Clock Start/From:	11
Clock To:	5
1st Value:	
2nd Value:	
Value Percent:	5.000
Continuous Index:	
Within 8" of Joint:	YES
Remarks:

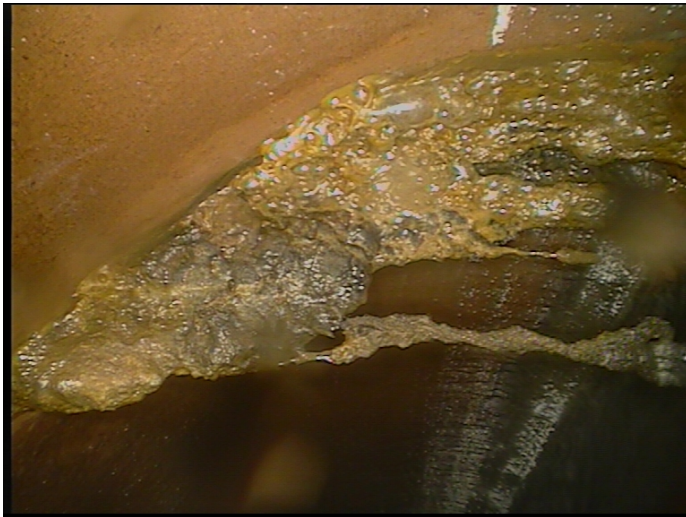
Code:	DAE
Description:	Deposits Attached Encrustation
Distance (ft):	60.4
Structural Grade:	0
O&M Grade:	2
Clock Start/From:	1
Clock To:	5
1st Value:	
2nd Value:	
Value Percent:	5.000
Continuous Index:	
Within 8" of Joint:	YES
Remarks:
